MARINE ACCIDENT

INVESTIGATION BRANCH

Summary of Investigations No 2/90

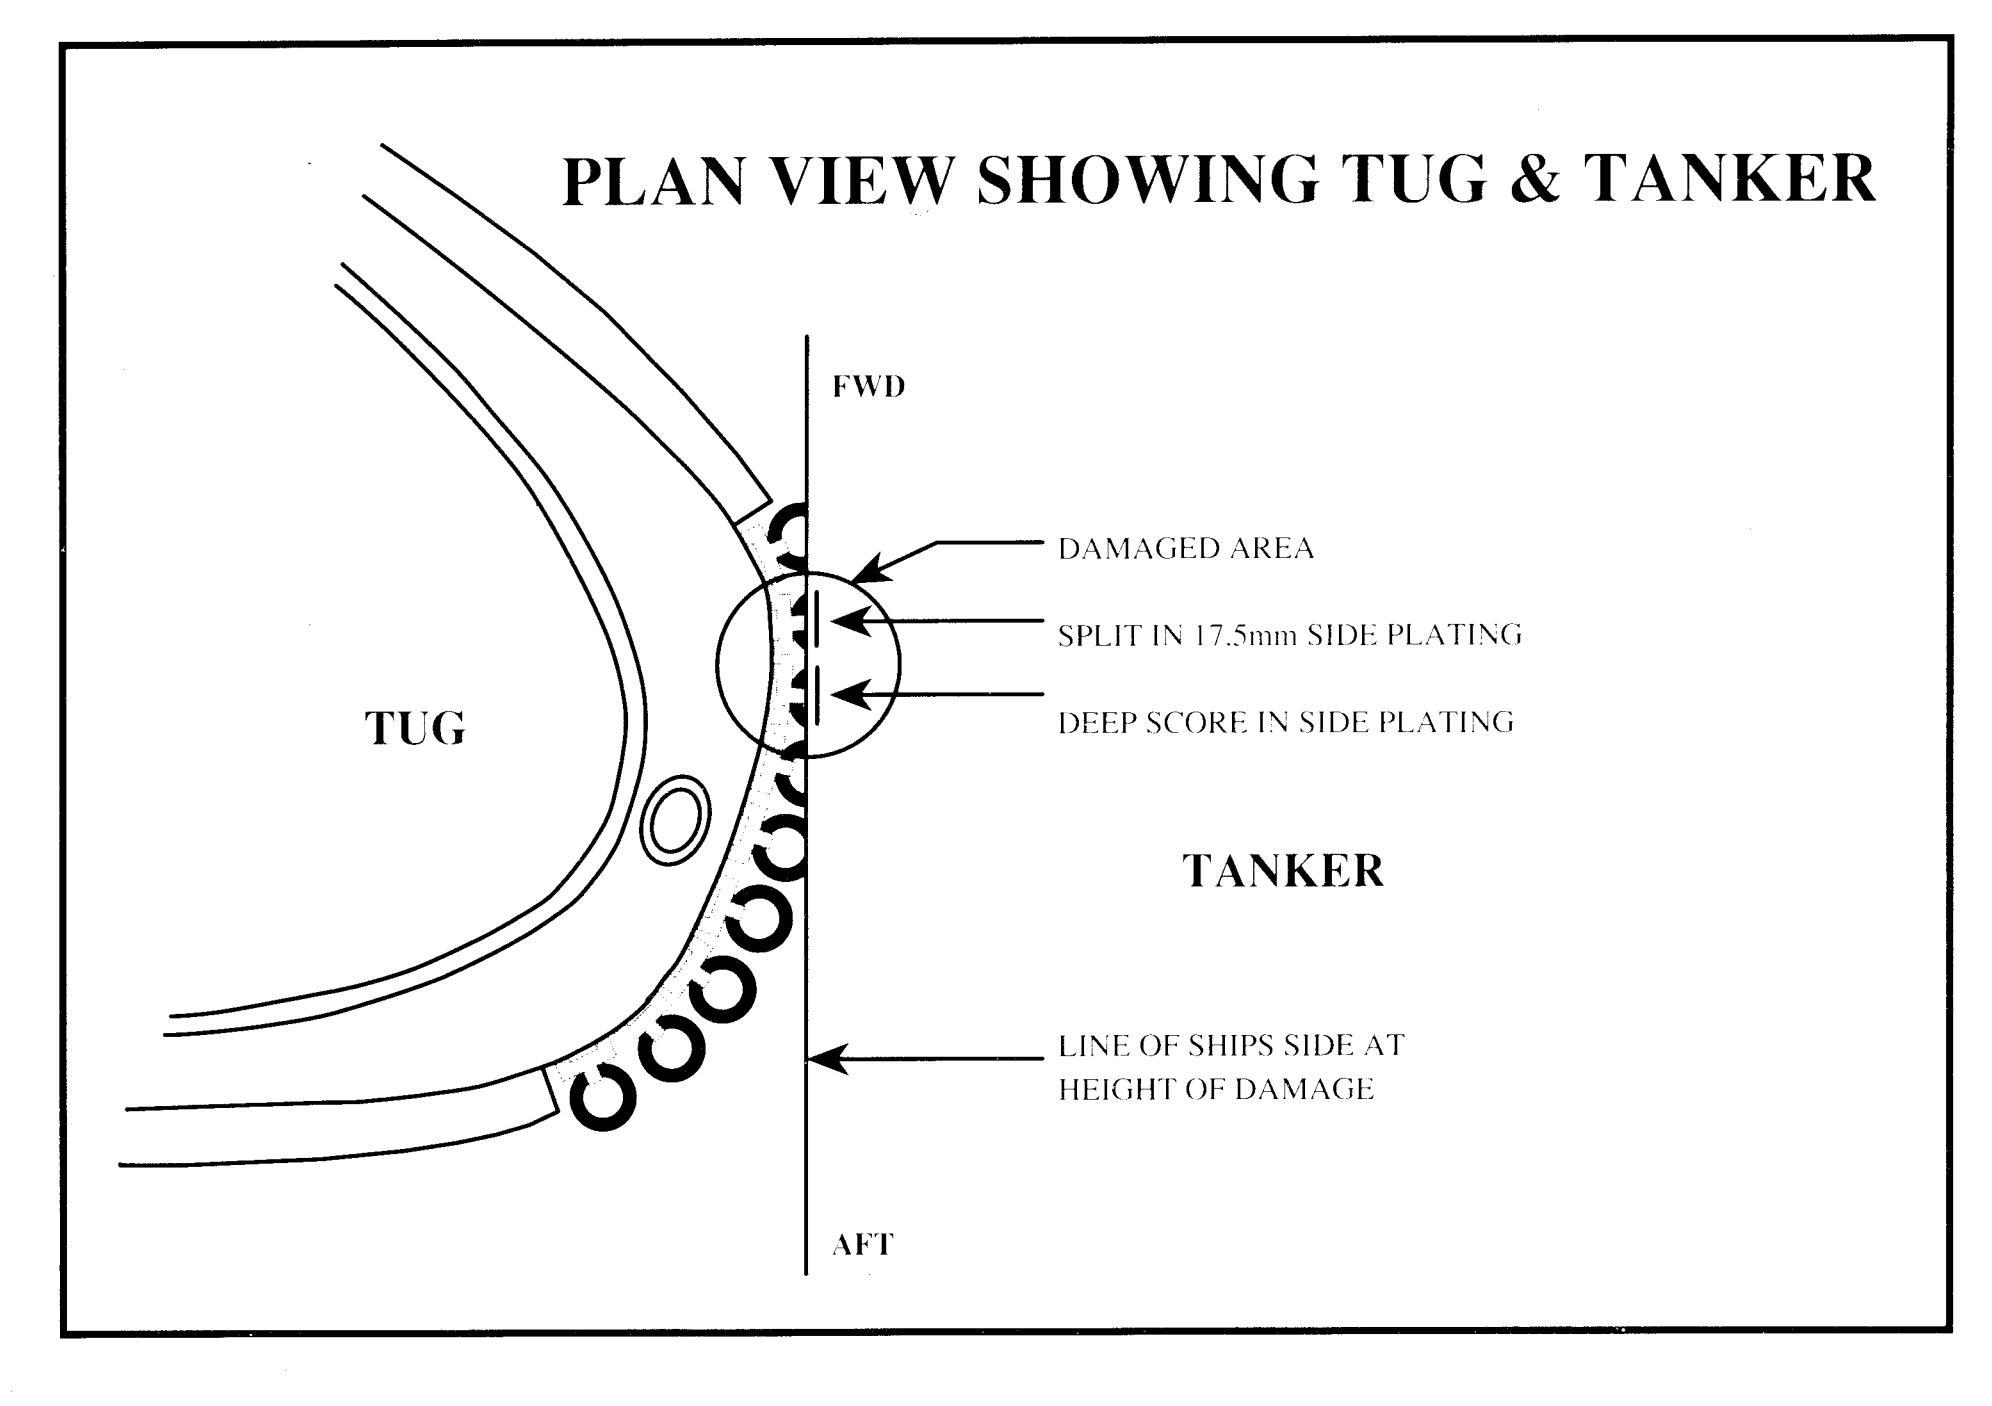
Figure 1

The oil came from the port bunker tank; action was quickly taken by plugging the hole from the outside and transferring the oil out of the tank, but just under 90 tonnes nonetheless escaped. Examination showed a fracture some 30 cms in length at the centre of the plating which was indented to a depth of 5 cms, with a deep score beginning 30 cms from the fracture and extending about 23 cms further aft. Apart from this damage, the plating was in good condition.

- 1. The tug had bow fendering made up of 9 lengths of 12 cms thick rubber tubing, held in place by vertical steel pins. The pins extended some 17 cms above the top of the rubber and each pin was rivetted into its own steel lug, this whole assembly being attached to the fender steel support structure. In elevation, the forward top corner of the lug presented a sharp edge, which was unprotected: see Figures 1 and 2.
- 2. Ordinarily, this did not matter when the tug was pushing against the vertical ship's side, for the impact was taken by the rubber fendering. In this instance, however, the point of contact between the tug and the ship was abaft the vertical side, so that the retaining lugs came into direct contact with the hull before the rubber fenders could cushion the blow. Moreover, for the same reason impact was concentrated on a much smaller area of contact than would be normal.

This accident would have been avoided if protection had been provided for the projecting part of the support assembly, by fitting additional rubber fendering. When this is not done, tugs with similar fender arrangements to that described above should be restricted to pushing only the vertical side of the ship being assisted.
