June 2020

HS2

Air Quality and Dust Monitoring Monthly Report - June 2020

Three Rivers District Council

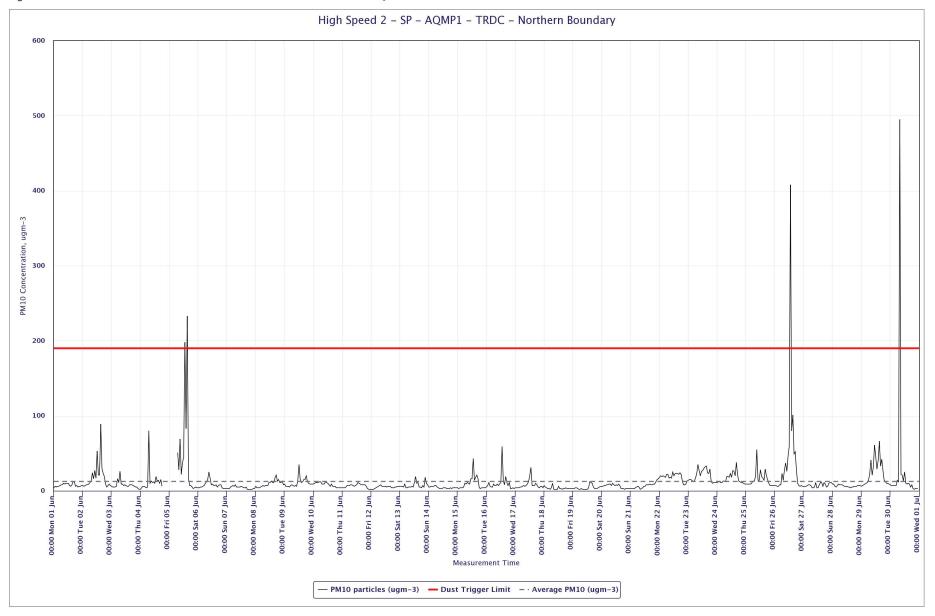
Figure 2: Continuous dust 1-hour mean indicative PM₁₀ concentration for SP-AQMP1-TRDC for June 2020

SP-AQMP1-TRDC	05/06/2020 13:01 - 14:00: 198.2 μg/m³	At the time of the trigger alerts, stripping of low-lying topsoil/grass and the creation of platform made up of type 1 aggregate was underway.	Dust suppression continued to be deployed, and works were completed when the second trigger alert was received.

1		T
SP-AQMP1-TRDC	05/06/2020 15:01 - 16:00: 233.2 μg/m³	These activities were taking place in close proximity to the monitor at approximately 10 m away. No dust plumes were visible on site and dust suppression was in place. Platform creation works are taking place close to the monitor, involving lime stabilisation works which is the likely cause of exceedance.	Contractors again reminded of the importance of good housekeeping measures and dust suppression techniques during this dryer period.
SP-AQMP1-TRDC	<u>26/06/2020</u> 13:01 - 14:00: 408.4 μg/m³	To avoid future exceedances, it has been agreed that the Wirgen mixer, which is an integrated machine which can spread and mix simultaneously, will be utilised in this area. The usual method is to dump lime and cultivate it in using the mixer on a different setting. This proposed method will be slower but creates less dust.	Immediate remedial measure was to allocate the tractor with the water bowser to the area shortly after the exceedance, to dampen down and minimise dust release.

Air Quality and Dust Monitoring Summary Report Three Rivers District Council	June 2020	
	For the stabilisation method to work, the area is not	
	able to be saturated any further prior to or during	ļ
	stabilisation, limiting the amount of damping down	ļ
	possible in the area.

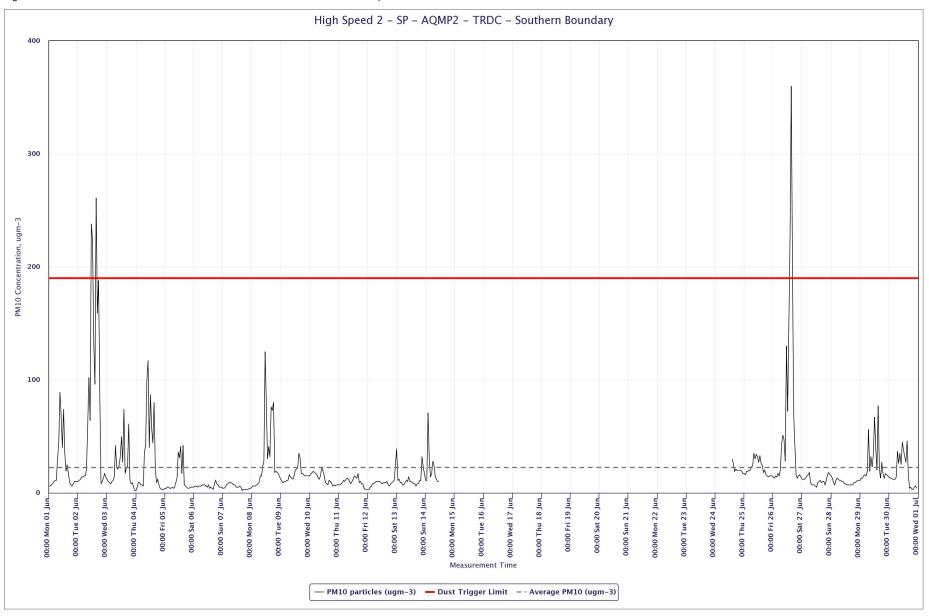
Figure 3: Continuous dust 1-hour mean indicative PM₁₀ concentration for SP-AQMP2-TRDC for June 2020

- 1.1.9 Data capture was below 90% for SP-AQMP2-TRDC for the month of June 2020. This was due to a damaged power cable and as a result no data was recorded between the 14/06/20 and the 24/06/20. The cable was replaced and monitoring resumed.

Monitoring Site ID	Period of trigger alert & Concentration recorded	Investigation	Outcomes / Resolution / Remedial measures implemented	
SP-AQMP2-TRDC	02/06/2020 11:01 - 12:00: 238.0 μg/m³	During the trigger alerts, there were two activities ongoing in proximity to the dust monitor. These activities are note attributable to ALIGN works, and	The concrete road was dampened down following the	
SP-AQMP2-TRDC	<u>02/06/2020</u> 12:01 - 13:00: 223.7 μg/m³	included:	trigger alerts and again during the morning of the next day (03/06) to prevent further trigger alerts.	
SP-AQMP2-TRDC	<u>02/06/2020</u> 15:01 - 16:00: 261.0 μg/m³	 Drainage works at gate 6 and septic tank excavation taking place; and Dust released from the concrete site road on which type 1 aggregate is stored, following excavator vehicle movements. 	With the current hot and dry weather being experienced, additional attention to ensuring good housekeeping measures are in place across the site in line with the Code of Construction Practice.

SP-AQMP2-TRDC	26/06/2020 14:01 - 15:00: 229.0 μg/m³	Haul road in use, with vehicles passing in close proximity to the monitor.	
SP-AQMP2-TRDC	26/06/2020 15:01 - 16:00: 360.0 μg/m³	Dust suppression is being carried out as and when required for Tilehouse Lane Cutting. A speed limit of 7 mph in the immediate location is controlled by a Traffic Marshal.	Immediate remedial measure was dampening down the Haul road to minimise dust release, however steep sections of the haul road are not damped down as this may cause vehicles to lose traction with the road, posing
SP-AQMP2-TRDC	26/06/2020 16:01 - 17:00: 198.3 μg/m³	The quarry road is still being used by the quarry, ALIGN are damping down the crossing point. To avoid future exceedances, Align will look at damping down more of the road.	health and safety risks to site personnel.
SP-AQMP1-TRDC	30/06/2020 08:01 - 09:00: 494.6 μg/m³	The new method involving the Wirgen mixer, which is an integrated machine which can spread and mix simultaneously, is now being utilised in this area for the platform stabilisation works. However, the plant is currently operating less than 1m from the Air Quality Monitor. The area was already dampened down as a result of the ongoing rain.	Works were stopped after the trigger alert was received, however due to the proximity of the monitor to the works and that the rainfall received had dampened down the area, no further action was taken. Works were slowly recommenced, and no further trigger alerts have been received.
