AAIB Bulletin: 6/2020	G-OENC	AAIB-25649
SERIOUS INCIDENT		
Aircraft Type and Registration:	Agusta Westland AW189, G-OENC	
No & Type of Engines:	2 General Electric Co CT7-2E1 turboshaft engines	
Year of Manufacture:	2017 (Serial no: 89002)	
Date & Time (UTC):	25 March 2019 at 1600 hrs	
Location:	Forties Charlie platform, Northern North Sea	
Type of Flight:	Commercial Air Transport (Passenger)	
Persons on Board:	Crew - 2	Passengers - 4
Injuries:	Crew - None	Passengers - None
Nature of Damage:	None	
Commander's Licence:	Airline Transport Pilot's Licence	
Commander's Age:	49 years	
Commander's Flying Experience:	14,000 hours (of which 600 were on type) Last 90 days - 16 hours Last 28 days - 16 hours	
Information Source:	Aircraft Accident Report Form submitted by the pilot

While operating to the Forties Delta platform the pilots misidentified and landed on the visually similar Forties Charlie platform.

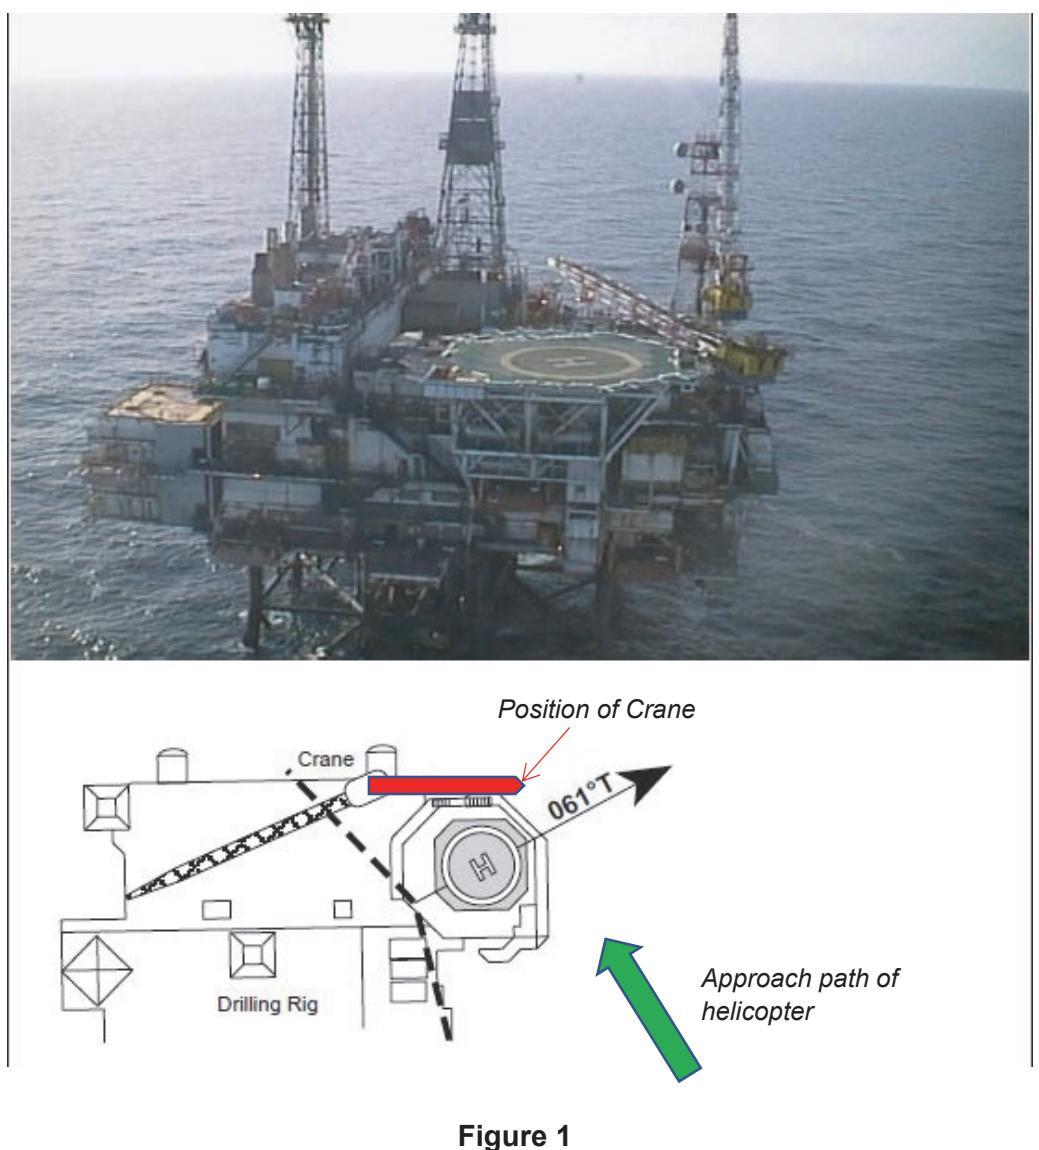
Forties Charlie (40C) platform

The 40A, 40B, 40C and 40D platforms look almost identical, with the helideck located on the north-east corner of the platforms, a central derrick and a vertical flare-stack on the south-west corner. Each has a crane on the northern edge of the platform adjacent to the helideck. The 40A platform is distinguishable from the other three by the addition of a bridge to a satellite platform on its western side. Both the 40C (Figure 1) and 40D (Figure 3) have their helidecks aligned on an identical heading of 061°T.

The crane on the 40C was not stowed as expected for flight operations, but this did not on its own reveal that the 40C was the wrong deck because the crane on the 40D was similarly not stowed.

Discussion between the pilots about the position of the crane on the 40C platform probably resulted in them switching their attention incorrectly to this platform and away from the 40D platform. The crane was not stowed on either platform, so did not serve as a distinguishing feature.

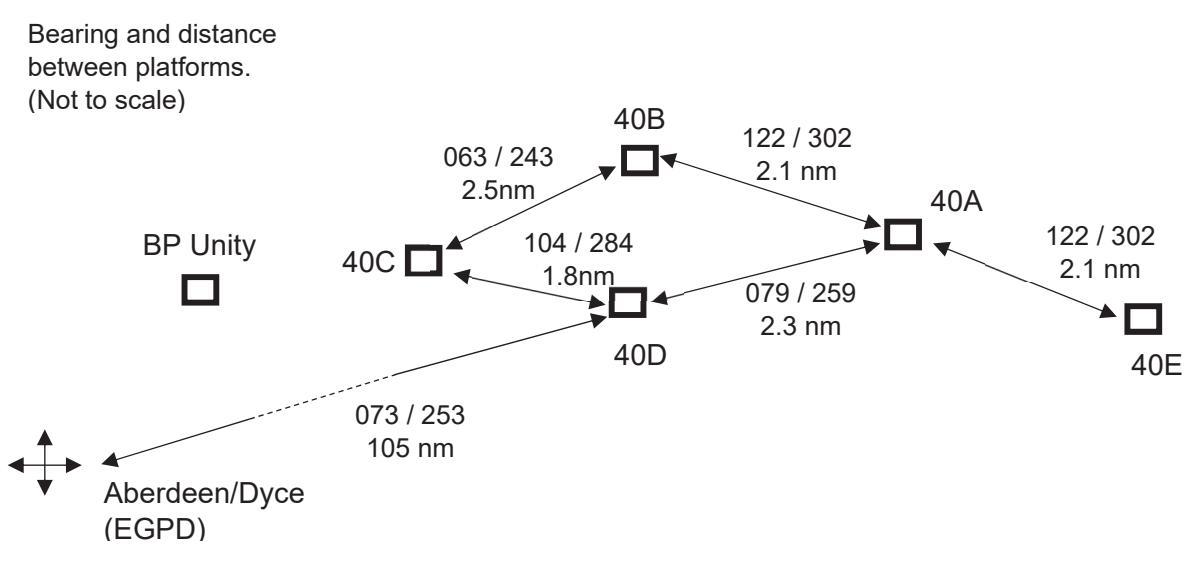
Figure 2 Forties field layout

The Forties field (Figure 2) is situated between 103 and 109 nm east of Aberdeen Airport and consists of five platforms. When viewed from height while approaching from Aberdeen, four of the platforms appear grouped in an elongated diamond with the 40C to the west, and the 40A to the east. The 40B is to the north and the 40D to the south, while the 40E lies to the east of this main group; the BP Unity platform is situated a few miles to the west.

The field layout means that, approaching from Aberdeen, the 40A platform is behind the 40D platform, with the 40C platform in front and slightly offset to the left. Once at 500 ft, the field will present a different visual perspective from that at height. Crucially, the 40A platform is likely to have been largely obscured behind the 40D platform and the pilots would only see one platform ahead, rather than the two they would expect, with the 40C platform offset to the left. It is possible they thought they saw the 40A platform ahead with the 40D platform offset to the left, when in fact the 40D platform lay ahead and the 40C platform was offset to the left. If so, this would have contributed to the subsequent mis-selection by the pilots and strengthened their expectation that the 40C platform was the destination platform.

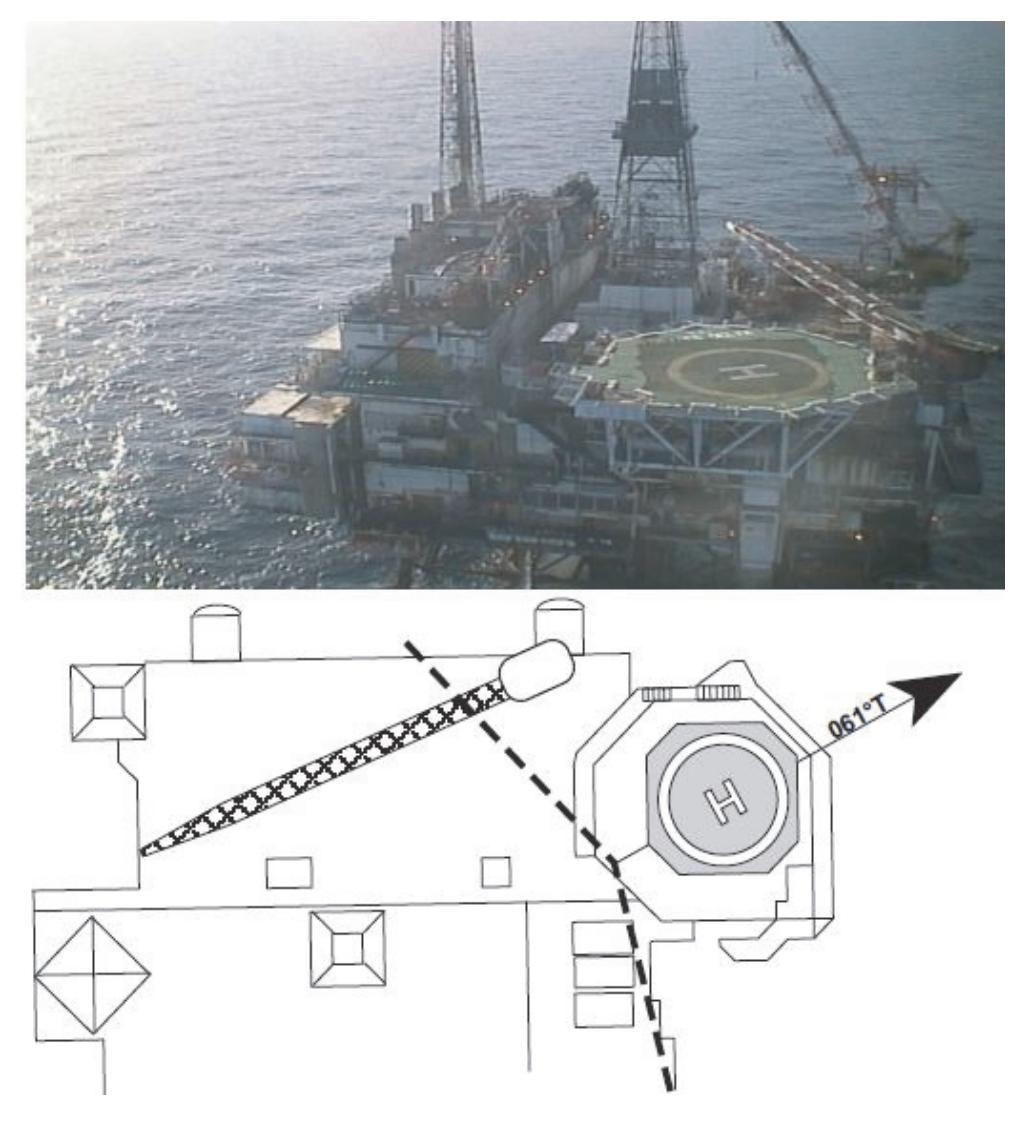
Figure 3 Forties Delta (40D) platform

The platform infrastructure on the 40D and the 40C is almost identical.

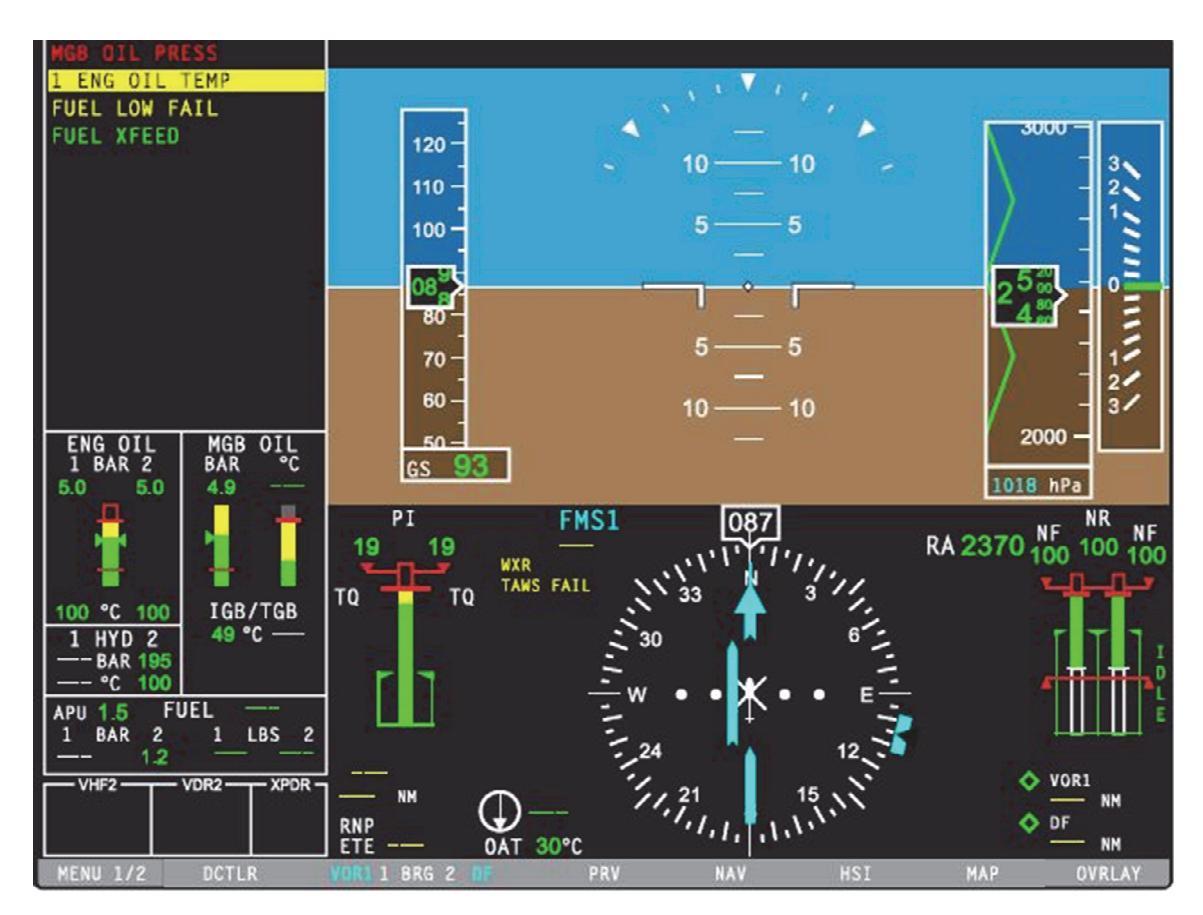
Figure 4

In the absence of a relevant standard operating procedure, crews had been encouraged during training to select the P-PLANT page on the inboard MFD to display engine parameters, which were considered relevant information to be displayed during the final stages of an approach and landing. This meant FMS navigation data was not displayed to the PM, whereas with the HSI mode displayed on the PFD the CDB would have indicated that the aircraft was left of track, highlighting that it was heading to the wrong destination.

Once the turn on to the final approach was complete the focus for the PF was primarily external, with the PM focusing on the key performance instruments (N_R , IAS, engine torque), rather than FMS navigation data. Selecting the P-PLANT page during the final stages of the approach encouraged a greater focus on engine parameters and probably led to the omission of the GPS cross-check.
