AAIB Bulletin: 1/2020	DJI Matrice 210	EW/G2018/10/23	
ACCIDENT			
Aircraft Type and Registration:	DJI Matrice 210 (UAS	DJI Matrice 210 (UAS, registration n/a)	
No & Type of Engines:	4 electric motors	4 electric motors	
Year of Manufacture:	2018 (Serial no: 0GC	2018 (Serial no: 0GODF680230091)	
Date & Time (UTC):	15 October 2018 at 1	15 October 2018 at 1245 hrs	
Location:	Merry Hill Shopping (Midlands	Merry Hill Shopping Centre, Brierley Hill, West Midlands	
Type of Flight:	Emergency services	Emergency services operations	
Persons on Board:	Crew - N/A	Passengers - N/A	
Injuries:	Crew - N/A	Passengers - N/A	
Nature of Damage:	Destroyed	Destroyed	
Commander's Licence:	Not applicable	Not applicable	
Commander's Age:	38 years	38 years	
Commander's Flying Experience:	6 hours (of which 6 w Last 90 days - n/k ho Last 28 days - n/k ho	6 hours (of which 6 were on type) Last 90 days - n/k hours Last 28 days - n/k hours

Synopsis

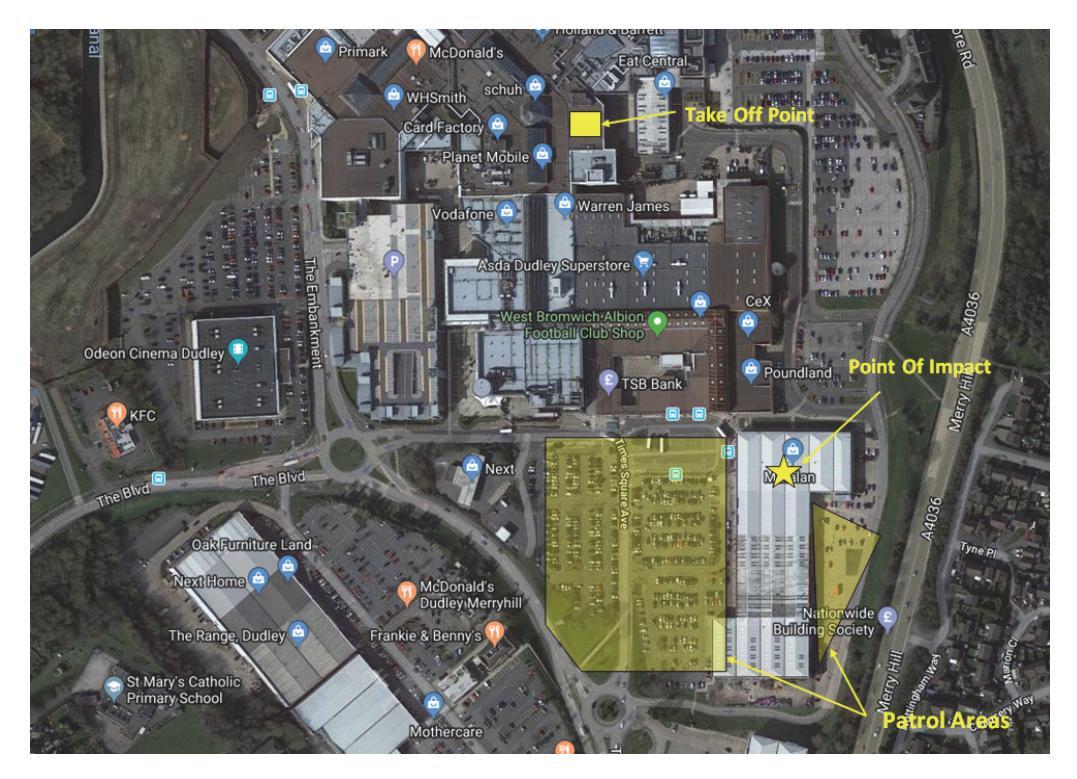
pilot brought the aircraft to a hover about 50 m above the roof of a shopping centre building. About one minute later, the aircraft suddenly dropped vertically and crashed into the roof of the building (Figure 1). The pilot had not made any control inputs and it was stated that there had been no warnings on the controller. The aircraft suffered severe damage (Figure 2).

Figure 1 Accident site location

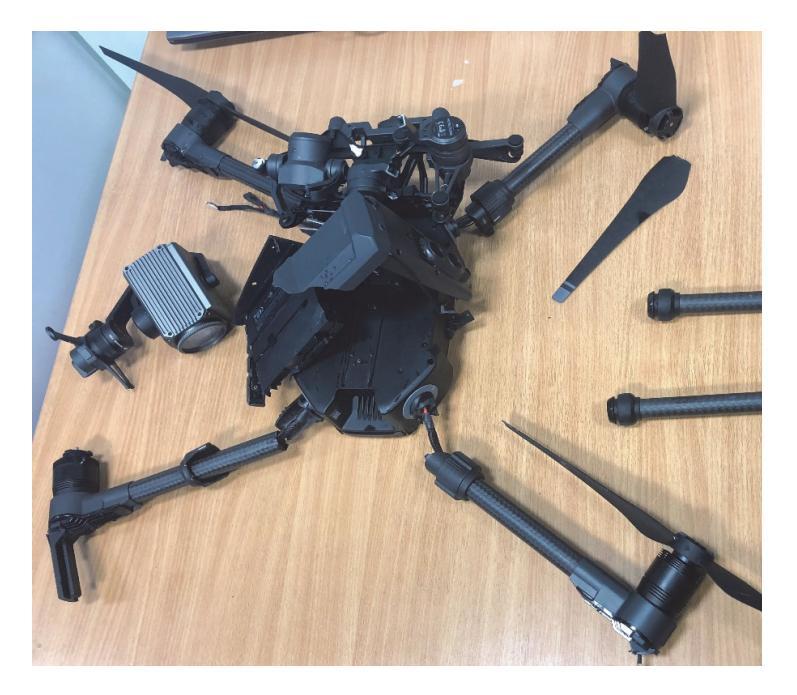
Figure 2 Damage to the aircraft

The recorded data from the aircraft indicated that the batteries were functioning normally and there was 22.8 V and 65% charge remaining on both batteries when it had hit the building. The manufacturer reviewed the data and confirmed that the loss of power which led to a loss of lift and control was caused by failure of the No 4 (right front) motor electronic speed controller.
