AAIB Bulletin: 3/2021

Alauda Airspeeder Mk II

#### ACCIDENT

Aircraft Type and Registration:	Alauda Airspeeder M	lk II, (UAS, registration n/a)
No & Type of Engines:	4 brushless DC elect	ric motors
Year of Manufacture:	2019	
Date & Time (UTC):	4 July 2019 at 1140 I	nrs
Location:	Goodwood Aerodron	ne, West Sussex
Type of Flight:	Demonstration flight	
Persons on Board:	Crew - None	Passengers - None
Injuries:	Crew - N/A	Passengers - N/A
Nature of Damage:	Destroyed	
Commander's Licence:	Remote Pilot Licence	9 <sup>1</sup>
Commander's Age:	22 years	
Commander's Flying Experience:	20 hours (of which 1 Last 90 days - 3 hou Last 28 days - 1 hou	8 were on type) rs r
Information Source:	AAIB Field Investigat	tion

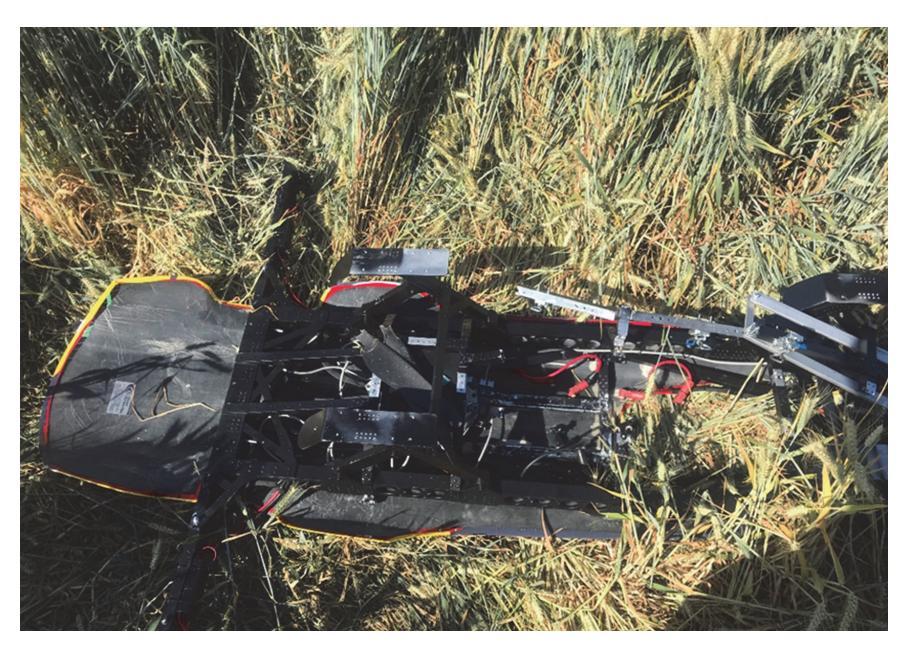
The UA came to rest inverted in a field of wheat, 875 m south-south-west of the takeoff point. The crop was dry and there was no post-impact fire. The accident site was 40 m from the nearest building which was in a group of houses on the north-eastern edge of Chichester, (Figure 4).

By the time the AAIB arrived, the operator had removed the main battery and placed it away from the crop (Figure 5).

**Figure 5** UA as found (inverted) at the accident site

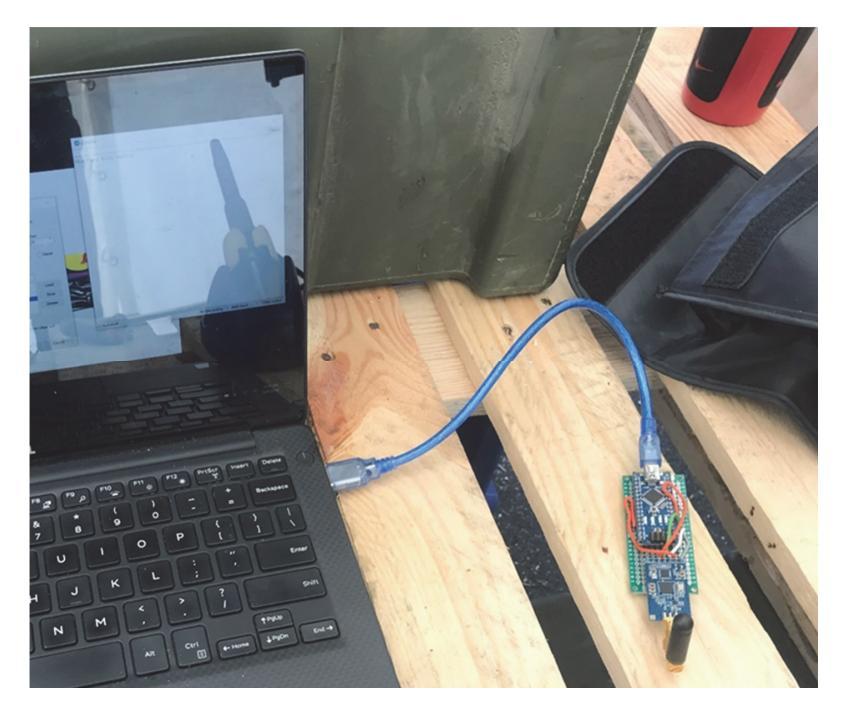
The ground-based part of the kill switch was a transmitter connected to a laptop via a trailing USB cable. All of the transmitter's electronics were exposed with no protective enclosure and, when used, the antenna and electronics hung underneath the laptop on the USB cable (Figure 8).

Figure 8 Ground-based kill switch

To activate the kill switch, a spotter was required to enter a command into a terminal on the laptop which communicated this to the USB transmitter. There was no two-way communication in the kill switch system. This meant that if connectivity was lost, it would remain unknown until an attempt was made to use the system.

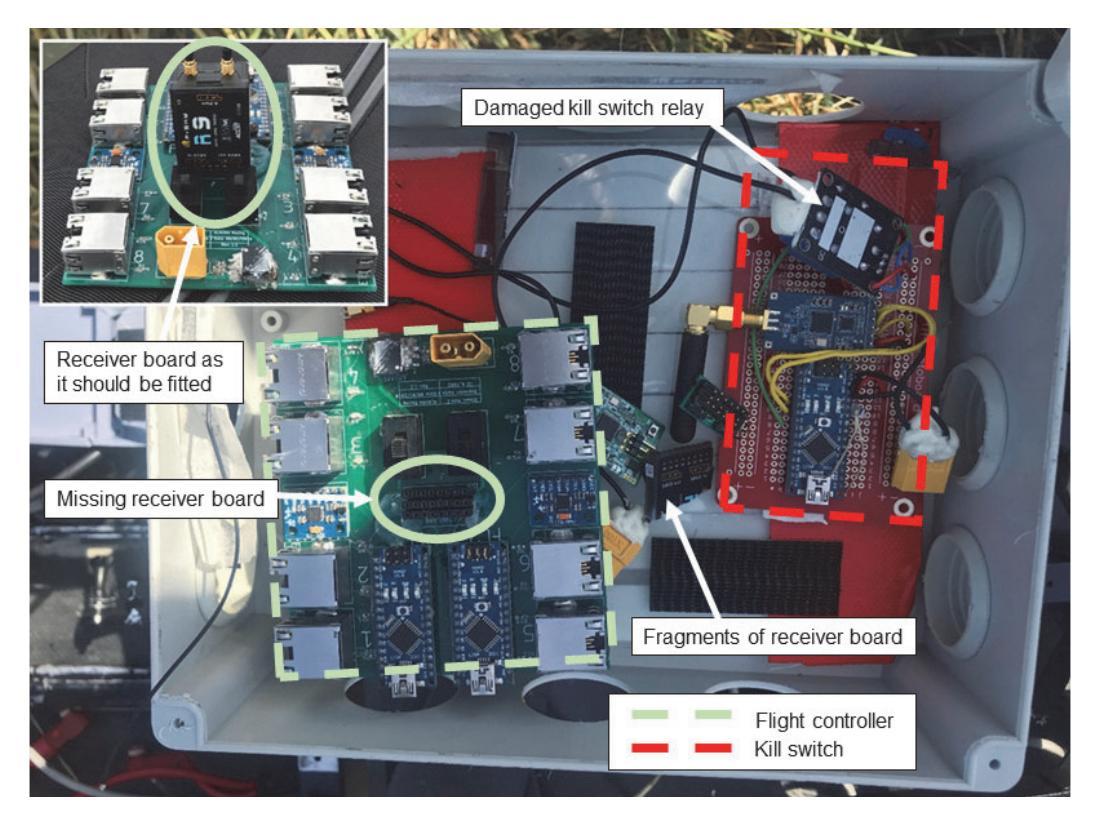
The flight control circuit board was present, but the operator had disconnected the ESC connection wires prior to AAIB arrival. The radio receiver, which was normally slotted into the circuit board, had detached and broken into several pieces (Figure 9). This damage was likely caused in the impact. Failure or loss of this component would lead to loss of link between the UA and pilot.

Initial examination of the on-board kill switch circuit board showed that the relay and one of the battery power supply leads had detached from the board. Loss of either of these components would render the kill switch inoperative. The antenna and the rest of the components all appeared to be in place.

Figure 9 Flight controls box at accident site

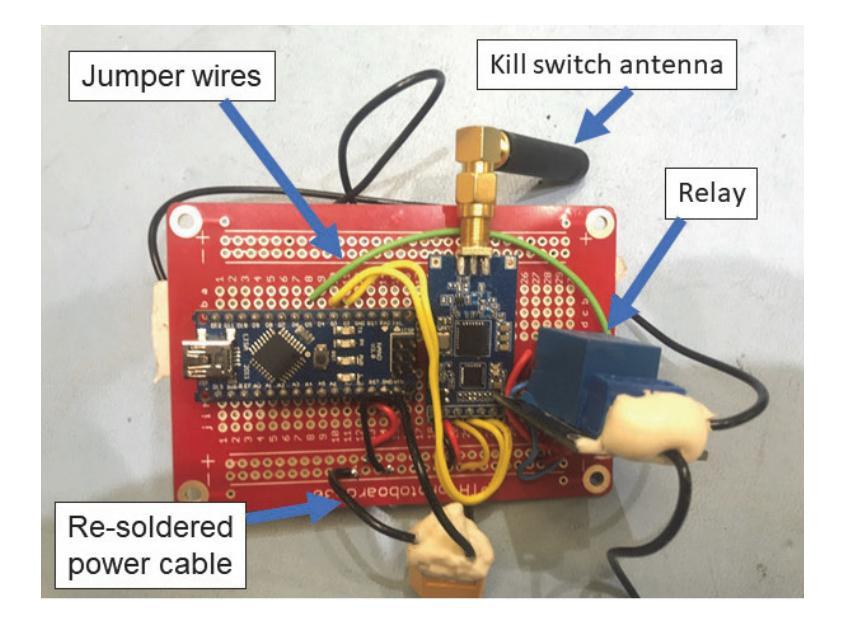
Initial examination of the circuit boards revealed some concerns regarding build quality and workmanship. The boards were populated with 'hobbyist' components with exposed wiring, large amounts of solder and lumps of adhesive. The kill switch used an electronics prototyping board with a number of jumper wires instead of a printed circuit. Failure of any of these wires would render the kill switch inoperative (Figure 10).

Figure 10 Kill switch on-board circuit board

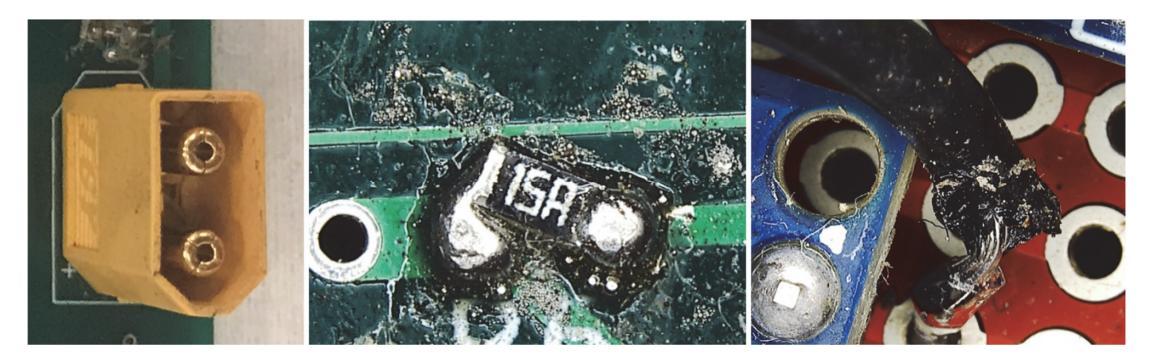
The examination revealed a number of issues with the flight control system and both the airborne and ground-based kill switch assemblies. All the assemblies failed an evaluation against all IPC A-610 classes due to quality and workmanship issues. Examples included misaligned components, burnt insulation, the use of solder bridges, excessive flux residues and a power connector that appeared to be installed in the incorrect orientation when compared to the drawn orientation on the circuit board (Figure 11).

Figure 11

Power connector installation, solder bridge and evidence of burnt insulation

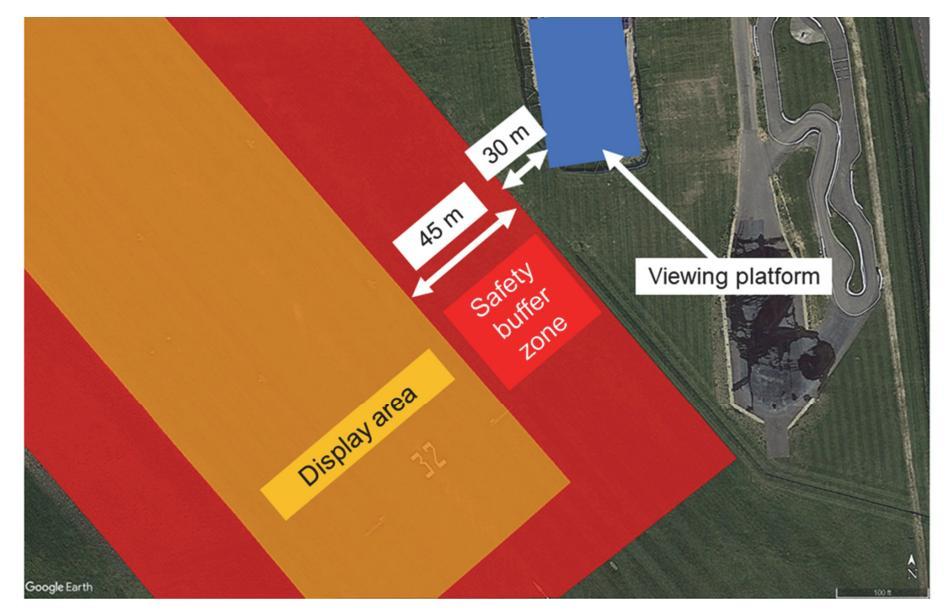
The display area dimensions (orange area in Figure 14) defined in the OSC were approximately 90 m x 450 m, with the safety buffer zone extending towards the viewing platform by 45 m. The viewing platform was 30 m from the edge of the red safety buffer zone (Figure 13).

**Figure 14** Viewing platform distances from display area and safety buffer zone

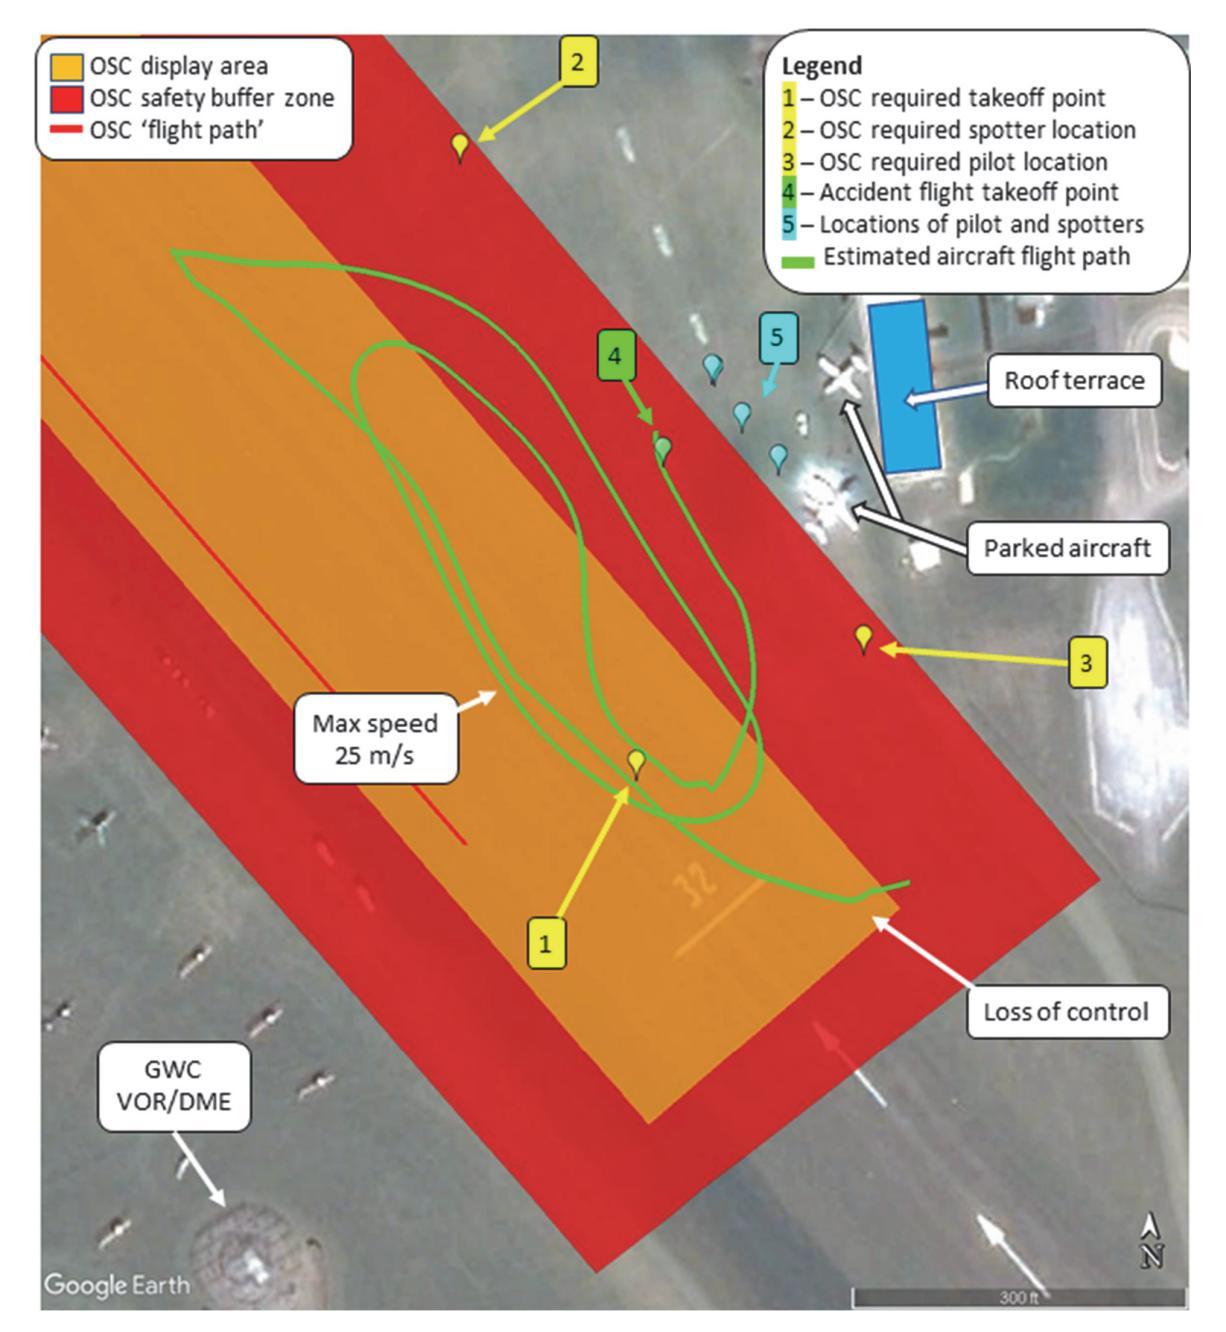
Figure 16 shows the takeoff location detailed in the OSC and the takeoff location ascertained from the video analysis. The aerial imagery is from a satellite image taken on the day of the accident. The aircraft took off 60 m from the aerodrome building and approximately 85 m from the designated takeoff / landing area.

# Figure 16

Overhead view of Goodwood Aerodrome showing estimated aircraft flight path, location of personnel and their required locations. © CNES (2019), Distribution Airbus DS

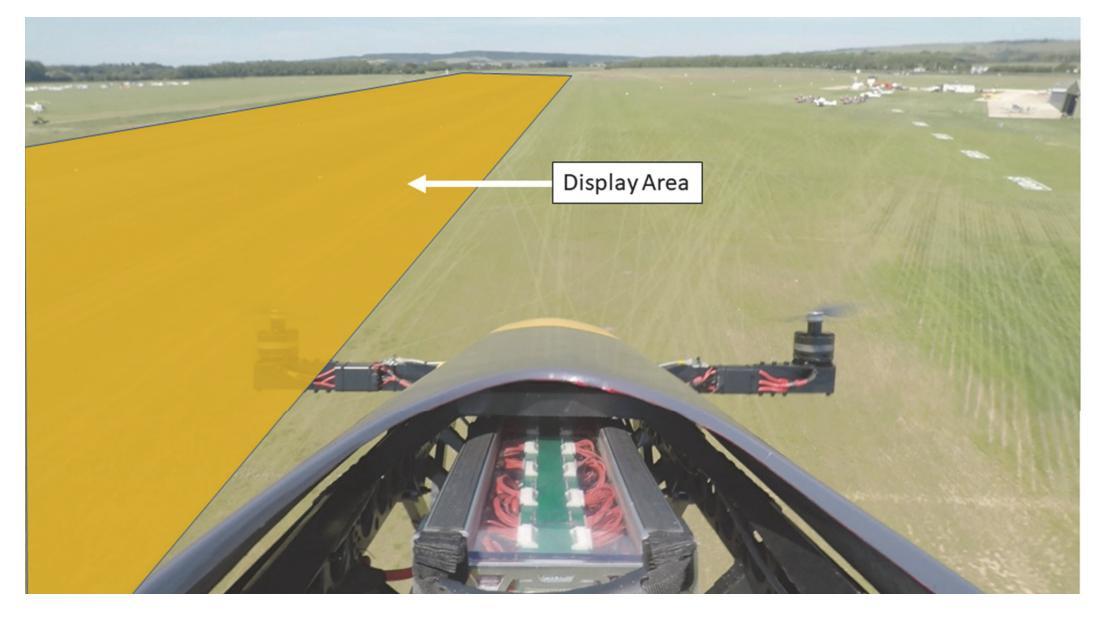
After takeoff, the aircraft tracked directly towards the threshold of Runway 32 at low speed, no post-takeoff control check was performed. The display then consisted of a number of runs past the aerodrome building where the aircraft initially pitched down to increased speed, before pitching up again to slow down prior to a turn. Parts of the first and third passes (left to right for the spectators) were performed within the safety buffer zone (Figure 18); the second and fourth passes were within the designated operating area (Figure 16).

**Figure 18** Aircraft on first pass to the east of Runway 32 inside the safety buffer zone

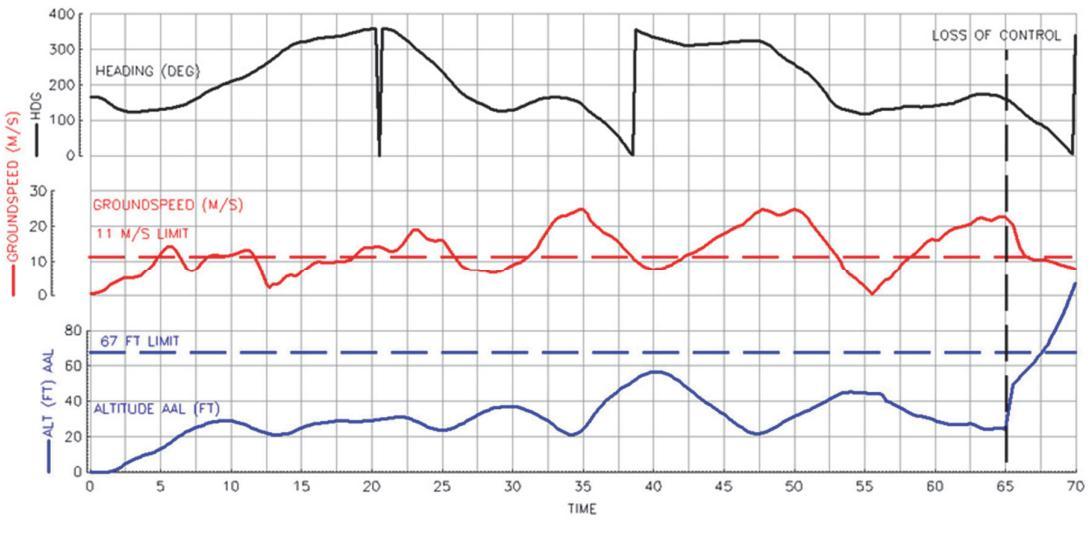
The calculated altitude during the display was within the CAA's exemption limit of 67 ft (20 m) but the groundspeed was in excess of 11 m/s on a number of occasions. The average groundspeed for the display was 12.9 m/s with a maximum of 25 m/s (Figure 19). With the aircraft at 20 m height and 25 m/s, using the CAA's calculations, the aircraft would travel 50 m if the kill switch was activated or power was lost.

Figure 19

Derived heading, groundspeed and altitude from video analysis

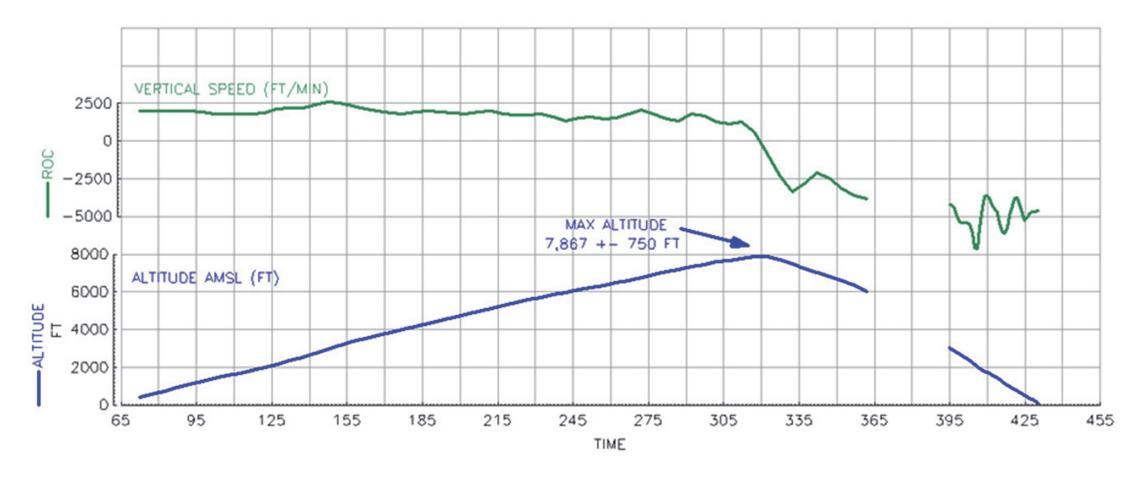
As per design, the aircraft continued at its previous throttle setting and with the self-levelling function, began a climb with a yaw rate of approximately  $40^{\circ}$ /sec. The aircraft climbed, uncontrolled, for 4 minutes 12 seconds, initially at around 2,000 ft/min. The rate reduced towards the top of the climb as the battery became depleted (Figure 20). The accuracy of the altitude estimation decreased as the altitude increased so a precise maximum altitude could not be established. The video analyst estimated this as 7,867 ft with an estimated error margin of  $\pm$  750 ft (see also below).

Figure 20

Altitude and vertical speed profiles. Note gap in the data is where analysis was not performed.

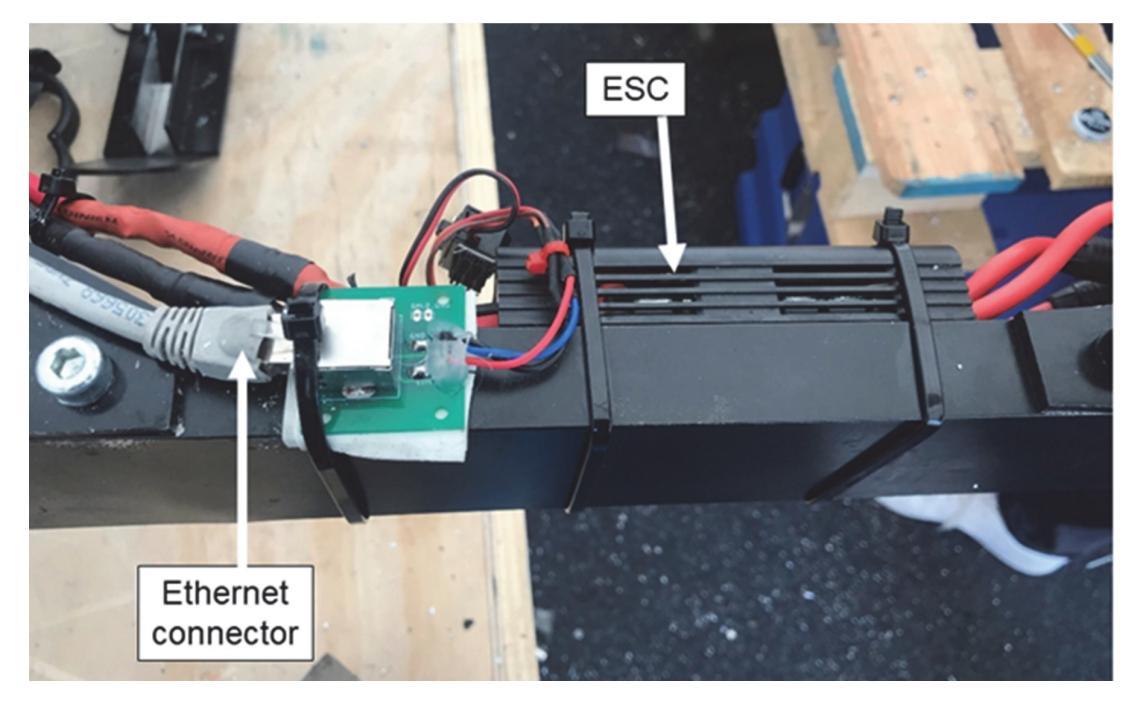
The construction of the aircraft used a large number of plastic tie-wraps to keep components in place. This included the ESCs, cabling and the connector plates from the control system ethernet cables to the ESCs (Figure 22). Failure of any of these connectors or cables would render the aircraft uncontrollable.

Figure 22 Ethernet cable, connector plate and ESC

For the flight controller, the primary mode of failure was identified as disconnection of cables linking the flight control box and the ESCs. The OSC stated '*To mitigate the risk of signal cable dislodgement due to vibrations or external forces, self-locking Cat-6 cables have been installed on the aircraft*'. This referred to cabling usually used for ethernet connections.
