Aquatic and riparian plant management:  
controls for vegetation in watercourses

Case study report

Project: SC120008/R3

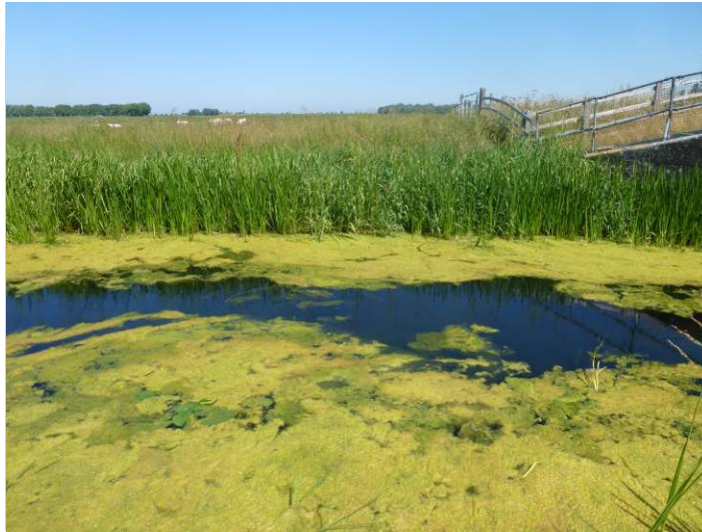
**Figure 4-3 Extensive algae (*Cladophora*) cover at Eldernell**

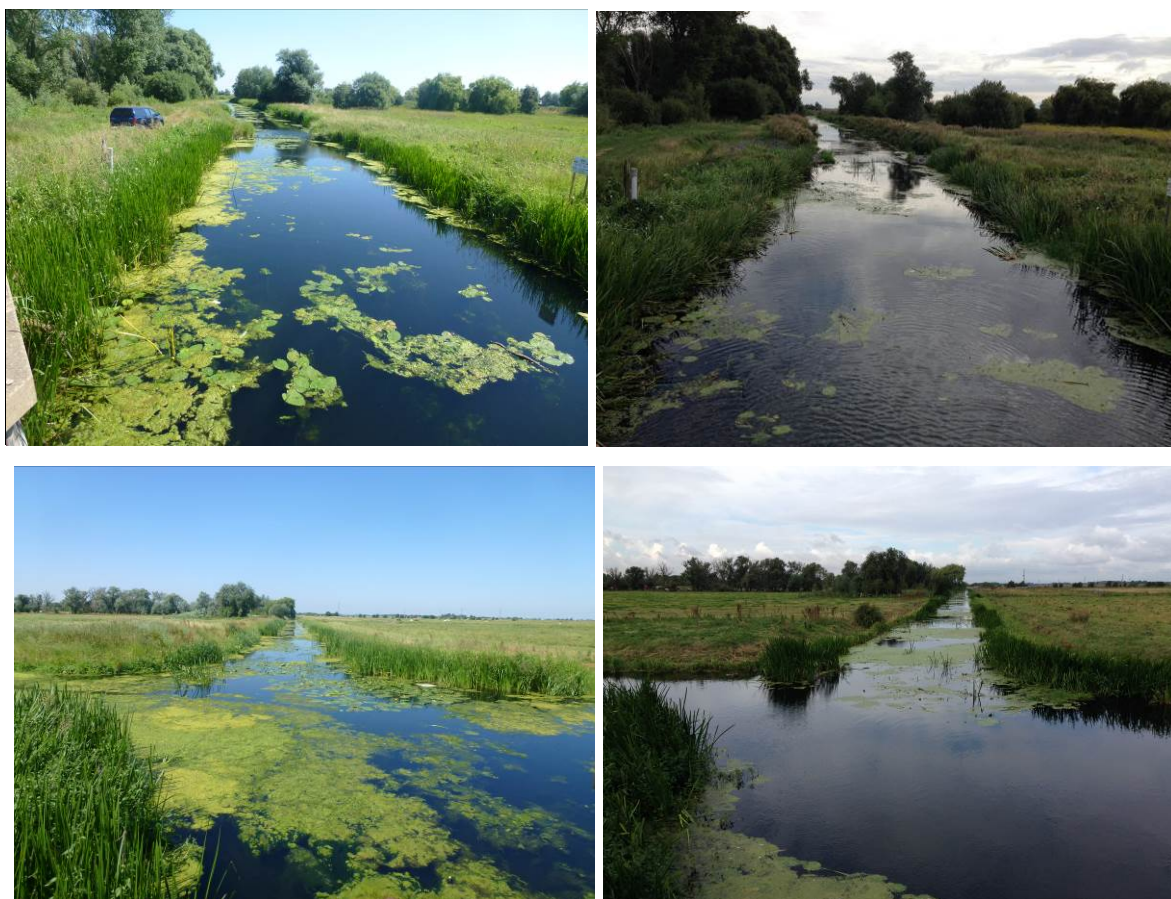
- The amount of algae in the channel in 2014 was significantly less than noted in 2013, when it was abundant/dominant in the channel. It is uncertain, however, if this is a result of the management undertaken or due to weather conditions, or to what extent each factor has influenced algal growth. When the survey was conducted in 2013 weather conditions were very hot which can cause excessive

- The amount of in-channel submerged and floating vegetation, in particular yellow water-lily, observed in 2013 and 2014 was very similar. Although upstream of the bridge at Little Bridge less submerged vegetation was present, with more open water (see Figure 4-6).

**Figure 4-6 Little Bridge in August 2013 (left) and August (2014) showing the significant decline in algae cover**

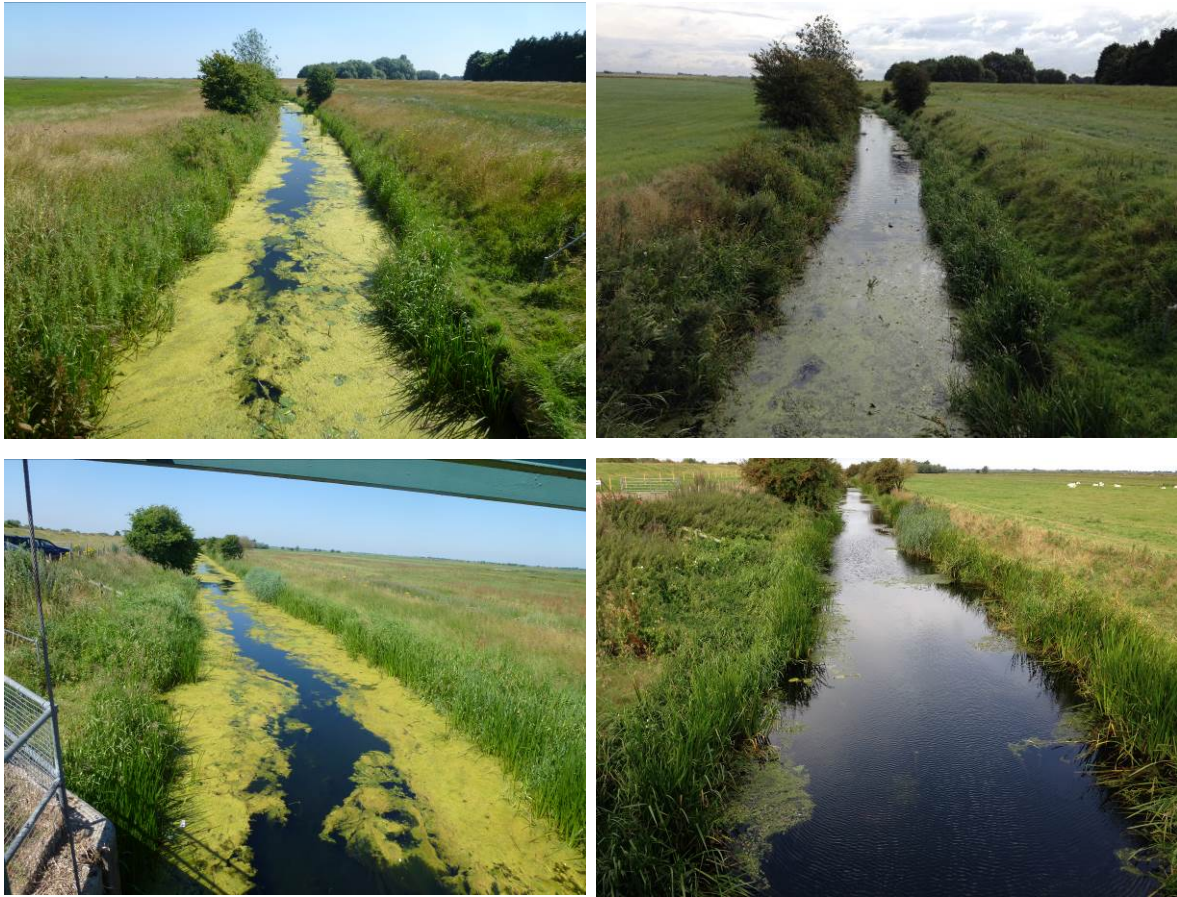
**Figure 4-7 Eldernell in August 2013 (left) and August 2014 (right) showing the significant decline in algae cover**

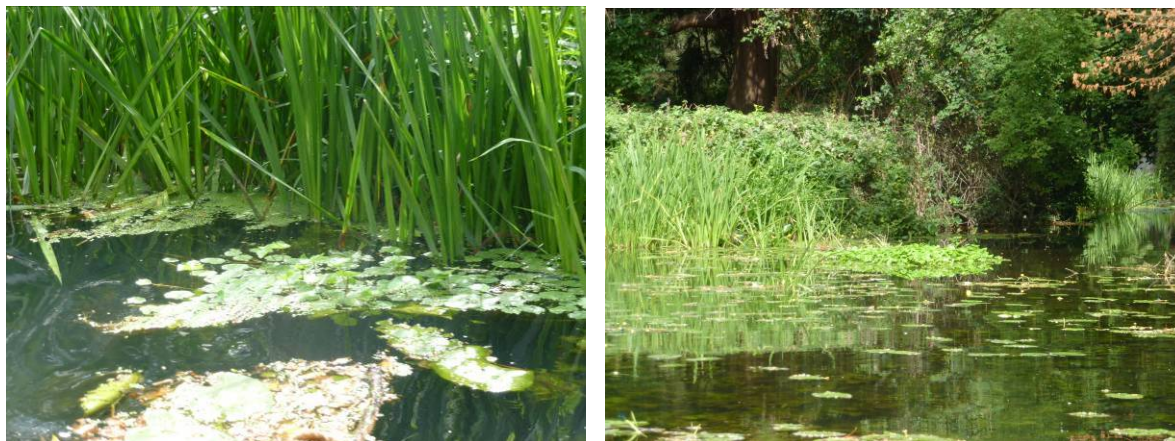
When the survey was conducted in July 2013, however, it was apparent that previous years of management had been successful, with very few areas of infestation found. Where this species was found it was only in small, localised patches, generally interspersed within stands of other species (generally branched bur-reed *Sparganium erectum*) and beneath structures that protruded into the river including decking and docking platforms (Figure 5.3).

**Figure 5-3 Floating pennywort infestation on the River Mole**

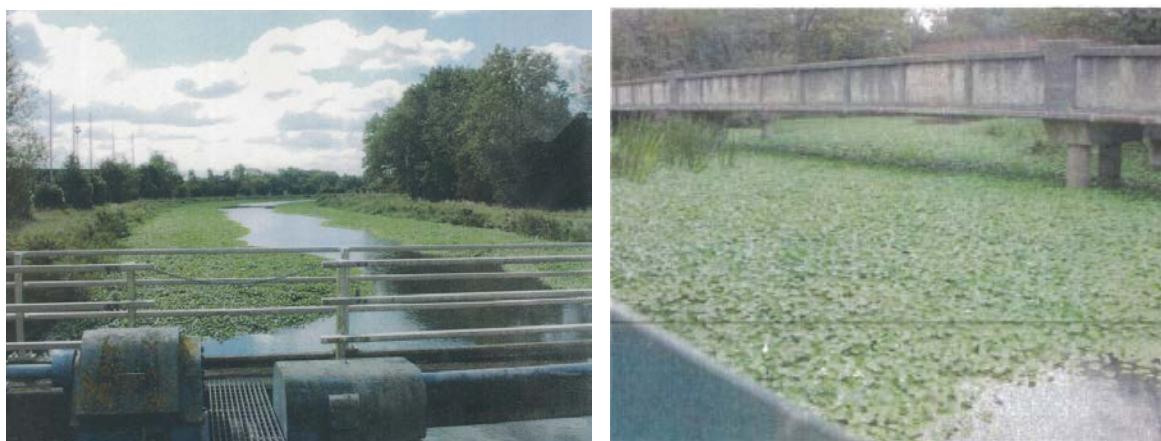
Historically the infestation of floating pennywort along this stretch of river has been much more extensive and problematic than what was evident during the 2013 site visit. Figure 5.4 shows the extensive rafts of this species that have formed in previous years.

**Figure 5-4 Floating pennywort Infestation at Island Barn sluice (left) and Royal Mills (right) (courtesy Michele Cooper, Environment Agency)**

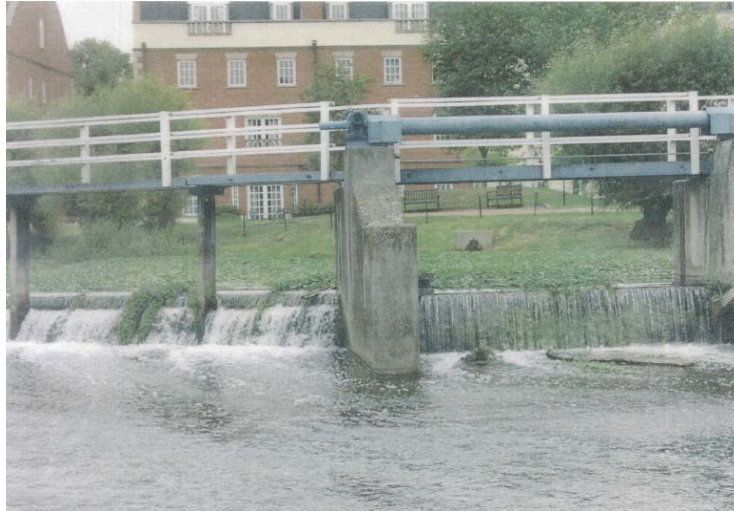
Floating pennywort is controlled primarily for flood risk management purposes as it has a tendency to block structures when it forms large rafts. Although the flood relief channel (the River Ember) constructed in the 1970s has reduced flood risk for the area, the blocking of weirs and sluices can have a localised impact. Figure 5.5 illustrates this issue at Zenith Weir in 2002.

**Figure 5-5 Zenith Weir in 2002 (courtesy Michele Cooper, Environment Agency)**

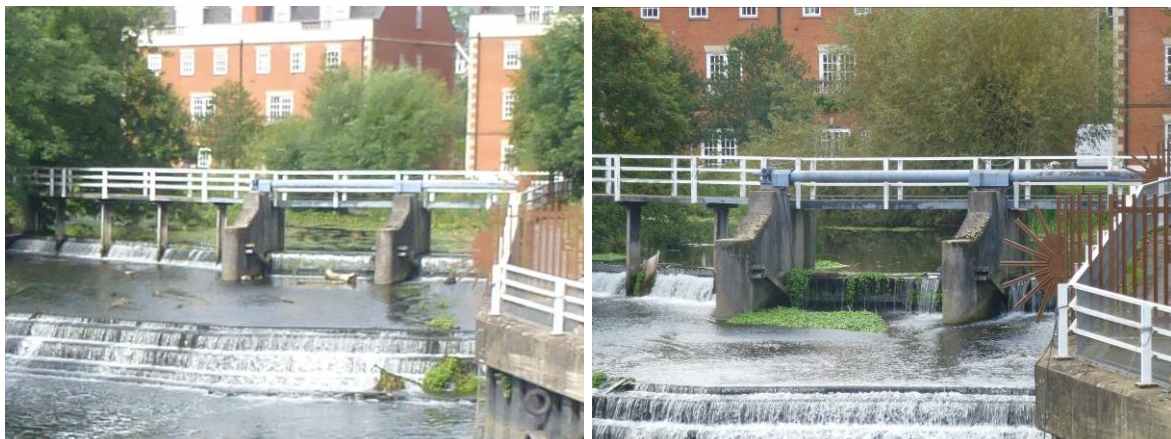
The return site visit identified that floating pennywort was still problematic within the River Mole, with some significant areas of this plant noted, and an increase observed from 2013 (see Figure 5-11). Rafts of floating pennywort were observed floating along the river, with some having accumulated around Zenith Weir (see Figure 5-11).

**Figure 5-11 Zenith Weir in July 2013 (left) and October 2014 (right)**

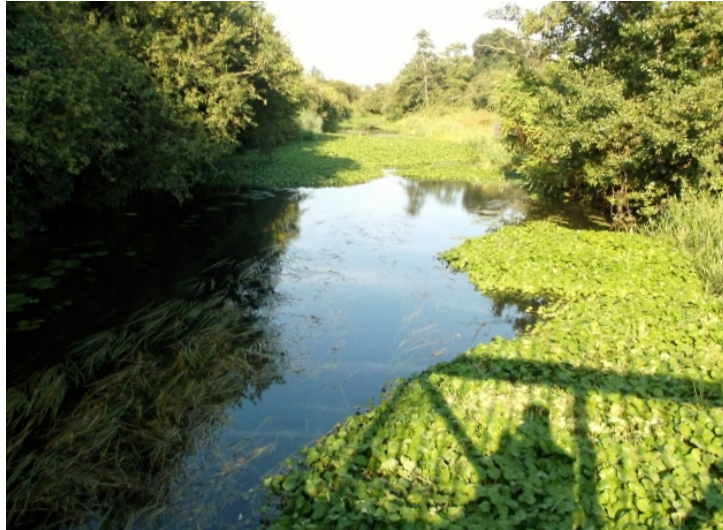
During the site visit this species was generally observed as only present in small patches alongside the margins of the watercourse. However, liaison with the Environment Agency indicated that earlier in the year the extent of the floating pennywort had been particularly severe, with the mild spring resulting in denser and earlier than anticipated growth. As a

consequence, the maintenance teams were not able to implement their early intervention approach which had been employed so successfully in 2013, and as a result the stands became extensive.

**Figure 5-12 Extent of floating pennywort on the River Mole in summer 2014 (courtesy Mary Seabourne, Environment Agency)**

Once the severity of the problem was identified, the management technique as employed in 2013 was implemented; this included manual removal of floating pennywort patches from the watercourse using hand rakes from both the bankside and boat.

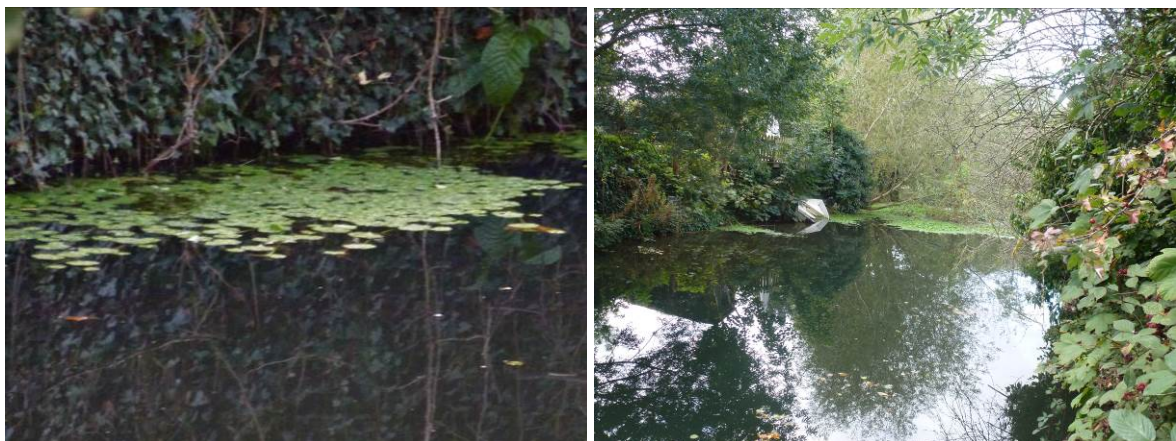
**Figure 5-13 Patches of floating pennywort observed on the River Mole in October 2014**

By October 2014, the extent of floating pennywort at the River Mole, although more than observed in 2013, was still in relatively small patches along the watercourse margins indicating that once the management had begun in 2014, it was relatively successful in limiting the extent of this species.

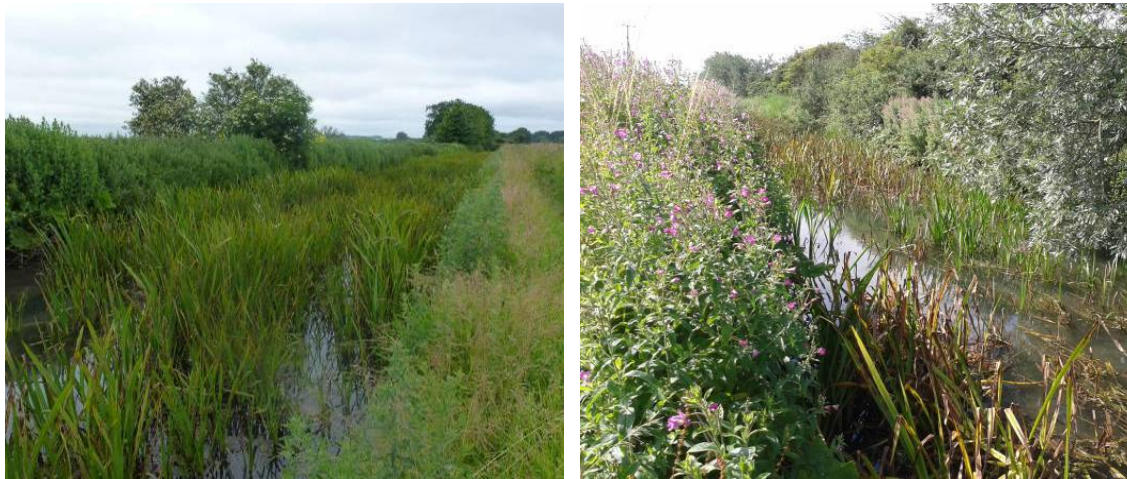
Chemical control was undertaken by the Environment Agency's contractor the week before the site visit. The spraying was undertaken by one operative from within the channel using a knapsack sprayer, which allowed for targeted control of the emergent branched bur-reed. Figure 6.3 shows the effects of spraying.

**Figure 6.3** Extent of branched bur-reed (left) and effects of spraying (right)

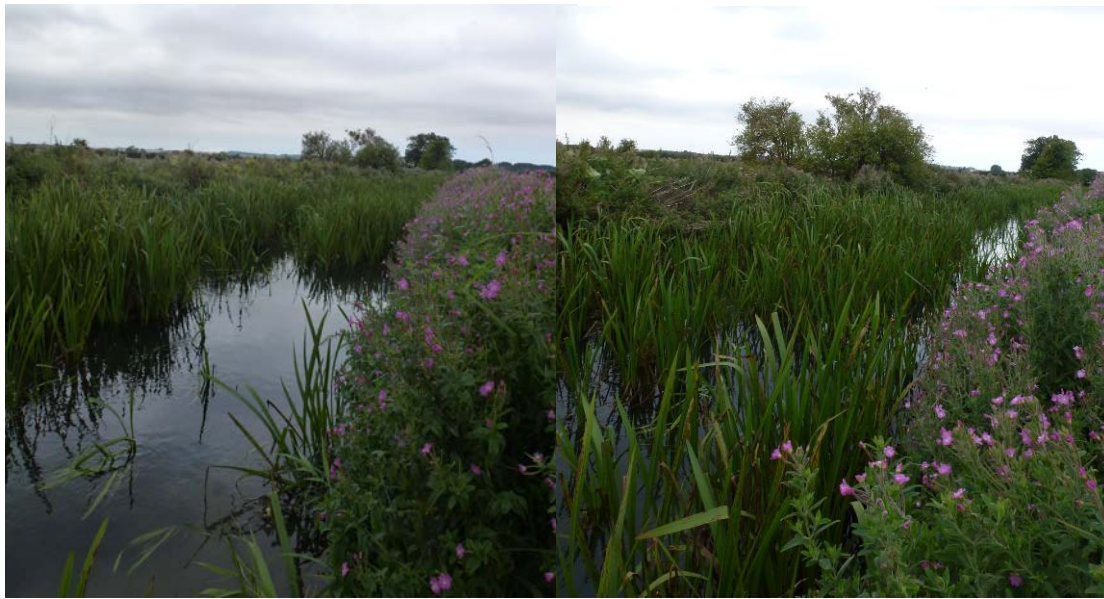
No submerged or floating species were found to have colonised the open water areas but this is likely due to the shallow depth of water and the high level of nutrients present.

**Figure 6.4 Extent of branched bur-reed in summer 2014**

Consideration should be given in the future to longer term management techniques such as shading, nutrient/pollution management and/or channel narrowing/deepening to manipulate the environmental conditions to help to limit the growth of branched bur-reed.

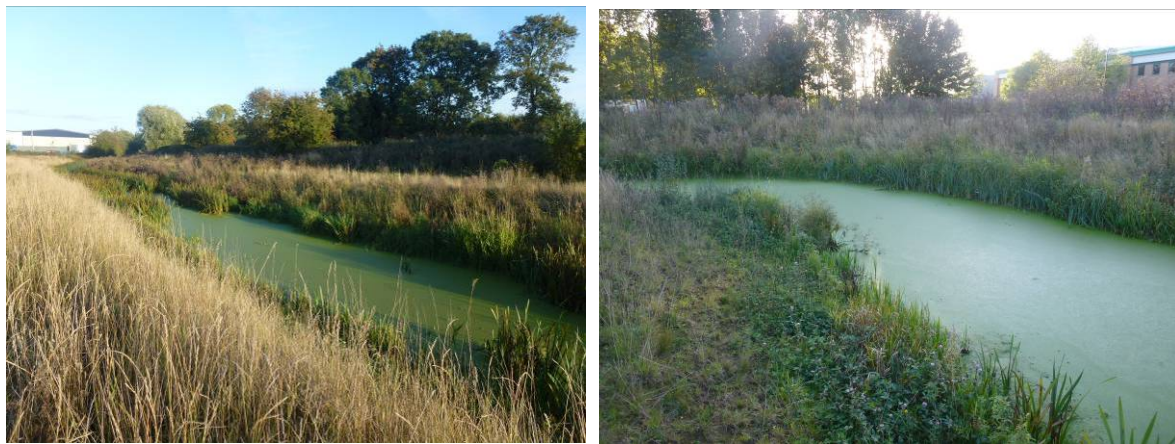
The species of concern at Boating Dike is currently common duckweed *Lemna minor* which, at the time of the survey, completely covered the water surface (Figure 7.2), potentially leading to impoverished submerged flora and fauna.

**Figure 7-2 Boating Dike with extensive common duckweed coverage**

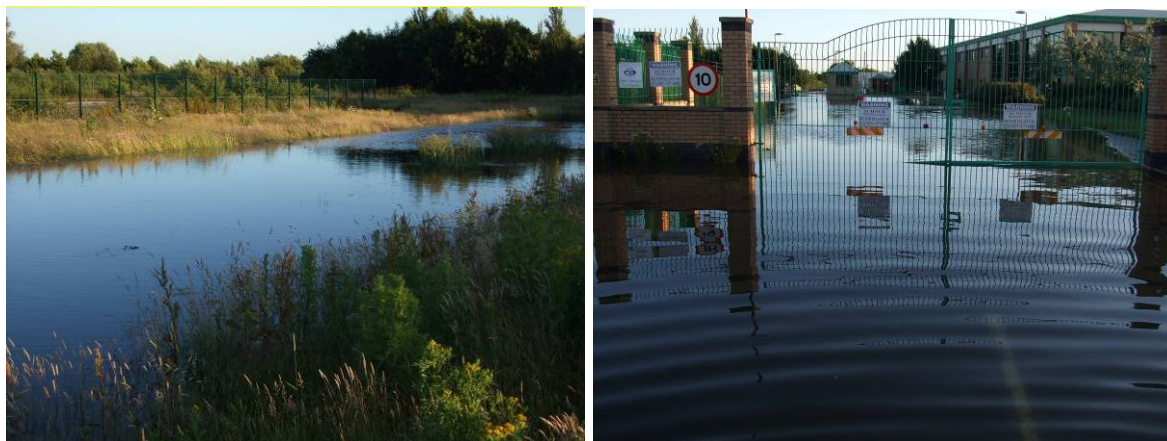
Most notably, in June 2007 the area suffered from extensive flooding as a result of overtopping of the banks (Figure 7.4). Consequently, there is a need to ensure that the conveyance and capacity of the watercourse is not impeded by tall emergent vegetation and that structures, including the weed screen cleaner, do not become blocked by the common duckweed.

**Figure 7-4 Boating Dike flooding in June 2007**

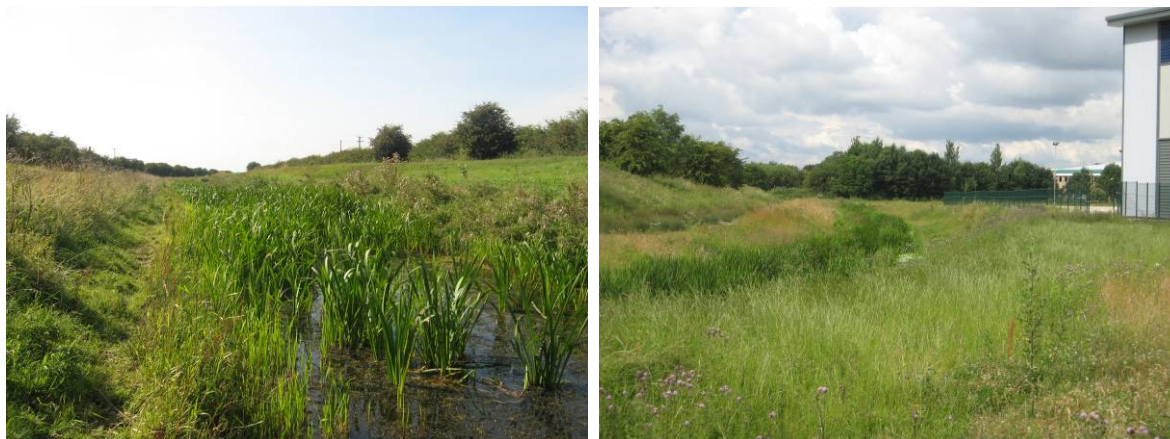
less of issue. Other tall emergent species were also frequent, including reed canary-grass, reedmace and lesser pond-sedge. Figure 7.5 shows the extensive tall emergent vegetation found in earlier years.

**Figure 7-5 Extensive tall emergent vegetation in 2010 (left) and 2009 (right)**

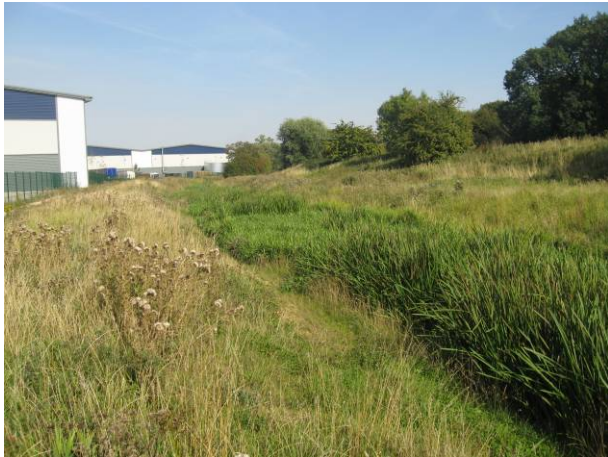
2010	In-channel tall emergent vegetation is very extensive, covering the majority of the channel width.

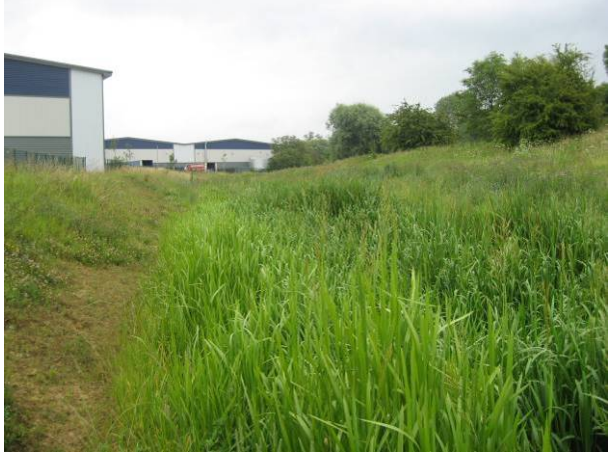
2011	In-channel tall emergent vegetation is very extensive, covering the majority of the channel width, with increasing proportions of reed sweet-grass.

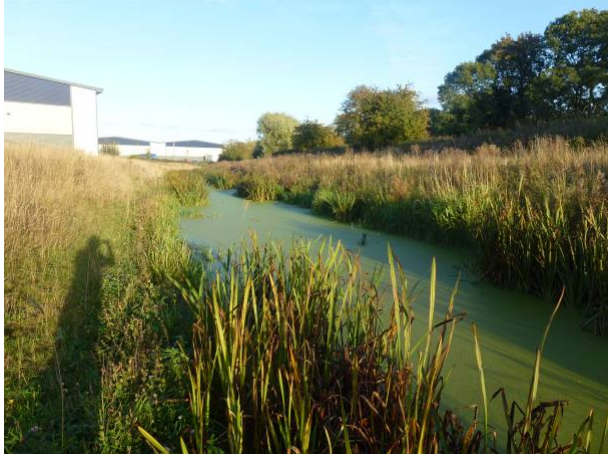
2013	One year following glyphosate-based herbicide application, the sprayed central channel is now clear of tall emergent species, with a marginal toe retained, although common duckweed now completely covers the water surface.

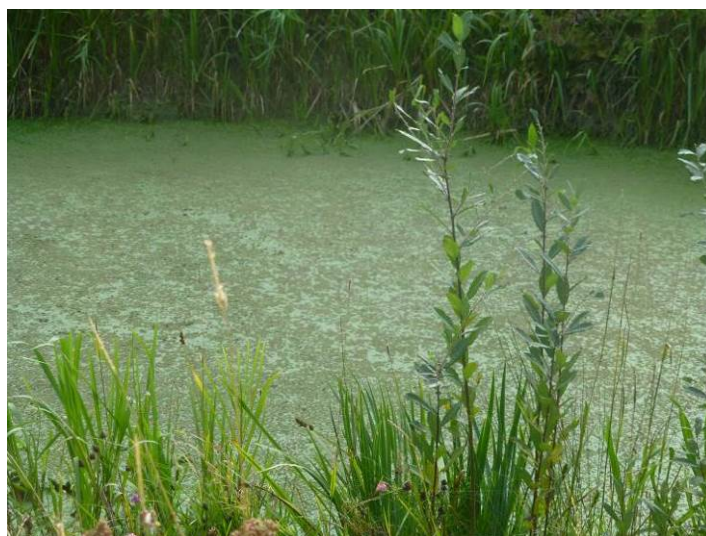
The re-survey of Boating Dike in 2014 found a similar situation to that observed in 2013, with common duckweed again dominating the channel, particularly within the downstream section. Water fern, which was noted in 2013 in very small patches, was however much more frequent in 2014, with it present in approximately equal proportions with the common duckweed in some parts of the channel.

**Figure 7-8 Water fern within downstream part of channel in 2014 showing that it has become more frequent**

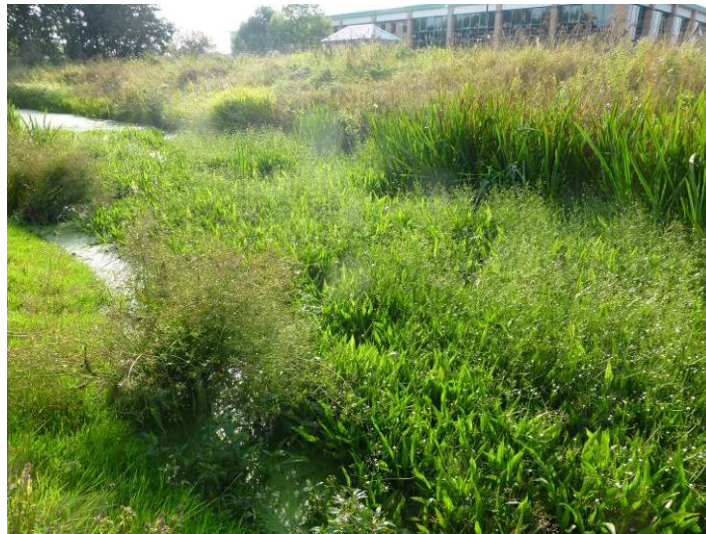
A further change to in-channel vegetation observed in 2014 was a dense stand of water plantain *Alisma plantago-aquatica*, which was noted approximately 50m upstream of the culvert and weed screen cleaner. This stand of vegetation only extended for approximately 15m of channel, but was very dense. This species does not usually form dense stands, as has occurred at Boating Dike, and was therefore not specifically included within the technical guide as a problematic species.

**Figure 7-9 Stand of water plantain at Boating Dike**

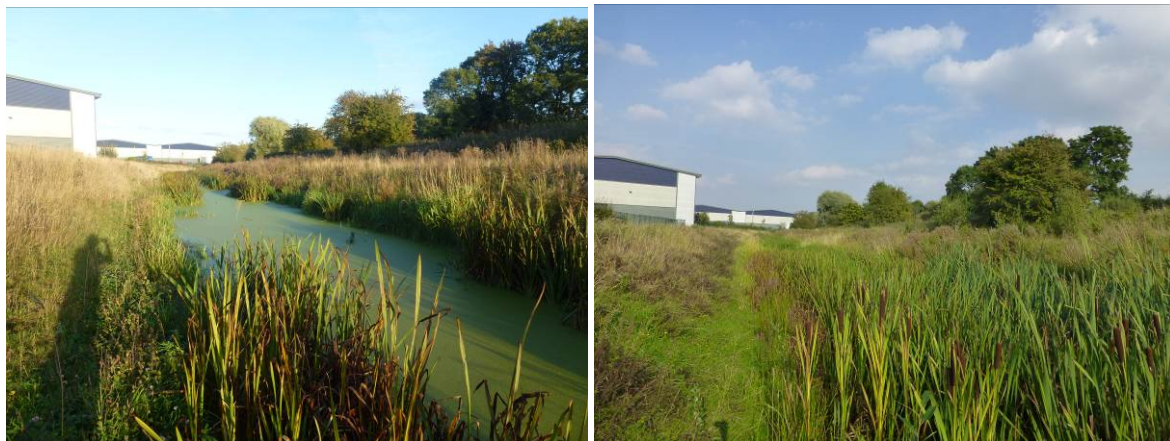
The upstream section of the channel, which historically has been dominated by tall emergent vegetation, was again dominated by reedmace, tall sedges and branched bur-reed. This section of watercourse was treated with a glyphosate-based herbicide in 2012, which maintained an open central channel in 2013, however, by 2014 the vigour of plant growth again resulted in their dominance in this section.

**Figure 7-10 Boating Dike in 2013 (left) and 2014 (right)**

Consequently, and following the adaptive management approach, the management technique employed at Boating Dike could be revised. The outputs of the decision-making spreadsheet are varied in the techniques they recommend given that the species present are relatively diverse. However, it could be that an integrated technique of glyphosate-based herbicide (which is already recommended to continue for the tall emergent vegetation) is used in conjunction with another technique, such as weevils to control the water fern, or suction harvesting. Over the long-term, shading using vegetation and/ or nutrient management would be advised to try and minimise the growth of problematic species.

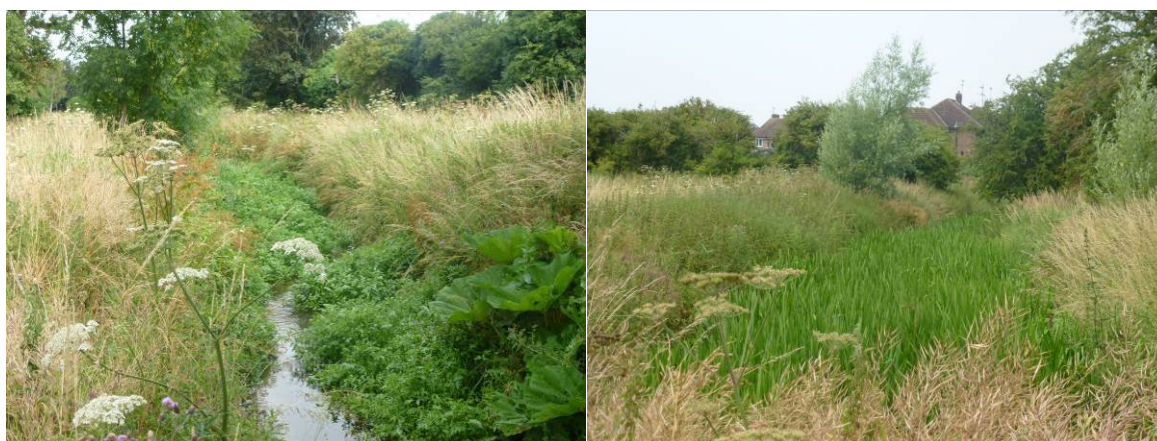
**Figure 8-3 River Lee showing problematic broad-leaved emergent growth (left) and tall emergent growth (right)**

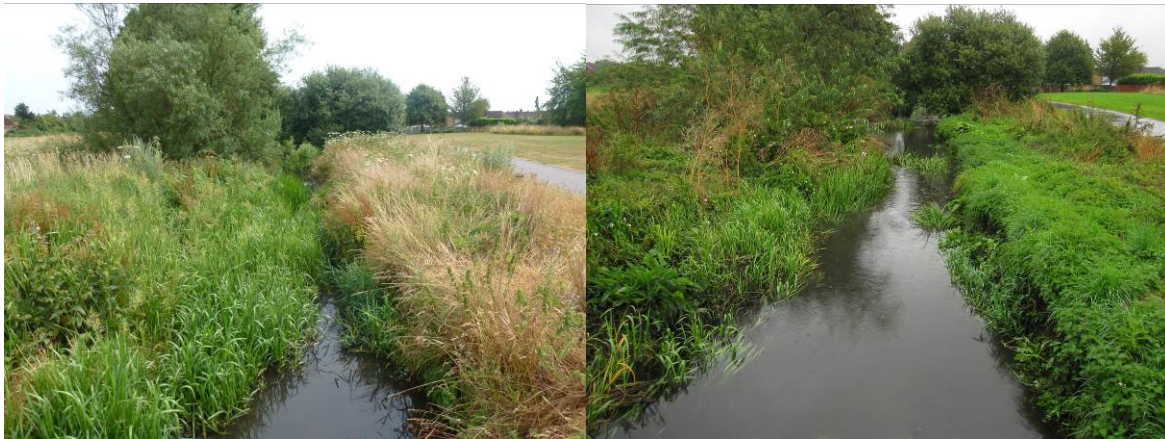
**Figure 8-6 The River Lee in Luton prior to management (left) and one year following treatment with a glyphosate-based herbicide**

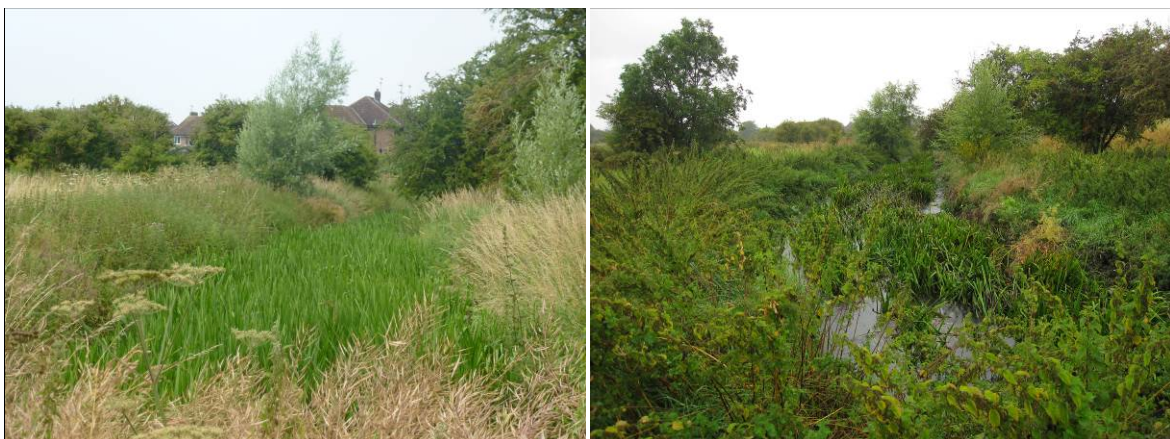
**Figure 8-7 Untreated section of the River Lee at Fallowfields (2013 on the left; 2014 on the right)**
