Rail Accident Investigation Branch

# Rail Accident Report

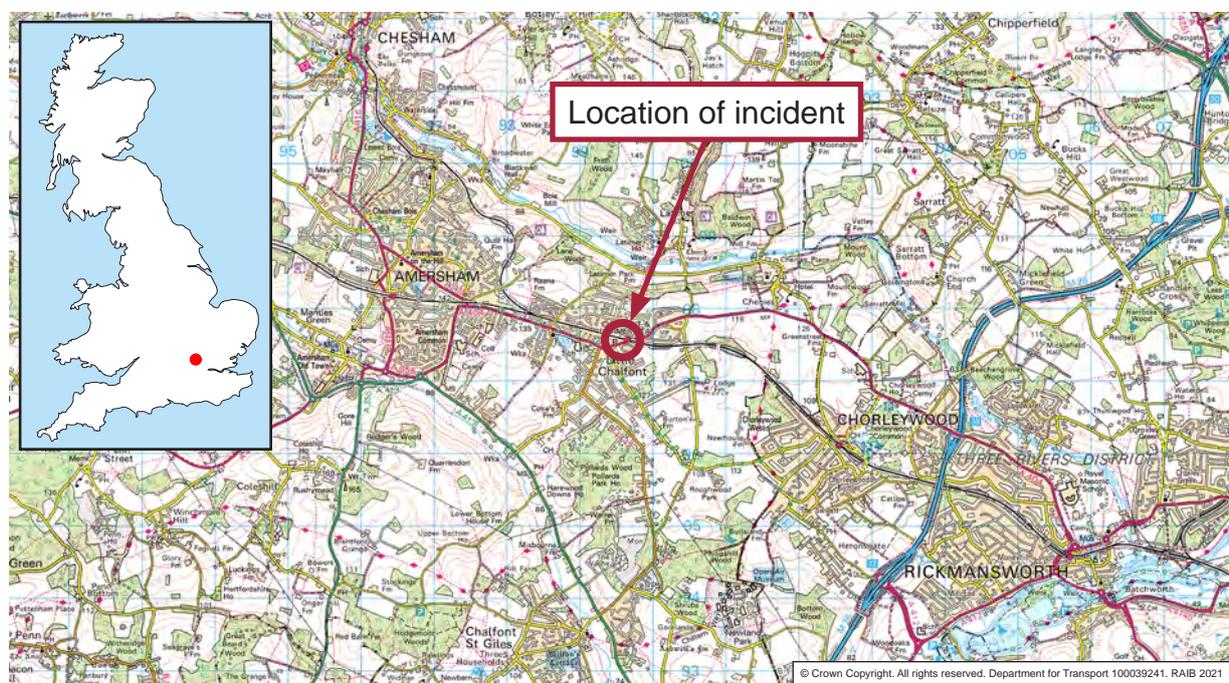
Figure 1: Extract from Ordnance Survey map showing location of the incident

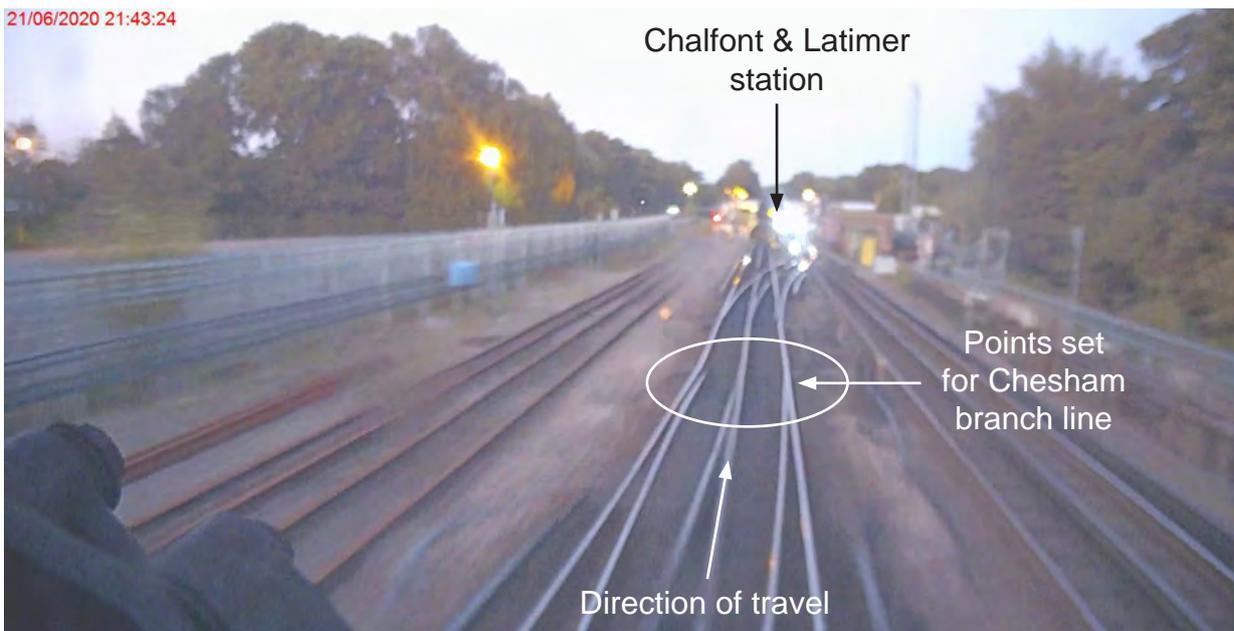
Figure 11: The train approaching the points set for the Chesham branch (FFCCTV image courtesy of Chiltern Railways)

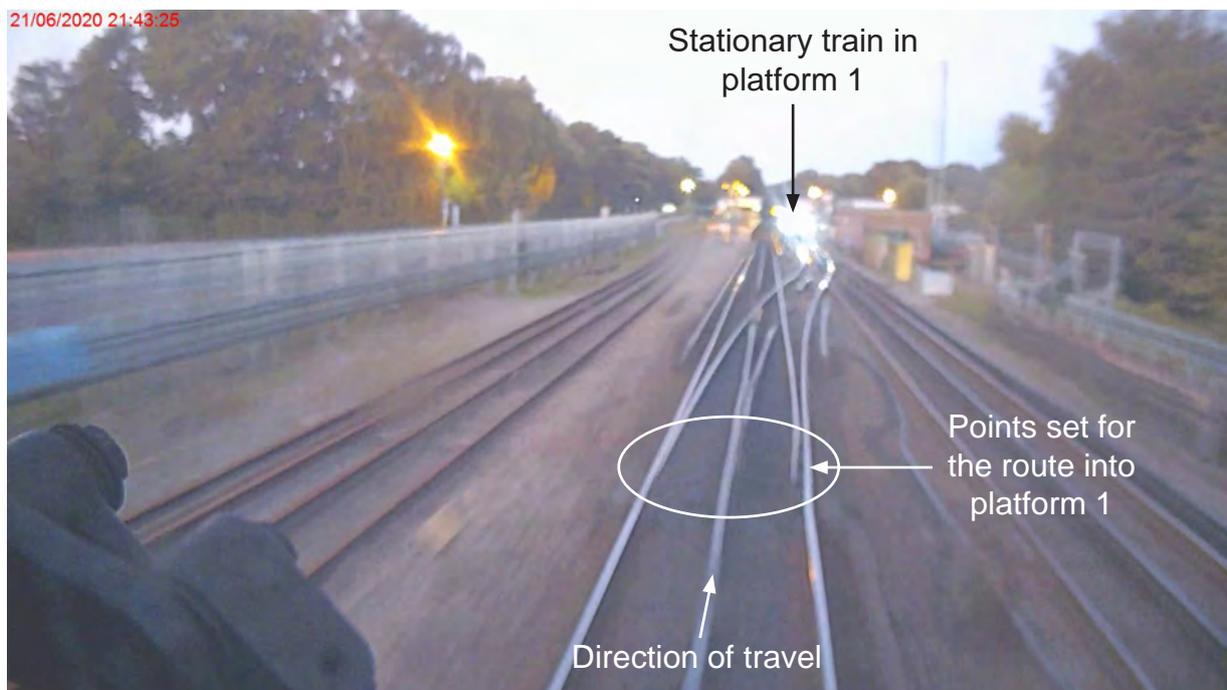
Figure 12: The train approaching the points set towards the stationary train in platform 1 (FFCCTV image courtesy of Chiltern Railways)
