AAIB Bulletin: 10/2021	G-INVN		AAIB-26839
ACCIDENT			
Aircraft Type and Registration:	Hawker Sea Fury T Mk.20, G-INVN		
No & Type of Engines:	1 Pratt & Whitney R2800-CB3 radial piston engine		
Year of Manufacture:	1951 (Serial no: 41H-636070)		
Date & Time (UTC):	4 August 2020 at 1518 hrs		
Location:	Harston, Cambridgeshire		
Type of Flight:	Private		
Persons on Board:	Crew - 1	Passengers -	1
Injuries:	Crew - 1 (Serious)	Passengers -	1 (Serious)
Nature of Damage:	Forward fuselage and wings detached from engine and tail section. Extensive internal engine damage		
Commander's Licence:	Air Transport Pilot's Licence		
Commander's Age:	47 years		
Commander's Flying Experience:	3,508 hours (of which 31 were on type) Last 90 days - 15 hours Last 28 days - 8 hours		
Information Source:	Field Investigation

During the aircraft's second flight following maintenance, its engine oil temperature rose and the oil pressure started to fluctuate. The engine then seized, forcing the pilot to make a landing in a field. The aircraft was extensively damaged and both occupants suffered serious injuries.

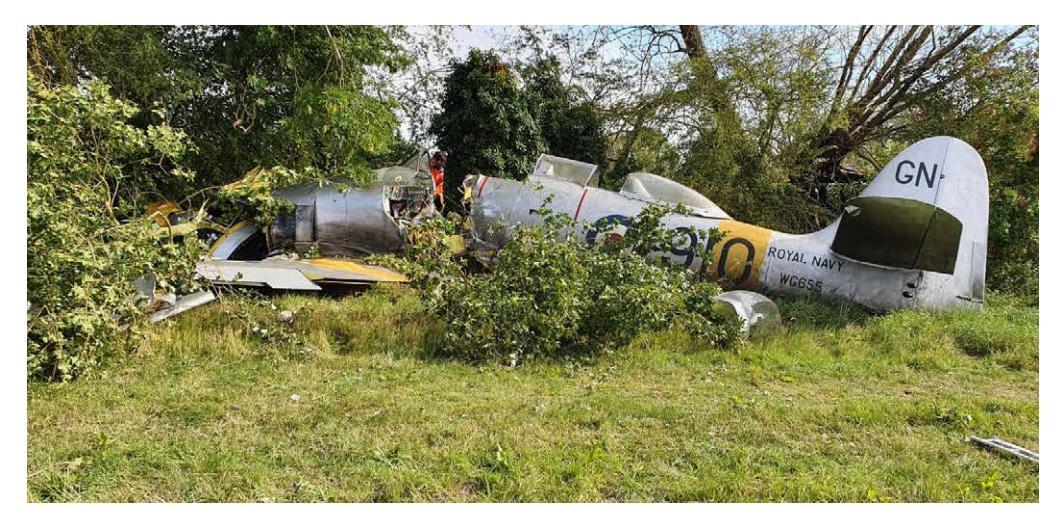
Figure 3 G-INVN after the accident

Nearing the ground, the pilot flared the aircraft to reduce the rate of descent but did not hold it off. The aircraft hit the ground and bounced, then hit again and skidded across the field. The aircraft slid into a tree on the far side of the field, which spun it around, and it came to rest in a hedgerow (Figure 3).

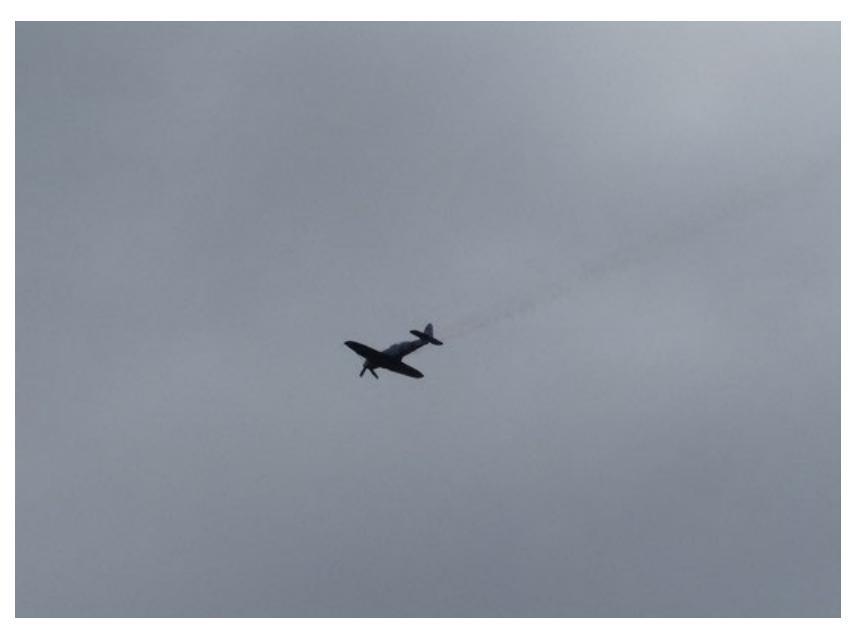
Figure 4

Several people in villages near the accident site reported hearing and seeing the aircraft before the accident. They reported hearing a rough running engine and seeing smoke coming from the aircraft. Several of them heard the engine stop. Video footage and several still photographs supplied to the AAIB showed a smoke trail coming from the aircraft (Figure 4). A witness who was close to the accident site saw the aircraft flying towards him. He described seeing "thick black smoke coming from both sides" and that "the propeller was rotating but then stopped and the nose dropped".

G-INVN in flight just prior to the accident with smoke trail visible (Photograph used with permission)

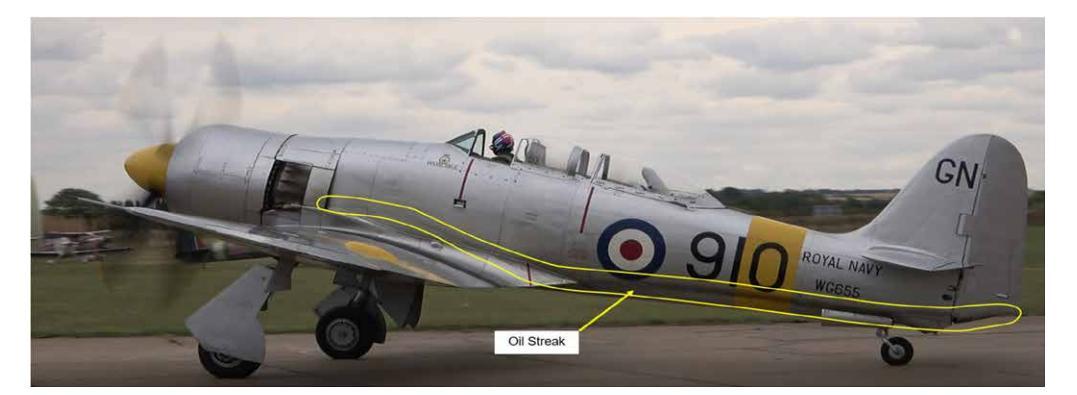
The image in Figure 6 was taken after the flight and showed an oil streak along the left side of the aircraft. The oil streak appeared to emerge from the crankcase breather duct positioned beside the cowling flaps.

G-INVN after the first flight showing an oil streak on the left side (Still photograph taken from video used with permission - Sky High Films)

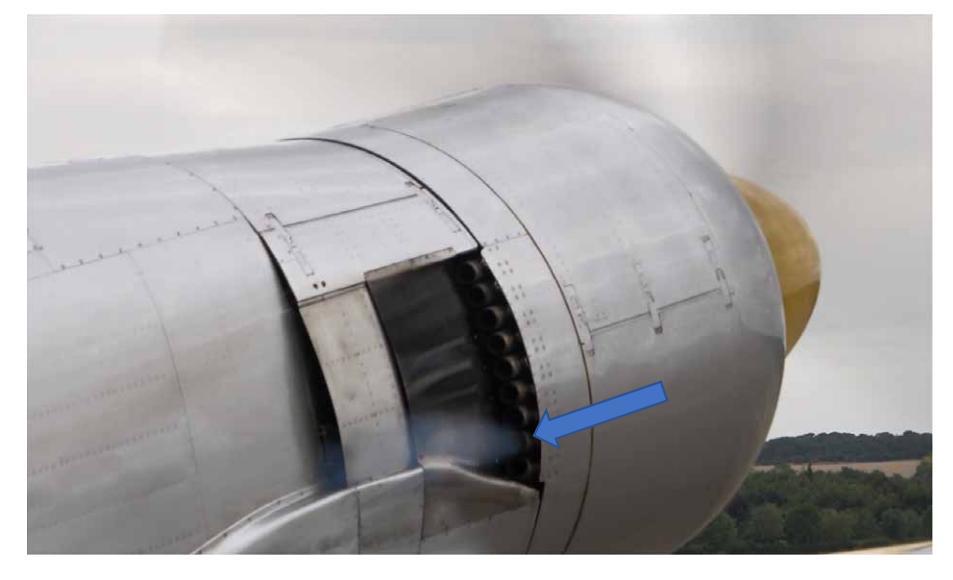
Figure 7

Further video footage showed the start-up, taxi and takeoff of the accident flight. During the pre-flight checks, smoke could be seen coming from the exhaust for the No 9 cylinder (rear bank, master cylinder) (Figure 7). No smoke was observed coming from any other exhaust. The footage also showed a smoke trail during the takeoff, and there appeared to be more smoke than was visible on the first flight.

G-INVN before the accident flight showing smoke from No 9 exhaust (Still photograph taken from video. Image used with permission)

Video footage of the engine run-up before the accident flight showed smoke emerging from the rear bank master cylinder (No 9) but not from any other exhaust. As the engine had been run for several minutes it is likely that any residual oil in the cylinders would have been burnt off or blown from the exhausts by that time. The No 9 piston exhibited substantial wear on the leading face of the piston (relative to engine rotation) and some of the piston rings were entrained into the piston ring grooves. This would have allowed oil to pass into the combustion chamber, generating the observed smoke, and would have allowed

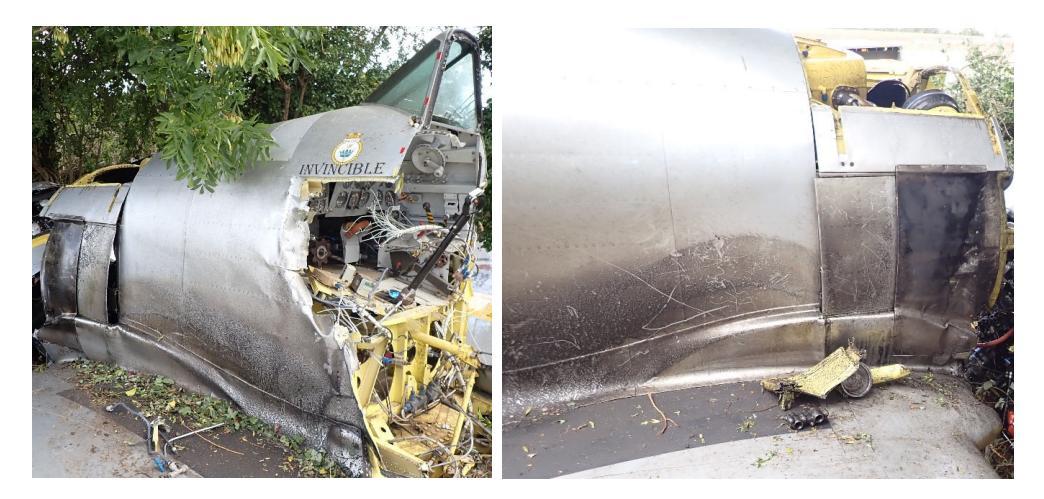
Figure 14 Oil streak from crankcase breather ducts

The fuselage had split to the rear of the windscreen and the gap between the two sections was approximately one metre. The sheet metal on the left side of the break showed signs of compression buckling and tearing in tension whereas the right side showed only tearing in tension. The cockpit instrument panels were largely intact, but the transponder had become dislodged and was found several metres to the right of the fuselage. All the CBs were closed (in) except the 'OIL CLR' and 'OIL TMP'. There was evidence of oil streaking along the side of the fuselage from each of the crankcase breather ducts (Figure 14).

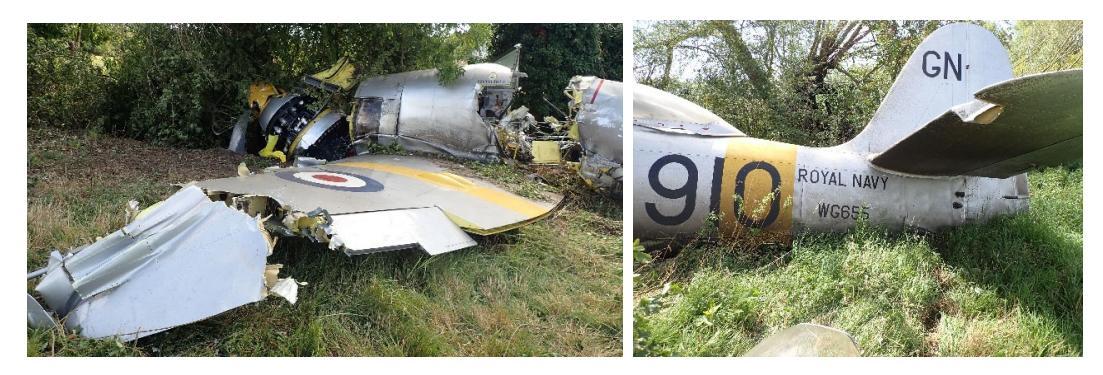
Figure 15 Engine section, aircraft forward and aft sections

The left wing was significantly damaged by the impact with the hedge, with multiple tears, and the tip structure had detached (Figure 15 left). The right aileron was significantly damaged and was deformed by a large tree. The flap lever was in the fully DOWN position and the flaps had partially deployed. The landing gear lever was in the UP position with the landing gear retracted, but the landing gear was not locked and the legs extended freely during the recovery. The tail structure was intact and the right tailplane had dug into the ground. The partially deployed tail wheel had scribed an arc in the grass (Figure 15 right).

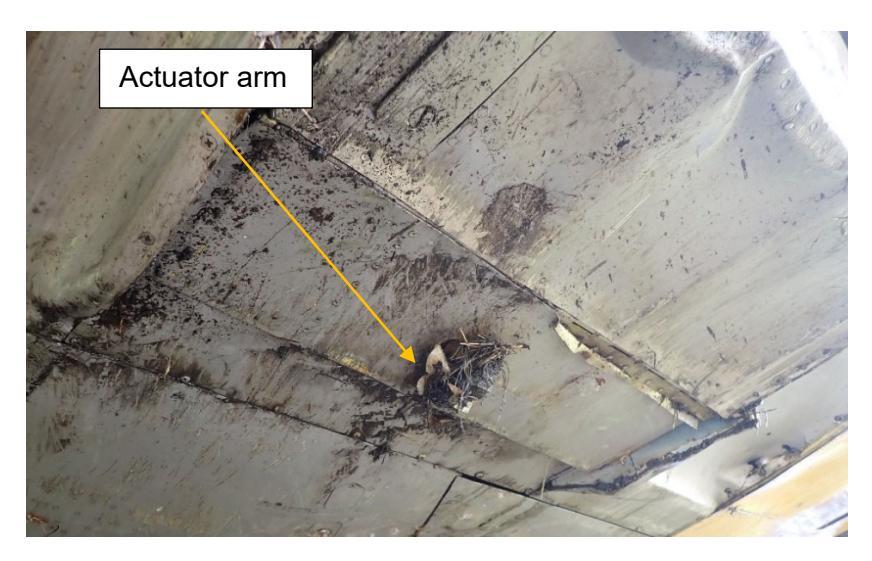
Figure 16 Oil cooler outlet flap

The oil cooler inlet cowling was deformed and the front of the cooler was clogged with earth. The outlet flap was closed but the actuator arm had penetrated through the surface, indicating that the flap had been at least been partially open and was forced closed during the ground slide (Figure 16).

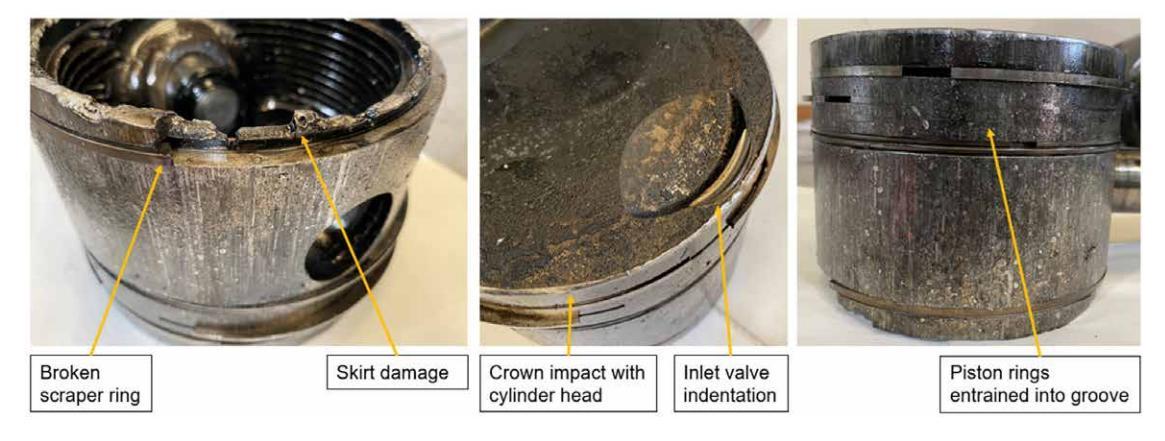
Figure 17

The engine had seized with the No 1 piston (rear bank) at or near top dead centre (TDC). Correspondingly the No 10 piston (front bank) was also at or near TDC. All the rear bank pistons were damaged below the scraper ring groove and the scraper rings were partially lost (Figure 17 left). Around the periphery of the piston crown it was evident that some pistons had struck the top of their cylinders (Figure 17 centre) and there were indentations from the inlet valves in all the piston crowns. The side of all pistons showed evidence of abrasion and the compression rings were entrained in the grooves of the master piston (Figure 17 right).

Rear bank piston damage (Piston No 9 shown)

The deterioration of the master rod bearing resulted in a reduction in the clearance between the piston bottom dead centre position and the crankshaft counterweight. As the crankshaft rotated the counterweight struck the lower edge of the piston skirt, removing pieces of it, and broke the oil scraper rings. These pieces of aluminium piston and steel scraper ring were then unrestrained within the crankcase and caused impact damage to the casing. The irregular shape and inconsistent position of the damage to the cylinder flanges inside the crankcase was probably caused by these pieces being caught between the rotating counterweight and the flange. There was no evidence of the counterweight striking the cylinder flange directly. The broken pieces of piston and ring were transported throughout the engine by the oil system and contributed further to the blocking of the oil system passageways.

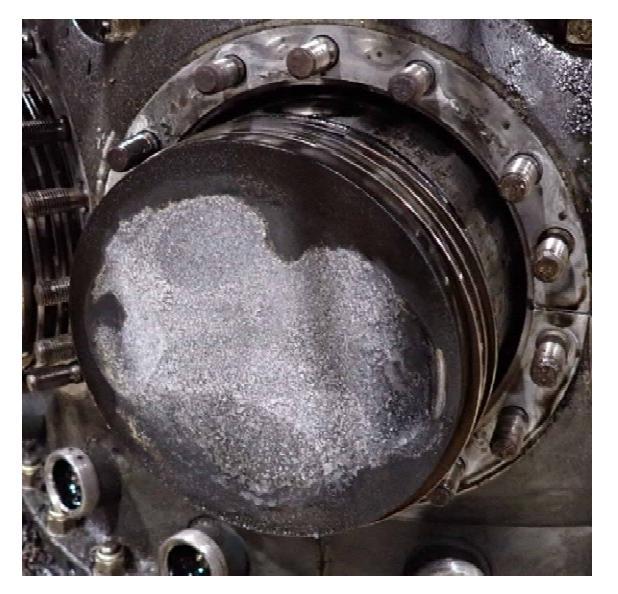
Figure 18 Piston crown deposit (piston No 13 shown)

There was considerably less damage to the front bank pistons, with only abrasion damage to the skirts and some pistons retaining metal fragments inside the rear of the piston. There was evidence on some piston crowns, in each bank, of a grey powder deposit (Figure 18). A sample was removed, analysed, and found to contain aluminium, carbon, oxygen, lead and bromine.

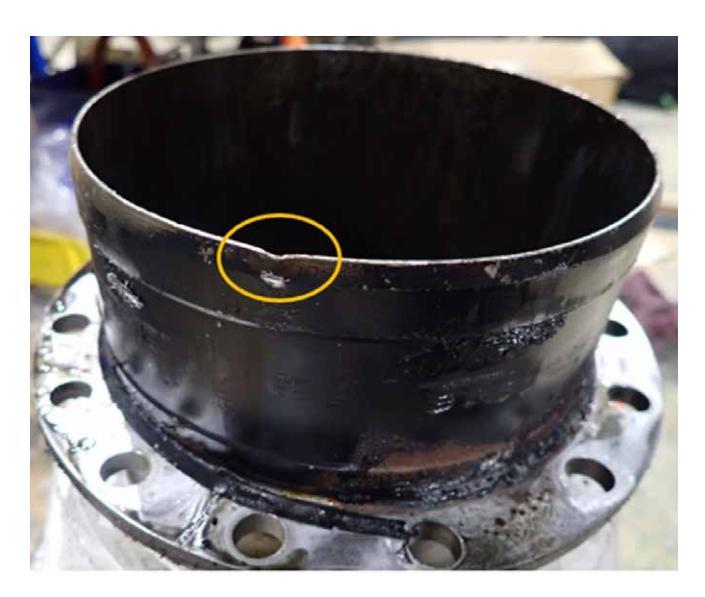
Figure 19 Cylinder flange impact damage (cylinder No 15 shown)

Some cylinder barrels had impact damage to the flange which engages inside the crankcase. The shape and size of the damage was inconsistent: whilst most flared outwards (Figure 19), one cylinder was flared inwards.

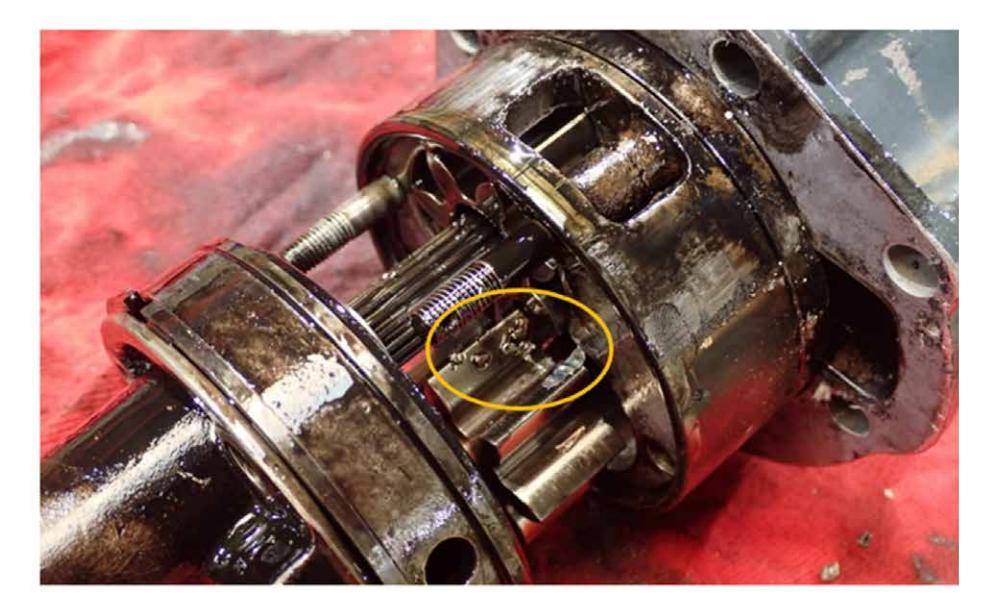
Figure 20 Front oil scavenge pump

The pressure oil pump was removed and could be turned by hand. There was evidence of fine metallic debris in the oil passageways. The front scavenge pump would not turn by hand but there was no evidence of damage to the drive gears. The pump was disassembled, and metallic debris was found within the gears, preventing them from turning (Figure 20). No other damage was observed.

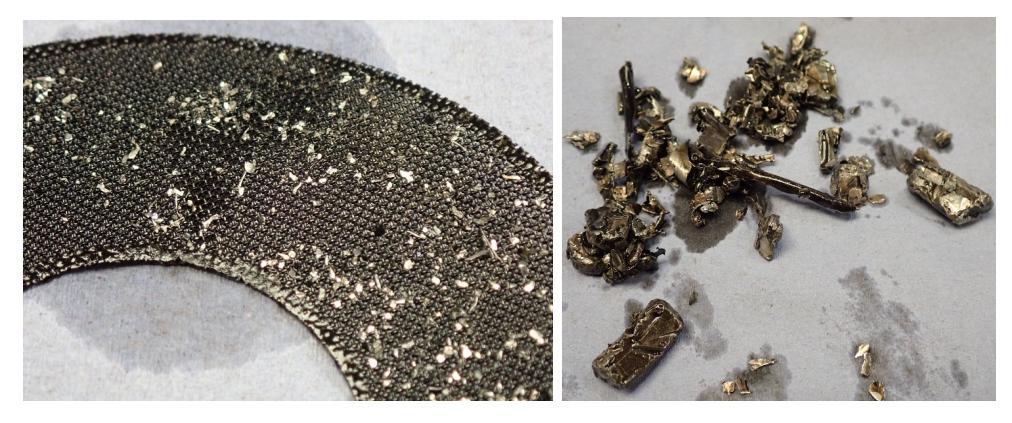
Figure 21

The two engine oil filters and the Cuno filter were removed and their contents examined. The metal mesh filters contained a large amount of fine metallic debris whereas the rear case screen contained a quantity of large metallic fragments (Figure 21). These fragments were identified as broken pieces of piston skirt and piston ring. The fine metallic debris was analysed and was found to be silver, iron, aluminium and copper.

Left – pressure oil strainer. Right – debris from rear case drain screen

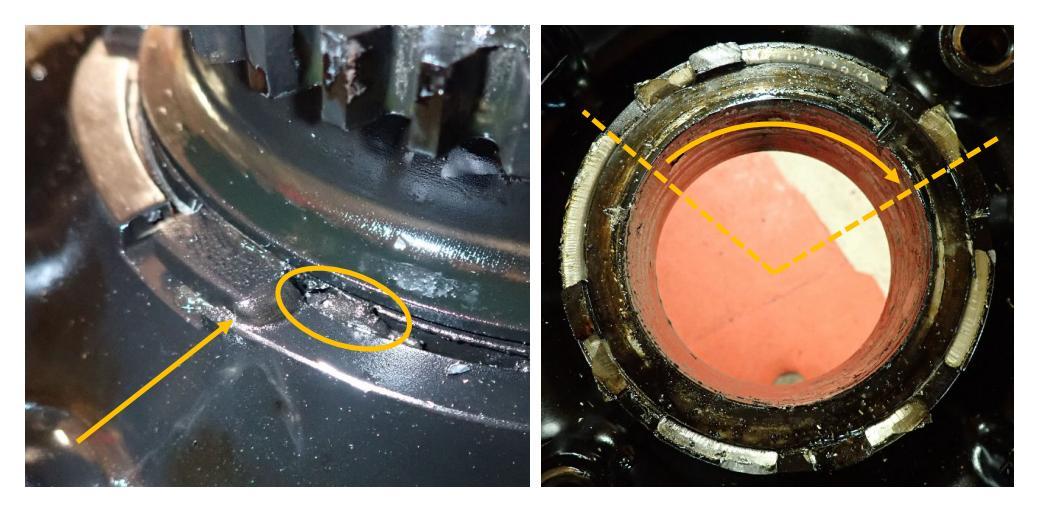
Figure 22

An inspection of the front and rear crankcases revealed evidence that the front and rear crankshaft journal bearings had rotated in the crankcase. The locking tabs of both bearings had dragged in the casing (Figure 22) with the front bearing having rotated approximately three to four degrees. The rotation of the rear bearing was at least 120° as there was continuous mechanical damage between the locking tab slots. It was not possible to determine if the bearing had rotated more than 120°. The bearing surfaces were heavily scored (Figure 23) and there was evidence that the silver had melted and solidified. The centre crankshaft bearing showed no evidence of rotation but some evidence of scoring. The silver bearing material was largely intact.

Left – Detail of front bearing rotation (arrowed) and molten metal (circled). Right – Detail of rear bearing rotation

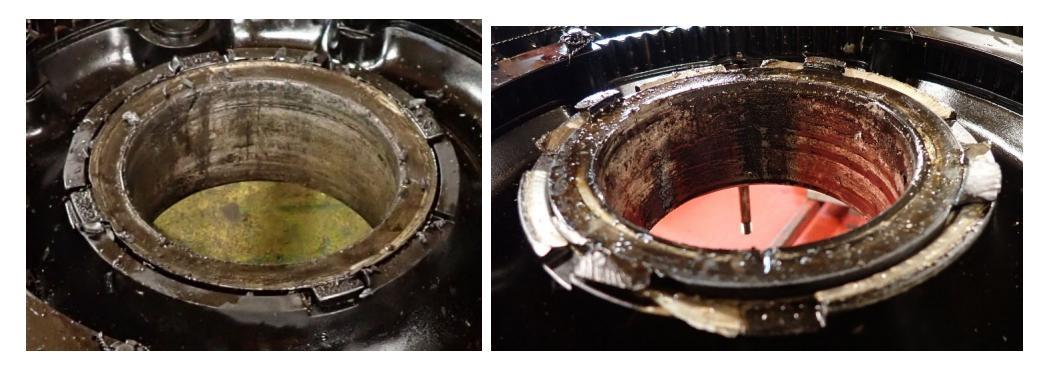
Figure 23

Left – Front crankshaft journal bearing Right – Rear crankshaft journal bearing

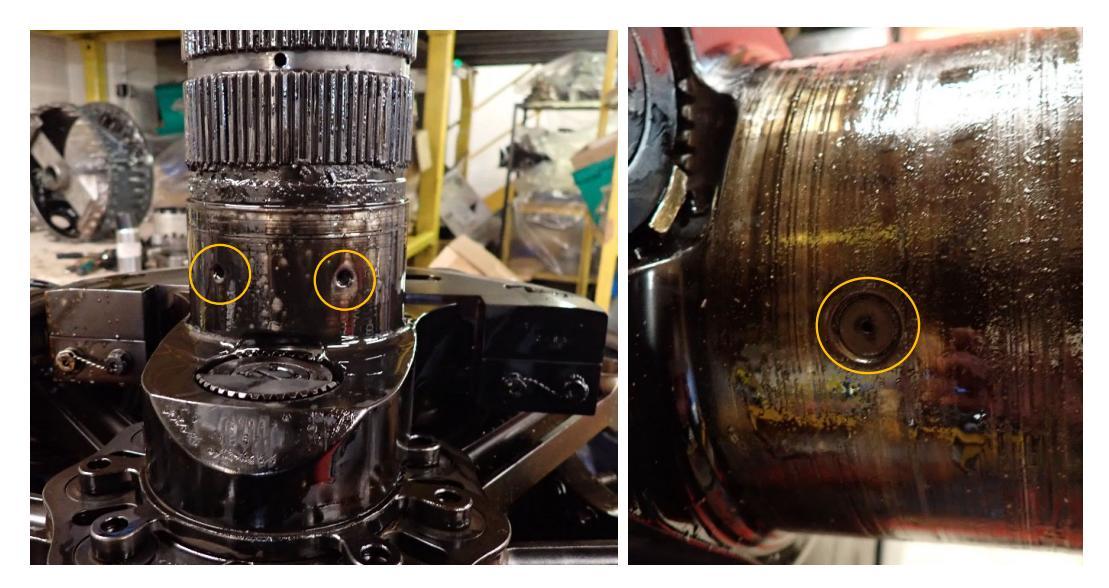
Figure 24

The crankshaft journals were heavily scored and there was evidence in the journal oil holes of a build-up of fine metallic particles (Figure 24). When the supercharger output shaft was removed from the rear of the crankshaft, the metallic particles retained in the crankshaft pocket were found on the end of the shaft (Figure 25). The oil pipe to the rear bearing was

Left - Front crankshaft journal (oil holes circled) Right - Rear crankshaft journal (oil hole circled)

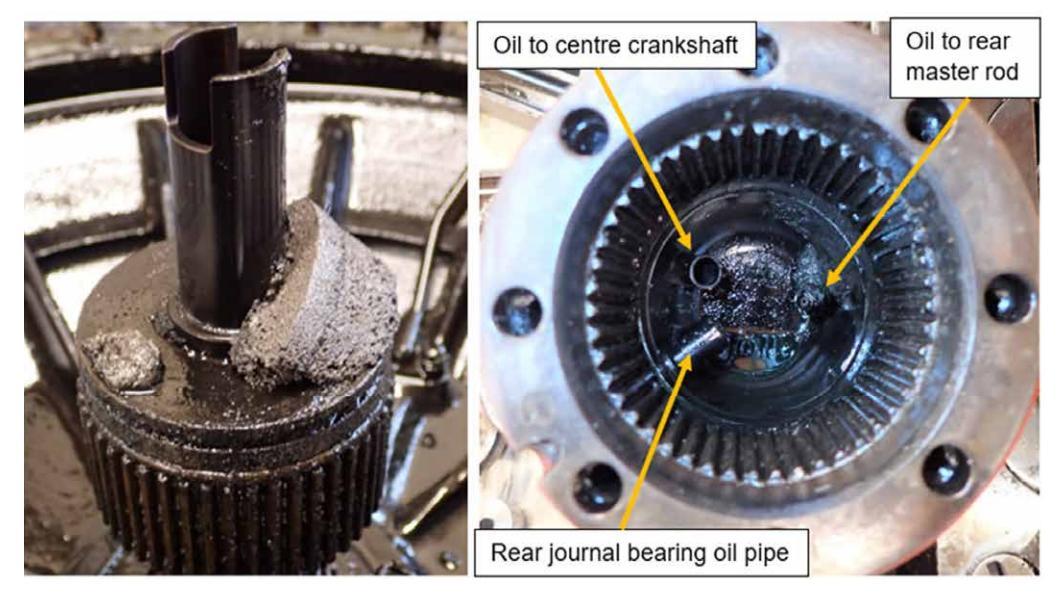
Figure 25

blocked and the rear secondary counterweight bearing showed evidence of running without lubrication. The front journal bearing hole was partially blocked restricting the supply of oil to the bearing.

Metallic particles filling the rear of the crankshaft Supercharger output shaft – Left. Crankshaft pocket – Right

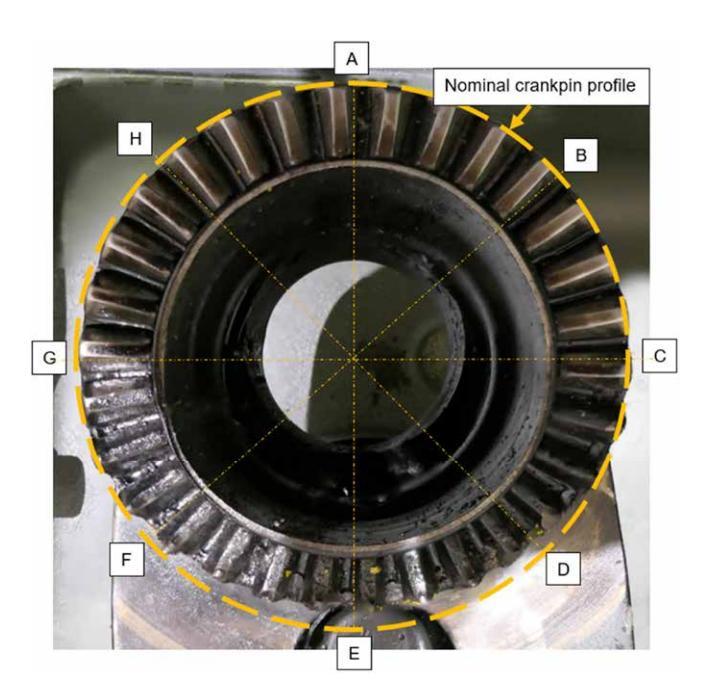
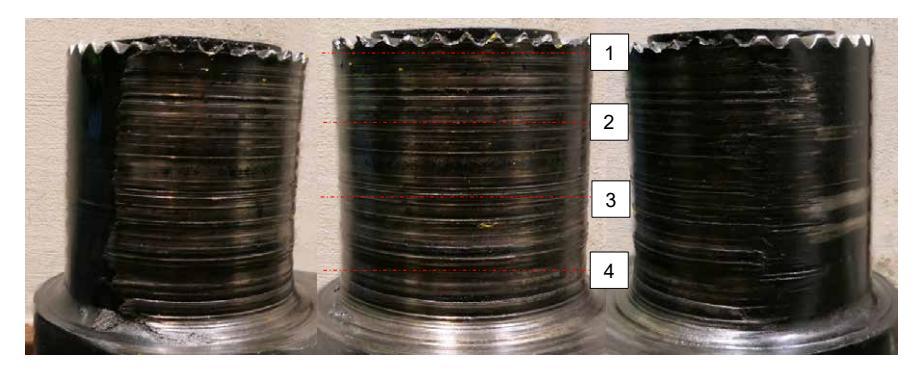
Figure 26 View looking aft on rear crankpin (centre crankshaft removed)

The crankshaft was split into its three sections and the master rod assemblies were removed. Both crankpins were deeply scored and one side of the rear crankpin was heavily worn. The nominal diameter of a crankpin is 89.027 mm (3.505 inches) and Table 1 shows the diameter with reference to Figures 26 and 27 for the rear crankpin. Front crankpin wear was similar to the rear but to a lesser extent, with the smallest diameter of 88.519 mm across the same line as the rear crankpin (A-E).

Side view of rear crankpin (centre crankshaft removed) Left - view on G. Centre – view on E. Right – view on C

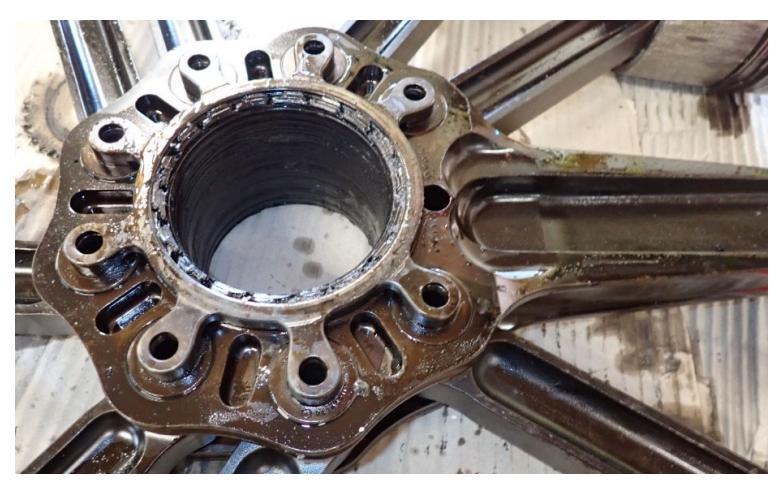
Figure 28 Rear master rod showing bearing damage

The rear master rod assembly also showed evidence of heavy scoring with very little of the bearing material remaining (Figure 28). There were also substantial amounts of loose, metallic particles on the bearing face. The castellations on both ends of the bearing had been significantly damaged along with the corresponding castellations of the retaining plate. The castellations had become swaged together and had to be cut away to enable the bearing to be pressed from the master rod. No defects or bending were found on the link rods of either master rod assembly.

The silver bearing metal of the rear bank master rod bearing was eroded and the steel bearing shell was running against the crankpin. Load, and therefore wear, is distributed over the full surface of the bearing shell due to the rotation of the master rod relative to the crankpin. However, the same segment of the crankpin always reacts the power stroke and therefore the wear was concentrated on this part of the crankpin. The nitriding slowed this wear but once the case-hardened layer had been worn away, the damage increased rapidly. This was evident in the shape of the rear crankpin when it was inspected after the accident, with approximately 5 mm being lost from the diameter of the crankpin. This material was liberated into the oil system and caused further damage.

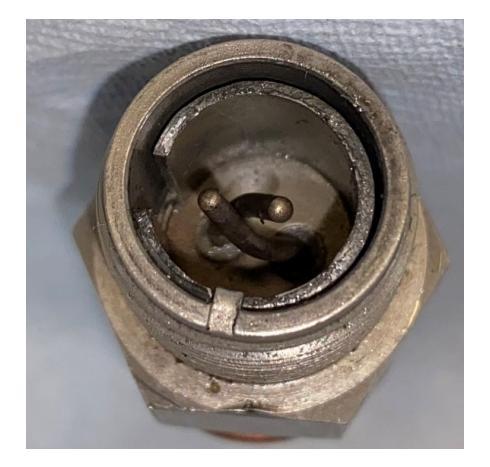
Figure 29 Oil temperature sensor electrical connection pins

The two temperature sensors were examined and subjected to an electrical continuity test. No defects were found with the sensor removed from the rear accessory case (rear cockpit) but the sensor providing indications in the front cockpit was damaged. The electrical connector was disconnected from the sensor and it was found that the pins had become twisted together (Figure 29).

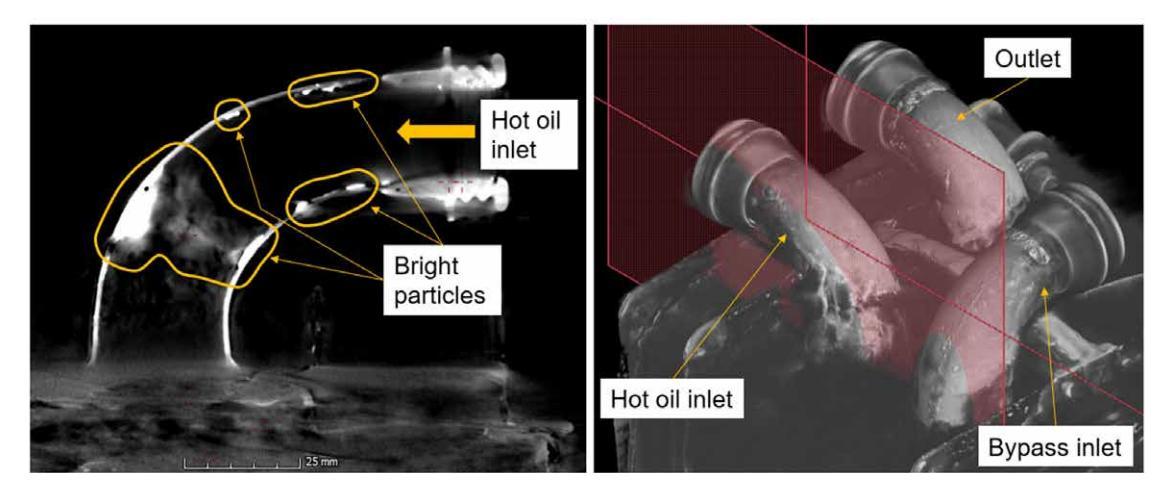
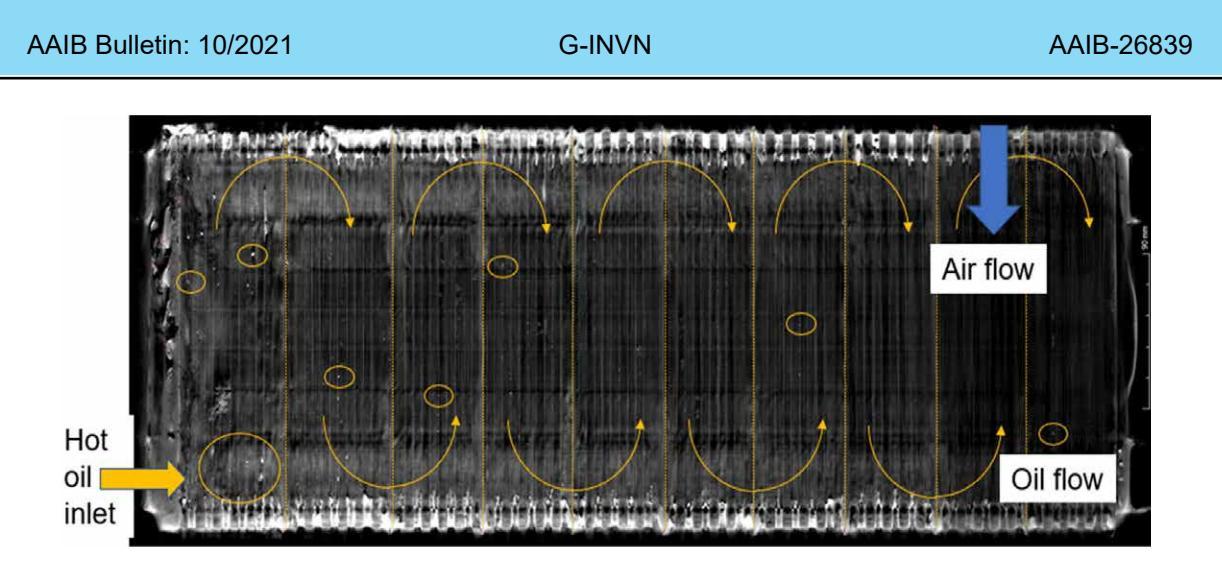
Figure 30 Section view through the oil cooler - hot oil inlet

The oil cooler was scanned using computerised tomography (CT), which showed many metallic particles within the cooler. Several large bright particles were visible in the hot oil inlet which were determined to be silver (Figure 30). Multiple bright particles were identified throughout the core of the cooler, with a higher concentration towards the inlet end (examples circled in Figure 31). Other particles, probably of aluminium, were also identified throughout the inlet and the core. It was not possible to perform a detailed analysis of the inlet pathway, from the inlet pipe to the first core pack, because the X-rays did not penetrate the multiple layers of brass and steel.

Figure 31 Oil cooler core. Some particles highlighted
