# The Island Project

**Jerrings Hall Farm, Tanworth Lane, Solihull,  
B90 4DX**

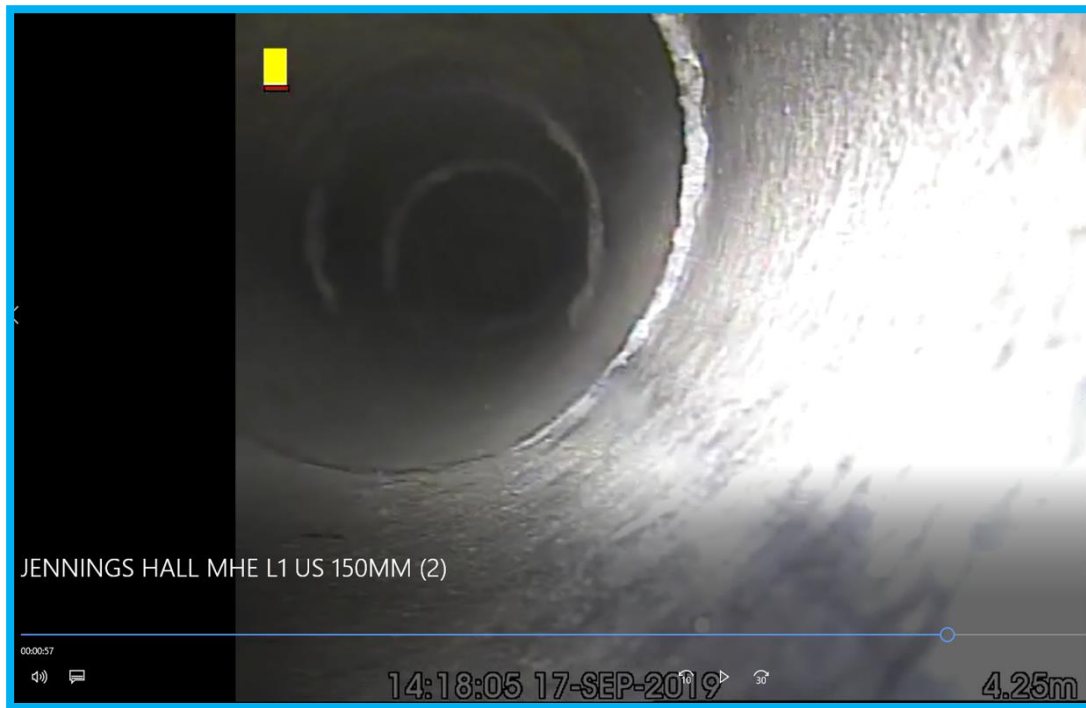
Fig 13 CCTV image of 150mm pipe draining southeastern corner of site (Solum Surveying).

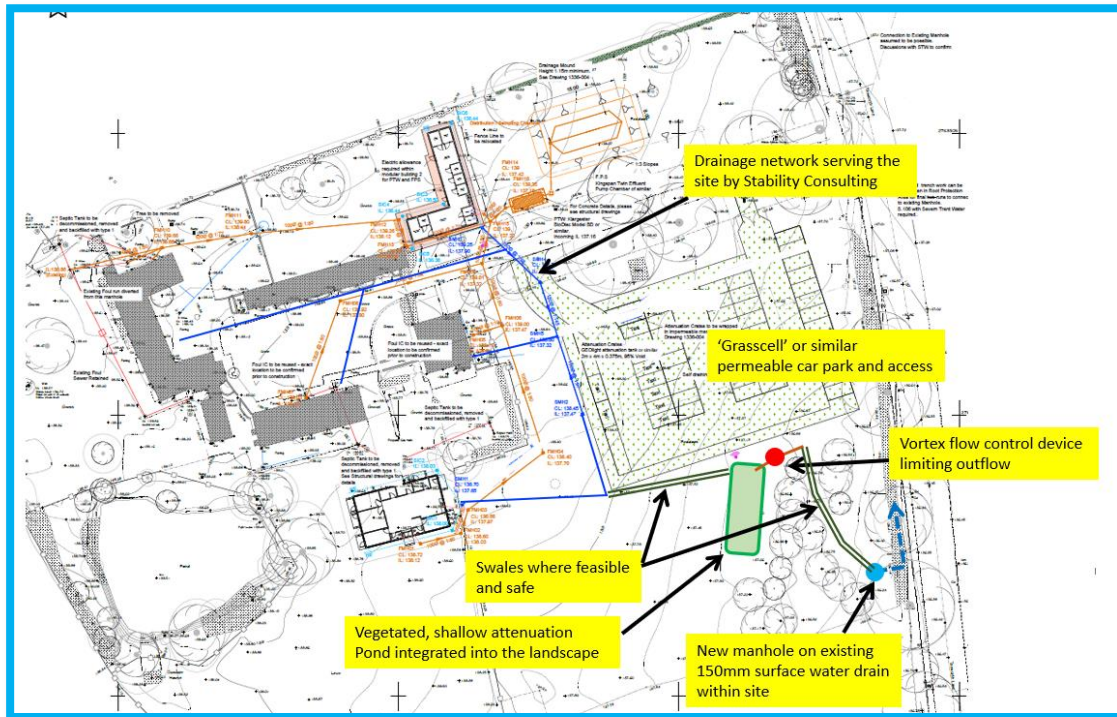
Fig 14 Surface and foul water drainage design (by Stability Consulting Ltd).

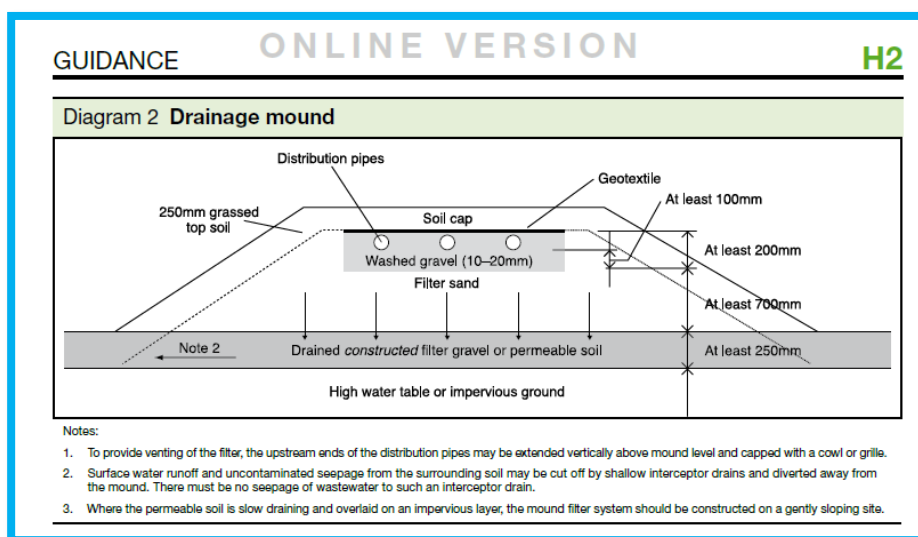
Fig 17 Extract from Building Regulations showing Drainage Mound suitable for ground with high groundwater. The distribution pipes will be in accordance with Diagram 1 of Building Regulations.

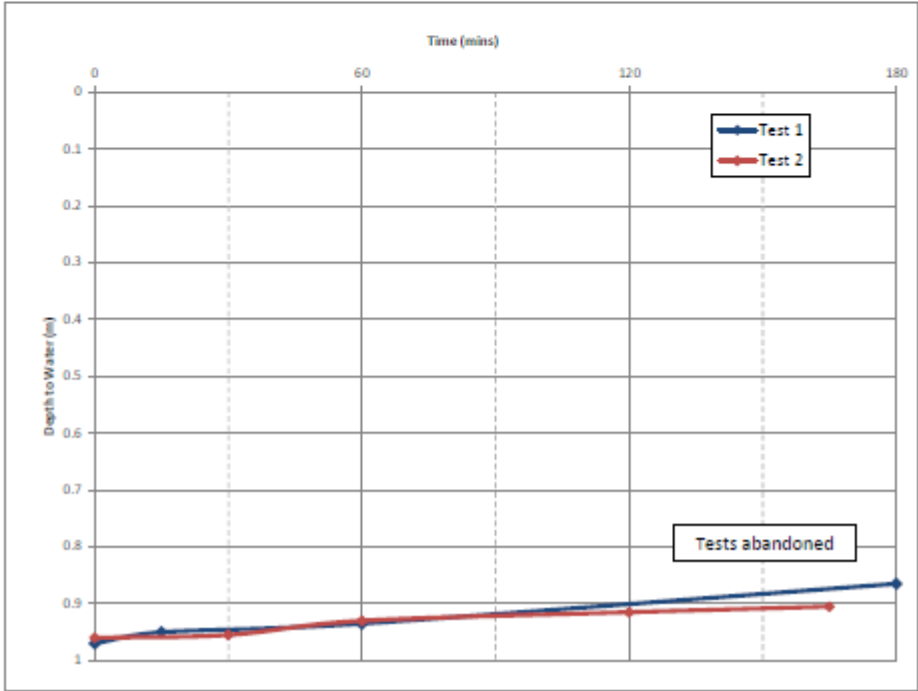
Soil Infiltration Rate (m/s)      **N/A**

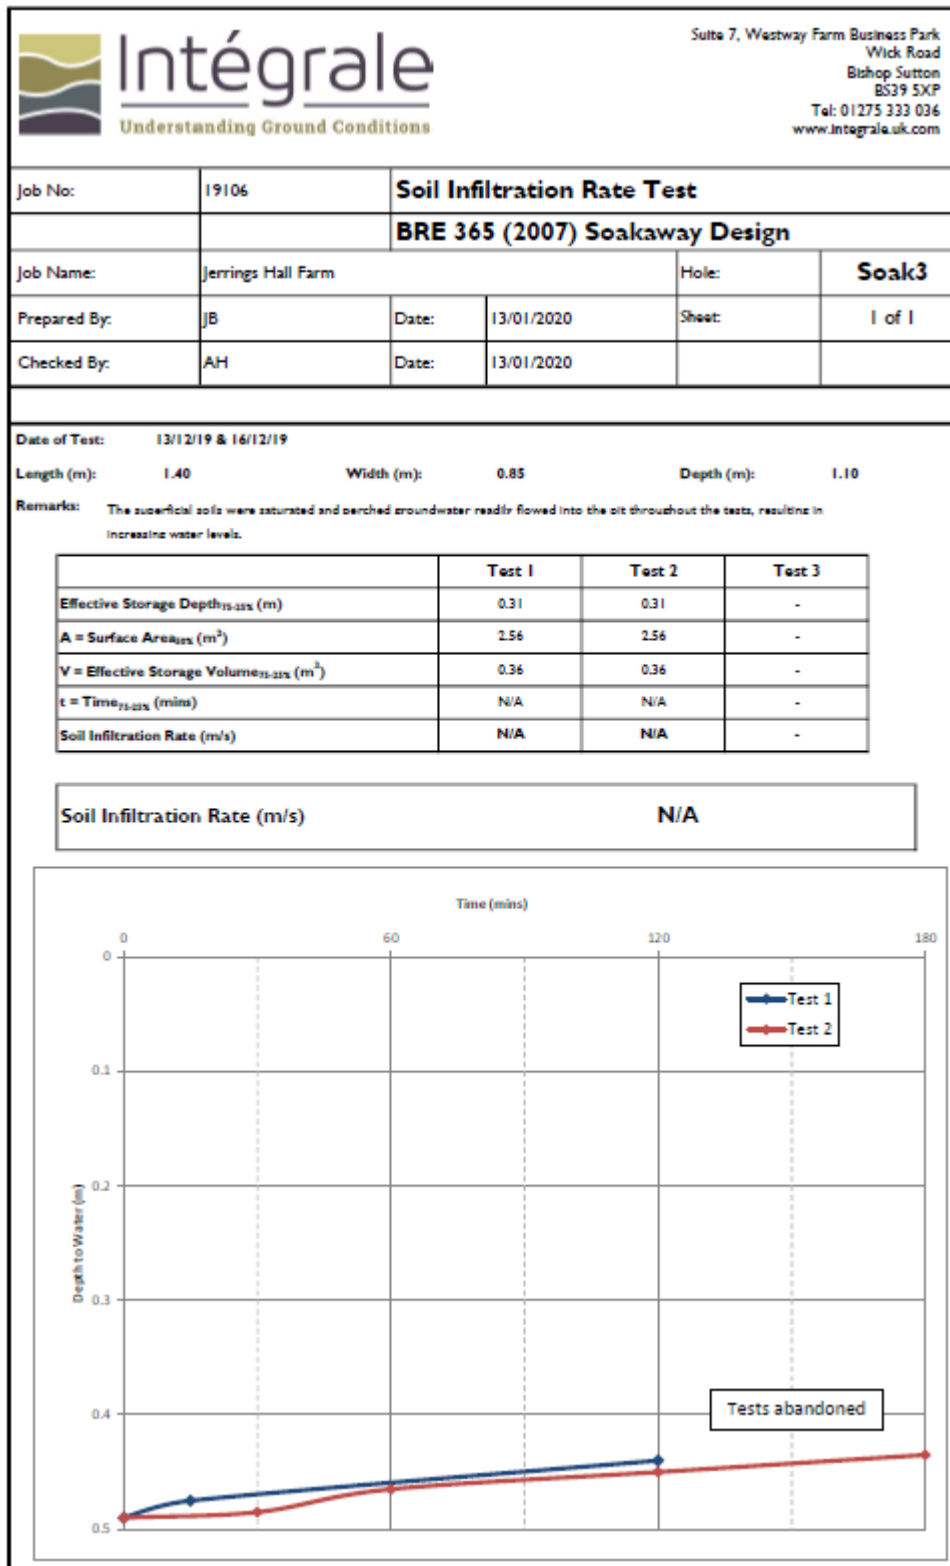
Soakaway Test – Soak4

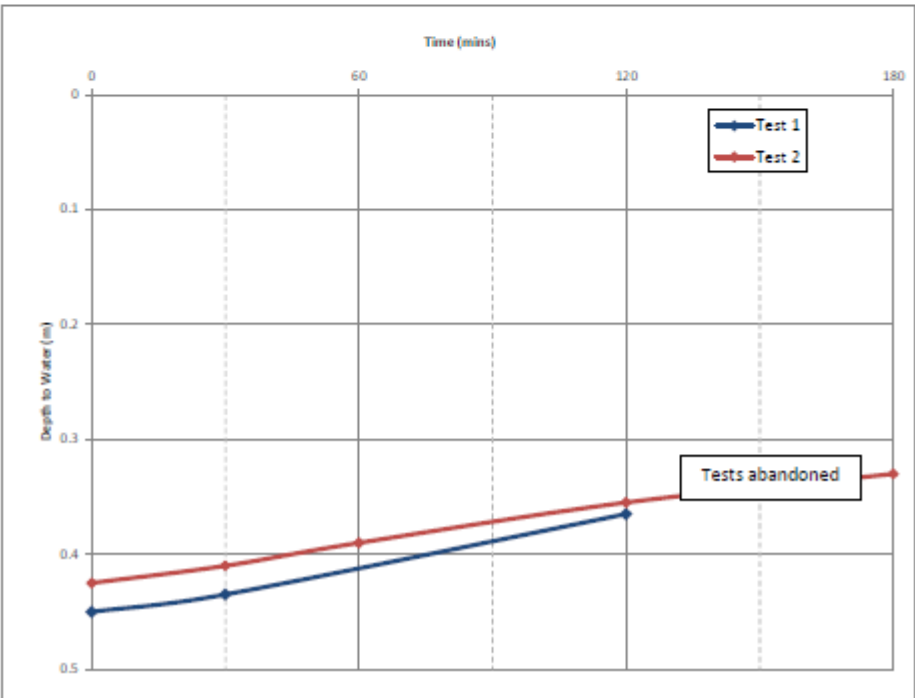
| | | | | | |
