MCP-01

DECOMISSIONING, DISMANTLING and DISPOSAL of the MCP-01 INSTALLATION MCP-A-RP-00009

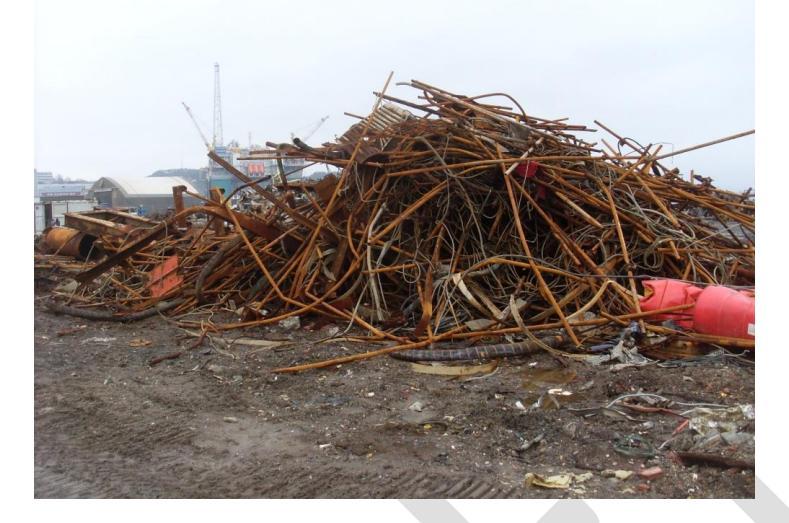
Recovered seabed debris awaiting recycling in Stord

For MCP01 the initial survey identified 164 potential targets. Ultimately, 100.2 tonnes of debris was recovered being a total of 641 individual items. Some small items, originally flagged were not ultimately recovered due to the object not being relocated in the recovery phase or having broken up when being handled by the ROV manipulator.

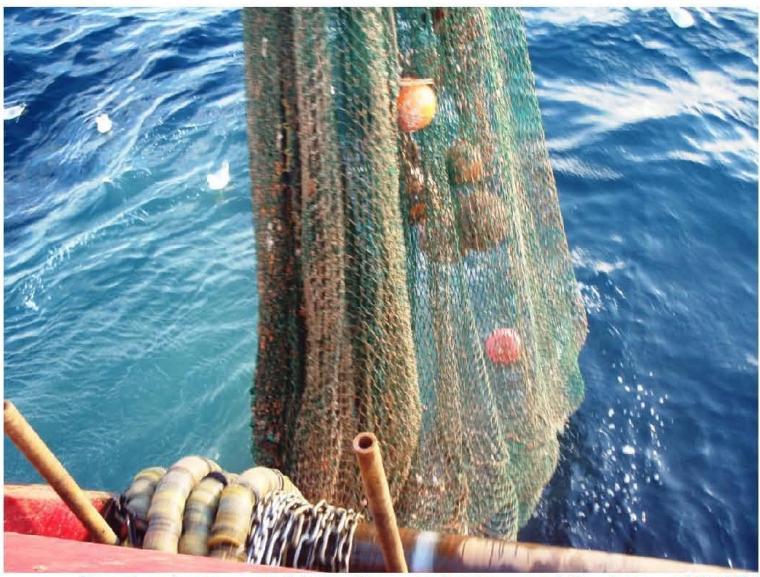
Trawling commenced at about 08:00hrs. and at 09:20hrs. the vessel came to a stop. The trawl was 'held fast'. After a short delay, the vessel moved again and the skipper surmised that the chain net had become stuck in mud on the sea bed. Three trawls were completed during the day, again following the grid pattern and recording the positioning of the vessel. When the last trawl was hauled onboard at 19:50 it was discovered that the chain net had entangled what appeared to be a complete trawl net from a fishing vessel. The net looked as though it had been on the sea bed for some time due to the organic growth on it. The assumption is that a fishing vessel had got too close to the platform and had entangled their net on the base of MCP01 and subsequently lost it.

Trawl net recovered from the sea bed around the base of MCP01

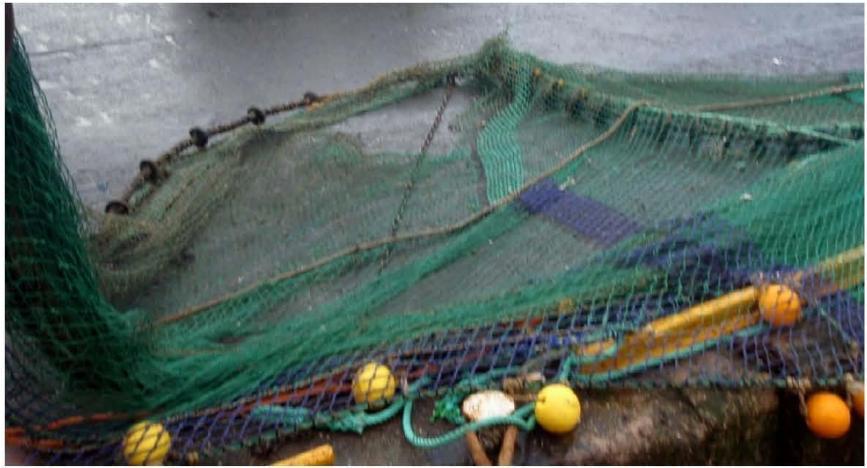
Following the three days of trawling with the chain net it was concluded that the sea bed was fairly clear of platform related debris, so the decision was taken to perform fish trawling to establish if there were fish in the area of the Safety Zone and if there were, to give an indication of the variety of species. The fish trawl was started at 08:00hrs. and hauled onboard about 11:30hrs. The trawl net showed some damage, possibly caused by platform debris or stones on the sea bed. Several varieties of fish had been caught, even though the net was damaged.

'Rebecca's' damaged trawl net on the quayside at Fraserburgh

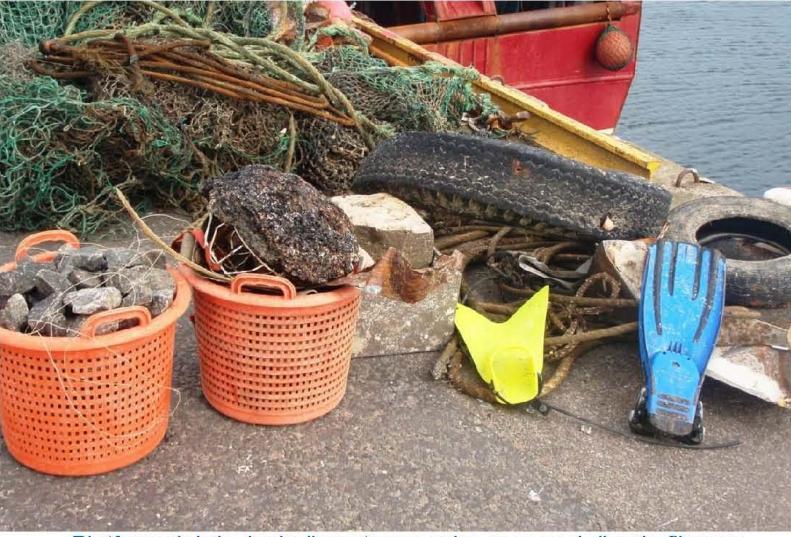
Platform debris, including stones, wire rope and diver's flippers.

The Rebecca returned to Fraserburgh on the morning of Wednesday, 18th May, following three days of using regular trawl fishing nets, to determine the variety of fish living close to MCP01. They recovered some further platform related debris including quite a number of stones, (probably from the 'rock dumping' operation following the by-pass of the pipelines around MCP01), some wire rope and diver's flippers.
