AAIB Bulletin:	G-LNDN	AAIB-27528
SERIOUS INCIDENT		
Aircraft Type and Registration:	MD 900, G-LNDN	
No & Type of Engines:	2 Pratt & Whitney Canada PW207E turboshaft engines	
Year of Manufacture:	2008 (Serial no: 900-00125)	
Date & Time (UTC):	25 July 2021 at 2014 hrs	
Location:	In flight between Royal London Hospital and RAF Northolt, Greater London	
Type of Flight:	Commercial Air Transport	
Persons on Board:	Crew - 2	Passengers - 2
Injuries:	Crew - None	Passengers - None
Nature of Damage:	Water damage to Symbol Generator and right Electronic Engine Controller	
Commander's Licence:	Airline Transport Pilot's Licence (Helicopters)	
Commander's Age:	58 years	
Commander's Flying Experience:	12,360 hours (of which 2,090 were on type) Last 90 days - 35 hours Last 28 days - 10 Hours	
Information Source:	AAIB Field Investigation

Synopsis

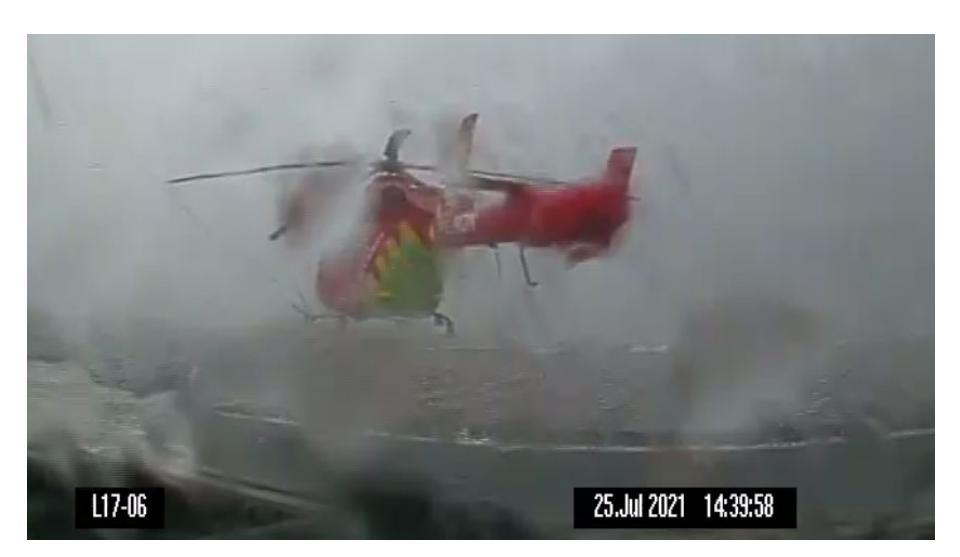
Figure 1 G-LNDN on the helipad at RLH during heavy rainfall

G-LNDN had been parked on the helipad at the RLH at the time of heavy rainfall. During this time rainwater entered the right engine bay through the mesh covered cut outs in the engine cowling. The rainwater had then flushed debris in the engine bay toward the rear drain hole, which then partially blocked. Either because of the partial blockage of the drain hole, or through sheer volume of water overwhelming the drains in the engine bay, it started to fill. As the water level reached the igniter lead through-holes, water was able to pass into the rear baggage compartment because inadequate sealing round the igniter leads, which had been applied whilst it was operated by its previous owner, did not prevent water ingress.

Had engine area or upper deck covers been used to protect the engine bays during the heavy rainfall, the pathway for the rainwater to enter the engine bay would have been blocked. The operator explored the feasibility of using engine cowl covers in addition to the tie downs and engine blanks already required, but this was considered detrimental to the operation of the helicopter when considering its three-minute launch target in its role as an air ambulance. The operator also identified risks of causing damage to the aircraft's antenna and creating possible foreign object debris (FOD) whilst removing the covers that protect the upper surfaces of the fuselage.

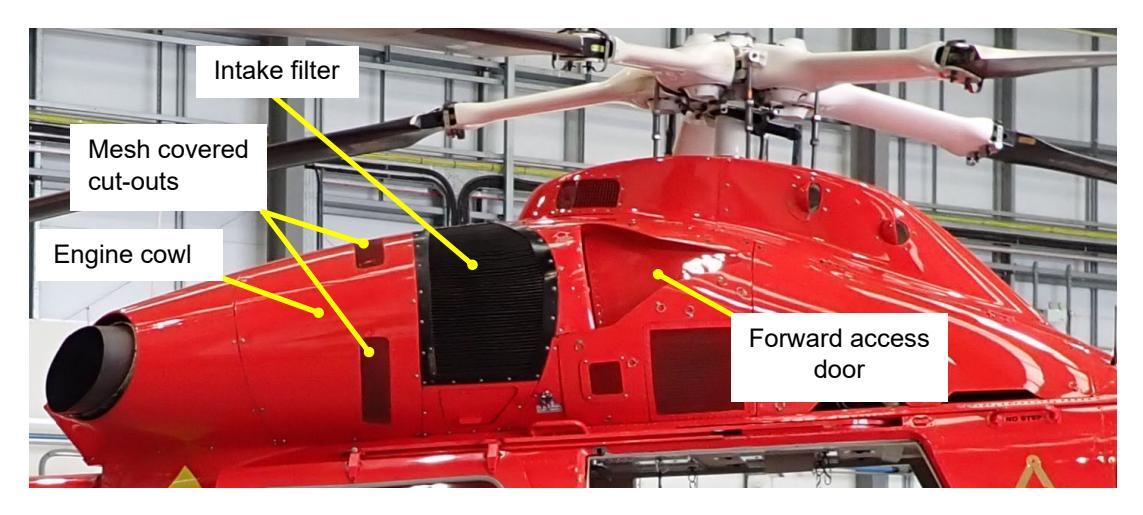
Figure 8 Right engine access doors and cowling

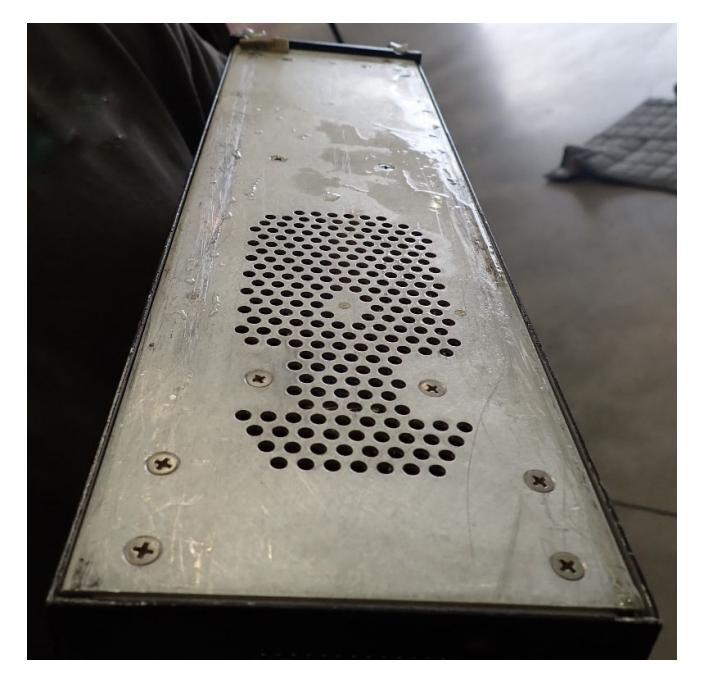
The Symbol Generator was found to have streaking along its outer casing and a bead of water was noticed on its locking mechanism. When it was removed the underside of the unit was wet (Figure 11). The Symbol Generator was returned to its manufacturer for assessment.

Assessment of the Symbol Generator by its manufacturer found that although the unit turned on, there was electrical 'noise' on the display output. Detailed assessment of the power supply and circuit boards identified some corrosion on the Display Processor-HSI board which was likely to have been caused by exposure to water.

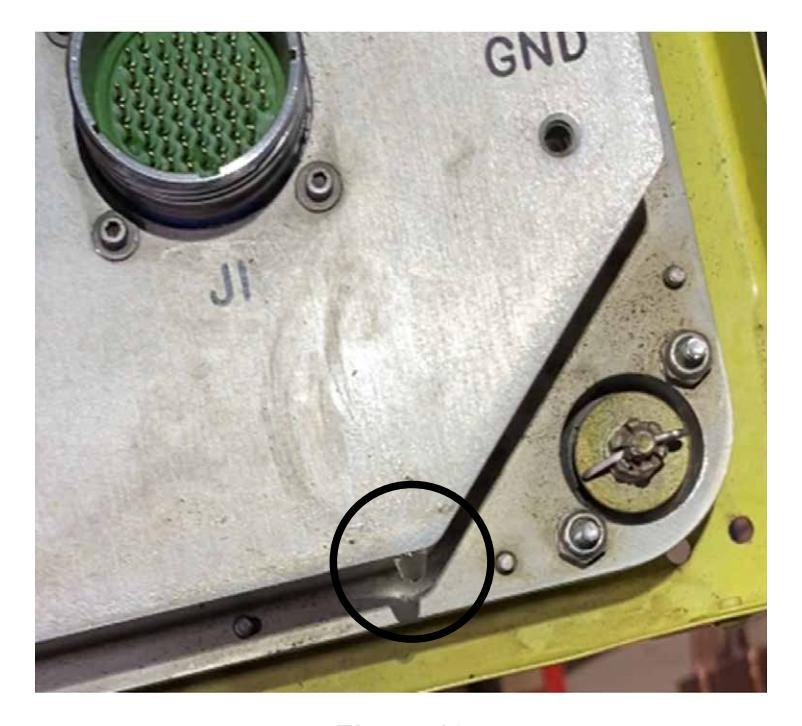
The right EEC, which is positioned inboard of the Symbol Generator, showed evidence of having been in contact with water. The unit is mounted horizontally in the helicopter and accessed by removing the rear mounts and then lowering it, hinging around the forward mounts. As the unit was lowered, water was seen dripping from the ambient pressure tapping on the rear of the unit (Figure 12). Water was also found accumulated within the JI connector when it was disconnected.

Figure 12 Right engine EEC showing water dripping from ambient pressure tapping

Assessment of the right EEC and its DCU found that, even after drying, the EEC would not power up. The DCU download did not show any information about the EEC failure but did record engine control being moved into manual. There were no further events logged on the DCU. It was considered most likely that exposure to water caused a short circuit on the power board causing the EEC to fail permanently.

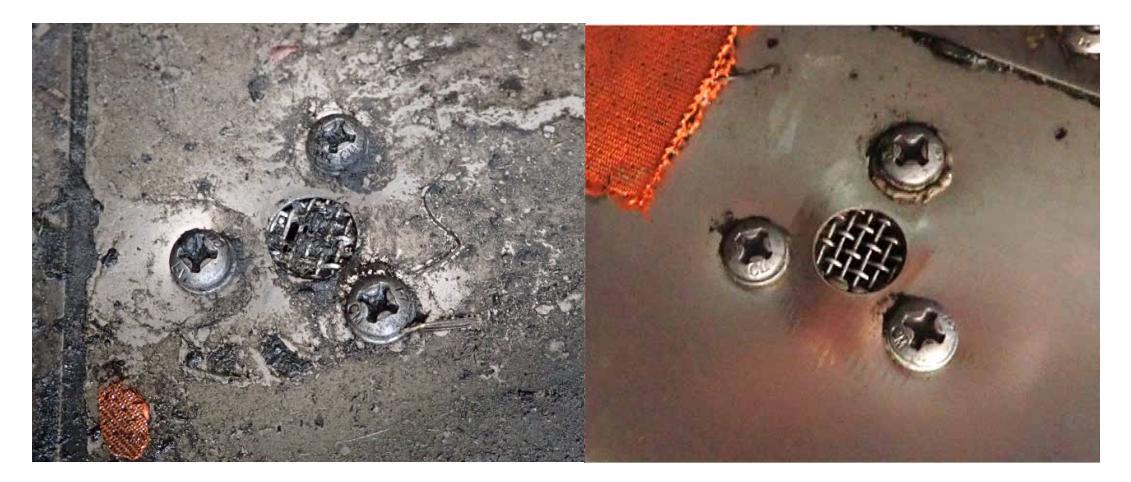
Figure 13

The right engine cowling was removed allowing access to the engine bay. With the thermal blankets removed it was possible to see that the rear bay drain hole was partially blocked with debris; the forward drain was clear (Figure 13). Both drains were functionally tested and showed that they could both pass fluid to the overboard drain outlets.

Rear and forward drain holes in right rear engine bay

The operator introduced additional maintenance procedures to ensure the engine bays remained clear of debris and the drains remained serviceable.

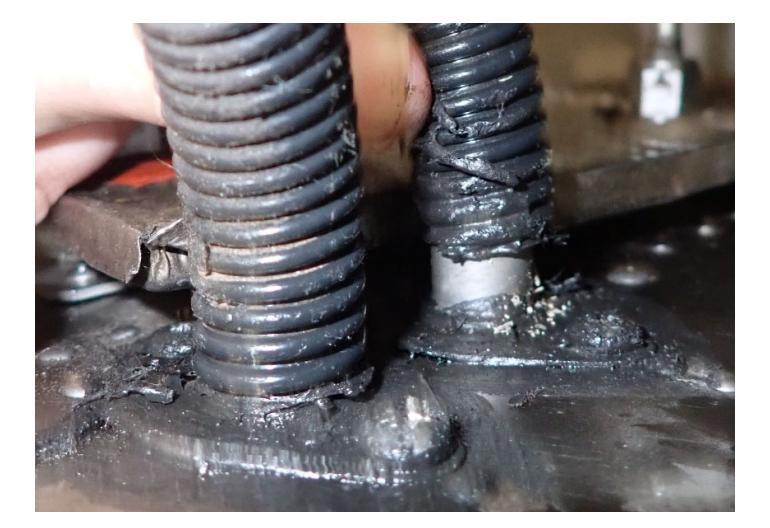
Figure 14

The amount of sealant around the right engine igniter cables as they passed through the deck was minimal. The outer sheaths between the deck and the engine could be moved away from the deck with little force (Figure 14). A liquid solvent degreaser was sprayed on the area where the igniter cable passed through the deck. A stream of solvent was immediately observed flowing into the rear baggage compartment from around the igniter cables. This fluid flowed directly onto the right EEC. A similar assessment of the left engine igniter cables was carried out. This found that the sealant was well applied around the igniter leads and no leaks were observed when solvent was sprayed at the interface. As the right engine had not been removed whilst it had been in operation in the UK, the sealant around the igniter leads is likely to have been applied when it was being operated by its previous operator.

Right engine igniter cable sheath easily moved away from deck

The right engine had not been removed from the helicopter since it had been acquired from its previous operator. Without the intervention of an engine removal there would have been no need to remove the igniter leads and re-apply the sealing compound around the base of the igniter lead sheaths. As the engine bay cowling is only removed during maintenance inspection, pilots cannot assess the condition of the components in the engine bay during pre-flight checks. This therefore relied on maintenance inspections to assess the condition and cleanliness of this area. The positioning of the thermal blankets on the floor of the engine bay would have prevented the amount of sealant and the quality of its application from being easily assessed. It is also unlikely that the thermal blankets would have been removed during routine maintenance to expose this location. After the incident, the operator inspected the sealant around the igniters on the other MD 902 they operated and found it to be in good condition. The operator also instructed regular cleaning of the engine bays to remove debris and inspect the drain holes for contamination. It is good practice to maintain inspection and husbandry standards with all aircraft.

The operator inspected its other aircraft to ensure that the sealant around the igniter leads was applied correctly.
