SERIOUS INCIDENT

History of the flight

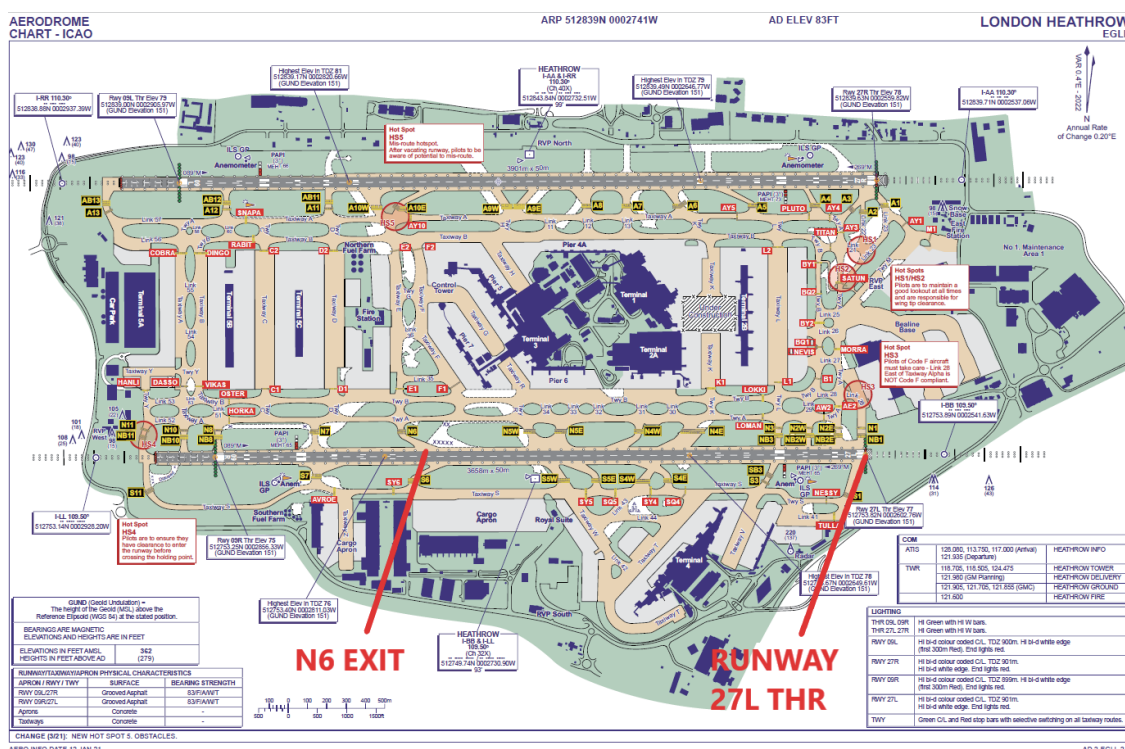
Figure 1
London Heathrow Airport Chart

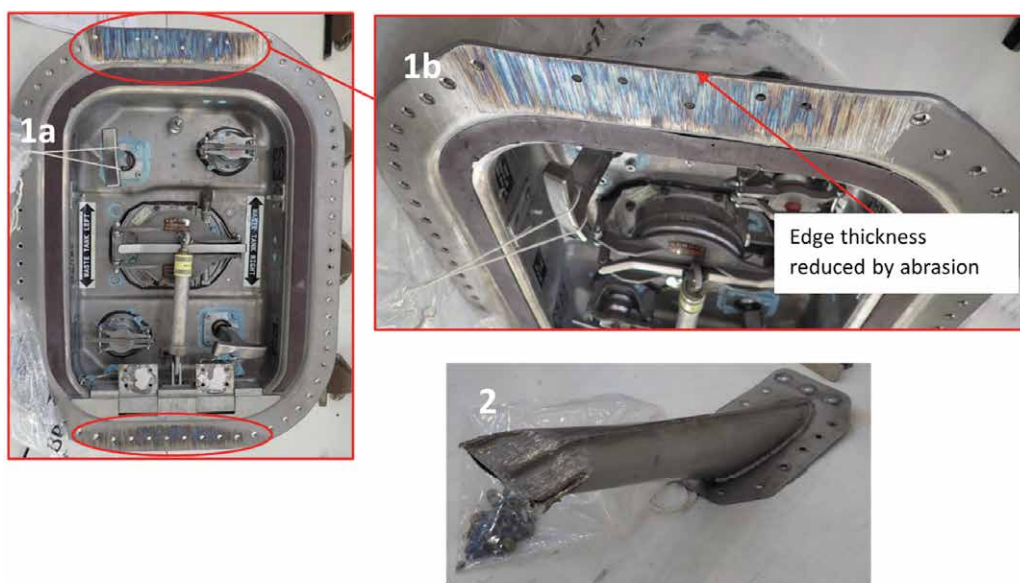
Damaged skin composite layers

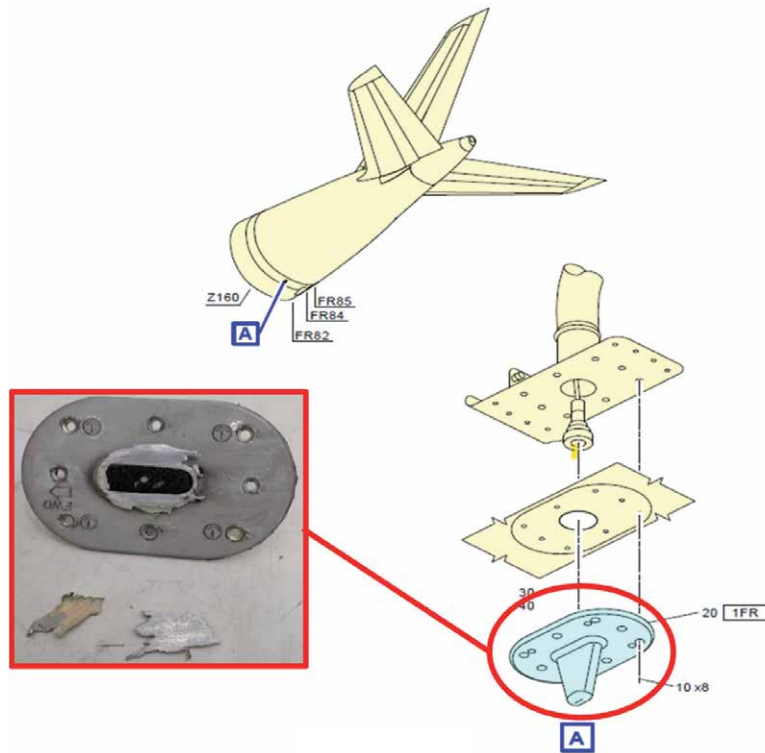
The primary component of the tailstrike indicator system is the tailstrike sensor which is designed to fracture when the aircraft's tail hits the ground. There are two wires inside the sensor (Figure 7) to allow for a fault condition should one of the wires become open circuit. In this state no tailstrike alert is displayed and the fault is added to the post flight report by the Centralised Maintenance System and included in a maintenance check.

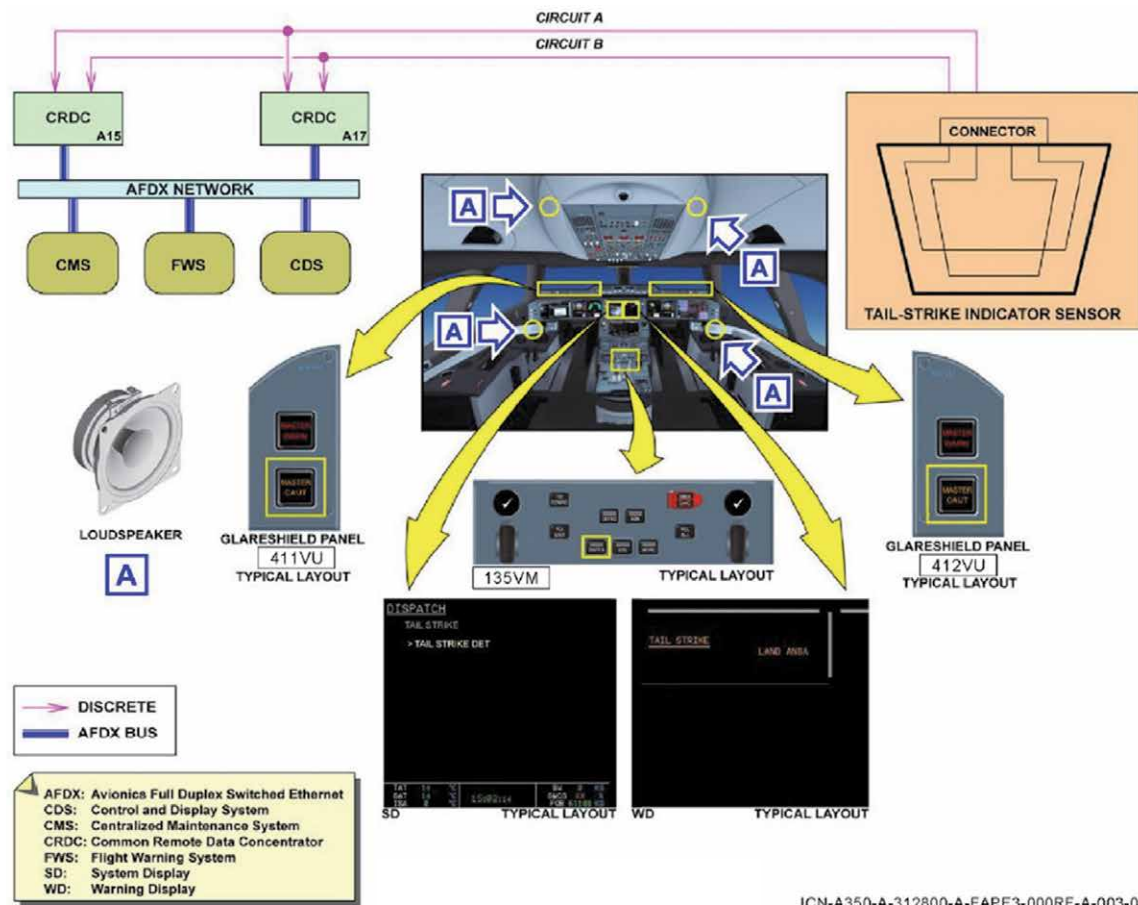
When a tailstrike does occur, the two wires in the sensor are damaged and become open circuit from their normally grounded (GND) state. The change of signal state is detected by the Common Remote Data Concentrators which change the format of the data and transmits it to the Flight Warning System (FWS) via the Avionics Full Duplex Switched Ethernet (AFDX). The FWS shows a warning on the ECAM Warning Display providing the aircraft is in the appropriate flight phase, landing or taking off. A single chime is also produced from the flight deck loudspeakers. On the cockpit glare shield and panels 411VU and 412VU, MASTER CAUT push buttons are also illuminated (Figure 8). Other than an ECAM message, the system warnings are inhibited when TOGA is selected during landing.
