## Supplementary Bat & Ecology Note

Former Friends School, Saffron Walden

July 2022

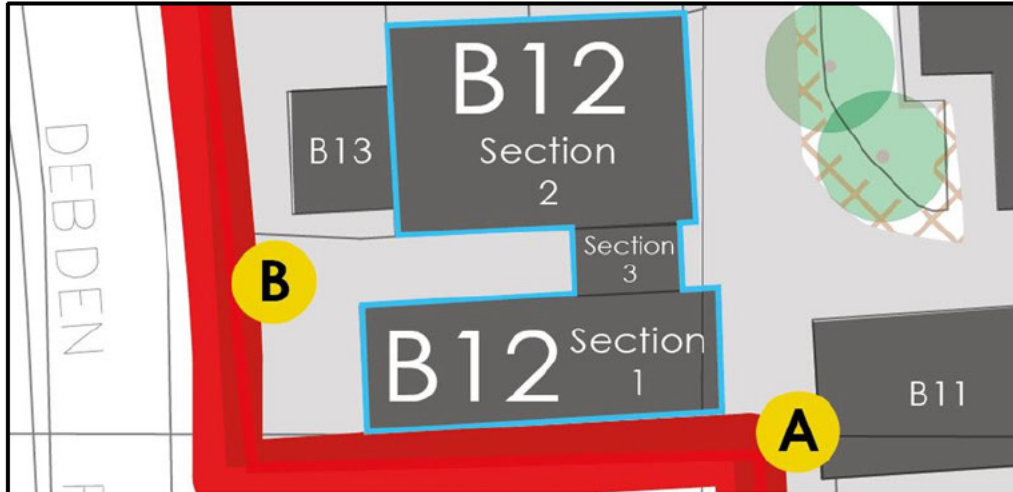
**Plate 1.** Building B12 (outlined blue), showing section 1, 2, and 3 with surveyor locations for emergence survey shown in yellow ('A' & 'B')

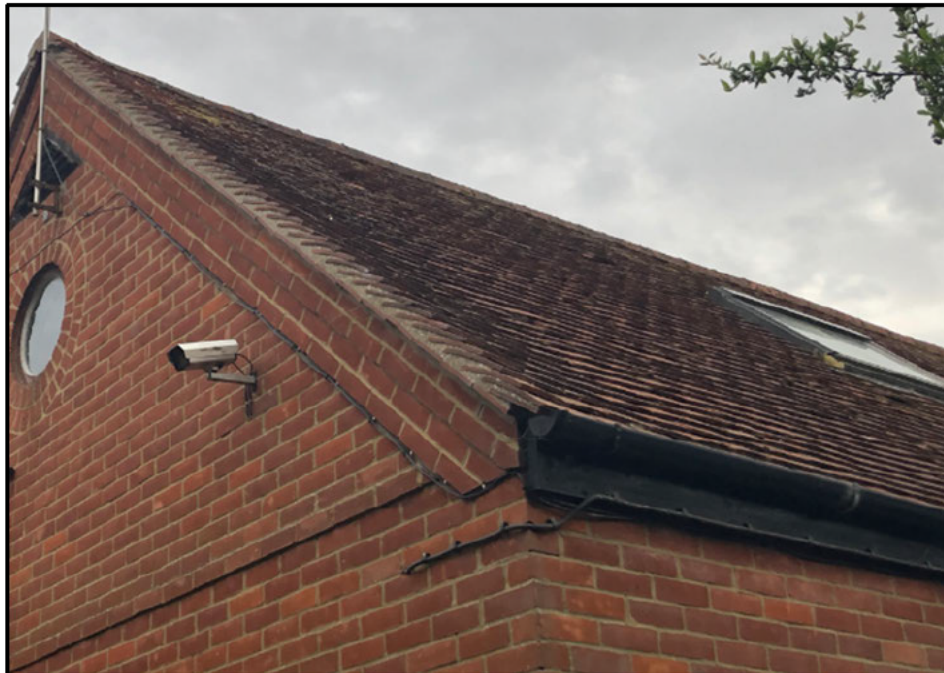
**Photograph 1** Northern elevation of Section 1 with skylight. Note roof with tightly fitted tiles across the majority of the roof.

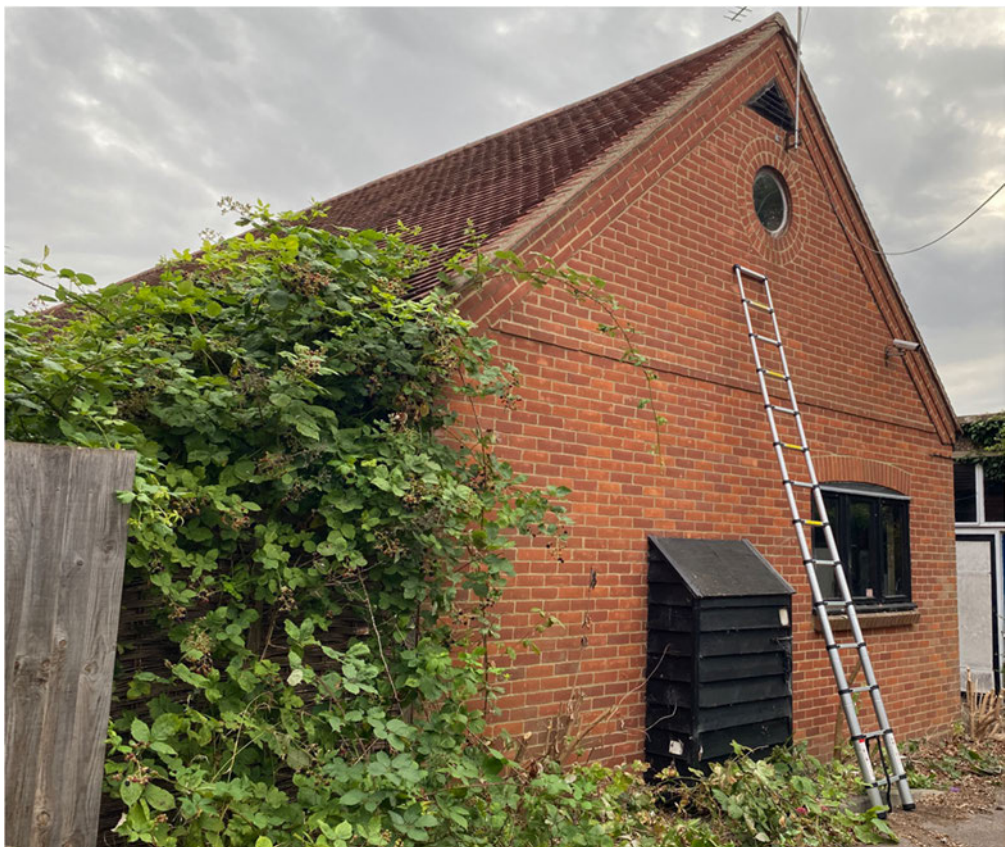
- 2.3 There were no limitations to the internal building inspection or emergence survey. Some dense bramble growth was present against the southern elevation of B12 which obstructed the view of much of the exterior wall. Whilst this vegetation may in principal obscure potential roost features the vegetation, it would itself have precluded bats from using or finding features present.

**Photograph 3** Southern and eastern elevation of Section 1. Note roof with tightly fitted tiles across the majority of the roof. Note bramble cluttering potential roosting opportunities/clear flight path.

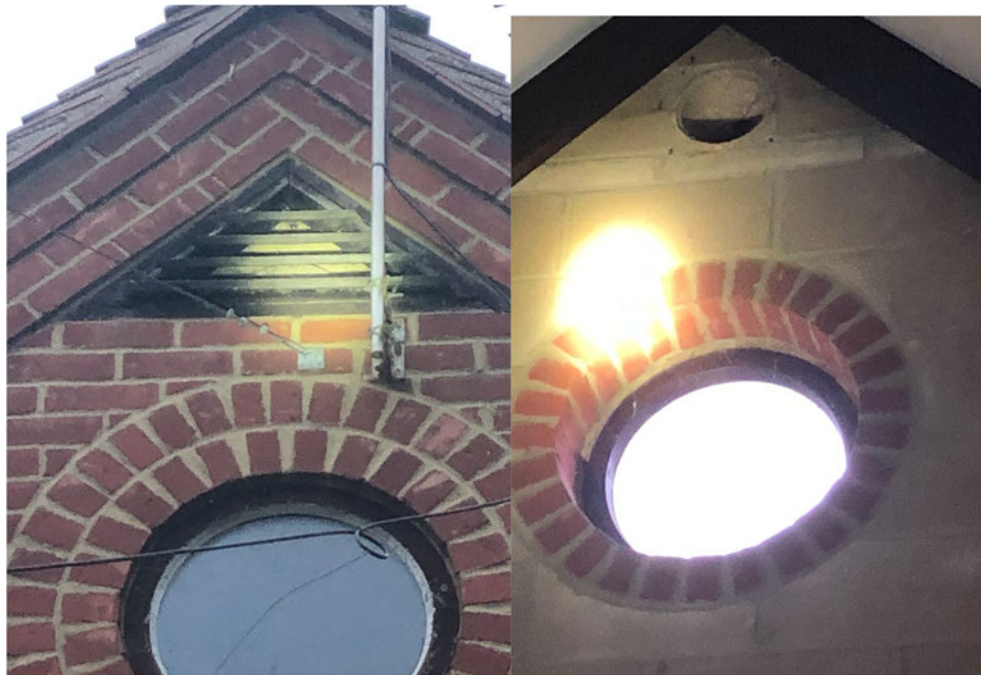
**Photographs 4 & 5** Air vents (on both eastern and western gable ends of Building B12). Obstructed and cobwebbing noted.

- 2.9 Air vents are present on the eastern and western gable ends of Section 1, above small circular windows. These vents appeared to be internally obstructed with insulation and other materials and were also heavily cobwebbed from both sides indicating unlikely use by bats. This obstruction effectively prevents bats from accessing the single room present in B12 (Section 1).
