Report on the investigation into the

stand up paddleboarding accident

that resulted in four fatalities

at Haverfordwest Town Weir, Wales

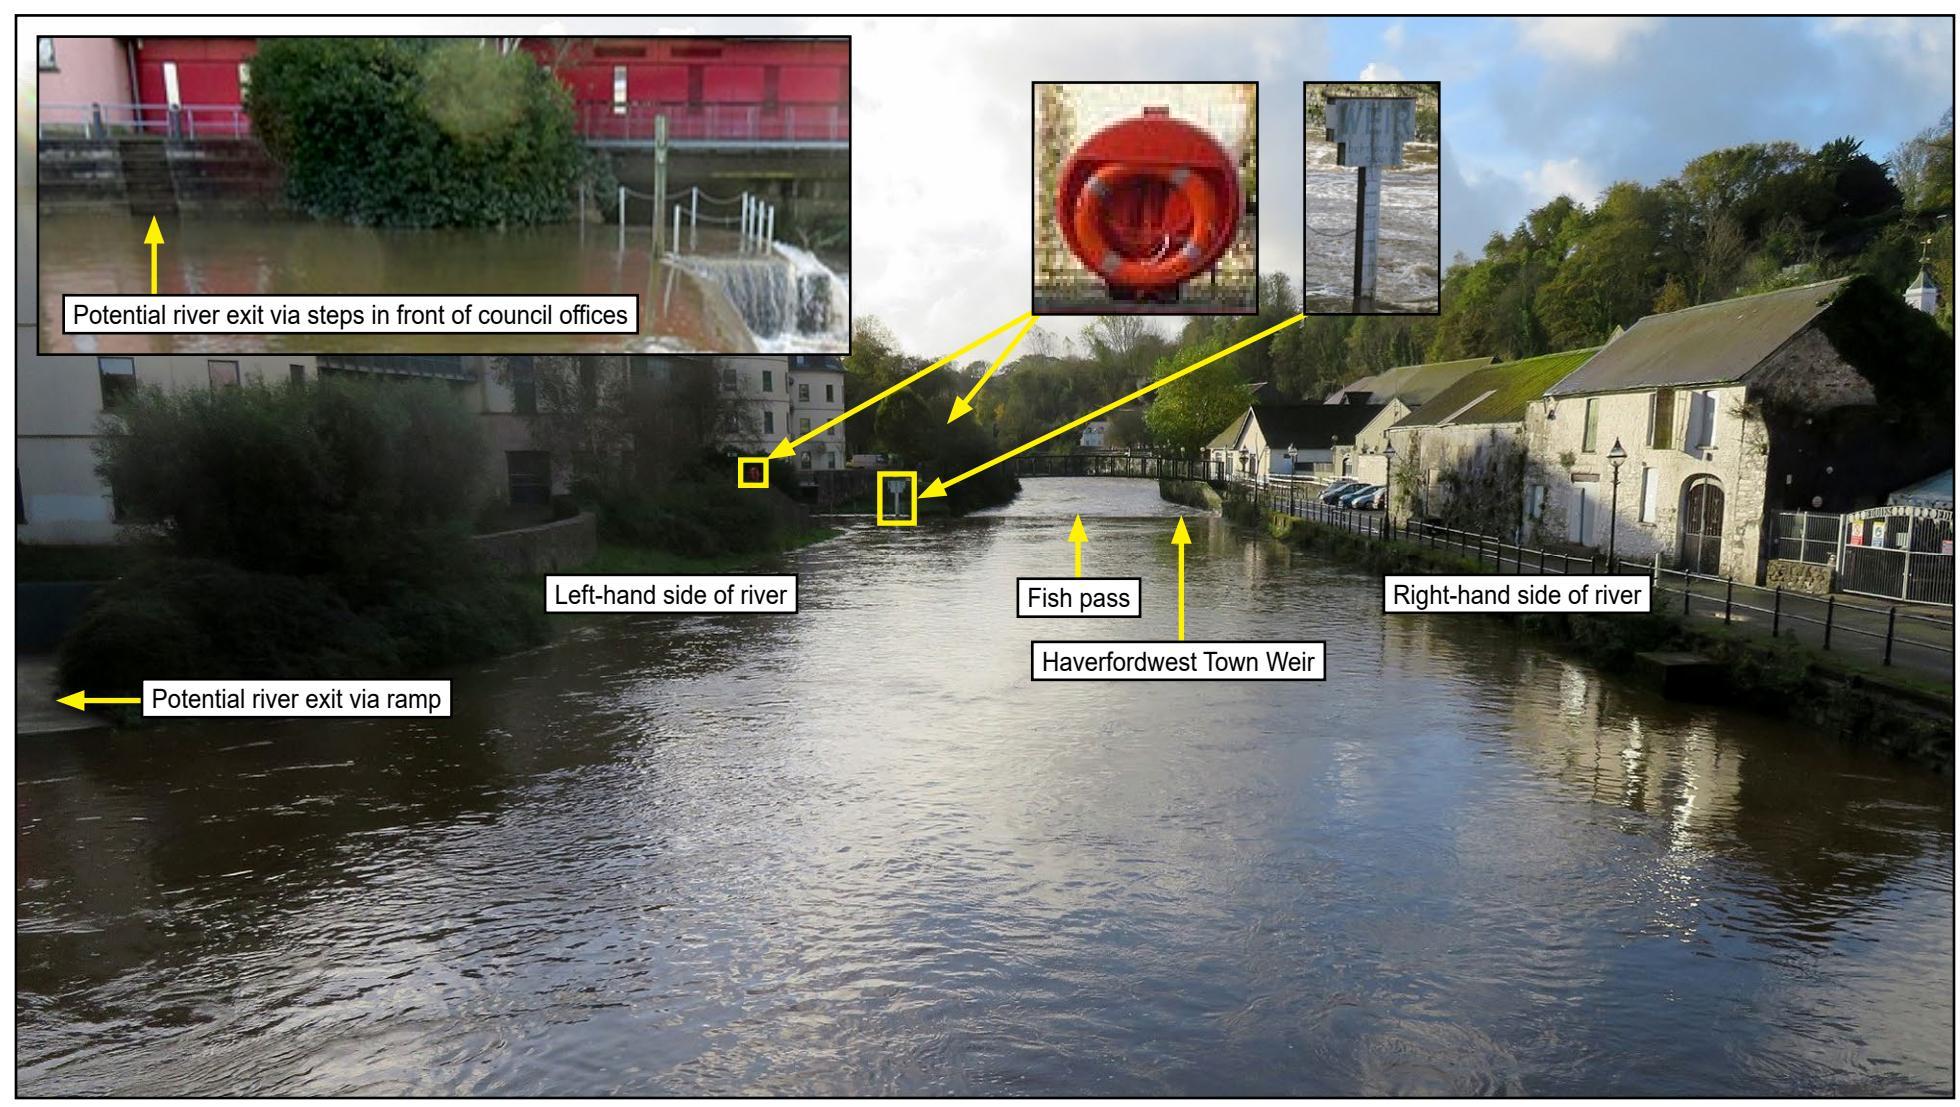
Figure 4: View of the town weir from New Bridge the day after the accident

Canoe England proposed that the construction should include the insertion of *corner fillets* of block stone at the bank ends and on either side of the fish pass to *considerably lessen the hazard of potential drowning due to entrapment in the hydraulic jump*¹⁴. The desired effect was that the *corner fillets* would weaken the hydraulic forces at the weir and create flush points to wash anyone trapped at the weir downstream (**Figure 10**). Plans show that these *corner fillets* were inserted in 2003; no flush points were observed at the weir, in similar conditions, the day after the accident.

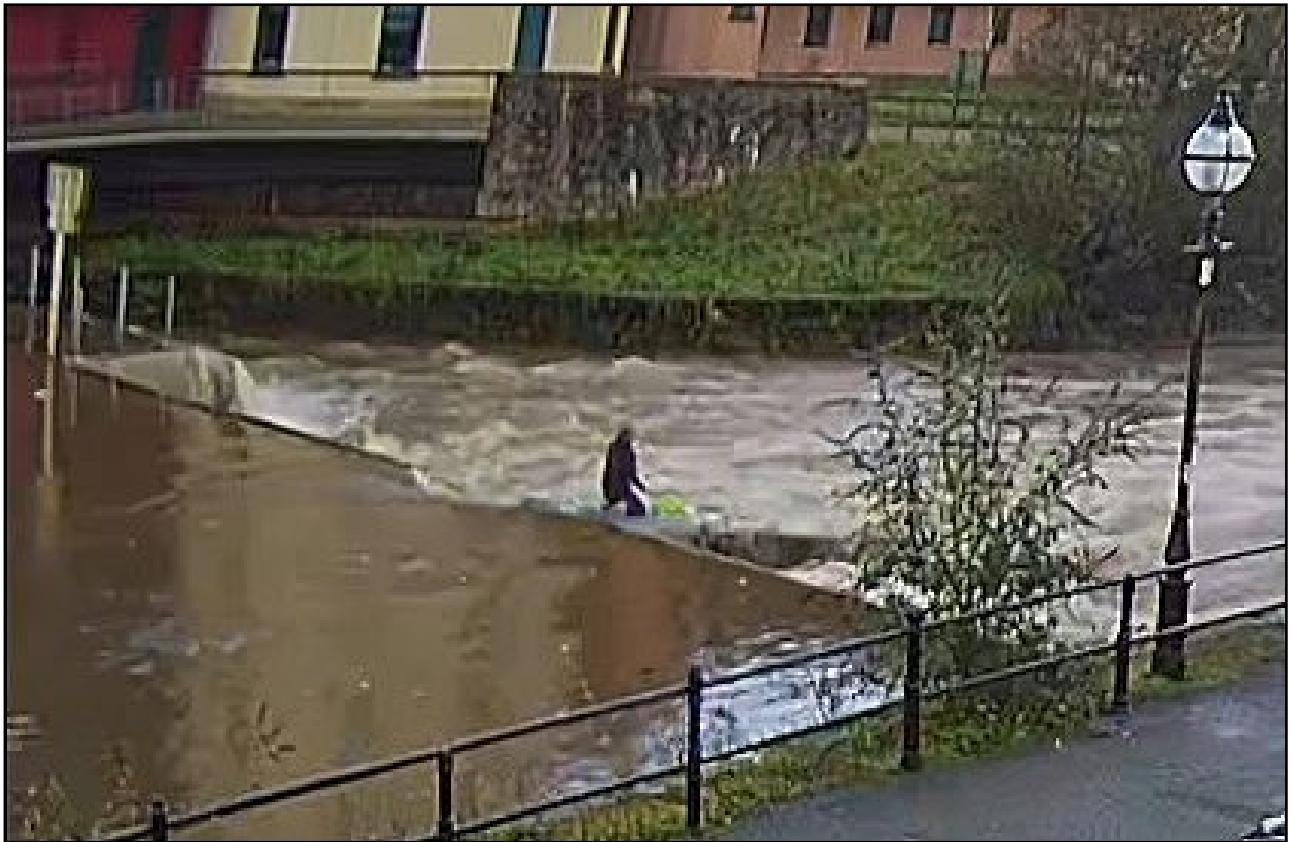
Figure 5: CCTV image of the Salty Dog Co Ltd's owner sliding down the fish pass at the town weir

At 0856, the tour leader, kneeling on her SUP, slid down the fish pass in the centre of the weir and was swept quickly downriver **(Figure 5)**. The next participant tried to copy the leader but was unable to align her SUP with the fish pass and was washed over its right-hand side. She fell from her SUP into the river and was swept downstream. As the other participants approached the weir, the fellow leader, who was following at the rear, told those nearby to kneel down and keep left.

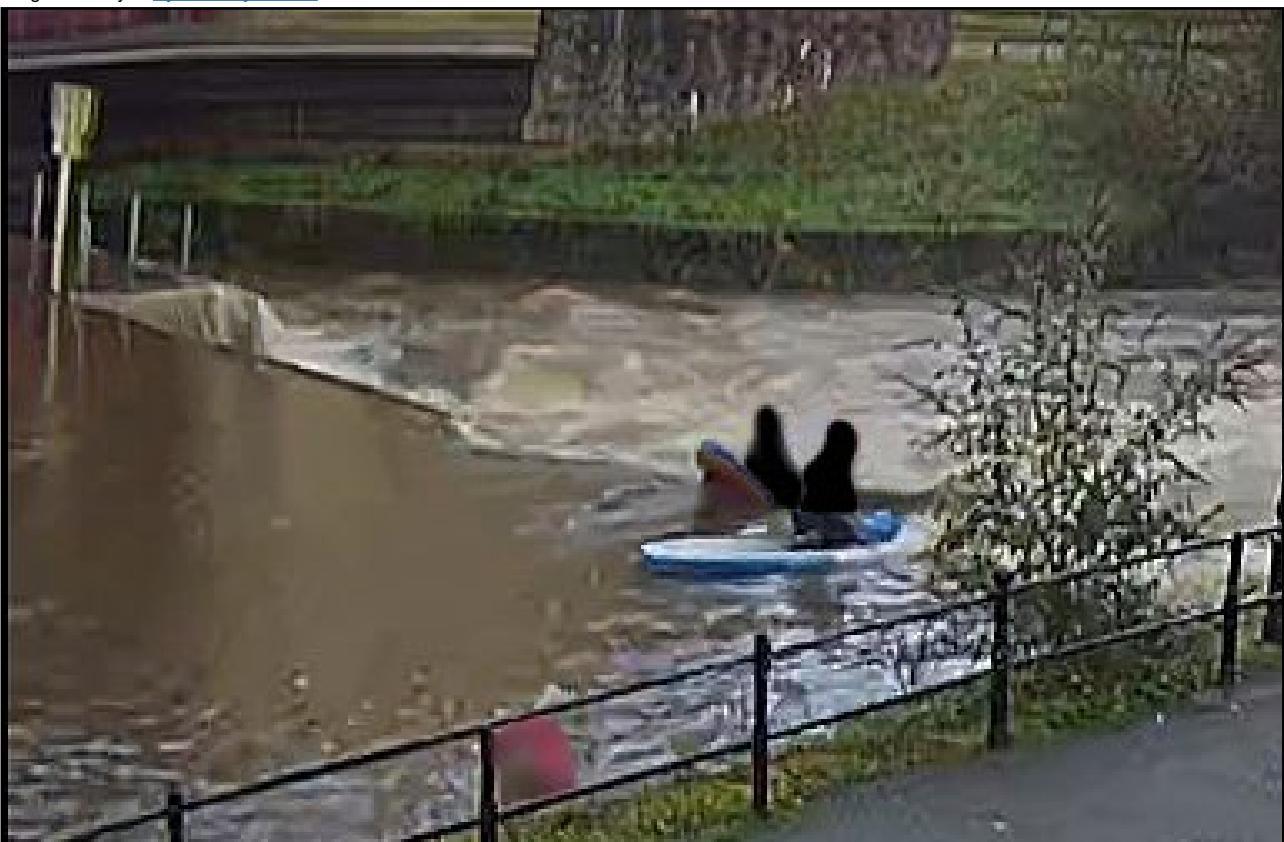
Figure 6: CCTV image of the Pembrokeshire Tour participants descending the weir to the right of the fish pass

Within about a minute, the next six participants of the group descended the weir; four to the right of the fish pass and two to the left. As they did so, their SUPs pitched forward and all six of them fell into the turbulent water at the foot of the weir **(Figure 6)**. Three of the group were washed clear and swept downstream, holding on to their SUPs. The other three were trapped within the recirculating flow on the downstream side of the weir; two to the right of the fish pass and one to the left.

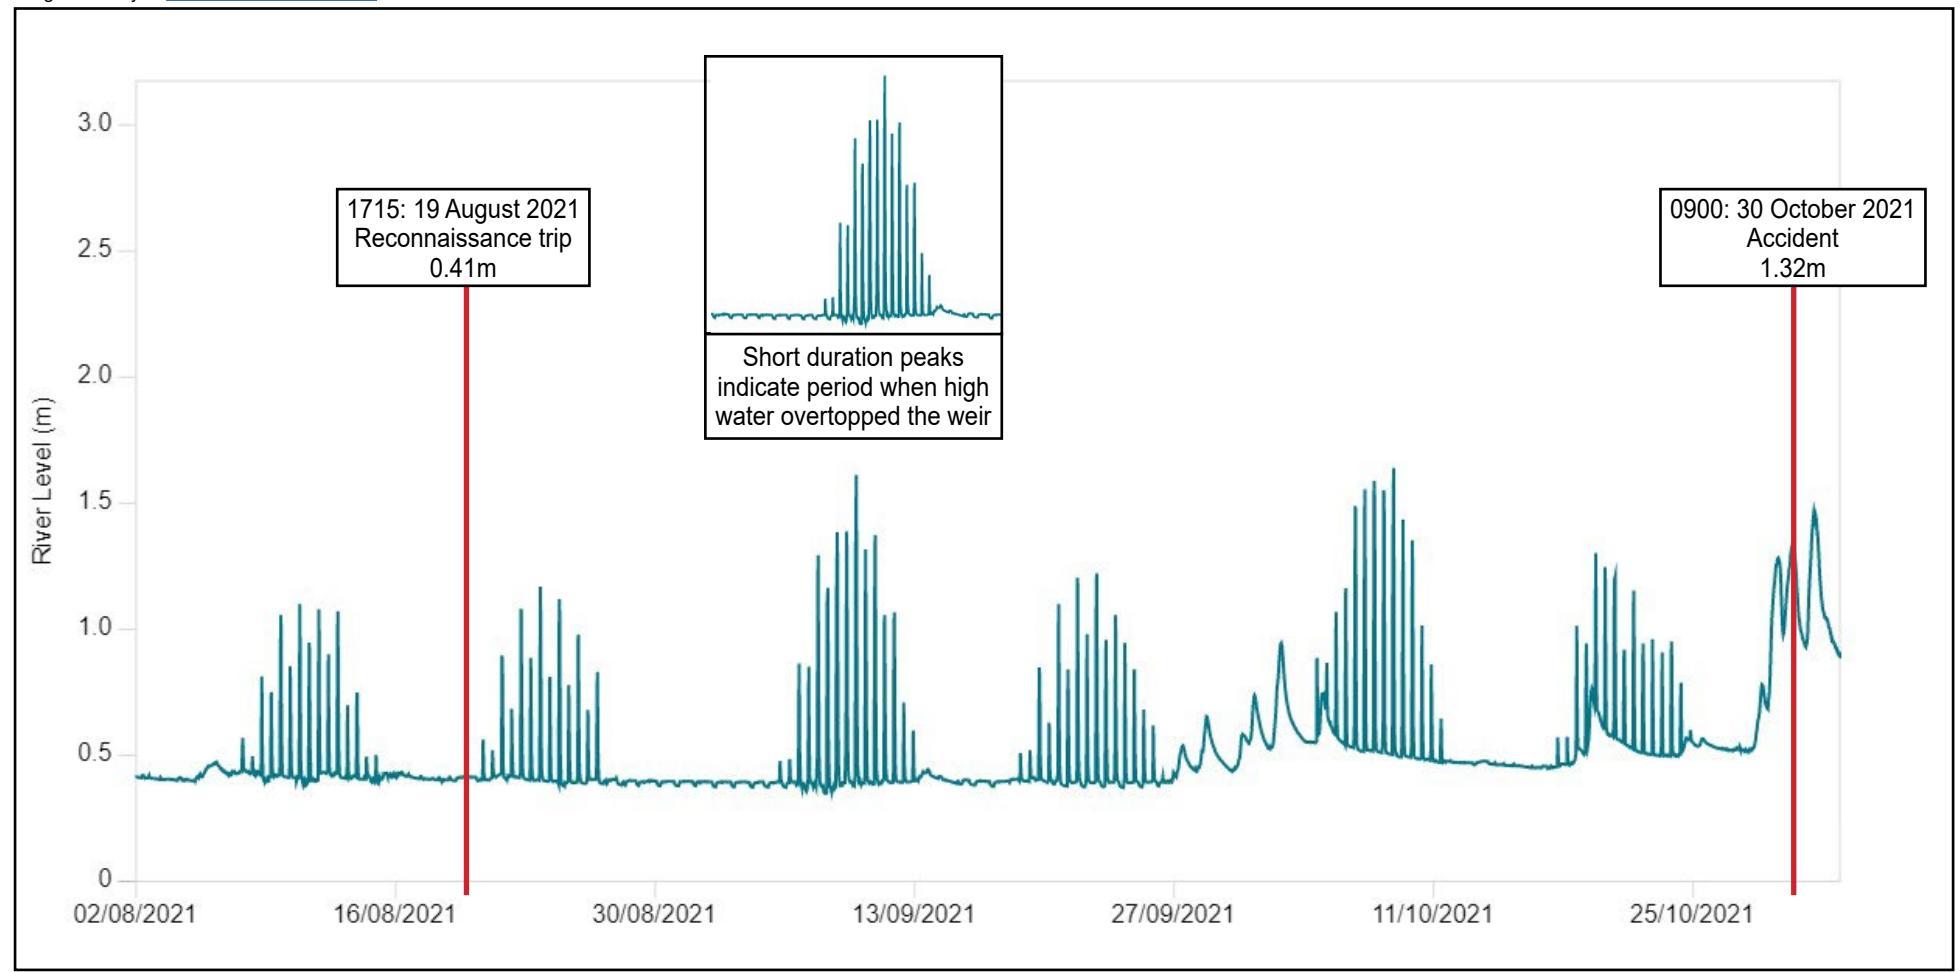
Figure 7: Natural Resources Wales graph of the river level at Haverfordwest for the reconnaissance trip (19 August 2021) and the accident (30 October 2021)

At 1645 on 28 October, NRW issued a flood alert for the Western Cleddau. At 1045 on 29 October, the alert was updated and was in force at the time of the accident. At 0900 on 30 October, the river level of the Western Cleddau at Haverfordwest was 1.32m.

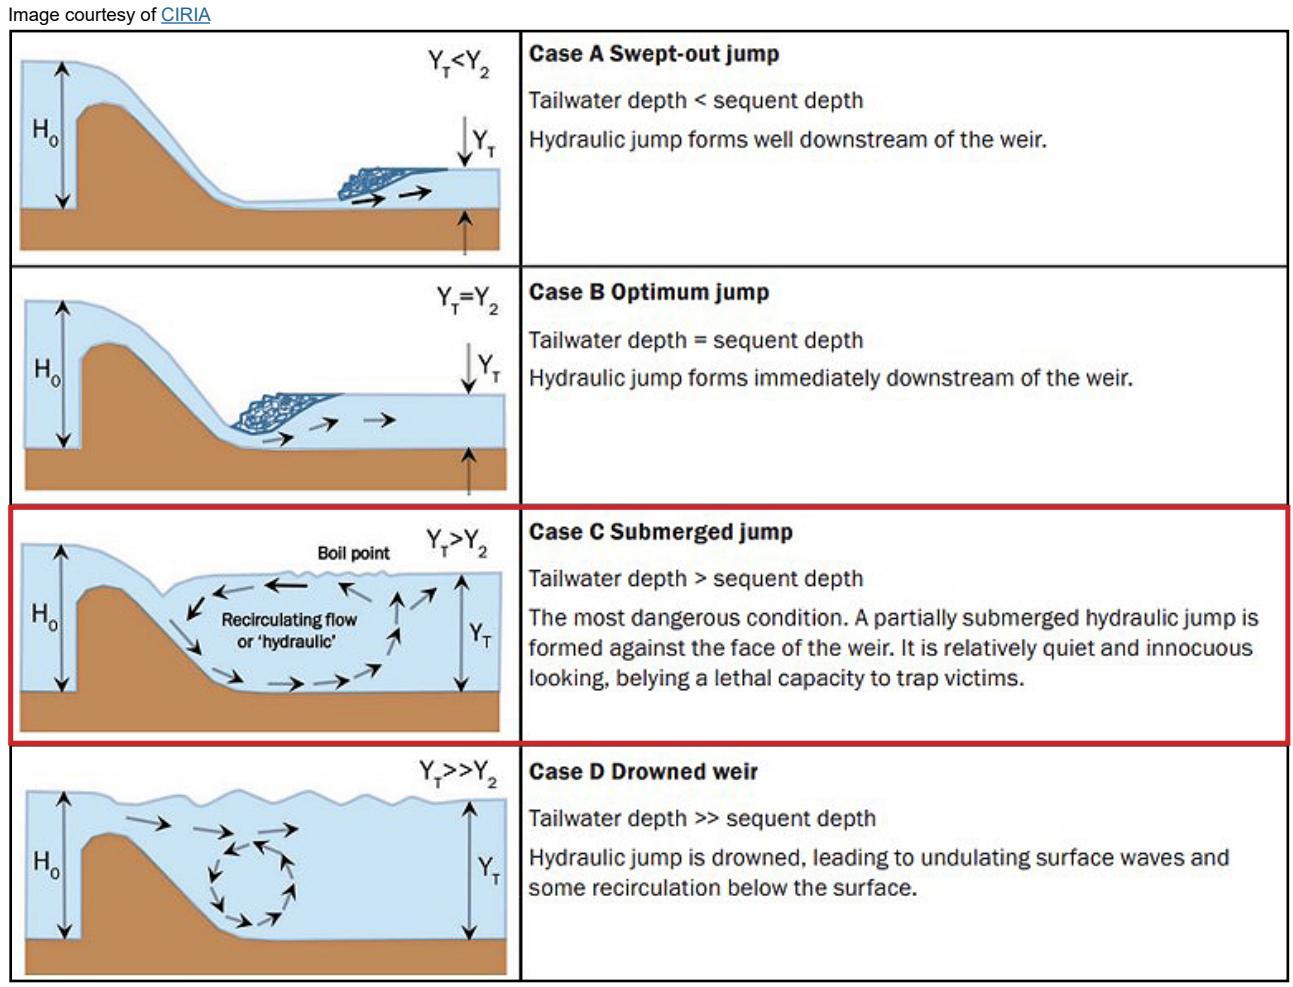
Figure 11: Weir flow types (from Tschantz and Wright, 2011)

MAIB observation of the weir in similar conditions¹⁸ the day after the accident indicated that *Case C Submerged jump* had been created, which the CIRIA paper described as *the most dangerous condition*. From the measurements taken on that day, the Weir Assessment System rated the weir hazard level as *Very High* and the likelihood of the weir to cause harm as *Very Likely* (Figure 13). At the time of the accident there were no records that DCWW, PCC or MHPA had conducted a risk assessment for Haverfordwest Town Weir.

On the morning of the accident, the high river level, fast current and low tide resulted in treacherous hydraulic conditions at the weir. These conditions created a powerful recirculating flow and *Submerged jump* with its associated *towback* at the base of the weir, described by the CIRIA paper as a weir's *most dangerous condition* (Figure 11).

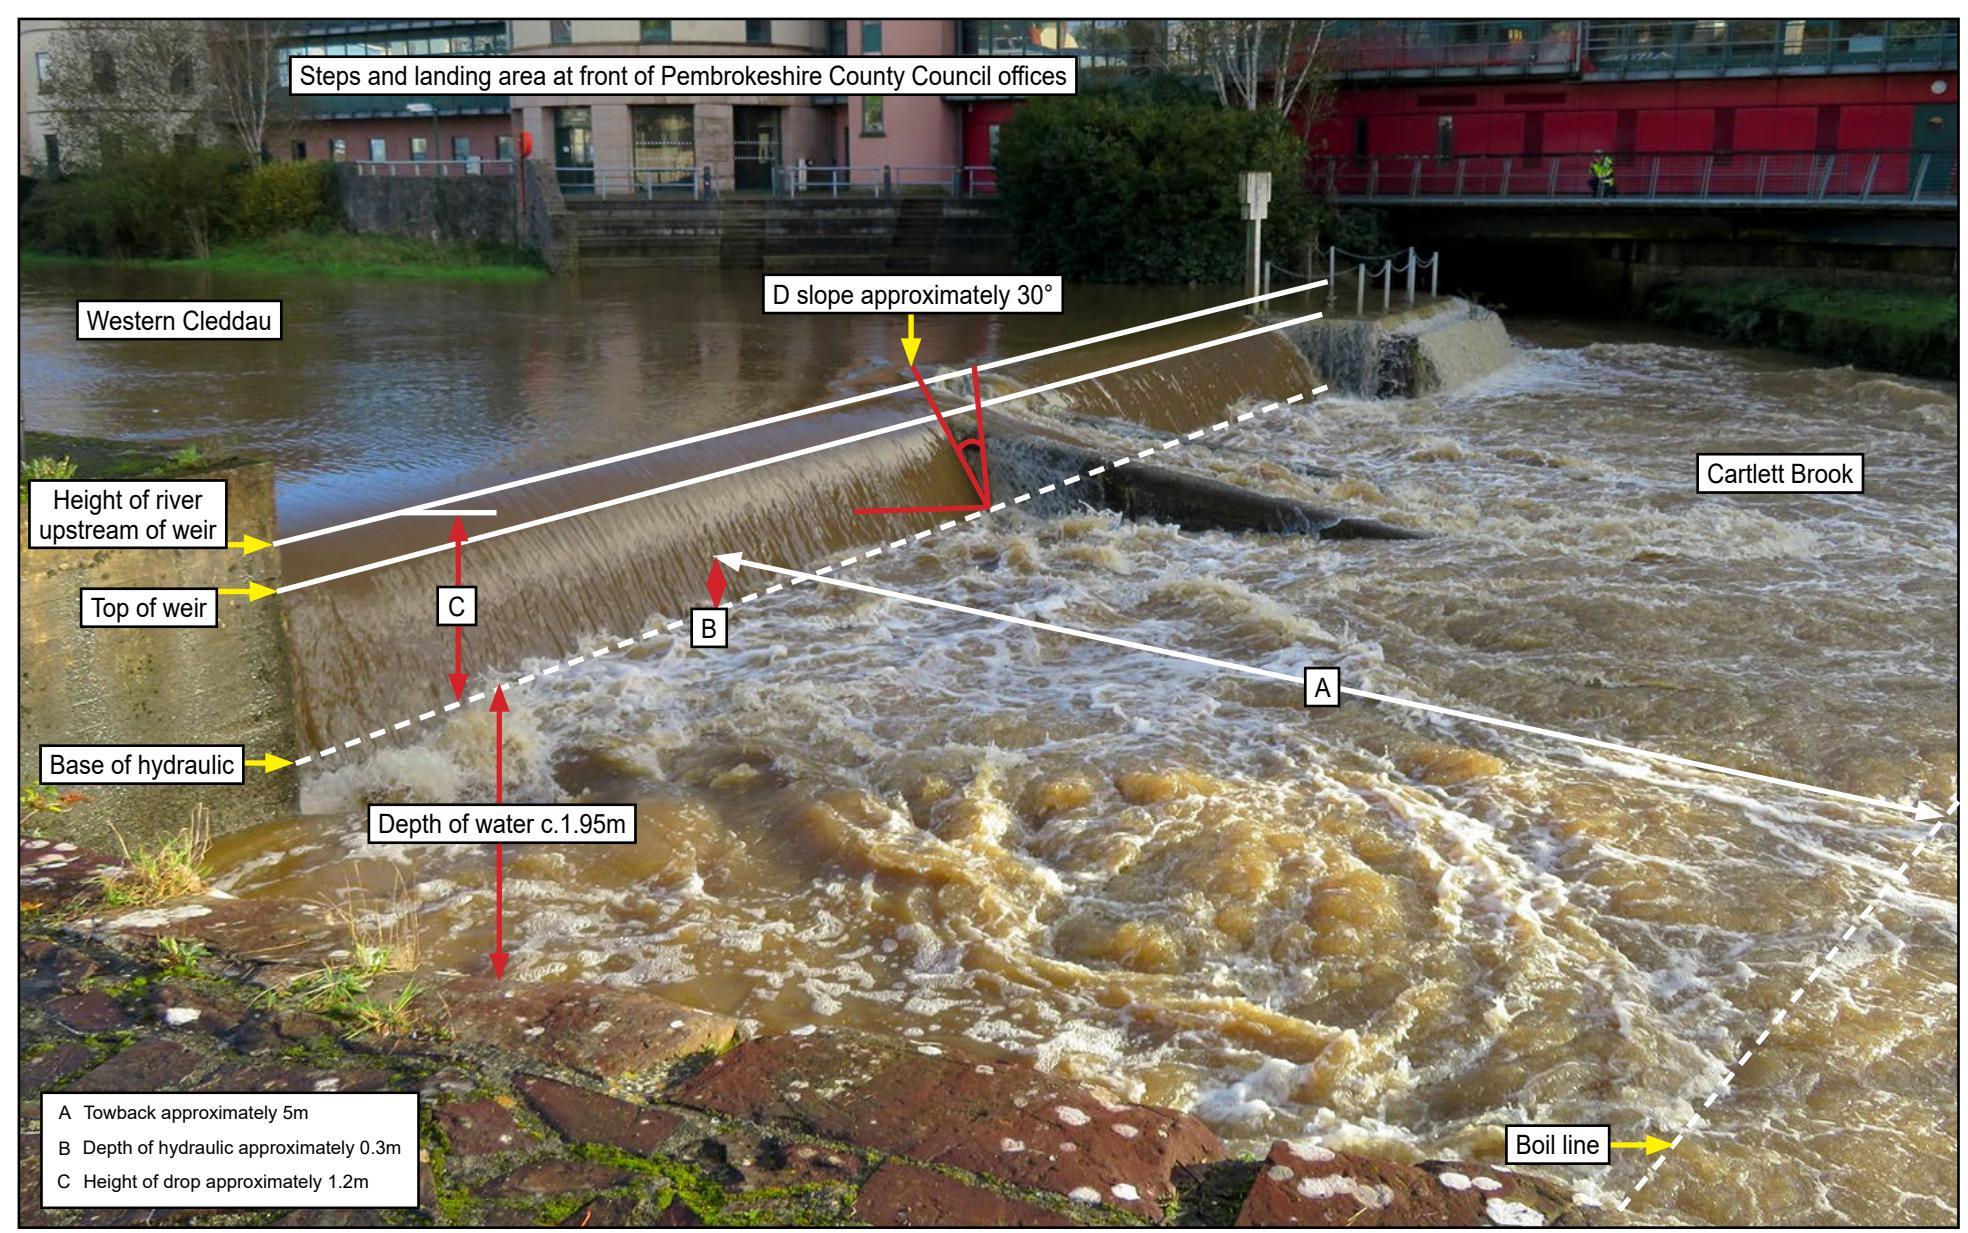
Figure 13: Conditions at the weir the day after the accident

It was also noted that the closed, vertical sides downstream of the weir, at both the fish pass and the right and left-hand banks, meant that there was no means of escape from the water for someone trapped at the weir; and, that it would be very difficult for others to rescue them.

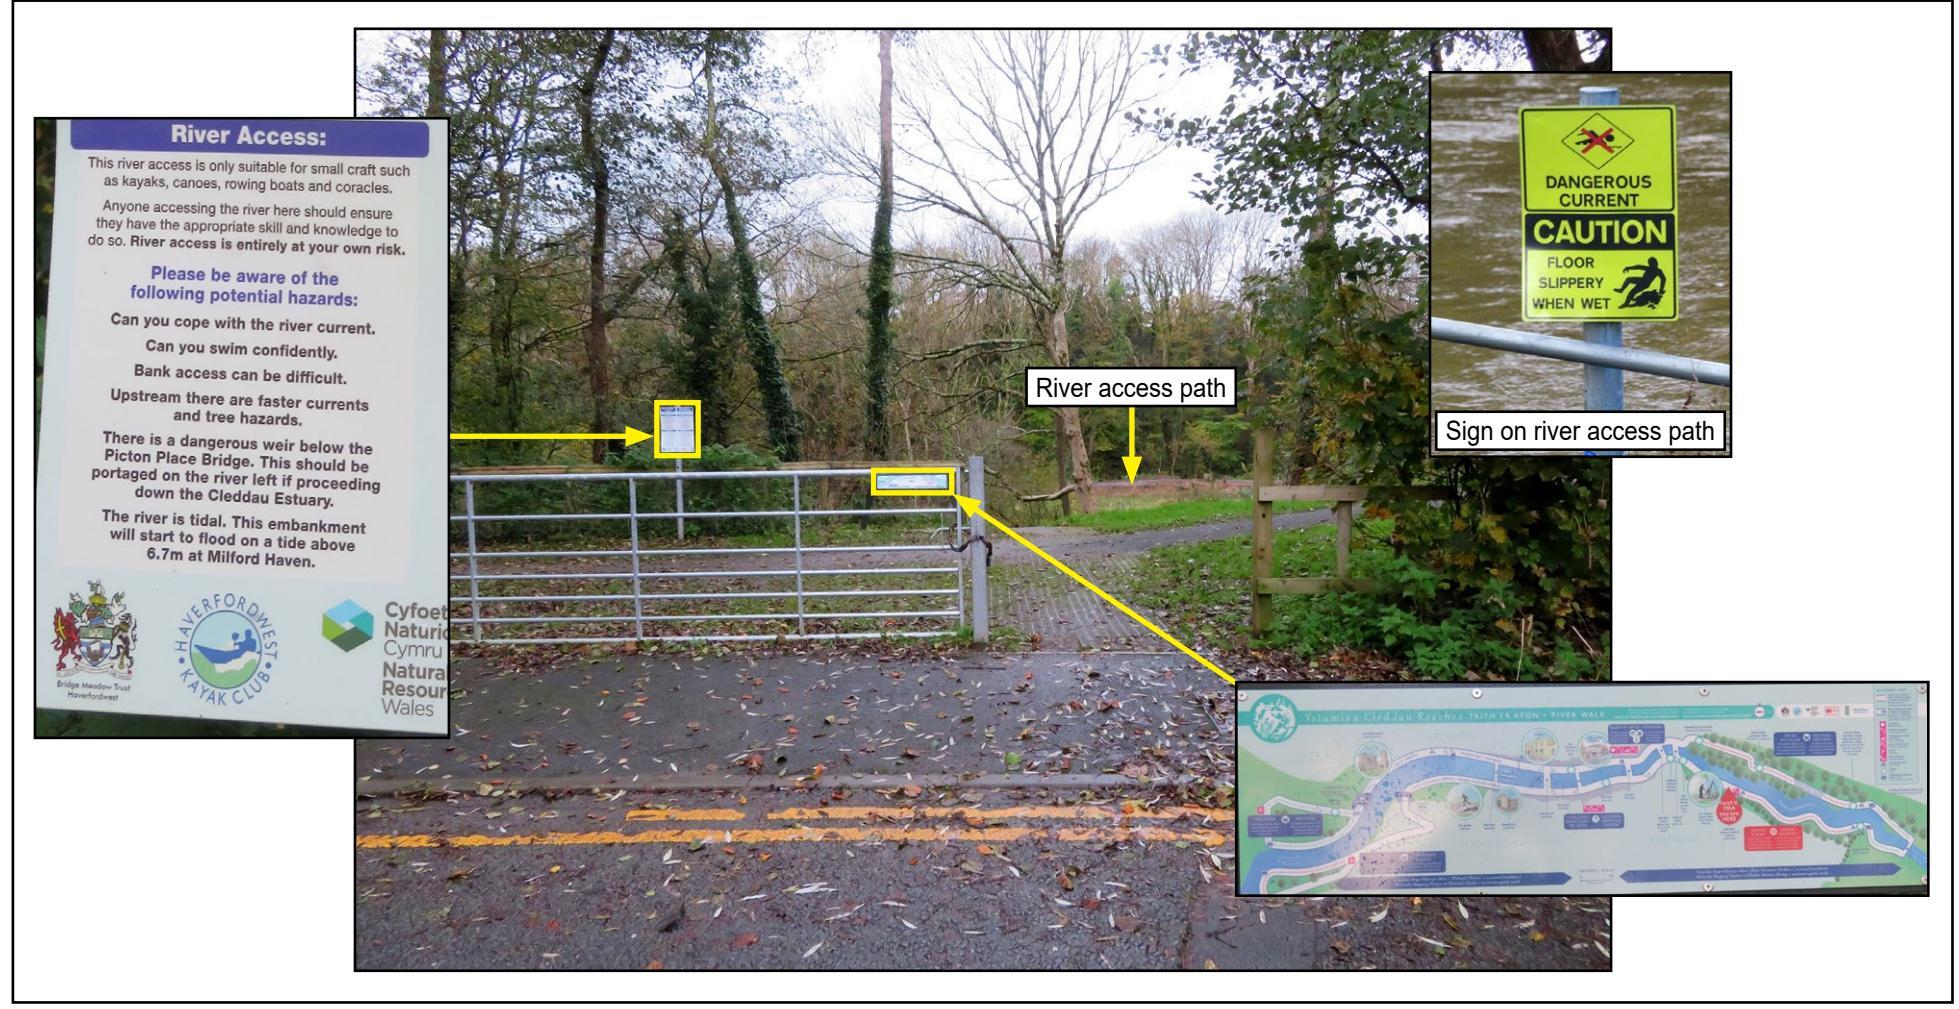
Figure 15: Signage adjacent to river access path used by the Pembrokeshire Tour group

The signage at the launch point of the tour, and on the river, did not conform with national water safety signage conventions or adequately alert the group to the location of the weir and the risks of descending it. The use of personal protective equipment such as clothing, buoyancy aids and leashes was also inconsistent across the group and did not follow recognised advice that stand up paddleboarders on fast-flowing water should wear a quick release waist leash and a personal flotation device.
