AAIB Bulletin:	LX-NST	AAIB-28139
SERIOUS INCIDENT		
Aircraft Type and Registration:	Bombardier Global 6000, LX-NST	
No & Type of Engines:	2 Rolls Royce BR700 engines	
Year of Manufacture:	2017 (Serial no: 9814)	
Date & Time (UTC):	7 April 2022 at 1625 hrs	
Location:	London Luton Airport	
Type of Flight:	Commercial	
Persons on Board:	Crew - 2	Passengers - None
Injuries:	Crew - None	Passengers - N/A
Nature of Damage:	Damage to right wing tip, flap fairing, leading edge slat and aileron	
Commander's Licence:	Airline Transport Pilot's Licence	
Commander's Age:	51 years	
Commander's Flying Experience:	7,200 hours (of which 1,350 were on type) Last 90 days - 34 hours Last 28 days - 0 hours	
Information Source:	AAIB Field Investigation

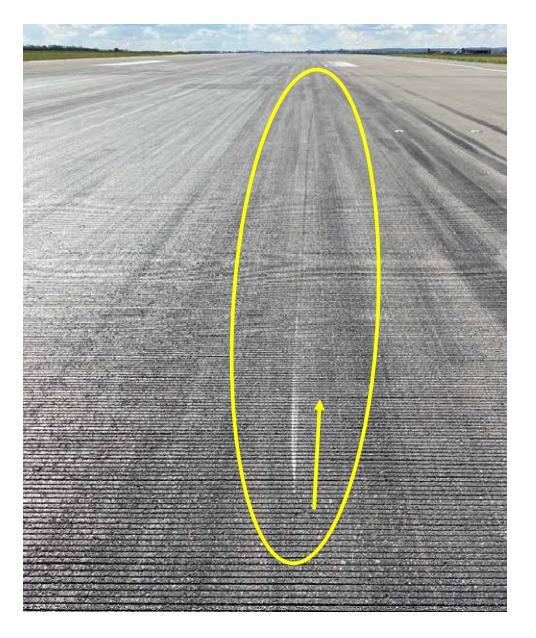
The aircraft had touched down on Runway 25 at Luton around the normal touchdown markers. There were marks visible from the right wing contacting the ground from around 390 m from the threshold of the runway for 18 m as shown in Figure 1.

Figure 1 Markings on Runway 25 with the arrow indicating the direction of landing

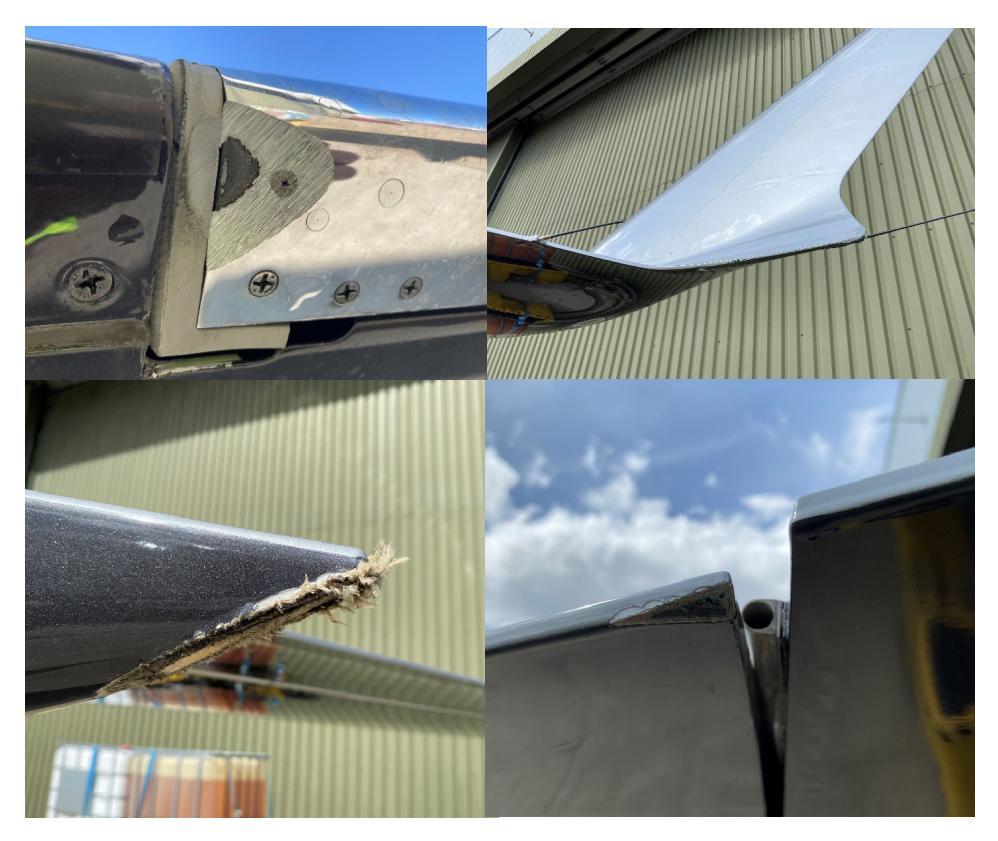
Figure 2

The winglet damage consisted of trailing edge and outboard skin damage. The flap fairing, which was composite construction, had been partly worn away. The outboard leading edge slat outer skin was damaged down to the second inner skin layer, and the aileron trailing edge lower outboard skin had been shaved off. Three of the static discharge wicks on the right aileron also required replacement. The damage is shown in Figure 2.

Damage to LX-NST Clockwise from top left – slat, winglet, aileron, flap fairing

- Right hand slat assembly
- Right hand aileron including three static dischargers
- Access panel

Repairs were made to the flap fairing and winglet trailing edge.

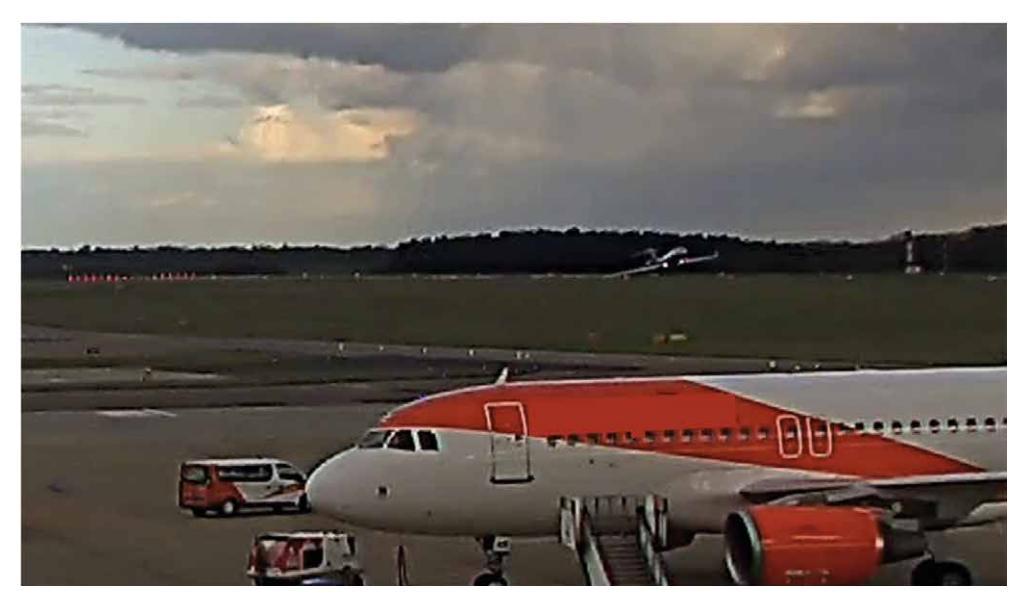
LX-NST's baulked landing was recorded on the airport's CCTV system. Figure 3 shows the moment the right wing contacted the ground.

Figure 3 Redacted CCTV image of LX-NST's wing contacting the ground

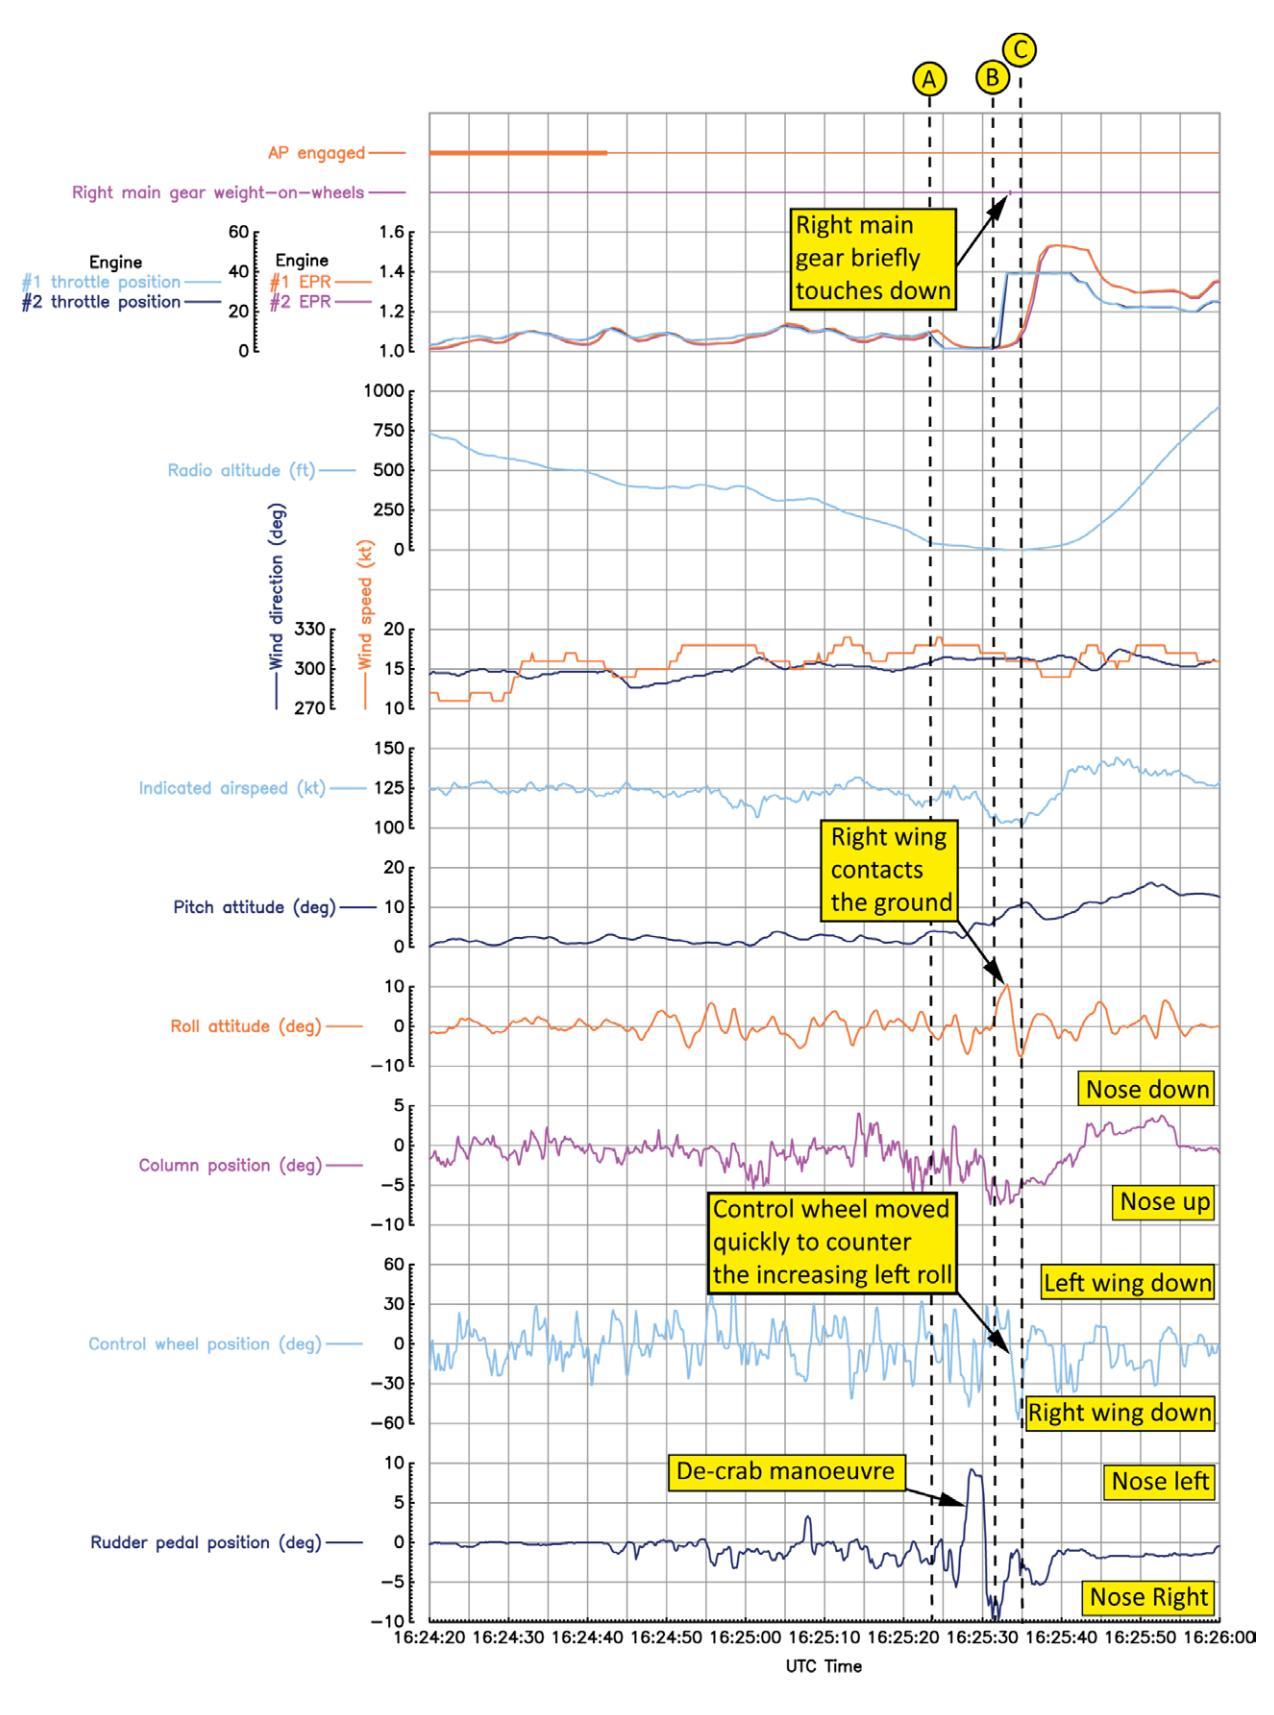
The recorded data, downloaded from the solid-state FDR fitted to LX-NST, showed that the autopilot was disengaged at 450 ft RA. In the windy conditions, significant activity was recorded on the controls, especially the control wheel position, and, after the autopilot was disengaged, on the rudder pedals. This resulted in larger roll perturbations, but the aircraft's flight path was generally well controlled. At point 'A' on Figure 4, at 50 ft RA, the ATS retarded the throttles towards idle. The wind, sampled four times a second and recorded by the anemometer situated near to the touchdown point of Runway 25, was from 308° at between 17 and 19 kt and varied little over the next 10 seconds – between point 'A' and point 'C'. Three seconds after the ATS had retarded the throttles, at approximately 25 ft RA, a significant nose-left rudder pedal demand and corresponding right-wing-down wheel input was made to de-crab the aircraft and align it with the runway. At approximately 10 ft RA, during the de-crab manoeuvre, the rudder and wheel position were reversed to demand a nose-right and left-wing-down correction, but almost immediately afterwards, at point 'B', the landing was aborted and the throttles were selected to full thrust. However, the aircraft rolled to the right and, before the engines had developed a substantial increase in thrust, reached 10.5° right angle of bank with a pitch attitude of 9.5°. At this point, the right main gear briefly touched down and the wing contacted the ground. The aircraft then began to roll rapidly left to 7.5° angle of bank, which was countered by a large, swift right-wing-down wheel input. Shortly afterwards, at point 'C' - three seconds after the selection of TOGA, the engine thrust began to increase significantly and the aircraft began to climb away.

Figure 4 Flight data from LX-NST's approach and baulked landing

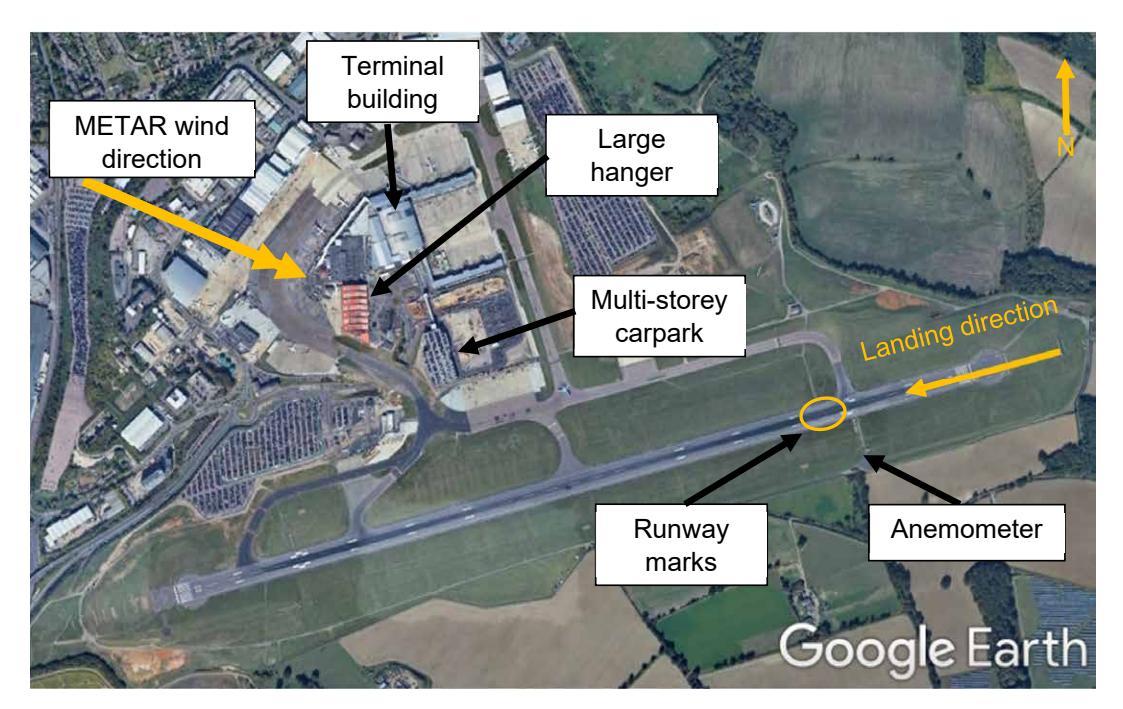
Luton Airport has a single runway orientated 07/25. The airfield sits on a hill at 526 ft amsl. The terminal and associated buildings are to the north of the runway and include a multistorey carpark which is 325 m from the centreline. Figure 6 shows these buildings in relation to the wind from the METAR and area in which the aircraft wing made contact with the runway.

Figure 6 Luton Airport layout

The layout of Luton Airport has a large multistorey car park, hangars and the terminal building to the northwest of the touchdown zone. This can mean that with a strong north-westerly wind, there can be turbulence and variations in the wind as aircraft land on Runway 25. Although the wind data from Luton does not show a large shift in wind direction or strength during the baulked landing, it is possible that the aircraft was affected by low-level turbulence or wind changes that did not reach the airport anemometer position and therefore are not recorded.
