ARBORICULTURAL IMPACT ASSESSMENT REPORT  
BS 5837:2012 'Trees in relation to design, demolition and construction. Recommendations'

Land east of Pines Hill, Stansted Mountfitchet, Essex

Luxus Homes Ltd

**DATE: August 2021**  
**OUR REF: SHA 1306**

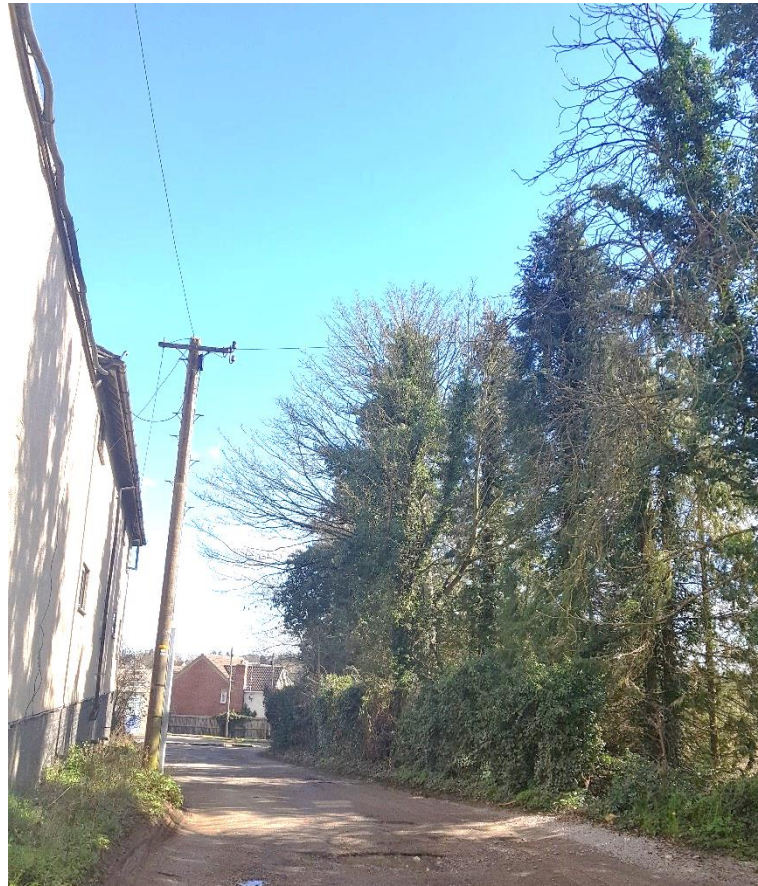
This informal wooded belt of trees provides collective visual amenity to Stoney Common Road. The trees are predominantly Lawson cypress, pine and spruce. Some trees are swamped with ivy and have a low vitality, whilst others have a fuller crown. The trees on the southern side of the group are spindly as planted too close together. Some trees have fallen and are resting on the ground.

*Photo 1 of W1 looking east along Stoney Common Road*

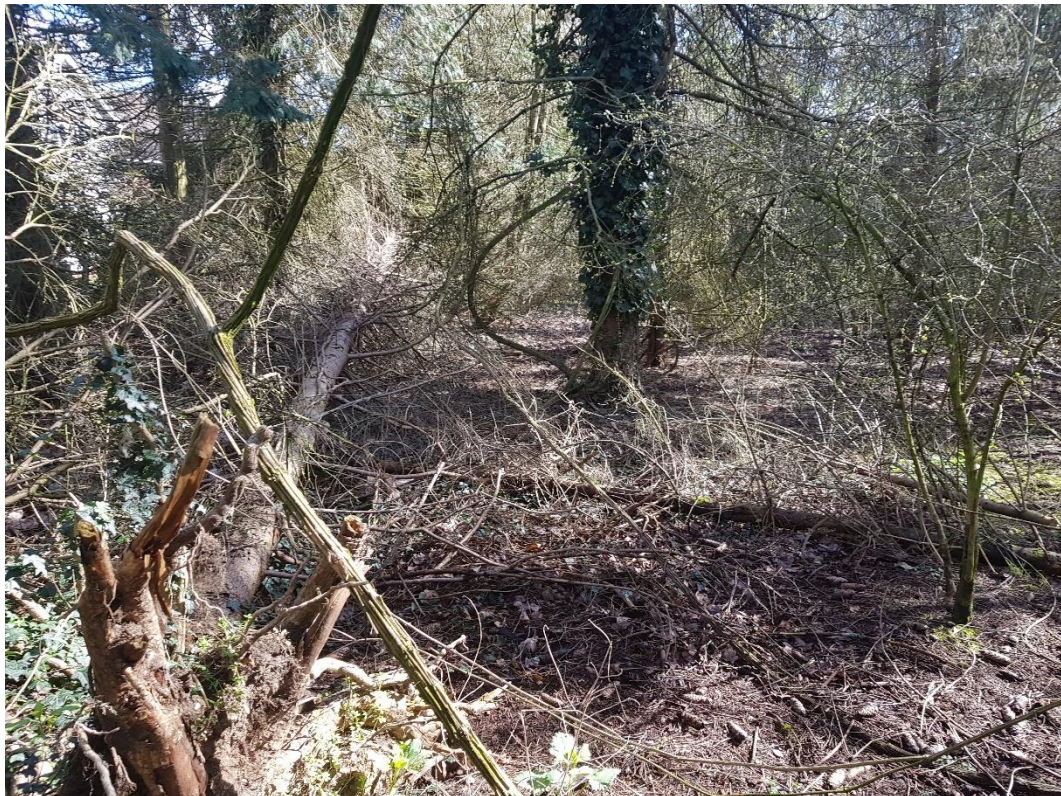
*Photo 2 of interior of W1*

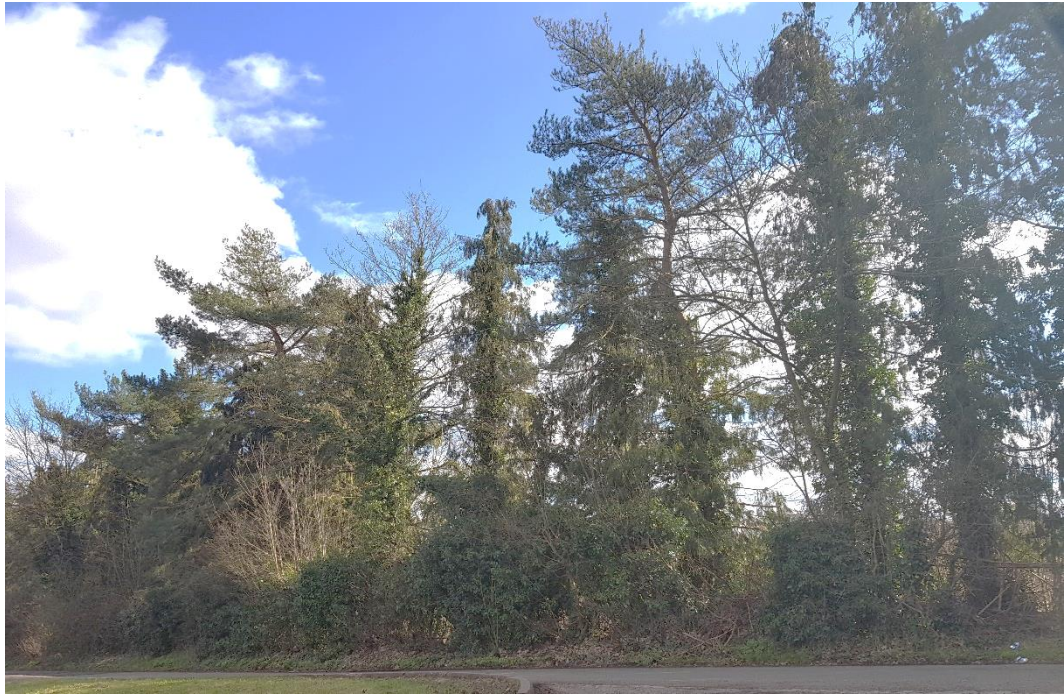
*Photo 3 of W1 looking south*

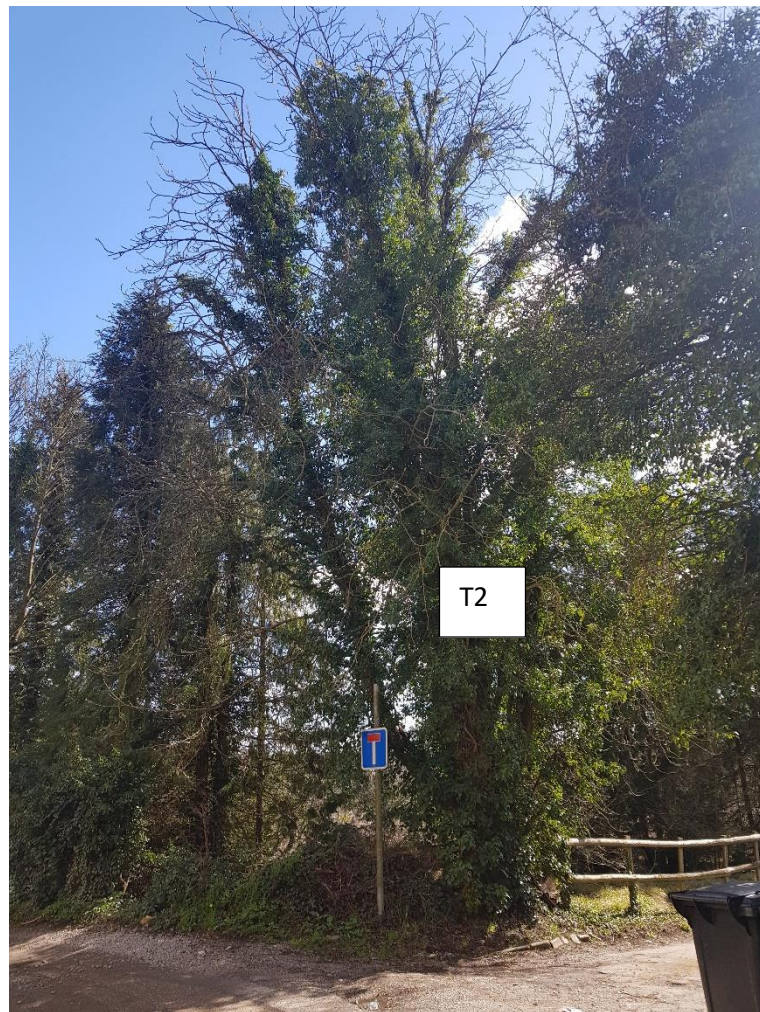
The horse chestnut is a mature tree on the corner of the access and Stoney Common Road. It is swamped with ivy making full inspection difficult.

*Photo 4 of T2 W1 looking south-east along Stoney Common Road towards the track*

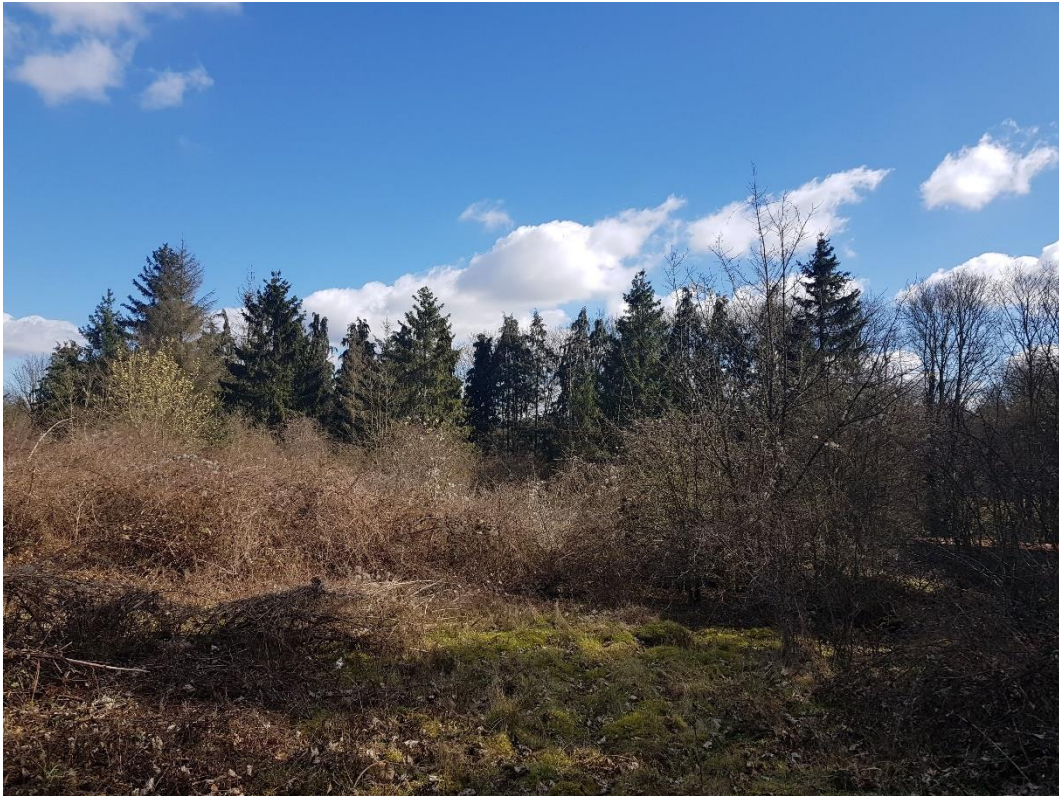
This Christmas tree plantation is predominantly spruce with occasional self sown early mature self-sown Norway maple. The trees average 18m high with average crown spreads of 4m. The group forms a dense screen but visual amenity is limited mostly to the immediate property to the west, and the site. The plantation is incongruous to the landscape character of the area.

*Photo 5 of G3 looking west*

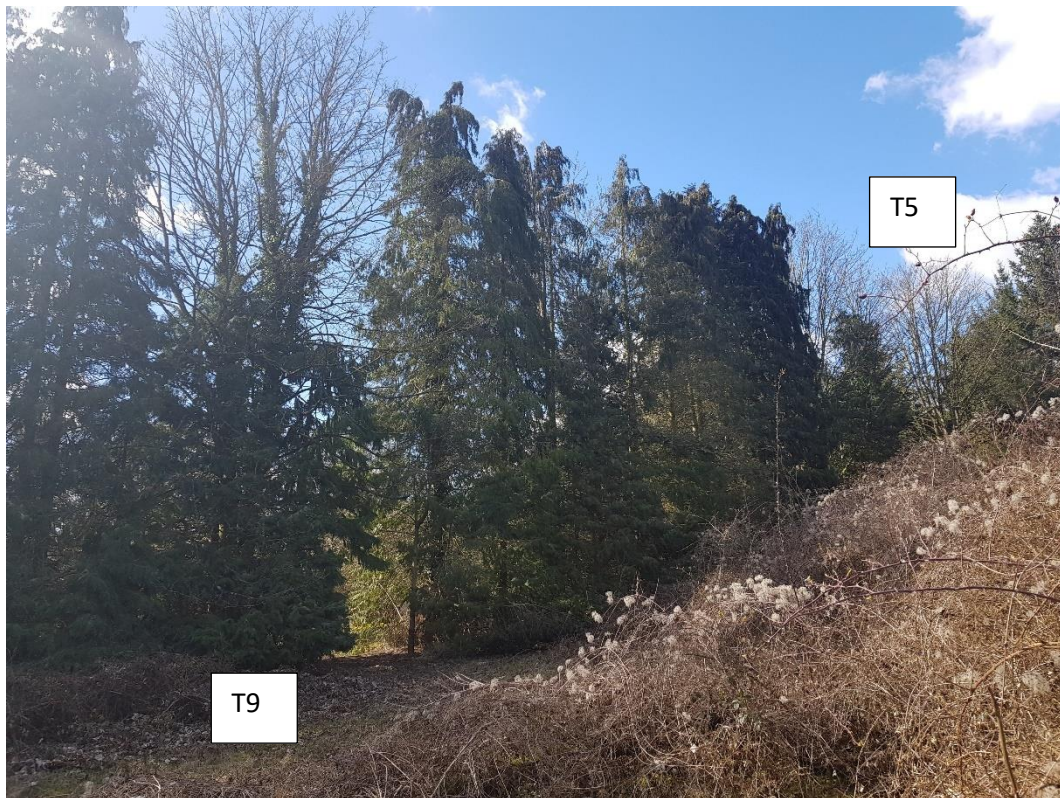
The mature sycamores average 18m high and are in a reasonable form and condition. They are growing amongst the line of Lawson cypress trees on the top of a steep bank. G14 Lawson cypress is also 18m tall and is a line of closely planted spindly trees forming a dense screen.

*Photo 6 of G14 with T5 - T9 looking south-west from within the site*

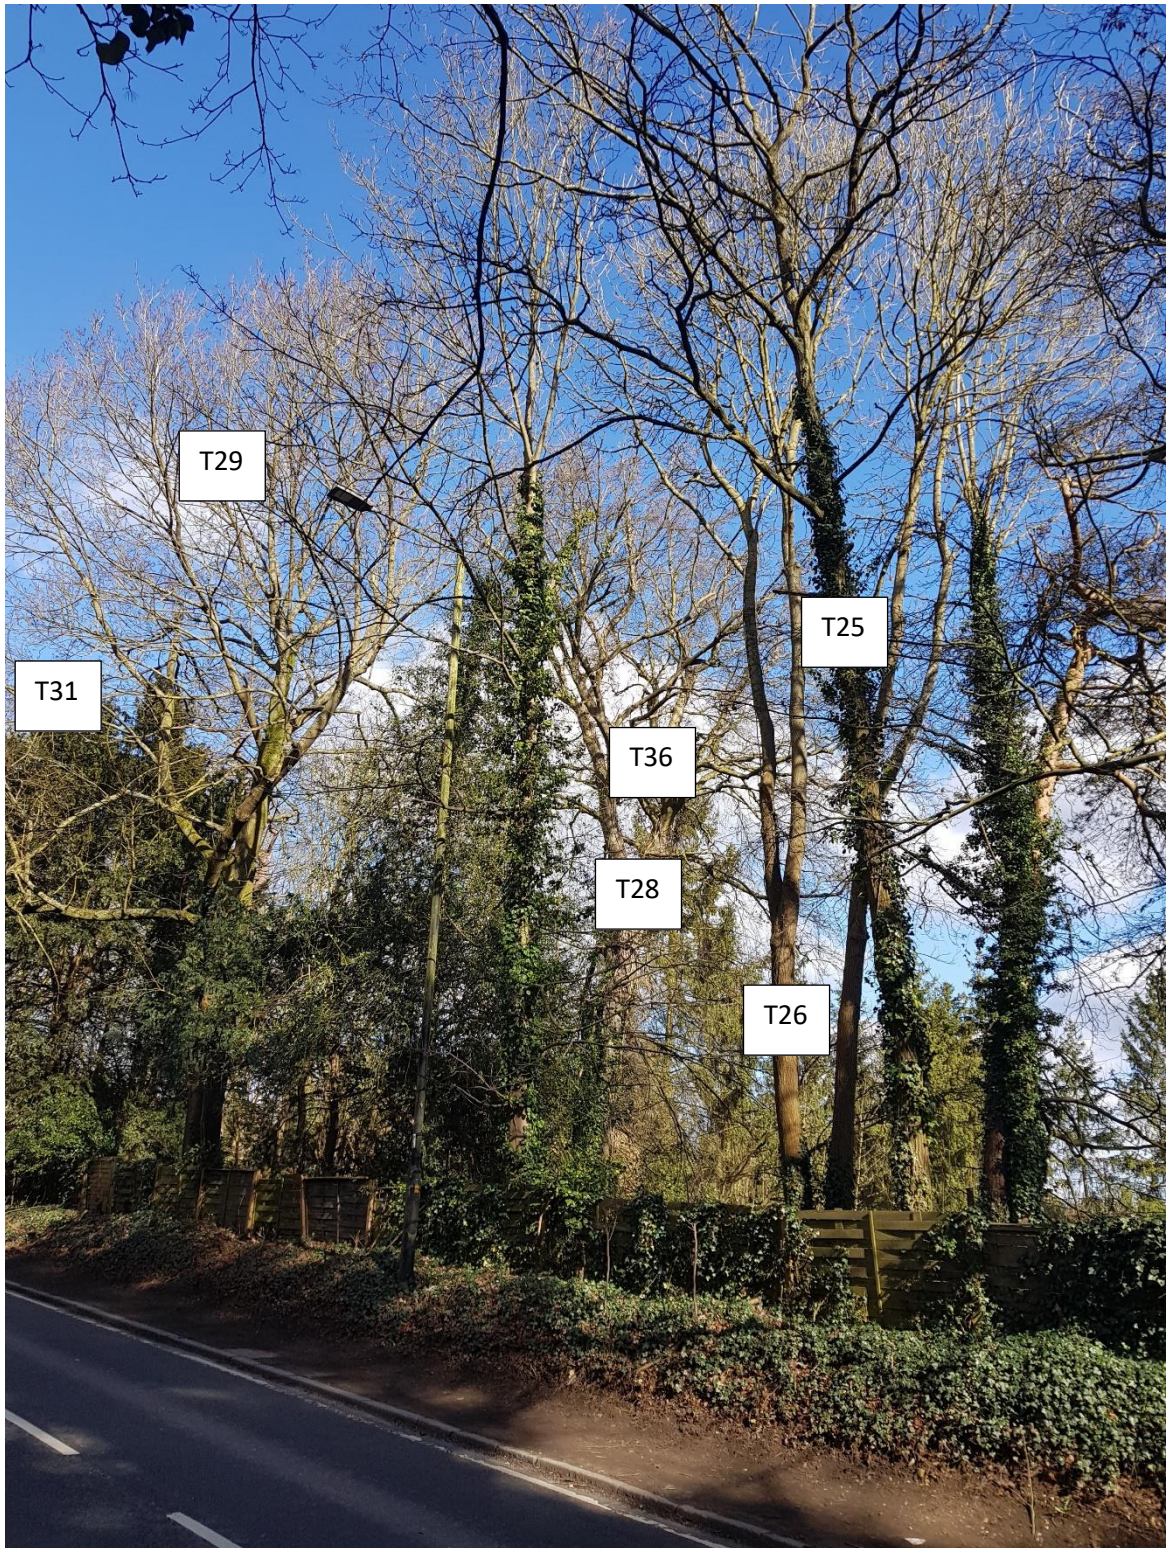
This densely planted area includes two Norway spruce plantations and a mix of deciduous and coniferous trees, some of which are in a poor condition as detailed in the tree survey sheets at appendix 1. The best tree in terms of condition and visual amenity is T17 beech.

*Photo 7 of the view from Pines Hill – key trees numbered*

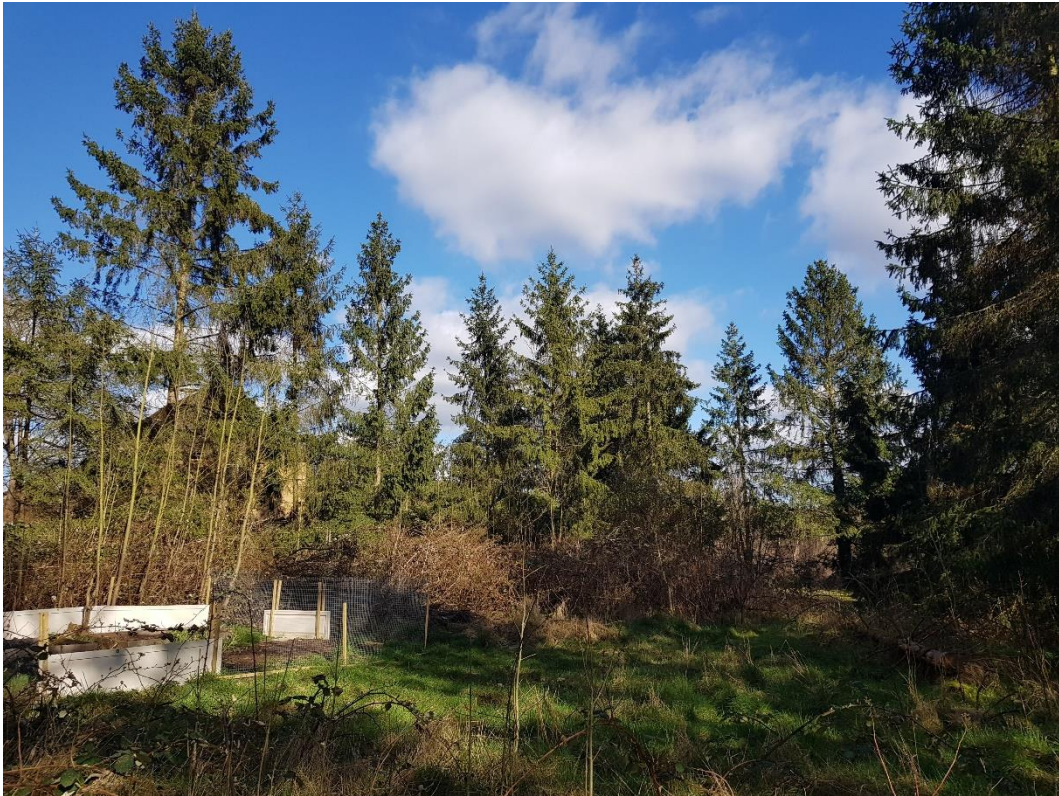
*Photo 9 showing the plantation in the western area near Pines Hill. Looking north.*
