Arboricultural Briefing Note - Offsite Byway Improvements

Site: LAND AT WARISH HALL FARM, NORTH OF JACK'S LANE, TAKELEY

Application reference: UTT/22/3126/FUL / S62A.2023/0016

8th June 2023

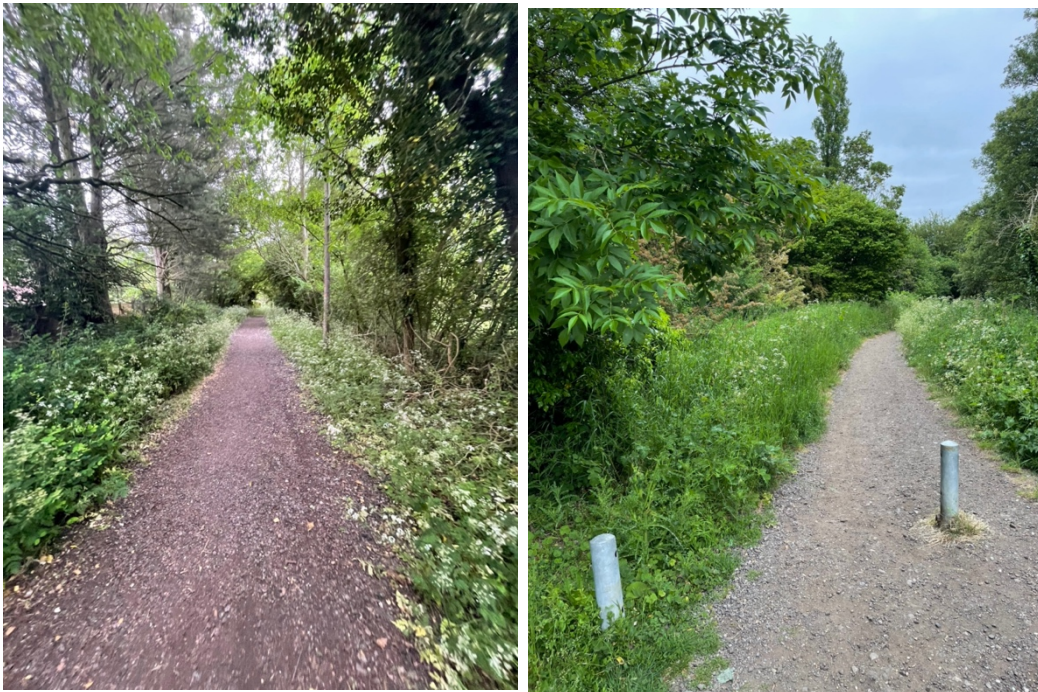
- 2.1 The existing Byway is well established. It is surfaced with well compacted soil/stone. The adjacent vegetation has been maintained in the past to provide clearance to the path.
- 2.2 The two images below show the current situation. The image on the left is a typical example of the path heading north from Jack's Lane along the eastern boundary of the site. The image on the right shows the path as it heads east along what is known as Jack's Lane to Burgattes Road.

- 2.3 The nature and quality of the vegetation either side of the paths is typical for what is expected along a path of this nature. There are no significant, high quality trees present close to the Byway. The existing compacted surfaces will likely have prevented or restricted any root growth beneath the path.

- 4.4 There may need to be some minor pruning back of vegetation close to, or overhanging, the path to provide appropriate, safe, clearance for users of the Byway. This will not be significant cutting back and is part of the routine maintenance of the Byway that should be undertaken irrespective of the upgrade works.
- 4.5 In principle the works are acceptable from an arboricultural perspective but it would appropriate for the works to be undertaken in accordance with an arboricultural method statement to avoid an unnecessary damage to retained vegetation occurring. This detail should be secured through the technical approval process for the offsite works.
