# LAND AT WARISH HALL FARM, NORTH OF JACK'S LANE, TAKELEY | UTT/22/3126/FUL / S62A/2023/0016

### **BRIEFING NOTE: BYWAY IMPROVEMENTS**

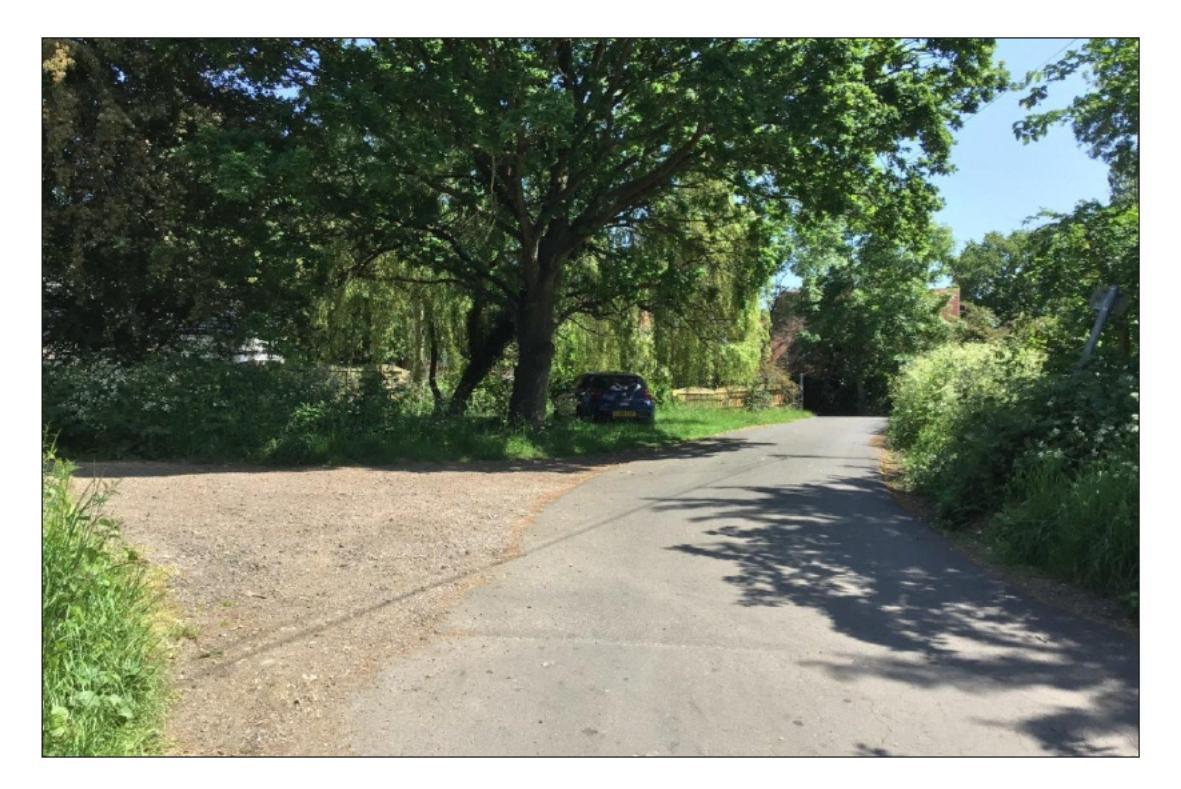
6. The area of study extends from southeast corner of the Jack's Field application site along Jack's Lane to Burgattes Road (see Weston Homes plan at Appendix 1). The initial stretch of Jack's Lane, adjacent to the site, serves residential properties to the south and east of the site (see Photograph 1). This is a tarmac single-track lane in good condition, and presumably there is limited improvement work proposed here. The remainder and majority of the study area is a byway closed to motor vehicle traffic that serves as a footpath and cycleway between Burgattes Road and Jack's Lane proper (see Photographs 2 to 4). Several pedestrians including dog walkers were observed during the course of the survey. Though consisting of a hardstanding surface, the feel is of an enclosed footpath with canopy closure overhead in places. Fixed bollards are present at both ends. Jack's Lane continues in this fashion to the east of Burgattes Road.

PHOTOGRAPH 1: Existing road southeast of Jack's Field site

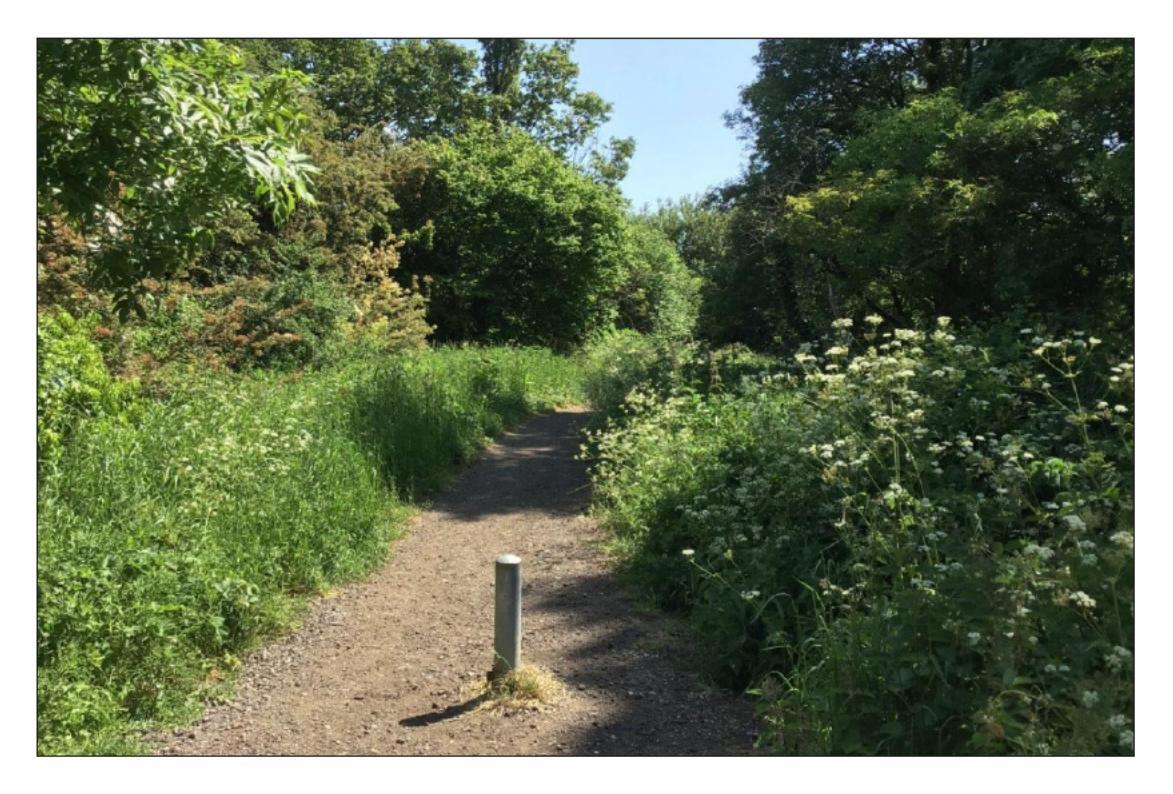
PHOTOGRAPH 2: Start of restricted byway section, looking east

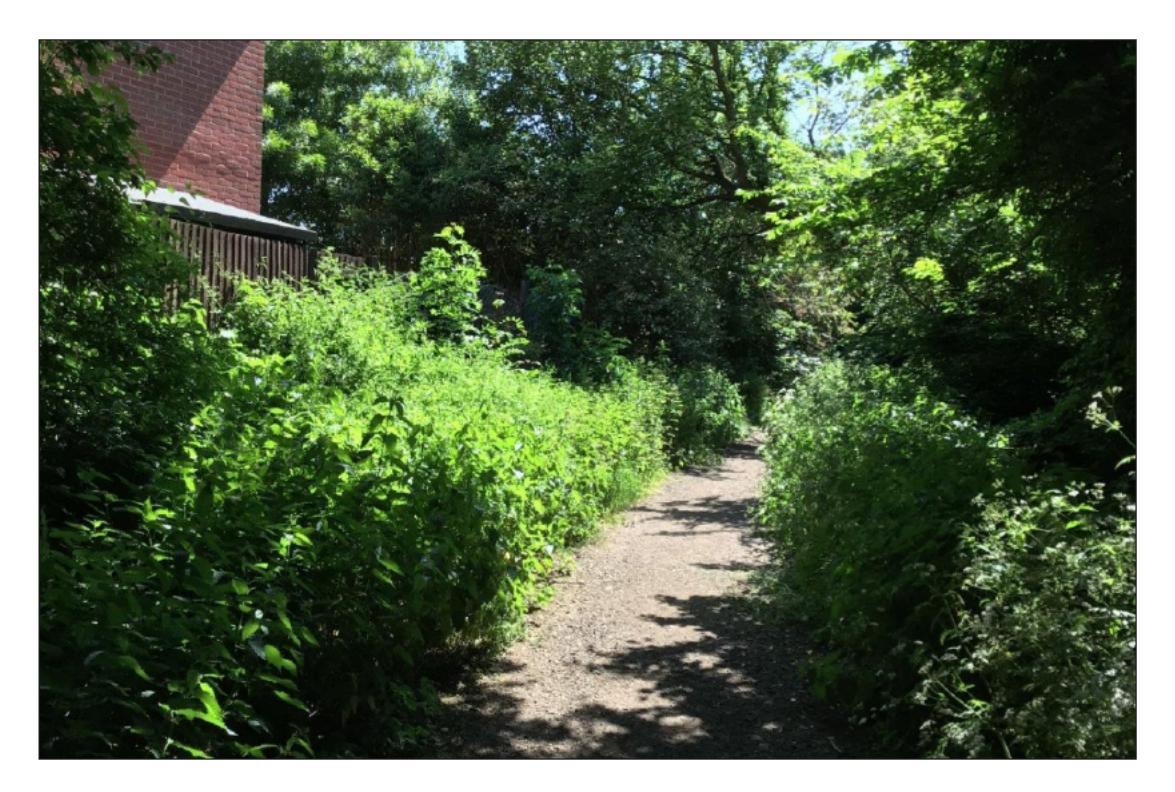
PHOTOGRAPH 3: Looking east, residential property to the north

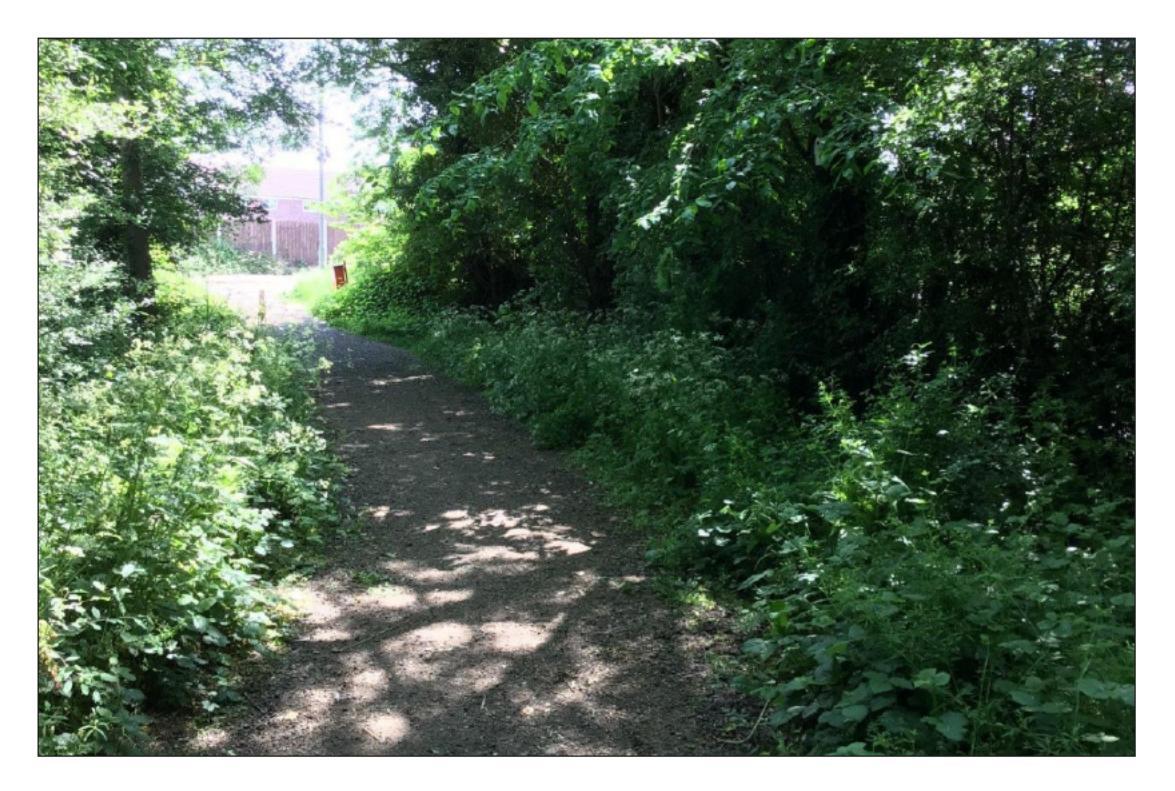
PHOTOGRAPH 4: Looking east to end of study area at Burgattes Road

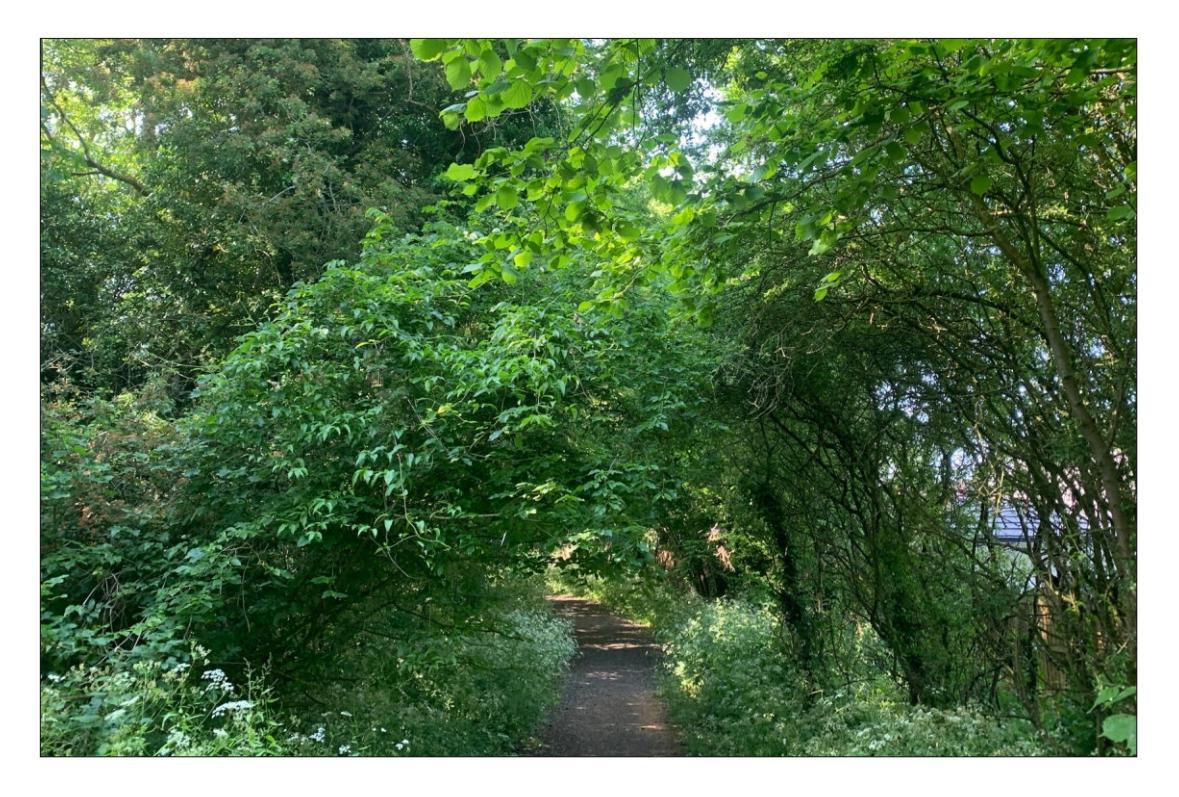
PHOTOGRAPH 5: Looking north from Jack's Lane

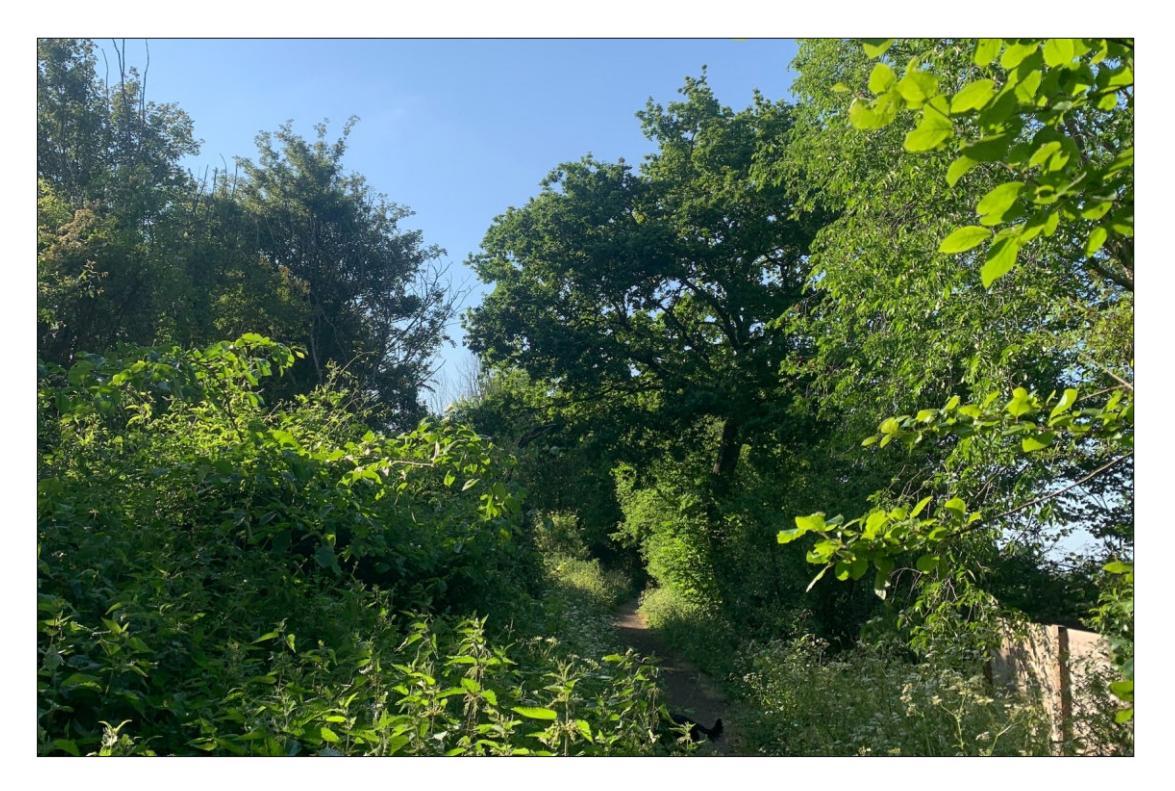
PHOTOGRAPH 6: Looking north at the northern end of the survey area

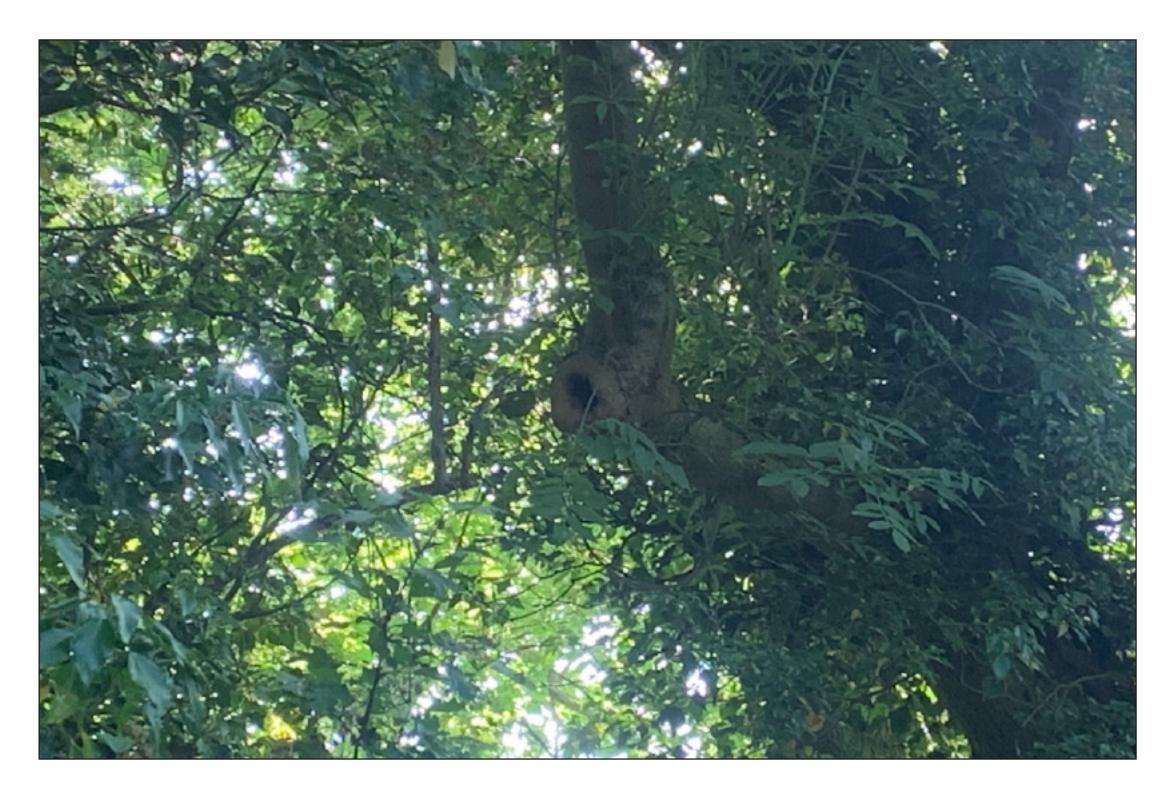
- 29. A mature ash covered in Ivy, located at W3W *Mystified.Number.Reddish*, has a large split 4m high on the main trunk, and a rot hole on the end of one of the branches facing the path, approximately 5m high (see Photograph 7). The entrance to the rot hole is approximately 2.5 inches in diameter and the depth of the cavity is unknown. Both of these features could provide potential roosting opportunities. The tree is considered to provide moderate roosting potential.

PHOTOGRAPH 7: Small rot hole in Mature Ash west of byway

- 32. The byway is likely to be used by commuting, foraging and possibly roosting bats. It is understood that all of the trees are to be retained. The low-level lighting bollards to be installed are not considered significant to commuting or foraging bats, but it should be ensured that their positioning will be such that they do not significantly illuminate the potential roost features identified above.

- 37. The potential bat roosts identified in the vicinity of the works should be protected from significant disturbance, both in terms of construction noise and damage, as well as light spillage from lighting bollards once operational.
- 38. There are no other significant ecological constraints to the proposed byway improvements. Recommendations have been made in respect of nesting birds.

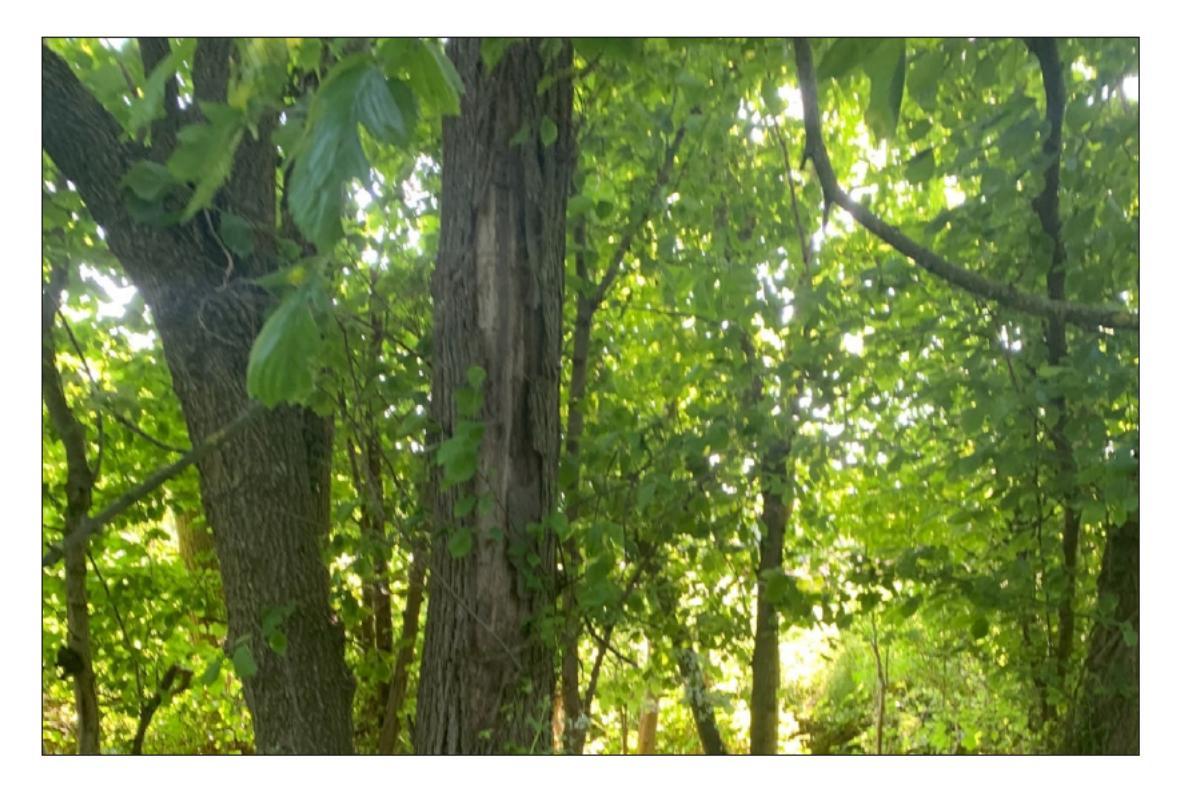
- 31. A mature Elm, located at W3W *Device.Object.Renovated,* also has peeling bark on the main trunk and is considered to provide low roosting potential (see Photograph 8).

PHOTOGRAPH 8: Peeling bark on mature Elm west of byway
