# TREE SURVEY REPORT – Rev C

Land adjacent to Eldridge Close, Stickling Green, Clavering, Saffron Waldon.

April 2020

Prepared by: Kirsten Bowden MA (Hons) CMLI Dip Arb L4 (ABC)

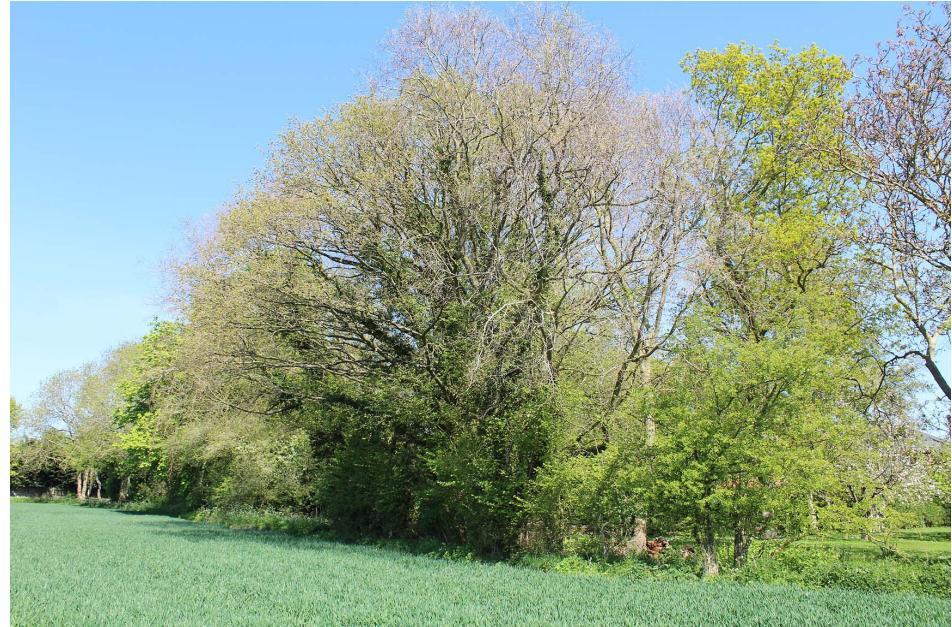
**Photo 02.** Group 2 is a closely growing group of Elms. Mature elms are an unusual sight and therefore have an elevated level of importance as a landscape feature. The fact that they are close to one another means that their overall form is affected. Heavily overgrown with ivy.

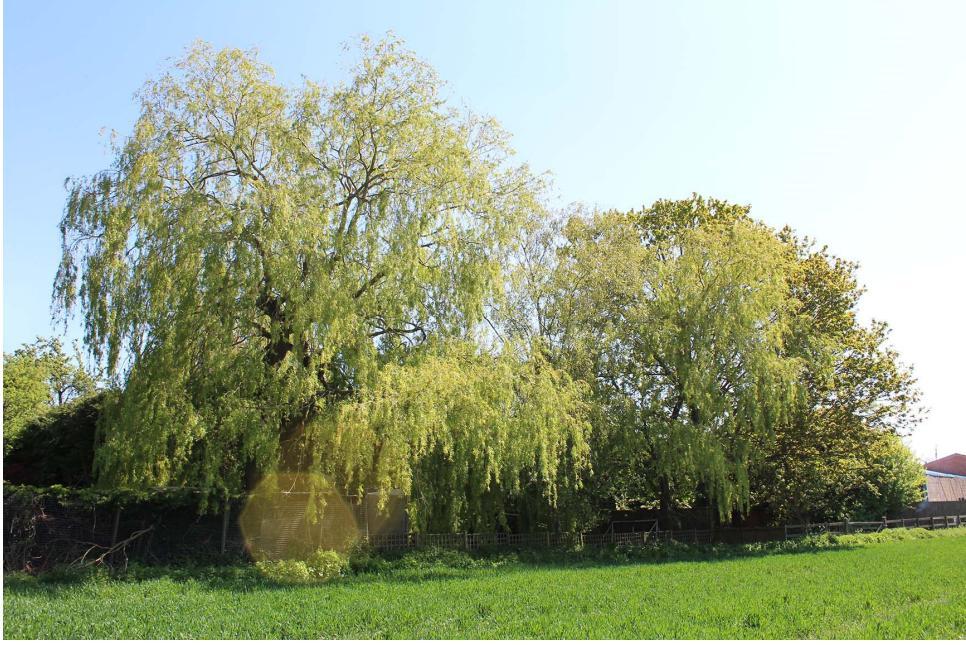
**Photo 03.** Growing in gardens of properties adjacent to the south-east corner of the Site, these mature specimens are in good condition, but the willows have some structural defects which has resulted in the group being classified as a B.

These trees are of moderate quality with an estimated remaining life expectancy of at least 20 years. They have been downgraded because of impaired condition such that they may be unsuitable for retention for beyond 40 years.

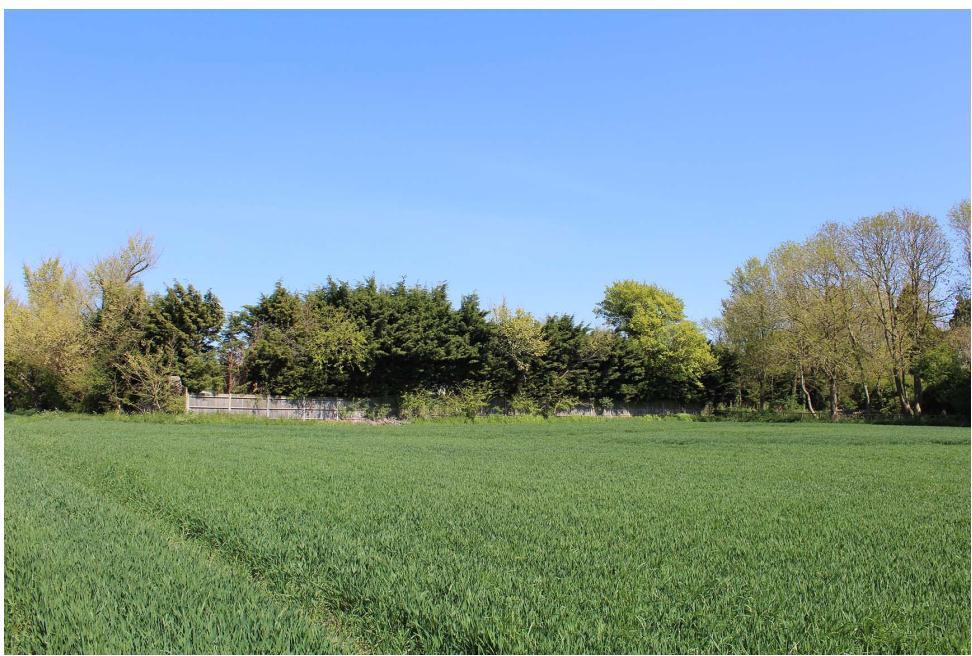
**Photo 04.** H1 is on the northern edge of the Site and is a conifer hedge growing in the garden of Elearon House. The bottom half of the hedge is obscured by a close-boarded timber fence, within which there is a Field Maple growing and an elm to the western end, which is growing from the base.

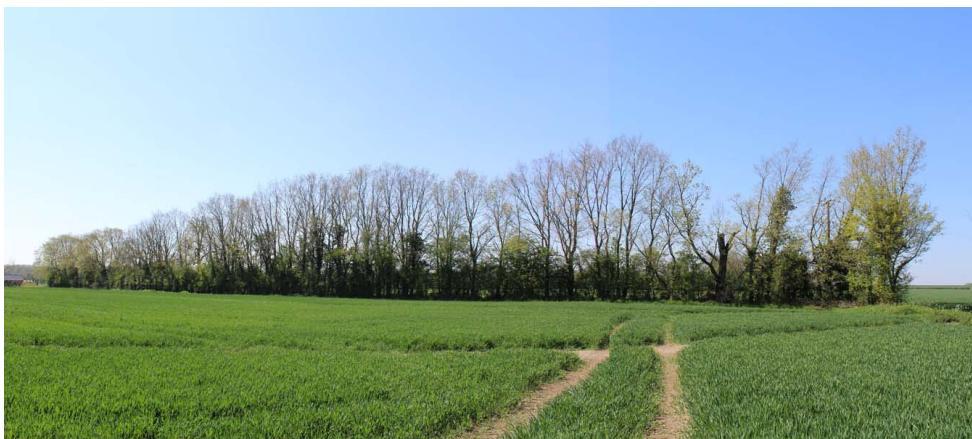
**Photo 05.** H2 is growing on the western edge of the Site and has several elms within it, with standing deadwood, re-shooting from the base. There are also other mixed native species forming an under-storey filtering views to the landscape beyond.

These trees are generally of low quality with an estimated remaining life expectancy of at least 10 years. They provide structure to the Site but they are generally unremarkable features with historically limited or poor management and do not qualify in higher categories.

It is recommended that a qualified tree surgeon removes any standing deadwood in H2 which may pose a risk to users of the public open space, turning head and the house and garden of Plot 9. All other trees are either not under site ownership or are not in need of work. Where there may be a risk, standing deadwood should be reduced in height to less than 3m, but it does not need to be completely removed as this provides important habitat as part of a wildlife corridor.

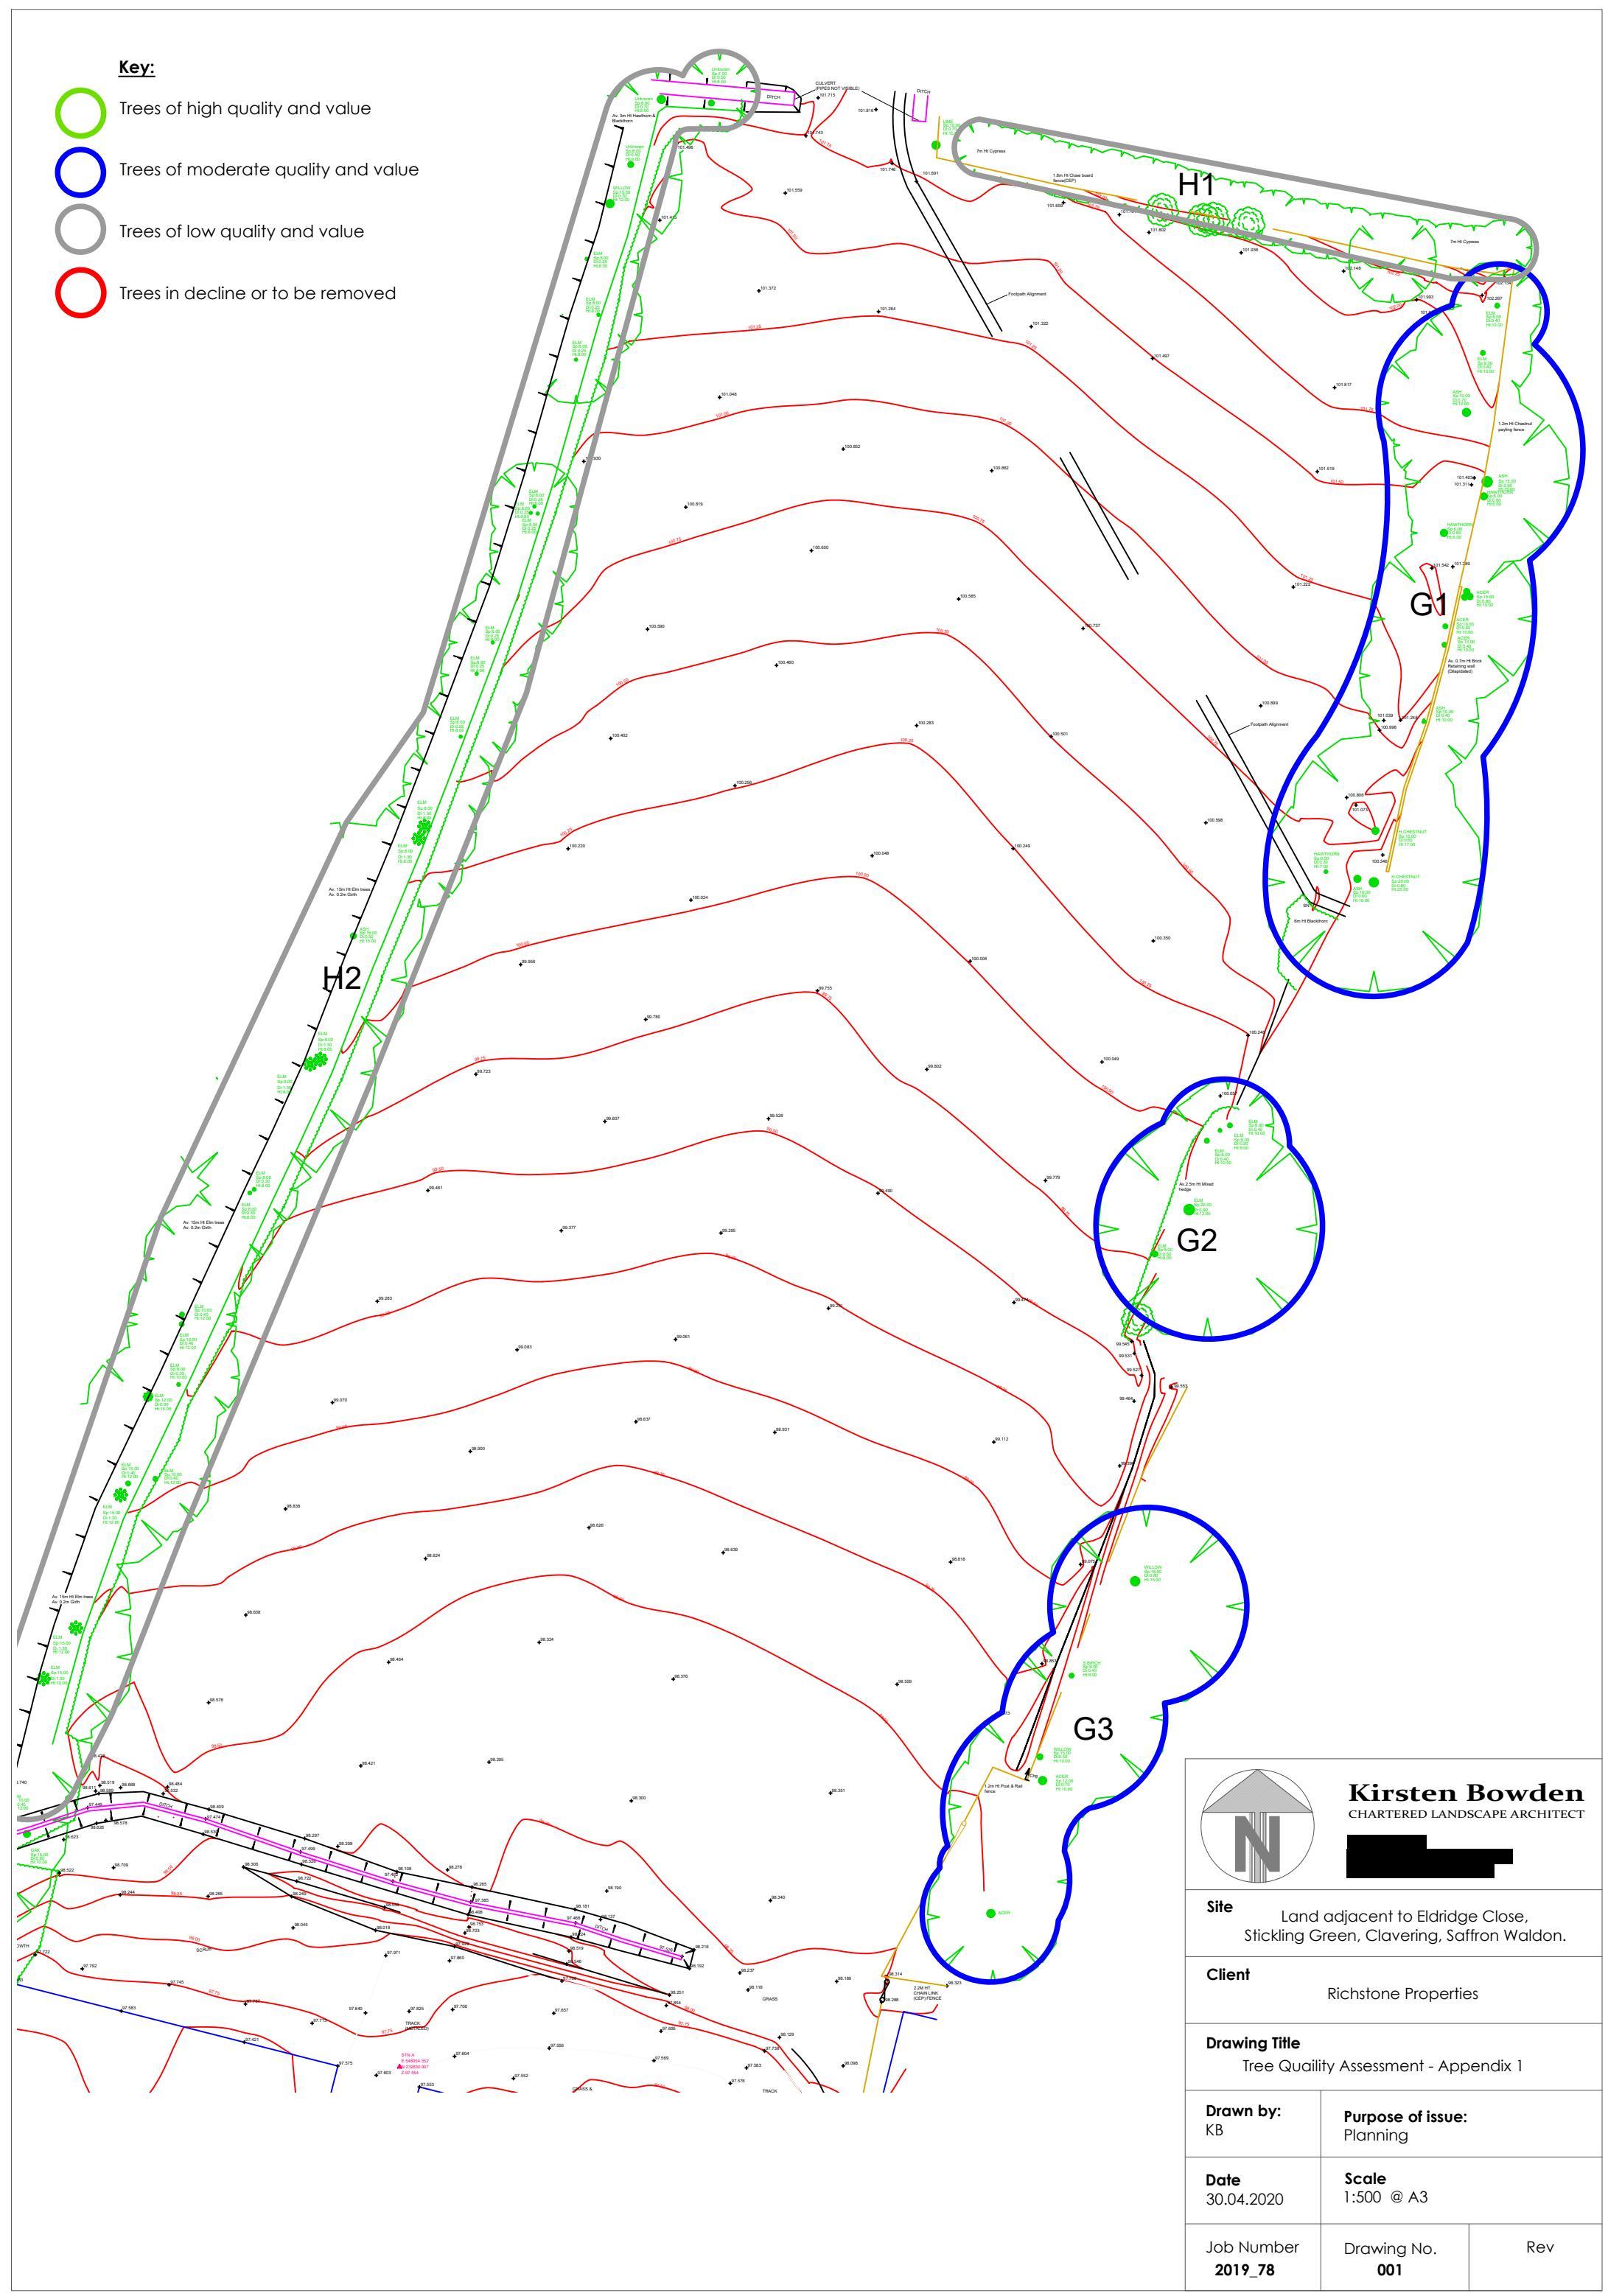
Three groups of trees and two hedges on site have been surveyed for planning purposes and catagorised according to BS5837: 2012 as a guide to their condition. They are coloured on the plan attached at **Appendix 1** to indicate their category and the colours are explained in the key of the plan. Table 1 indicates whether the tree is to be removed or retained as part of the proposed layout. The full tree quality assessment chart, which gives a more detailed explanation of the definition of the subcategories, has been attached at **Appendix 2**.
