AAIB Bulletin: 12/2023	G-RVDB	AAIB-28620
SERIOUS INCIDENT		
Aircraft Type and Registration:	Vans RV-7, G-RVDB	
No & Type of Engines:	1 Superior XP-IO-360-B1HC2 piston engine	
Year of Manufacture:	2018 (Serial no: PFA 323-14526)	
Date & Time (UTC):	29 August 2022 at 0753 hrs	
Location:	Ronaldsway Airport, Isle of Man	
Type of Flight:	Private	
Persons on Board:	Crew - 1	Passengers - 1
Injuries:	Crew - None	Passengers - None
Nature of Damage:	None	
Commander's Licence:	Private Pilot's Licence	
Commander's Age:	71 years	
Commander's Flying Experience:	1,874 hours (of which 1,769 were on type) Last 90 days - 23 hours Last 28 days - 9 hours	
Information Source:	Aircraft Accident Report Form submitted by the pilot and other AAIB enquiries

# Synopsis

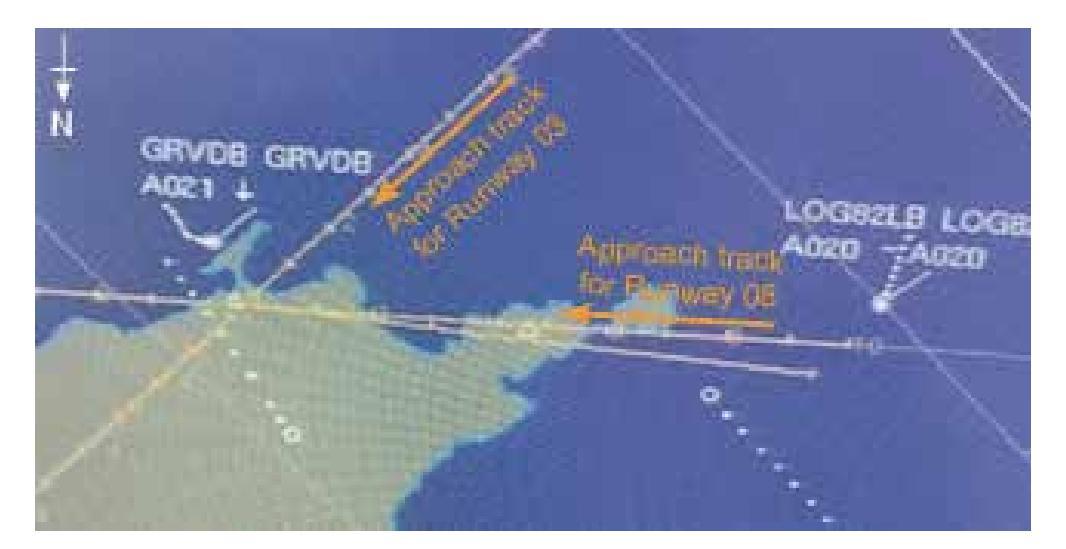
**Figure 1** G-RVDB's position after pilot requested Runway 08

The pilot requested Runway 08 before being instructed to 'REPORT READY FOR RIGHT BASE RUNWAY ZERO EIGHT.' The aircraft appeared to turn downwind for Runway 08 although its position was also consistent with right base for Runway 03 (Figure 1)<sup>1,2</sup>.

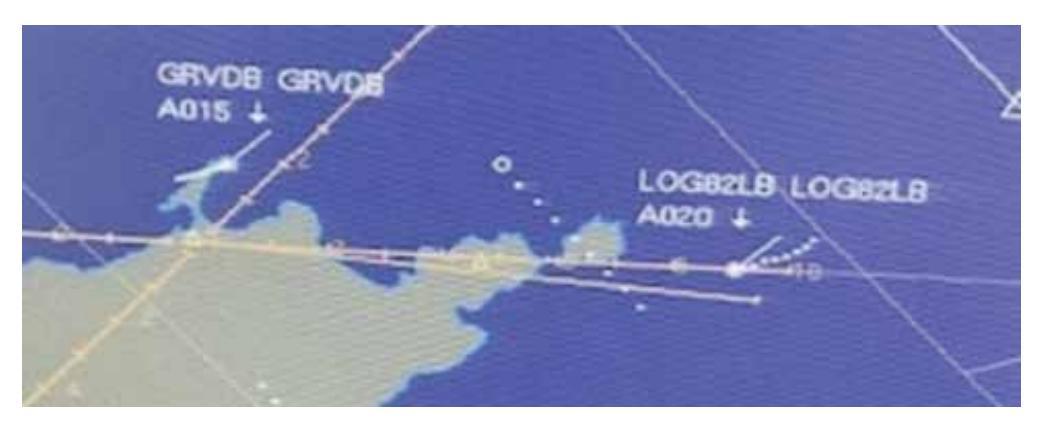
Figure 2

From there, the pilot reported ready for right base (Figure 2). He was instructed to orbit left to accommodate an ATR 76 on a commercial air transport flight that was joining final for Runway 08 at 8 nm.

G-RVDB's position when the pilot reported ready for right base Runway 08

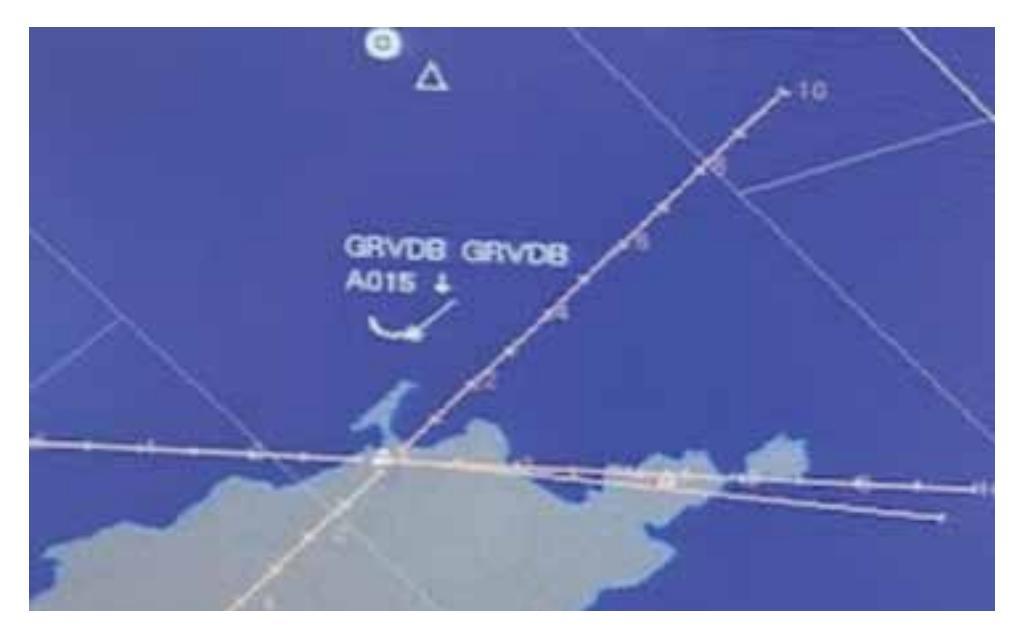
**Figure 3** G-RVDB leaving orbit

The pilot was unable to see the ATR during its approach so the ATCO advised him when it landed, and the pilot reported ready to leave the orbit (Figure 3).

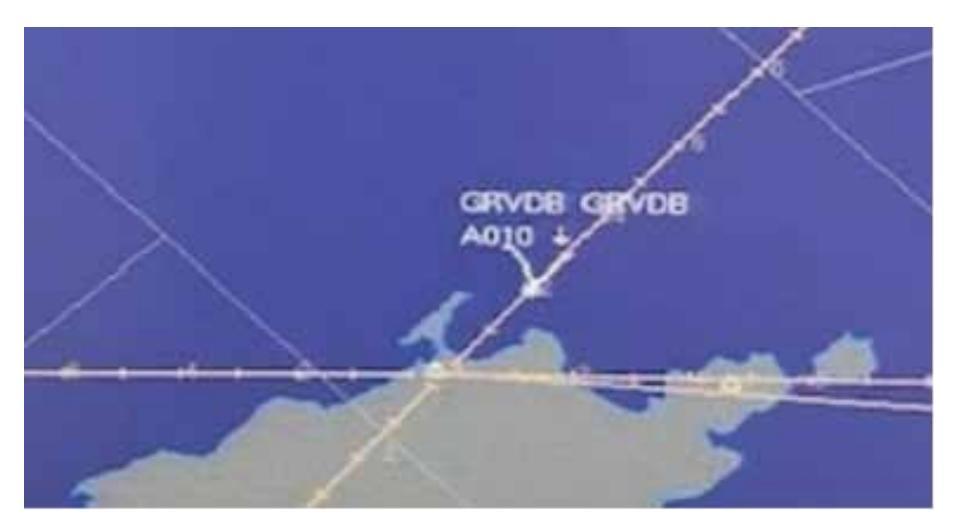
**Figure 4** G-RVDB reports turning final Runway 08

The pilot reported that he aligned the aircraft with a "large runway slightly off to [his] right", calling 'FINAL ZERO EIGHT' on the radio frequency, and was cleared to land on Runway 08 (Figure 4). However, he inadvertently performed an approach and landing on Runway 03 instead.

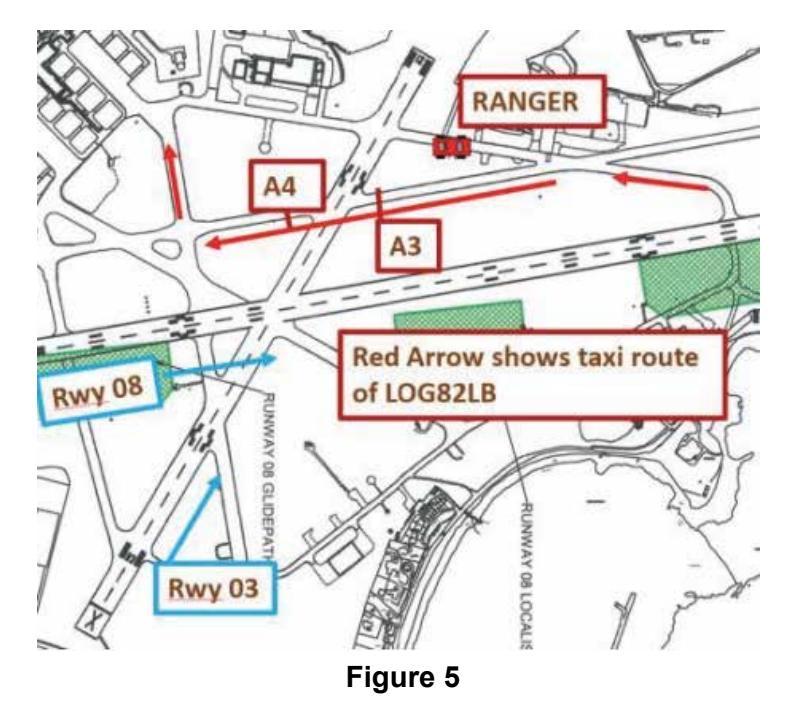
The aircraft stopped its landing roll around the intersection of the two runways (Figure 5). Confusion over taxi instructions, which the ATCO issued as though the aircraft had landed on Runway 08, led the pilot to re-orientate the airfield against the chart he was using.

Ground situation after the ATR had landed

In this case the outcome of G-RVDB landing on the wrong runway was benign. However, Figure 5 illustrates the potential for conflict with other aircraft using the active runway or taxiways.

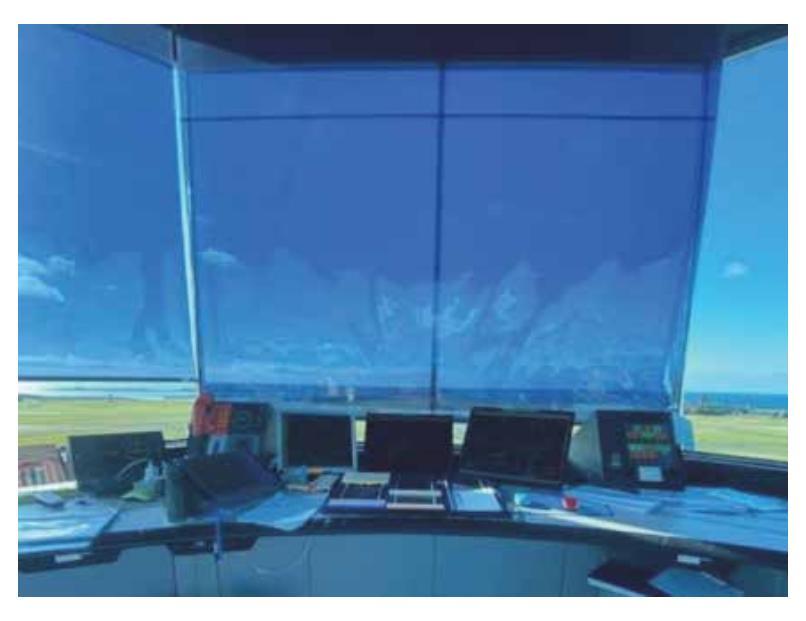
## Figure 6

Both the ATCO and air traffic services assistant (ATSA) said it had been a quiet morning. Glare from the morning sun and sea made it difficult to see aircraft from the south-facing control tower, with the sunblinds themselves presenting a "margin" across the window and additional glare from their "shiny" surface (Figure 6).

View of Runway 03 approach with similar glare and sunblind position as the incident<sup>4</sup>

The ATSA could see G-RVDB while it orbited. The ATCO referred to the ATM because of sun glare, which was known to impede direct visual observation of aircraft at Ronaldsway. While the ATSU considers sun glare to be inherent to Ronaldsway's south-facing control tower, it intends to explore alternatives to the existing sun blinds.

The ATSU has published a reminder to controllers to monitor all stages of an aircraft's final approach to recognise when an aircraft might be incorrectly or dangerously positioned. It intends to provide TRM training for all members of the ATS section and to replace the VCR sun blinds if a better solution can be found.
