Air Quality and Dust Monitoring Monthly Report – November 2023

Cherwell District Council

A report prepared by EWCs and MWCCs on behalf of HS2 Ltd.

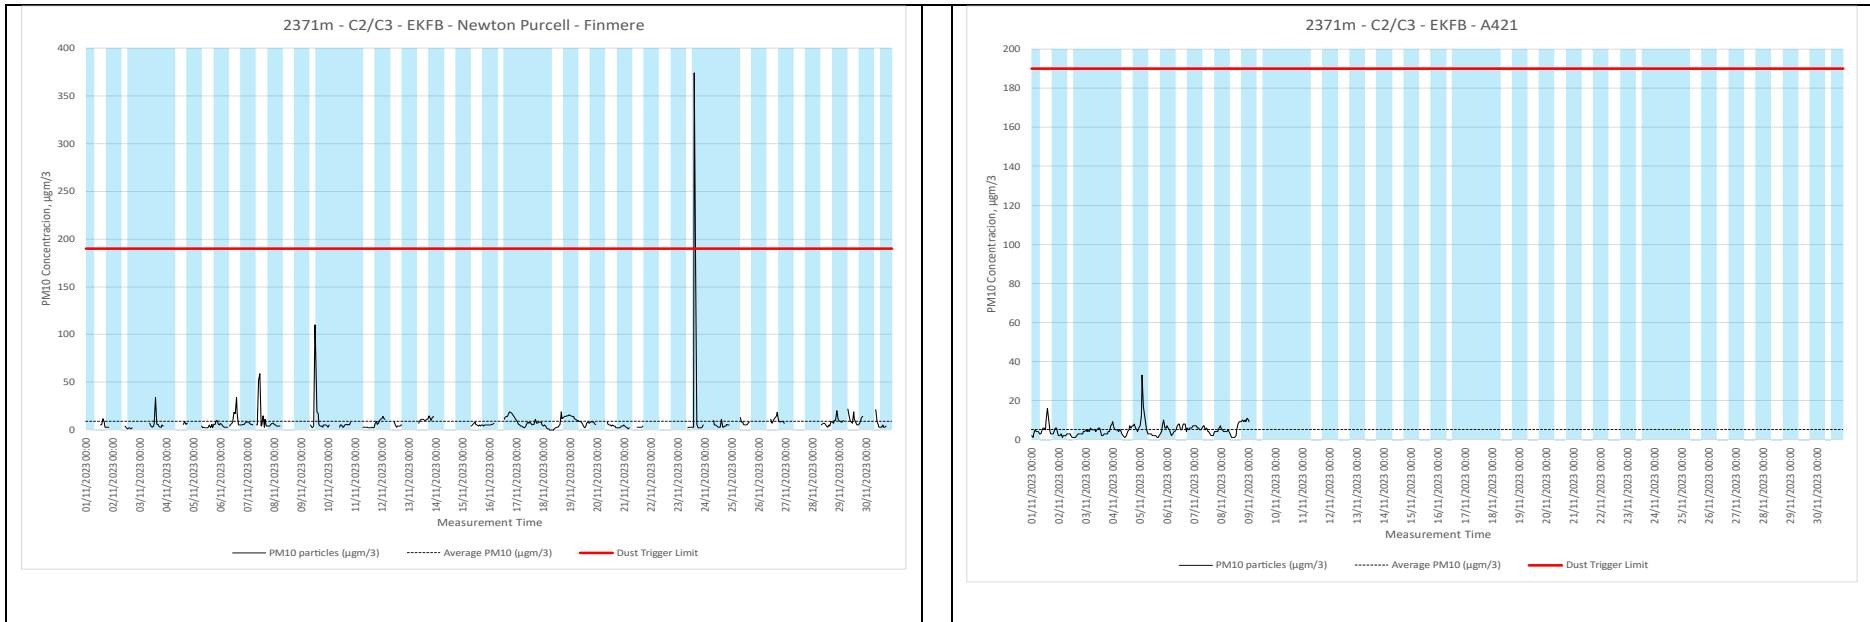
Figure 2: Continuous dust 1-hour mean indicative PM₁₀ concentration for all monitors

Monitoring Site ID	Period of trigger alert & Concentration recorded	Investigation	Outcomes / Resolution / Remedial measures implemented
Newton Purcell - Finmere	23/11/23: 14:00 - 14:59; 374 µg m ⁻³	There is no direct evidence of the cause for this exceedance using the data from the day of the 23 rd November or data from before or after the event. Therefore this dust exceedance may have been caused by the movement of aggregate along the site access road. The monitor is positioned circa 30m from the site access road. The exceedance may have been caused by the adjacent residential caravans circa 5-10m behind a fence, and the dust producing activities that were undertaken on that day. There were no heavy dust producing work activities near this location occurring on the 23 rd November. This exceedance is an anomaly, and it is difficult to be certain on the cause.	Dust levels will continue to be monitored by the site black hats, and water will be dripped from the water bowser tractors in areas at risk of dust generation.
