## **EXAMPLE** Summary of learning

# 6. Safe design, operation and maintenance of on-track plant and trolleys

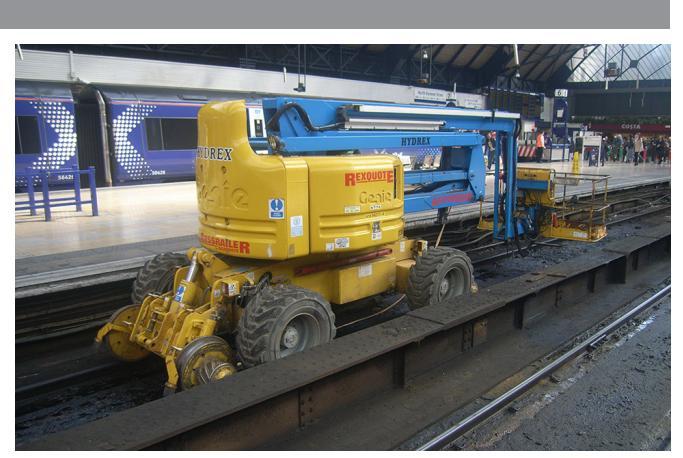
RRV after running away into Glasgow Queen Street station.

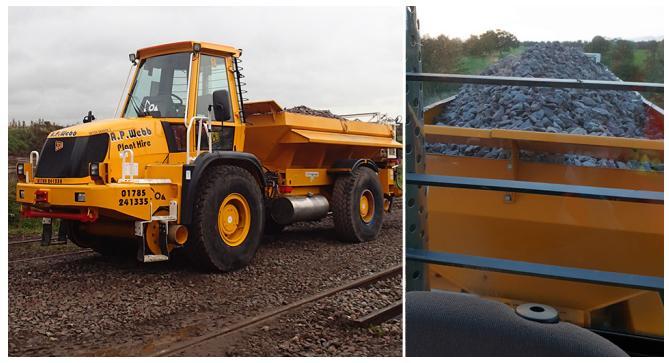
Ballast distributor RRV, and the view from the cab when running in reverse.

in reverse, and did not see another, smaller, vehicle on the line before they collided with it.

Compliance with the restriction placed on the machine, that its movements should always be controlled by a person on the ground when it was being driven in reverse, would have meant that it could not travel at more than 3 mph. This would have had significant implications for the efficiency of the work and should have been considered when this machine was selected as being suitable for the planned work activity.
