FEBRUARY 2024

**Extracts from
The United Kingdom
Merchant Shipping
(Accident Reporting and
Investigation) Regulations
2012 Regulation 5:**

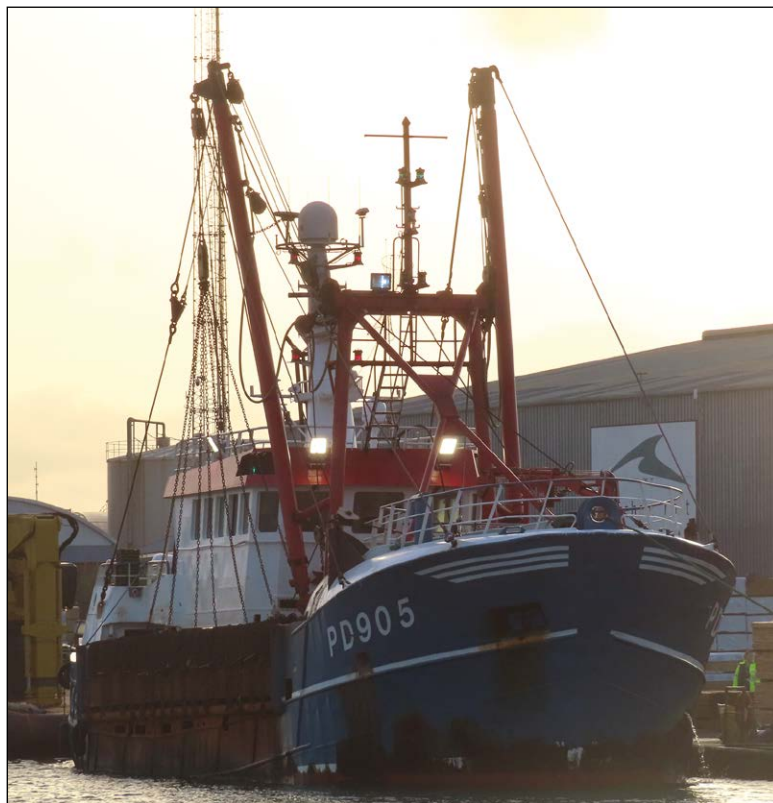
**Fatal injury to a deckhand following a chain failure
on the scallop dredger
Honeybourne III (PD905)
approximately 16 nautical miles south of Newhaven, England
on 6 October 2023**

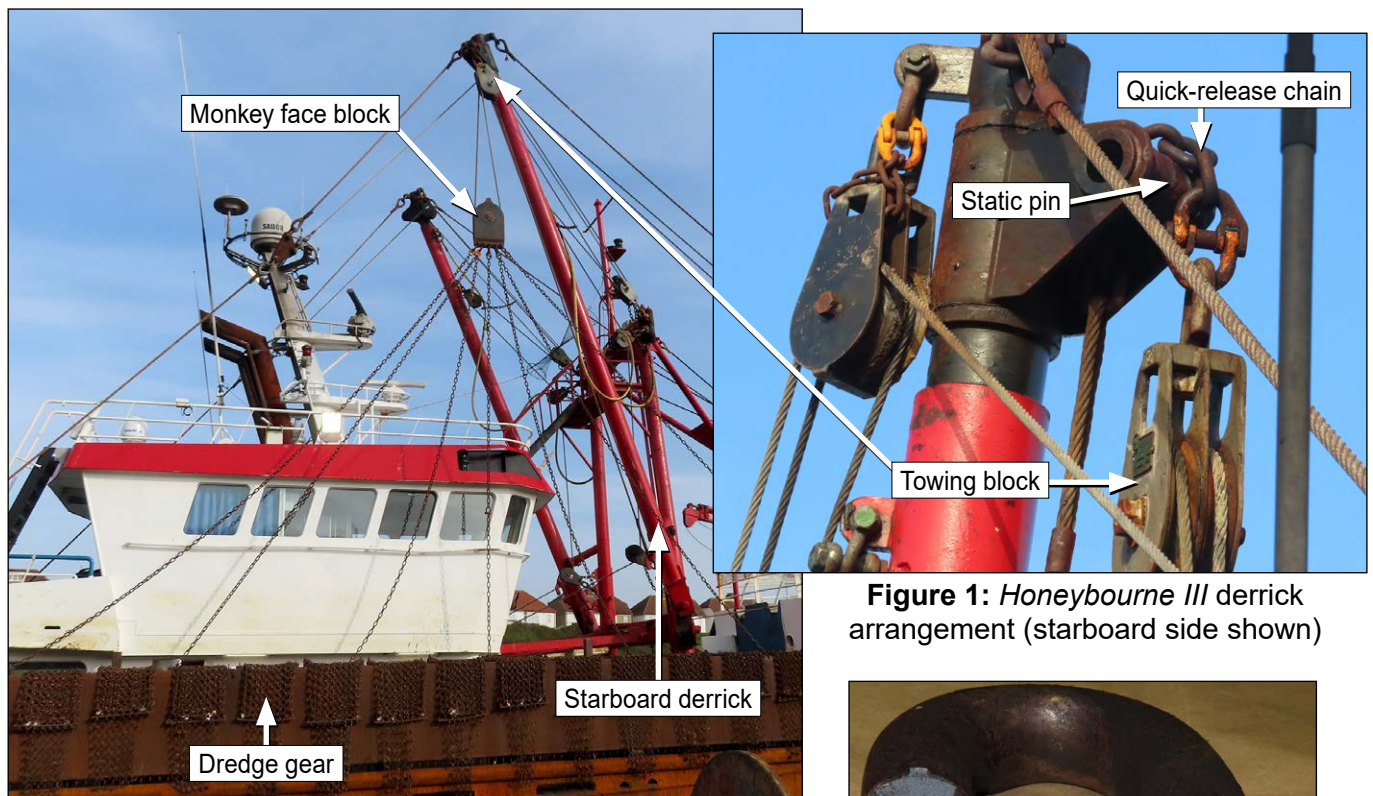
Figure 1: *Honeybourne III* derrick arrangement (starboard side shown)

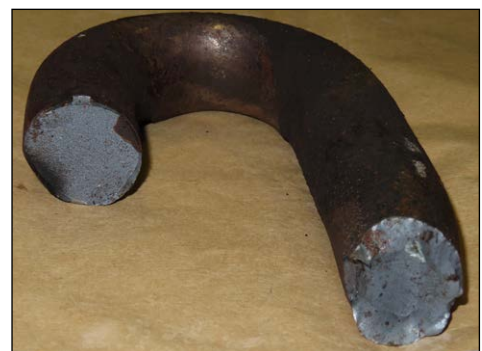
Figure 2: Failed chain link on *Honeybourne III*

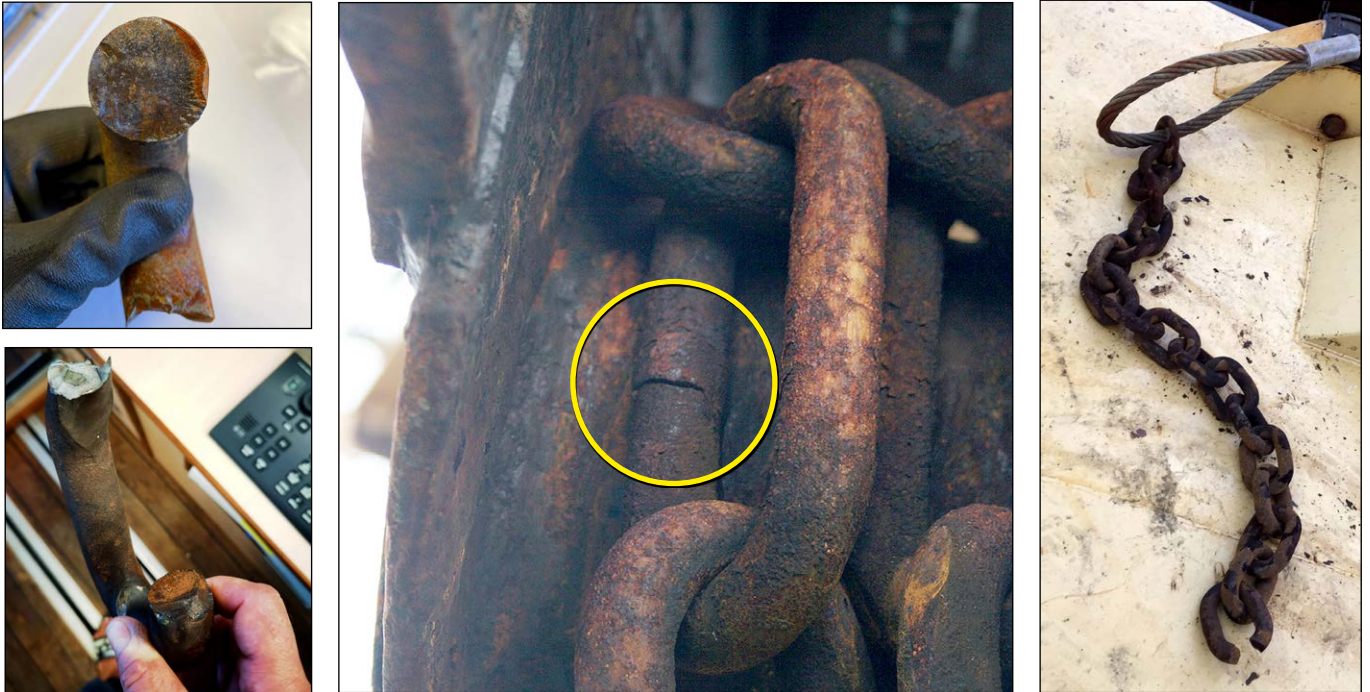
Figure 3: Identified chain defects in static pin arrangements

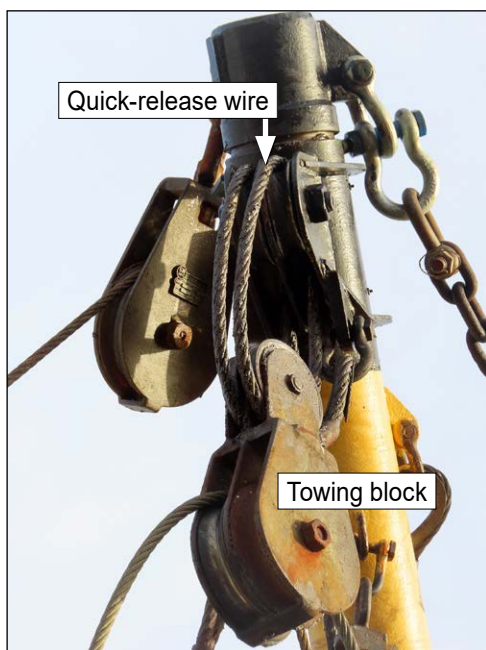
Figure 4: Quick-release arrangement with derrick head quick-release wire and sheave
