Land at Stebbing, Essex: GROUND LEVEL TREE ASSESSMENT TECHNICAL NOTE

25 November 2022

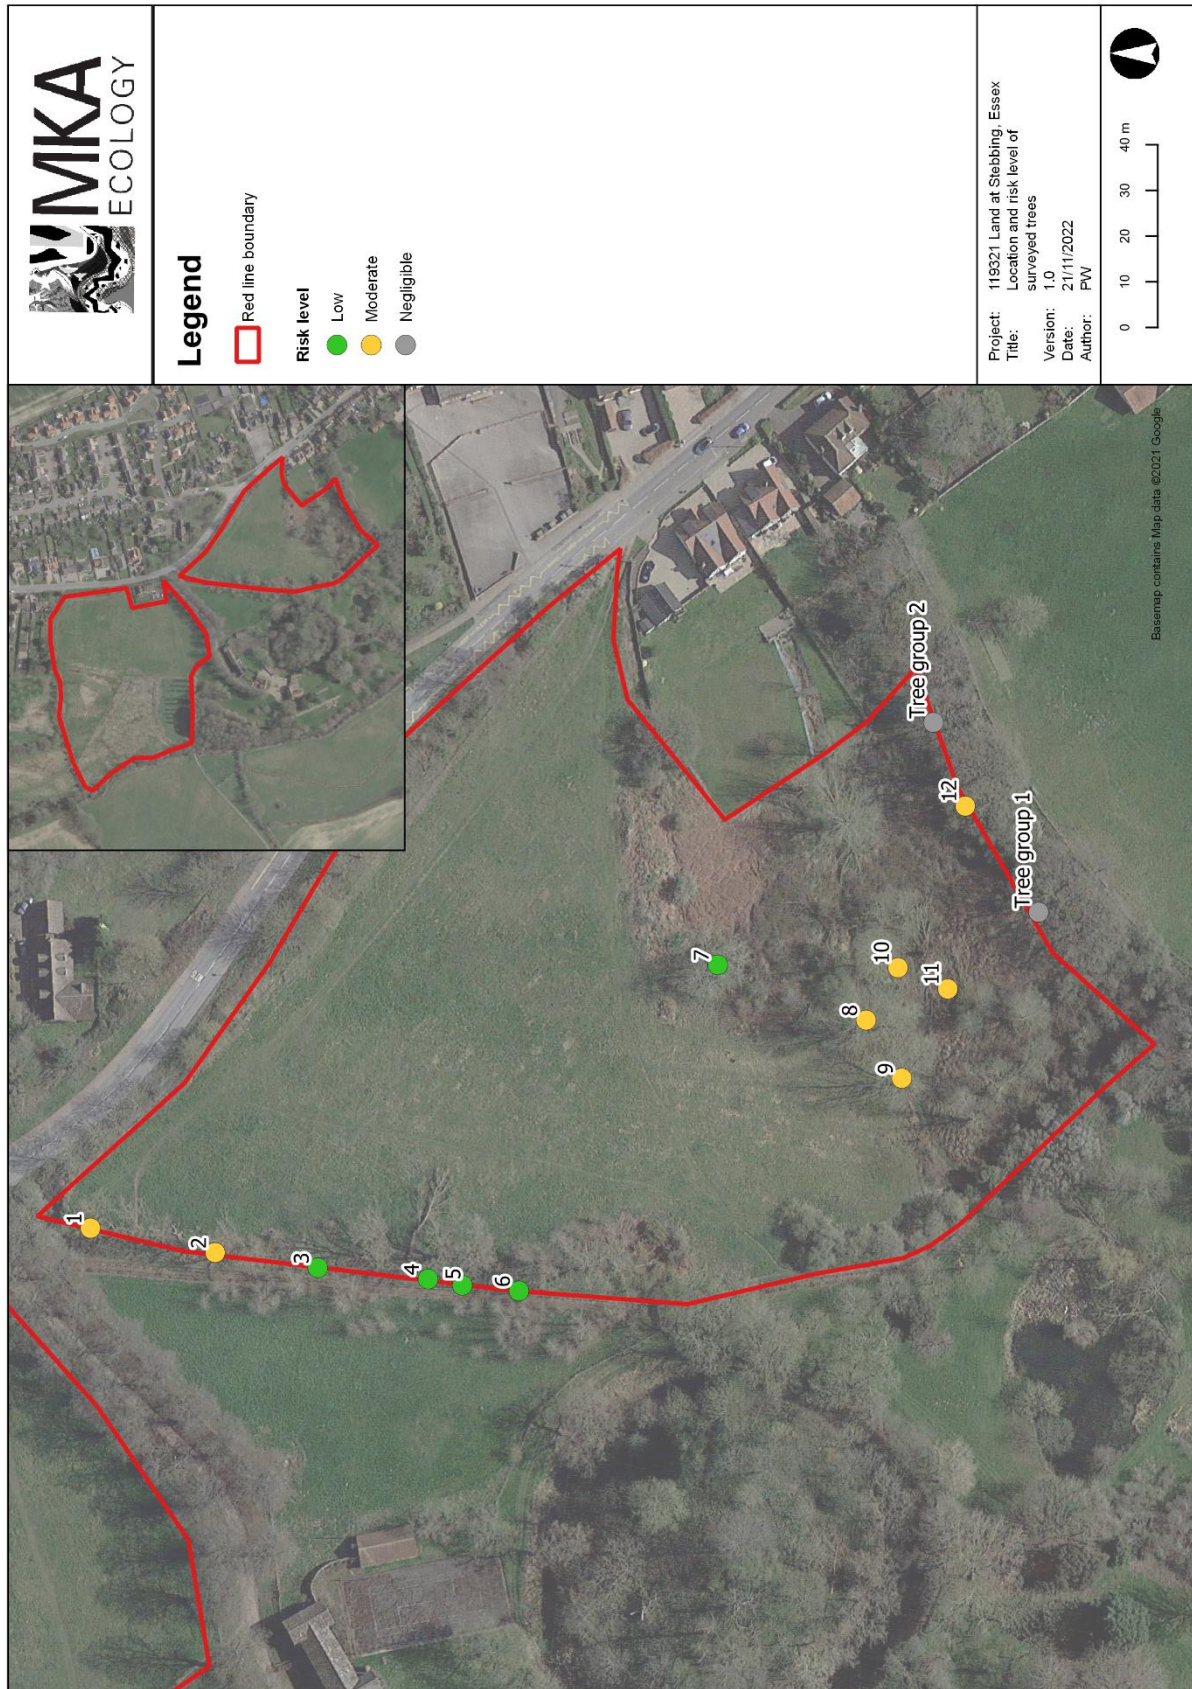
Figure 1: Location and risk level of surveyed trees

12 trees and two tree groups were assessed during the Ground Level Tree Assessment. All of the individual trees were found to support potential bat roosting features, but the two tree groups were found to be negligible for their bat roost potential. Each potential roosting feature is outlined in Table 1 below. The results of the survey are also shown in Figure 1, [Appendix 1](#).

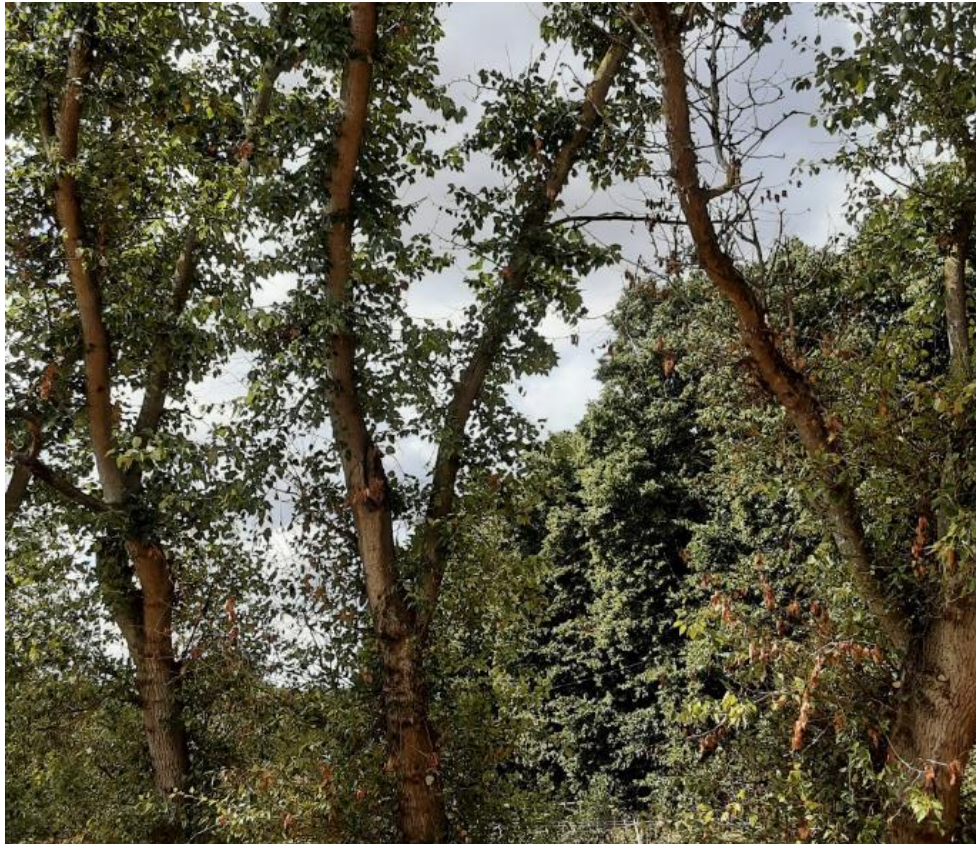
Photograph 1: Tree 1, Poplar.

Tree number/ group	Tree species	Potential roosting feature (PRF)	Photograph number	PRF suitability	Overall risk level for tree
Tree 1 (Photograph 1, Appendix 2)	Poplar	A knot hole-like cavity is present behind a broken off branch. The cavity appears to completely surround the broken branch. Potential Roost Feature (PRF) is 4m high and north facing.	Photograph 2, Appendix 2	Moderate	Moderate
Tree 2	Poplar	Multiple cavities are present within the trunk of the tree. PRFs are 4m high and east facing.	Photograph 3, Appendix 2	Moderate	Moderate
		A woodpecker hole was also identified within the tree trunk. PRF is 5m high, east facing.	Photograph 3, Appendix 2	Low	
Tree 3 (Photograph 4, Appendix 2)	Poplar	A narrow vertical crack is present in one of the dead branches of the tree. PRF is 10m high, and northeast facing. Vulnerable to water immersion.	Photograph 5, Appendix 2	Low	Low
Tree 4 (Photograph 6, Appendix 2)	Poplar	A predominantly dead tree, containing a woodpecker cavity and a large tear out originating from the trunk. PRFs are both 5m high, and east facing. Hornets were identified occupying the main trunk cavity.	N/A	Low	Low

Undertake nocturnal emergence/re-entry surveys on Trees 1, 2, 8, 9, 10, 11, and 12 with moderate bat roost suitability, where impacts are predicated upon them.

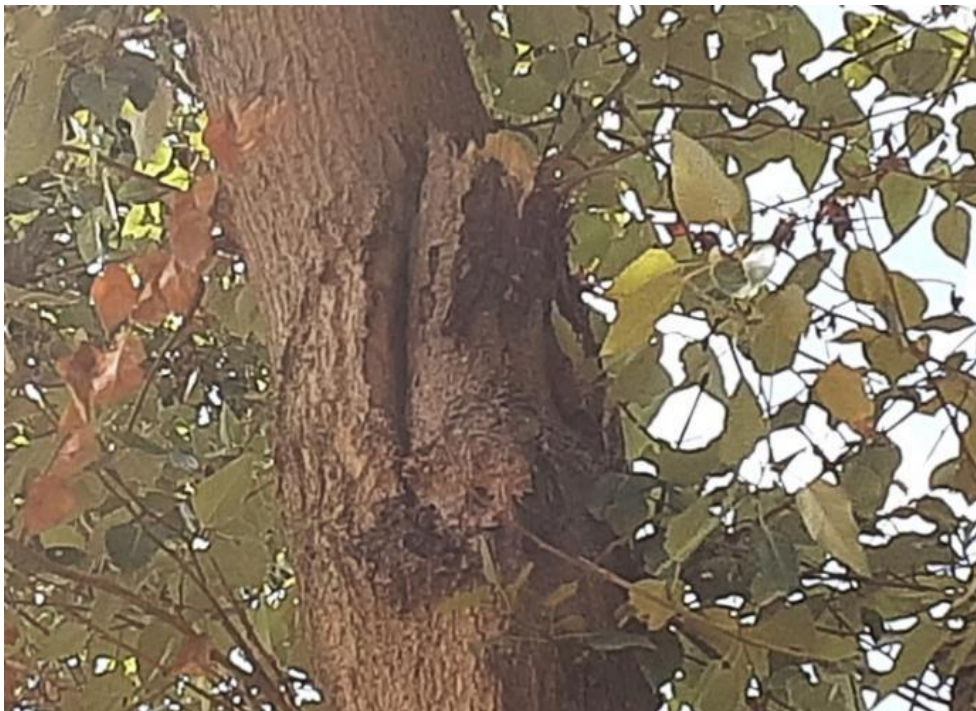
Photograph 2: Tree 1. Knot hole like cavity behind broken branch.

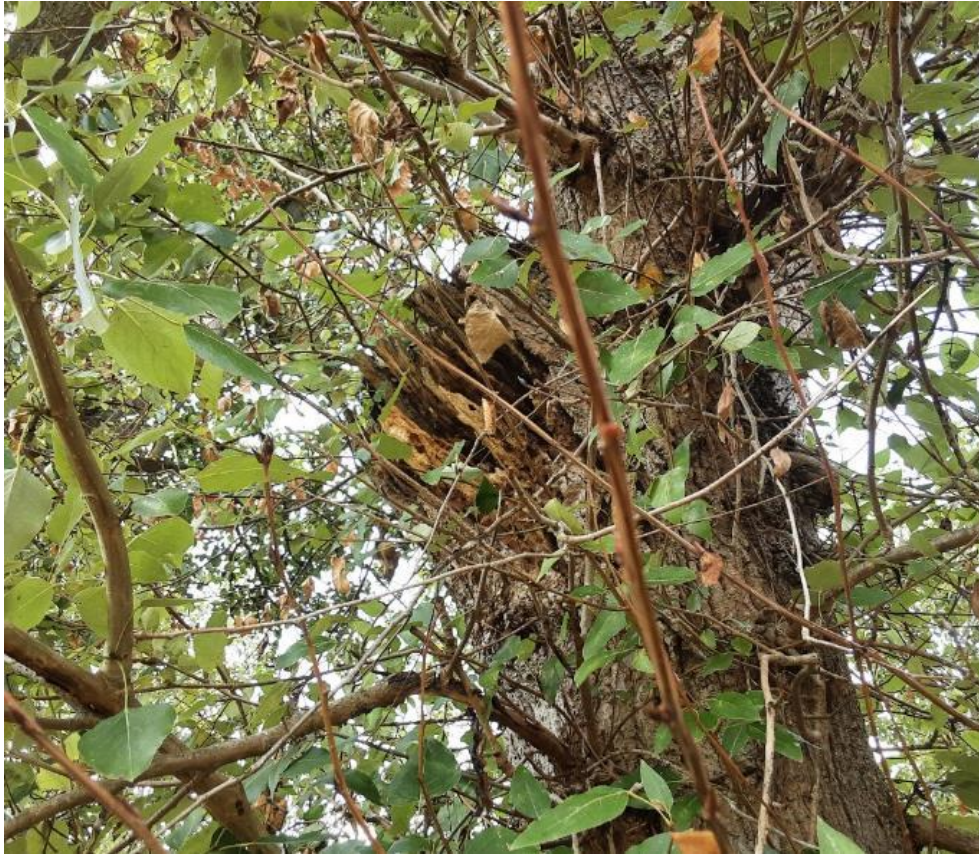
Photograph 3: Tree 2, poplar. Cavities located in the tree trunk.

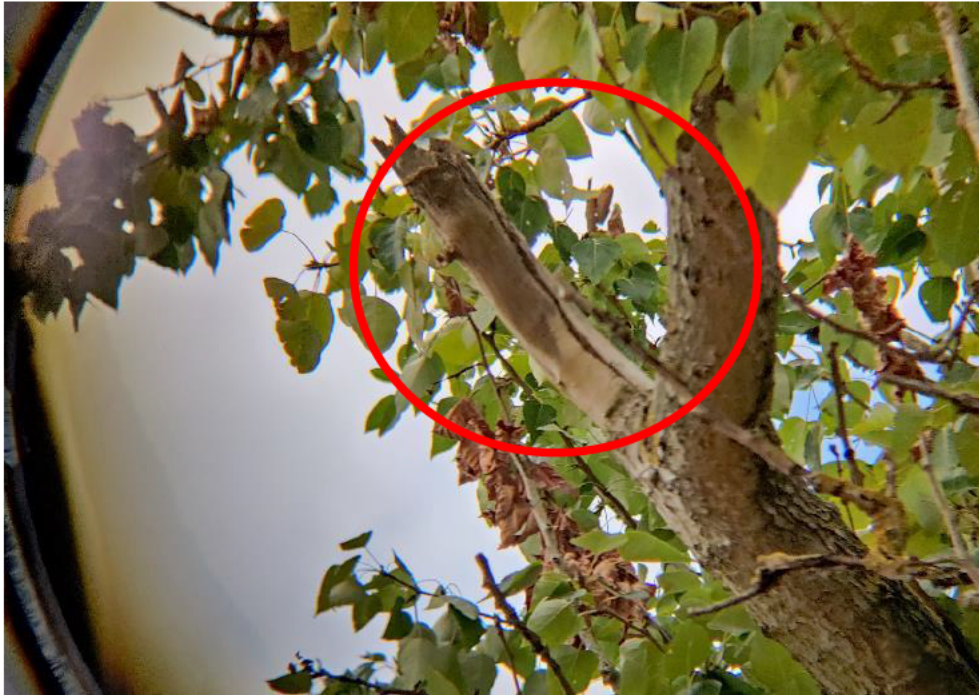
Photograph 5: Tree 3. Narrow crack present in one of the dead branches.

Where impacts are predicted on trees 3 ,4 5 6 and 7 with low risk of supporting roosting bats, these will require an inspection undertaken by a suitably qualified ecologist and liaison with arboricultural contractors prior to felling and likely to require a soft felling exercise.

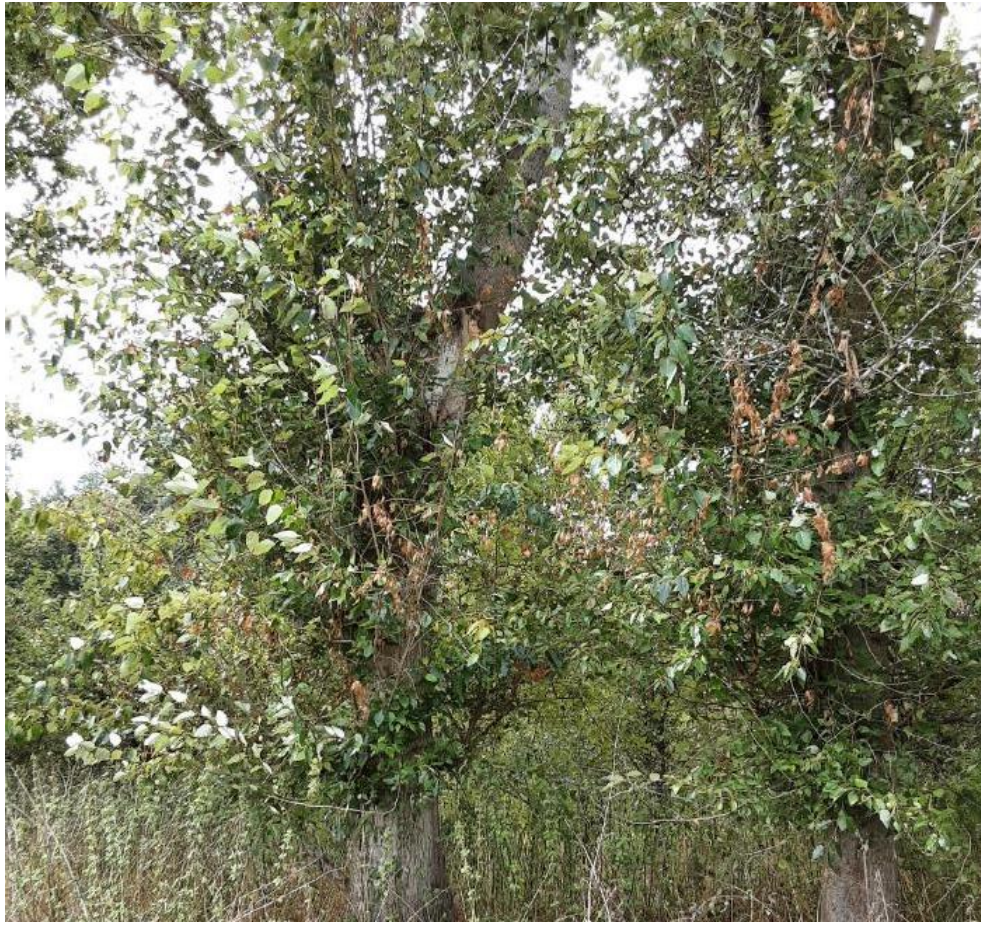
Photograph 7: Tree 5, poplar.

Tree number/ group	Tree species	Potential roosting feature (PRF)	Photograph number	PRF suitability	Overall risk level for tree
Tree 5 (Photograph 7, Appendix 2)	Poplar	A large tear out and associated cavity is present within the trunk of the tree. PRF is 4m high, and east facing.	Photograph 8, Appendix 2	Low	Low
Tree 6	Poplar	Cracks were identified within the bark present on one of the branches that had been cut. PRF is 5m high and east facing.	Photograph 9, Appendix 2	Low	Low
Tree 7 (Photograph 10, Appendix 2)	Ash	A branch tear is present on the tree, as well as a small adjacent cavity. Both PRFs are 10m high and north facing.	Photograph 11, Appendix 2	Low	Low
Tree 8 (Photograph 12, Appendix 2)	Willow	Cracks were identified in a tear out located 6m high and north facing.	Photograph 13, Appendix 2	Moderate	Moderate
		Numerous cracks were identified in the bark all around the tree; particularly lower down on the tree.	N/A	Moderate

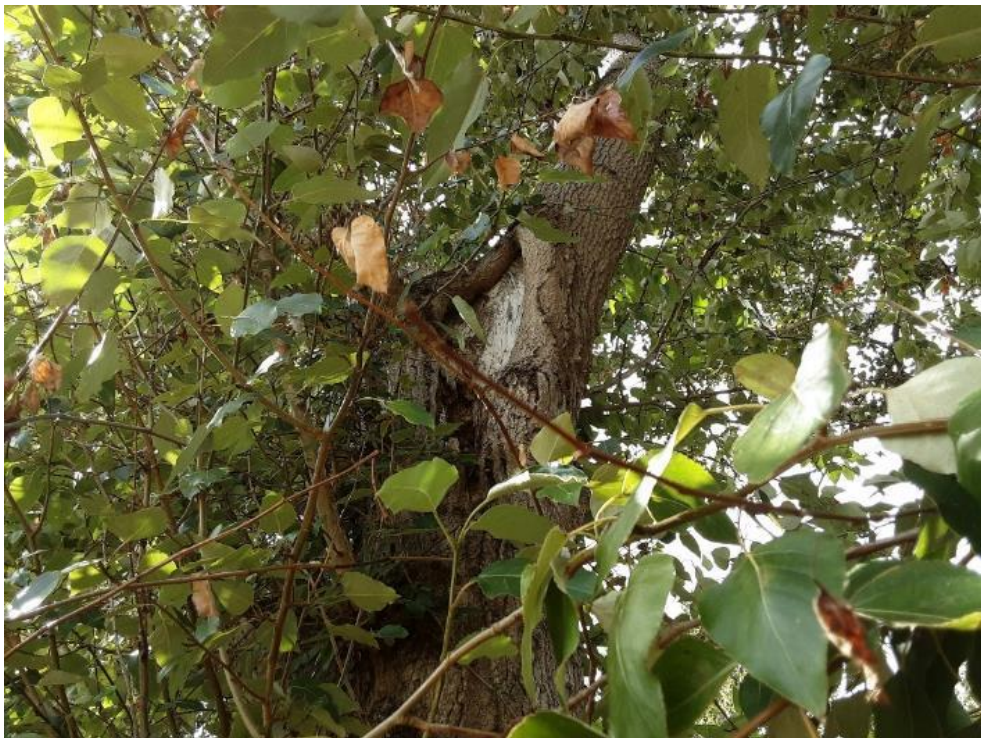
Photograph 8: Tree 5. Tear out and cavity within the tree's trunk.

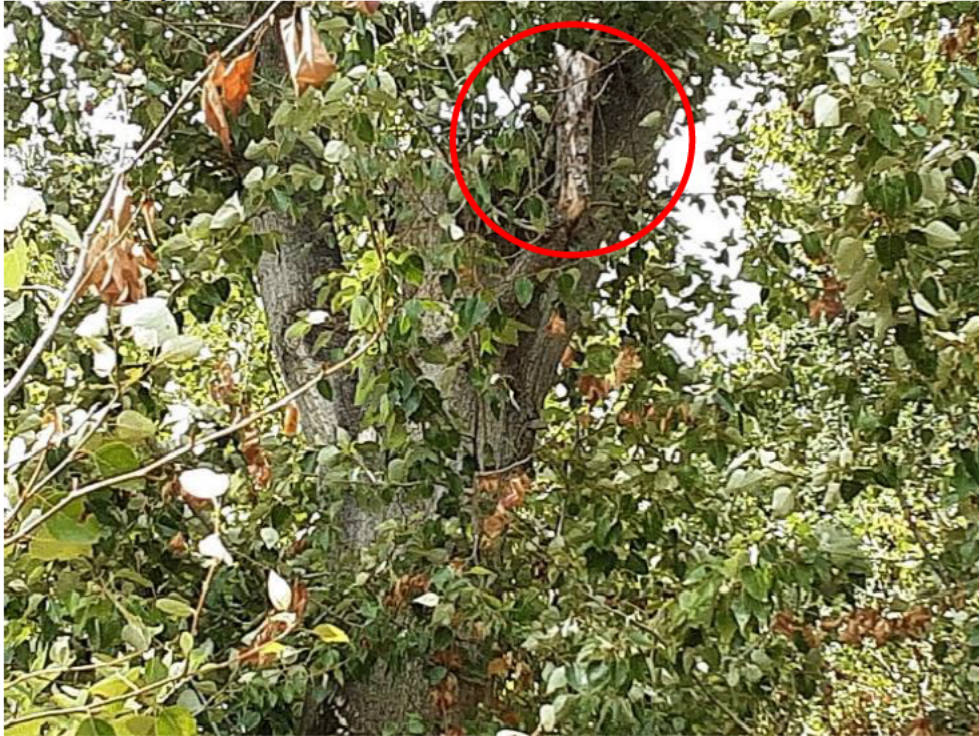
Photograph 9: Tree 6. Cracks on branches where the tree had been cut.

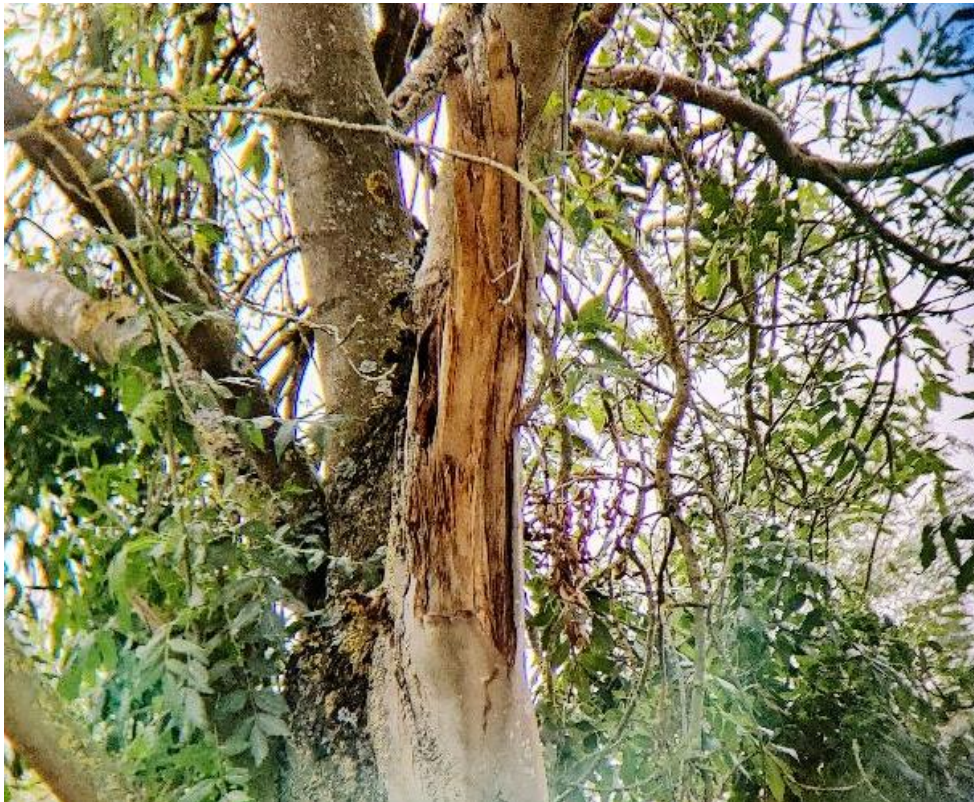
Photograph 11: Tree 7. Branch tear and small adjacent cavity.

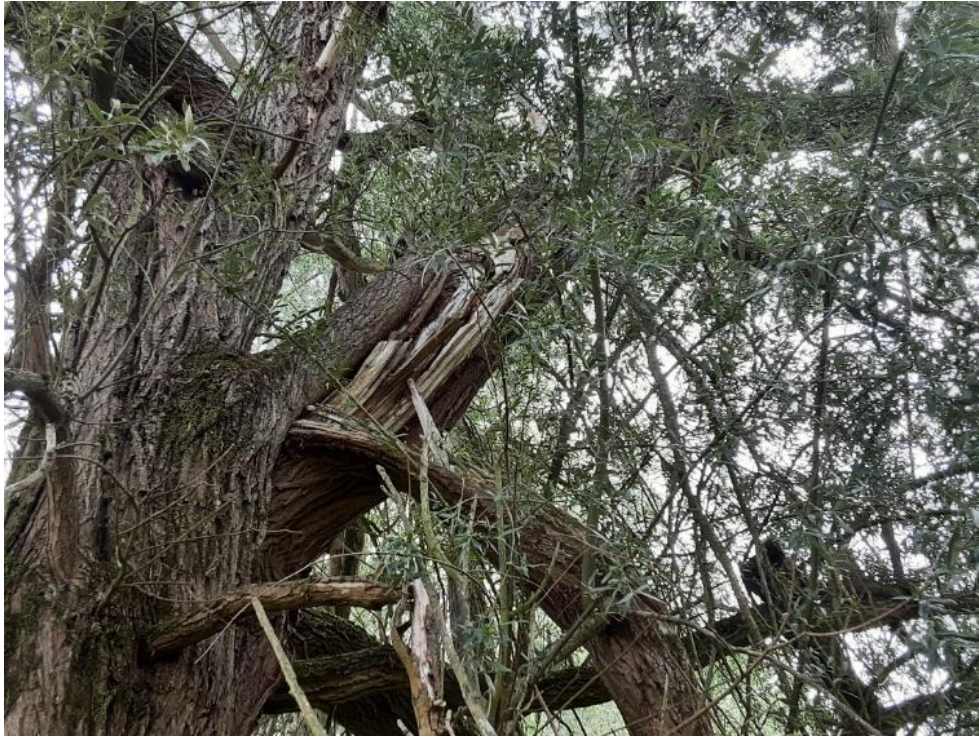
Photograph 13: Tree 13. Cracks within tear out.

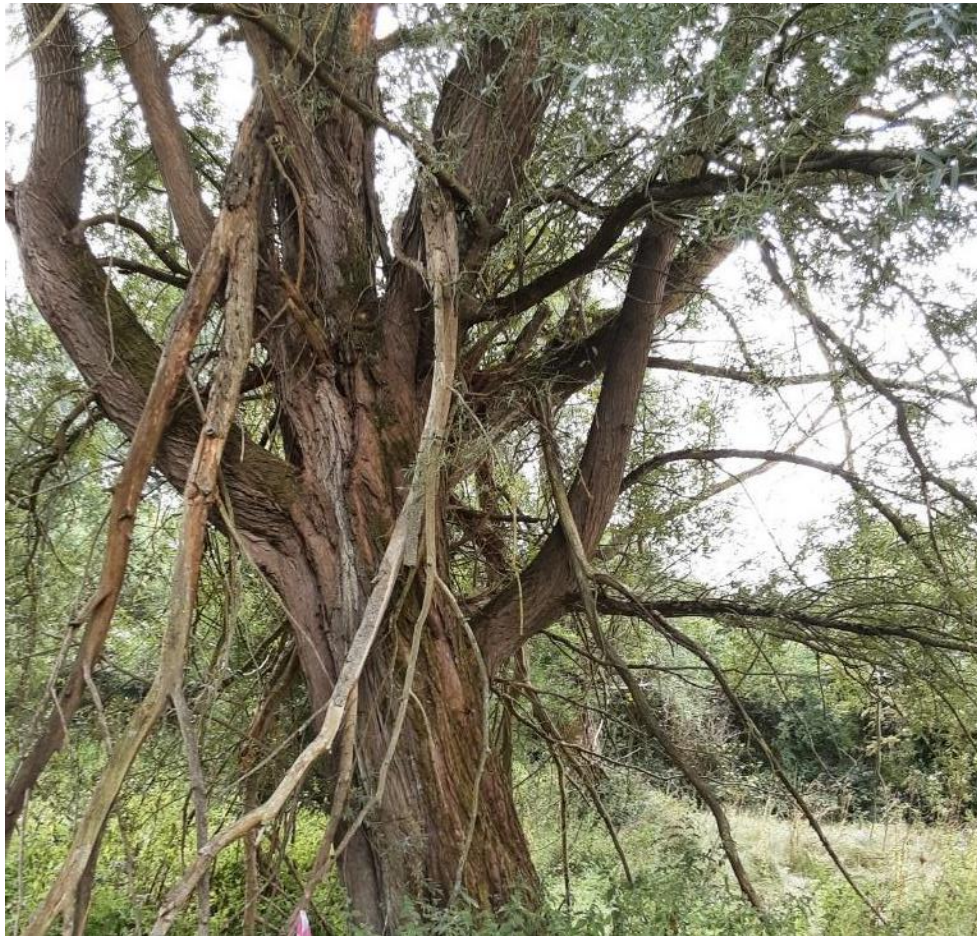
Photograph 14: Tree 9, Willow.

Tree 9 (Photograph 14, Appendix 2)	Willow	Numerous cracks are present in the bark around the entirety of the trunk and some dead branches are present.	Photograph 15, Appendix 2	Moderate	Moderate
Tree 10	Willow	This tree is a dead stump containing numerous holes and cracks.	N/A	Moderate	Moderate
Tree 11 (Photograph 16, Appendix 2)	Willow	Numerous cracks and tear outs were identified around the majority of the trunk and branches.	N/A	Moderate	Moderate

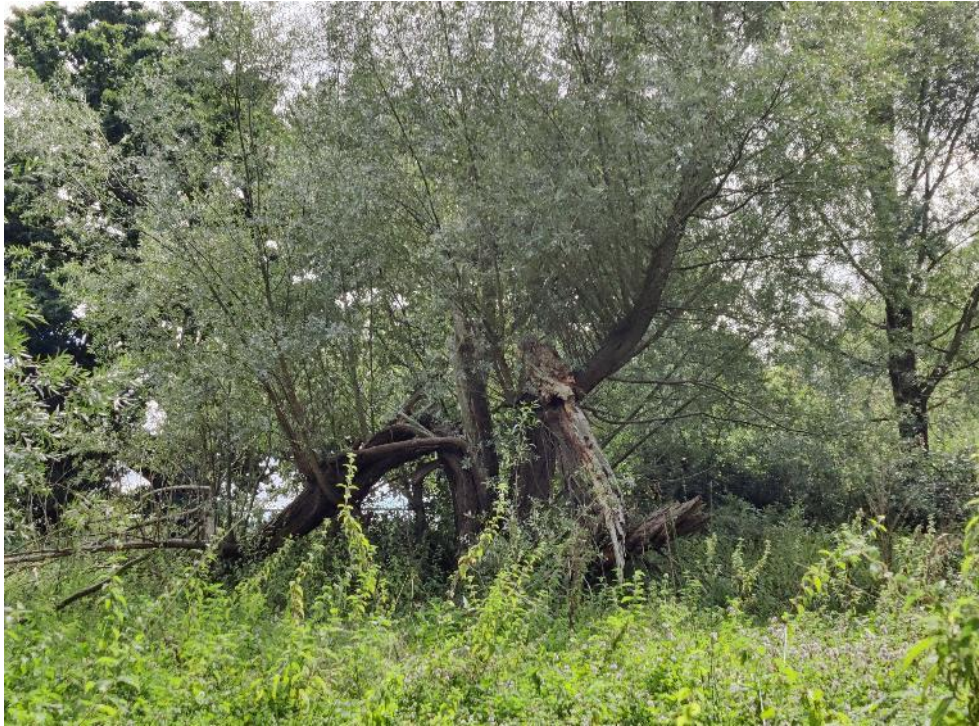
Photograph 15: Tree 9. Numerous cracks within the bark of the tree.

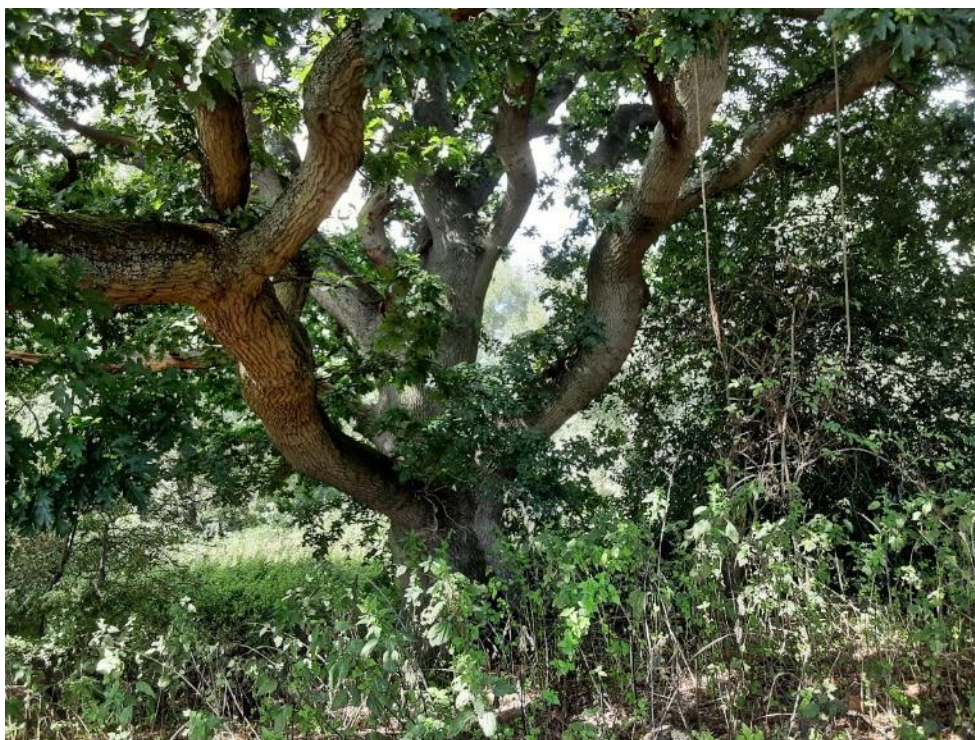
Photograph 17: Tree 12, pedunculate oak.

Tree number/ group	Tree species	Potential roosting feature (PRF)	Photograph number	PRF suitability	Overall risk level for tree
Tree 12 (Photograph 17, Appendix 2)	Pedunculate oak	A woodpecker hole and deadwood with cracks were identified on the trunk of the tree.	Photograph 18, Appendix 2	Moderate	Moderate
		A deep cavity was identified on the end of a dead branch that travels far into the trunk of the tree. PRF is 2m high and south facing.	Photograph 19, Appendix 2	Low	
Tree group 1	Pedunculate oak	A tree group, containing three trees, with no PRFs identified.	N/A	N/A	Negligible
Tree group 2	Pedunculate oak	A tree group, containing two trees, with owl boxes present.	Photograph 20, and Photograph 21, Appendix 2.	Negligible	Negligible

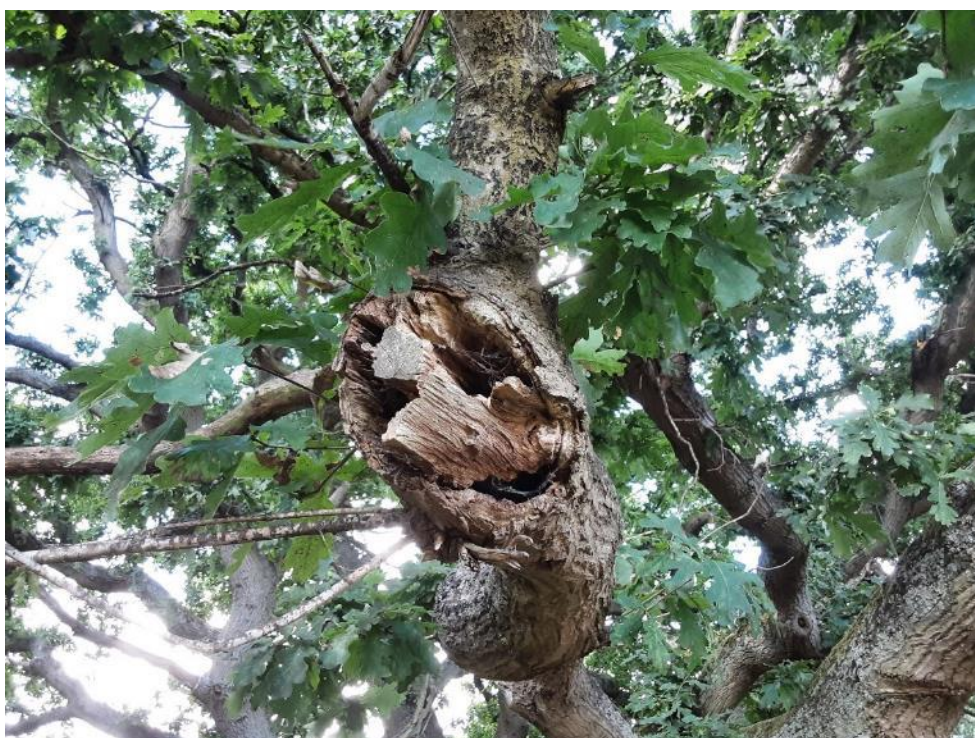
Photograph 18: Tree 12. Woodpecker hole and dead wood cavity.

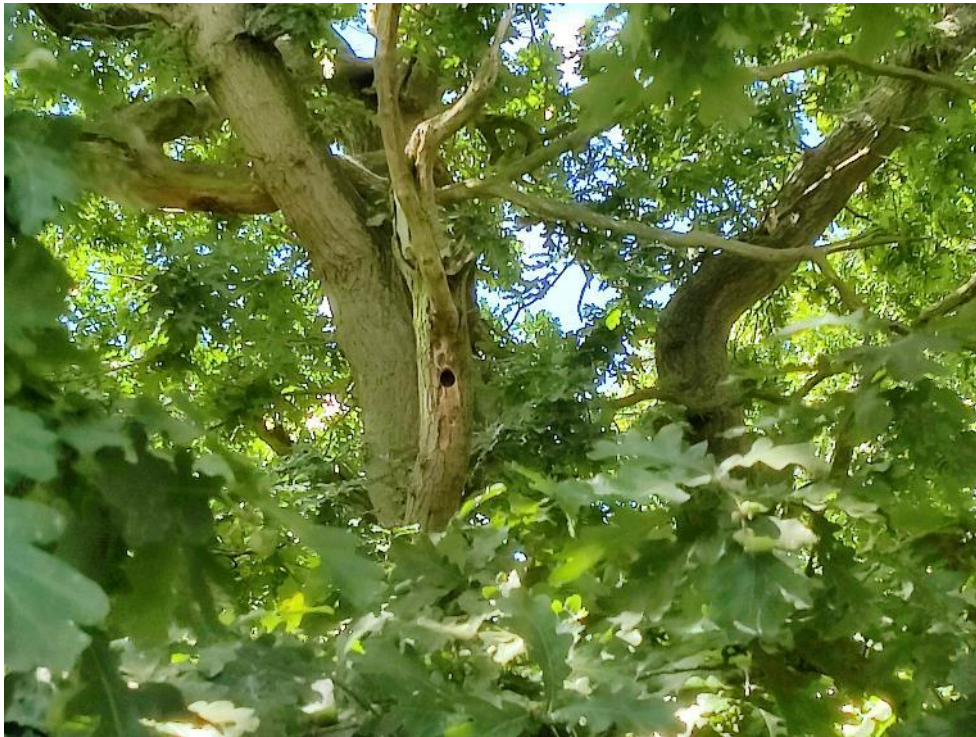
Photograph 19: Tree 12. Deep cavity on the end of dead branch.

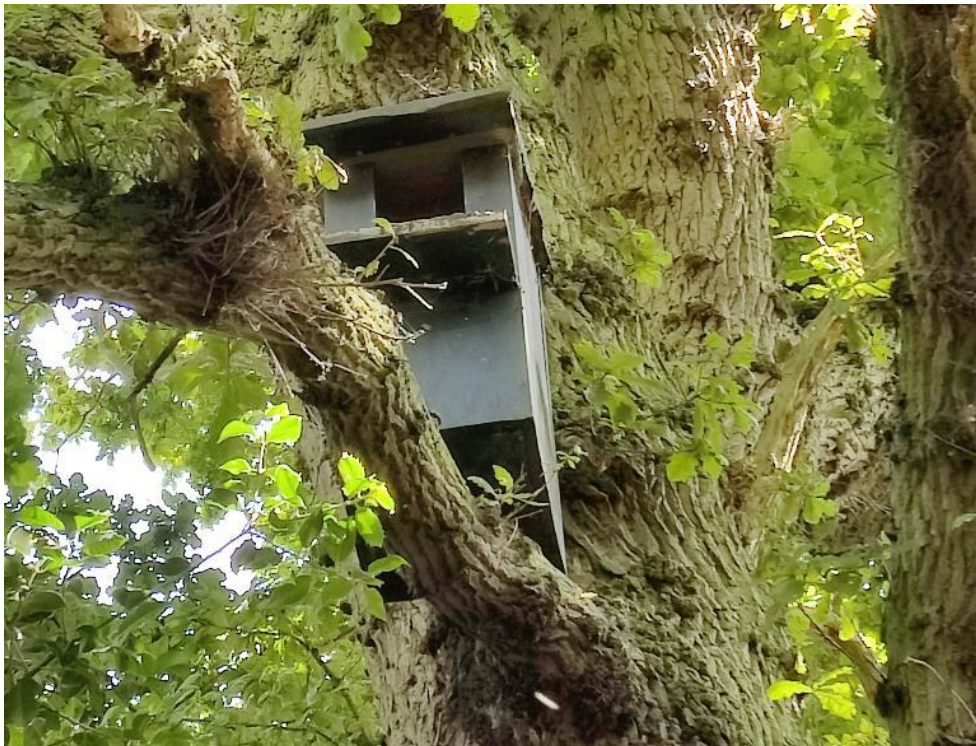
Photograph 20: Tree group 2. Owl box present on tree.

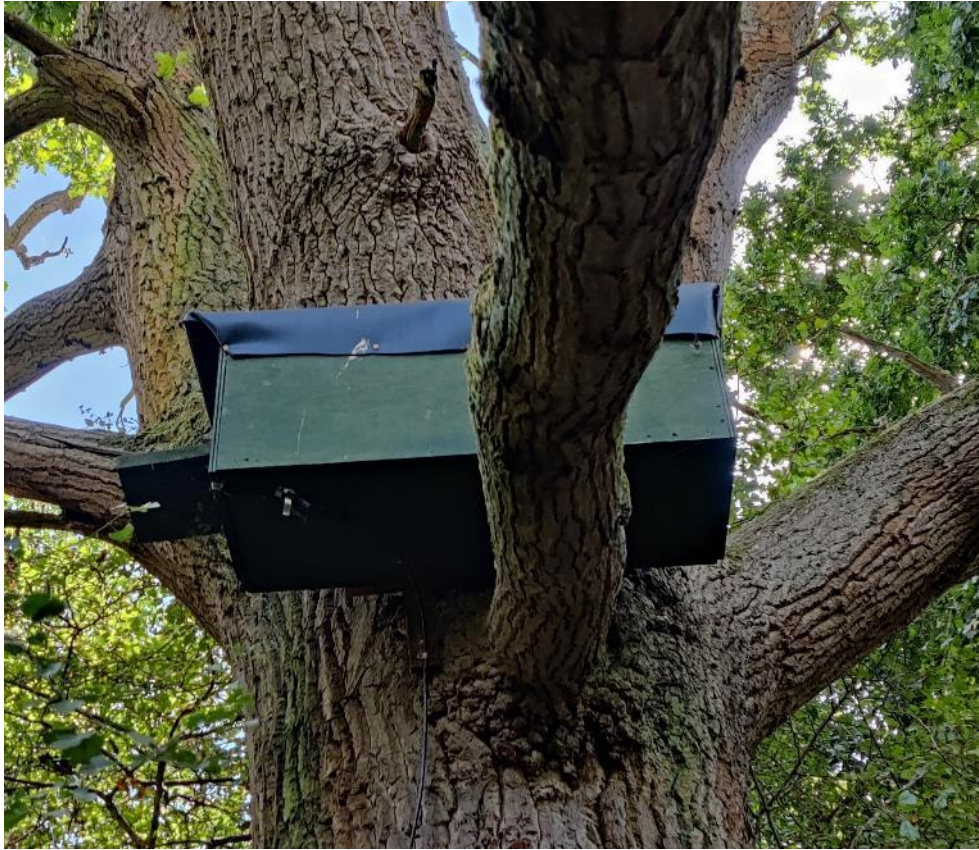
Photograph 21: Tree group 2. Owl box present.
