# Rail Accident Investigation: Interim Report

Collision between passenger trains near Talerddig, Powys 21 October 2024

> Report IR1/2025 April 2025

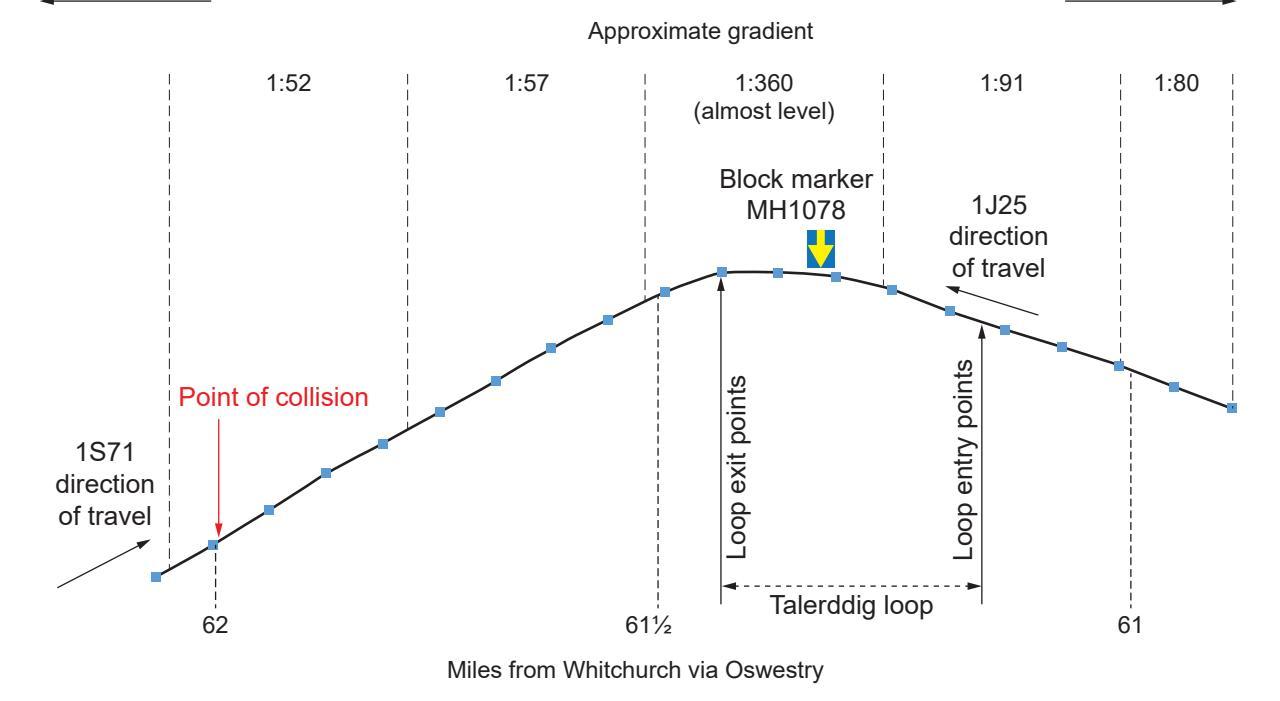
- 26 The loop at Talerddig is located on a summit with an ascending gradient for westbound trains approaching it. The exit from the passing loop for westbound trains descends to the collision point (figure 4).

Figure 4: Track gradient at Talerddig passing loop (gradient detail from an RAIB survey).

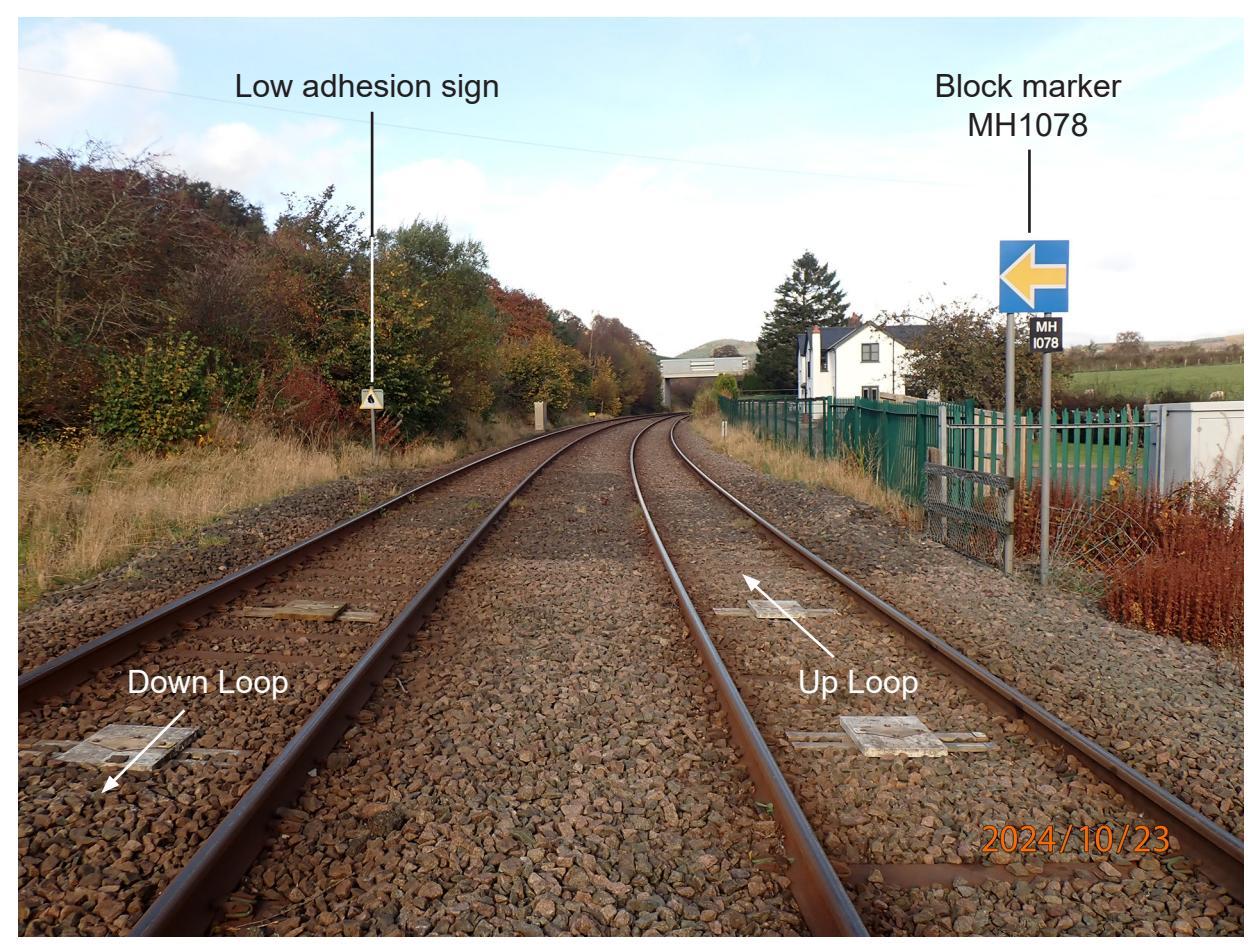
Figure 5: The intended stopping position for train 1J25, at block marker MH1078 on the Up Loop. A low adhesion warning sign is also visible on the left of the Down Loop.

- 60 Network Rail's sectional appendix identifies an area of known low wheel-rail adhesion starting towards the western end of Talerddig loop. This lies beyond the intended stopping position of train 1J25 at block marker MH1078. This area of known low adhesion is marked with a lineside sign, positioned in the cess of the Down Loop (figure 5), and continues west down the gradient towards Machynlleth for 5.9 km (3.7 miles).

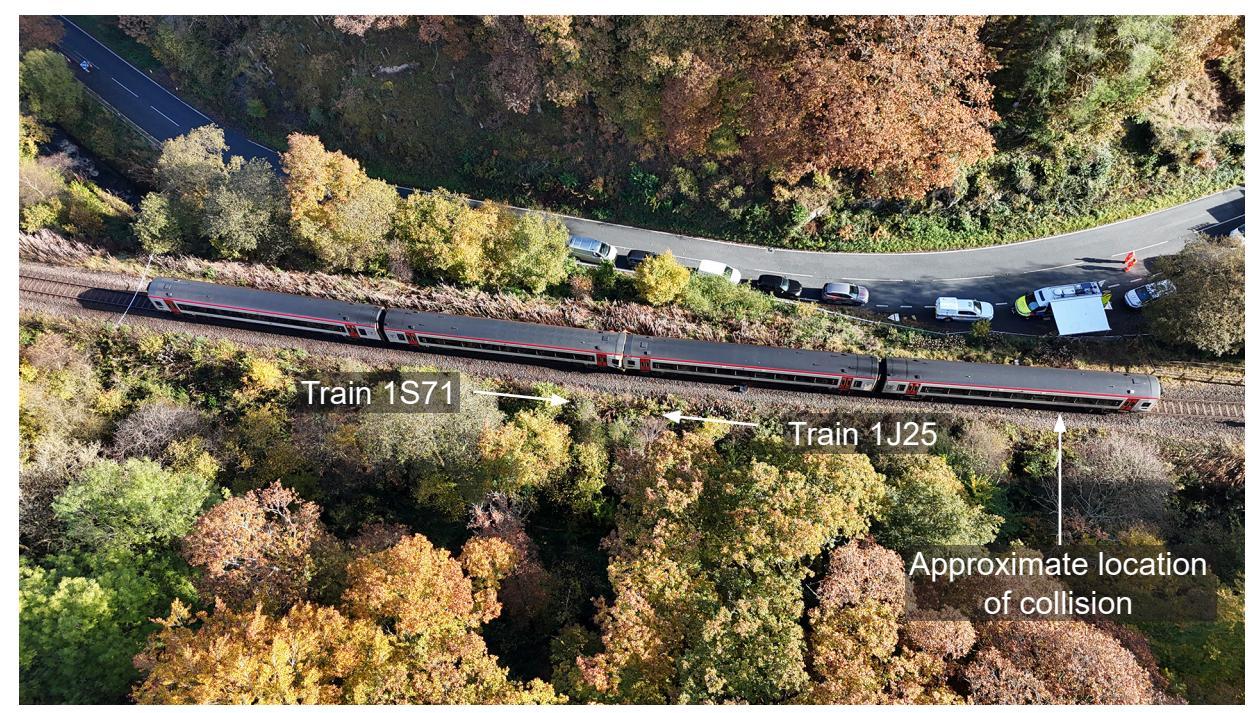
*Figure 8: The trains involved, showing the approximate location of the collision and the final resting position.*

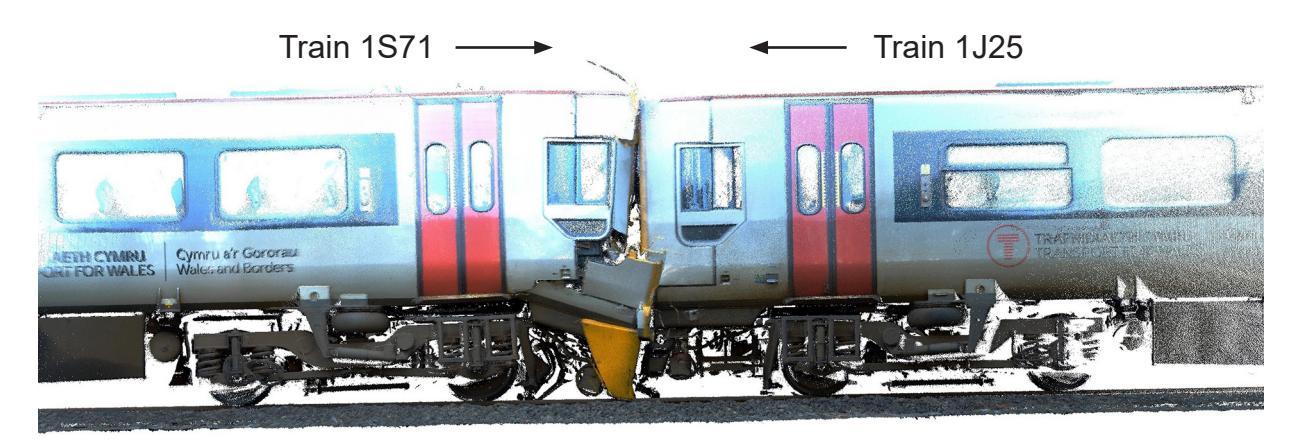
- 52 There were six people on board train 1S71, including the train driver and the guard. The driver was in the process of attempting to leave the driving cab when the collision occurred. The driver became trapped during the collision and was seriously injured. The remaining five people on board reported minor injuries.
- 53 The leading end of each train suffered damage in the collision (figure 9). The driving cab of train 1S71 received the most damage and was significantly deformed. The basic structural integrity of the passenger compartments on each train was maintained although some internal panels became detached, and some internal and external doors became inoperable. Some of the underframe equipment on both trains was displaced but did not become detached.

Figure 9: Side view of the collision (image created from laser scans).

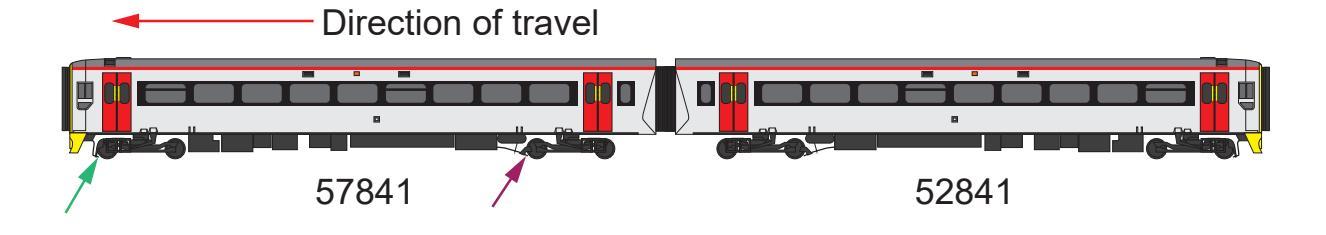
Although these sanding systems are installed on each vehicle, only the sanders on the leading vehicle are active (figure 10). In the case of train 1J25, the active sanding systems at the time of the accident were therefore fitted to vehicle 57841. RAIB has concluded from the available evidence that neither the automatic sander nor the emergency sander on this vehicle discharged sand in the moments immediately before the collision.

Figure 10: Automatic sanders at third wheelset (purple arrow) and emergency one-shot sanders at first wheelset (green arrow) are available when vehicle 57841 is leading. The same equipment is also installed on vehicle 52841 but will only be available when this vehicle is leading.

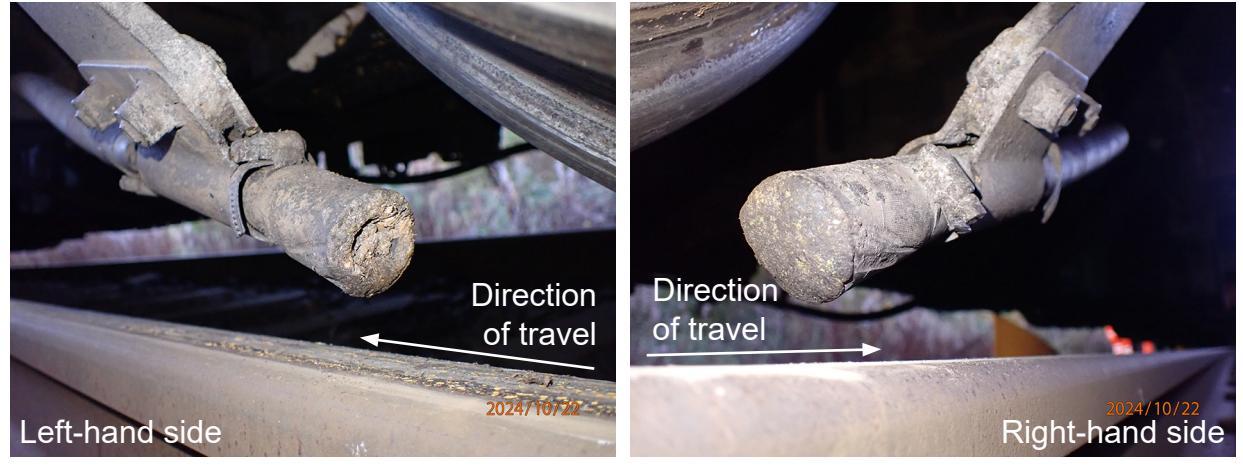
- Both sand delivery hoses were found to be blocked (figure 11). This fault would have prevented sand from being ejected from the hoses.
- 74 No defects relating to the sanders were reported by any drivers of unit 158841 on 20 or 21 October. However, it cannot be determined if the train encountered areas of low wheel-rail adhesion during this period which would have activated these systems and potentially alerted drivers to any defects which may have existed.

Figure 11: The blocked sand delivery hoses on vehicle 57841.

76 After the accident, RAIB removed the blocked sand hoses for analysis. Although the hoses were blocked at the outlet end, there was no evidence of any significant build-up of sand in the pipe behind the blockage. There was dry sand in the sand hopper, and sand flowed freely from the sand valve under the hopper when the test button was pressed during subsequent testing.

- 77 A detailed examination of one of the blocked hoses has been undertaken. The blockage consisted of a plug of material which was approximately 30 mm deep in the outlet end of the sand hose. RAIB considers that the material blocking the hose probably originates from a source external to the sanding system. Visual examination of the material with an optical microscope revealed organic matter and very small particles of sand-like material. Preliminary DNA testing of the organic material indicates that it comprises leaves and debris originating from ash, acer and wild cherry trees.

- 85 TfWRL raised a National Incident Report on 25 October 2024 (NIR4106) titled 'Class 158 low speed collision'. Such reports are generated for the use of railway industry duty holders. NIR4106 described the risks of blocked sander hoses and described additional checks to be carried out.
- 86 TfWRL raised a second National Incident Report on 14 January 2025 (NIR4134) titled 'Class 158 sander hidden fault'. This report highlighted the electrical defects identified with the automatic sanding system (paragraph 73) and described additional checks to be carried out.
