# SAFETY FLYER TO THE FISHING INDUSTRY

### Fatal accident to a deckhand on board the beam trawler *Cornishman* (PZ 512), 44 nautical miles south-south-west of the Isles of Scilly, England on 6 February 2021

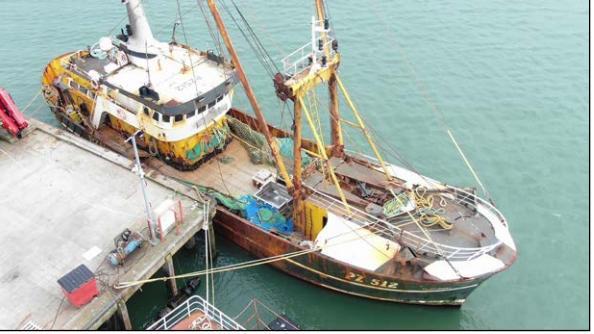
Cornishman

At about 0630 on 6 February 2021, the crew of the beam trawler *Cornishman* were repairing the port trawl gear between fishing operations when the suspended steel trawl beam suddenly fell to the deck, striking and trapping a deckhand who was working underneath. The deckhand was declared deceased 1.5 hours later by the attending helicopter paramedic.

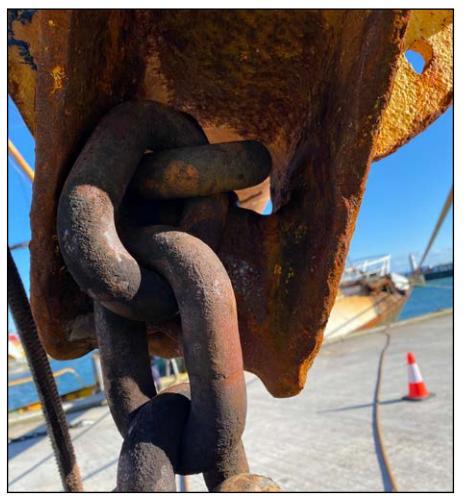
The investigation established that a 32mm Grade 8 chain link forming part of the port trawl gear's quick-release mechanism supporting the port beam had fractured and allowed the beam to fall. The chain was operated over a 150mm diameter fixed steel pin (**Figure 1**) at the top of the derrick; both the chain and its links were found to be corroded, heavily worn, and cracked.

Figure 1: Quick-release chain over fixed steel pin

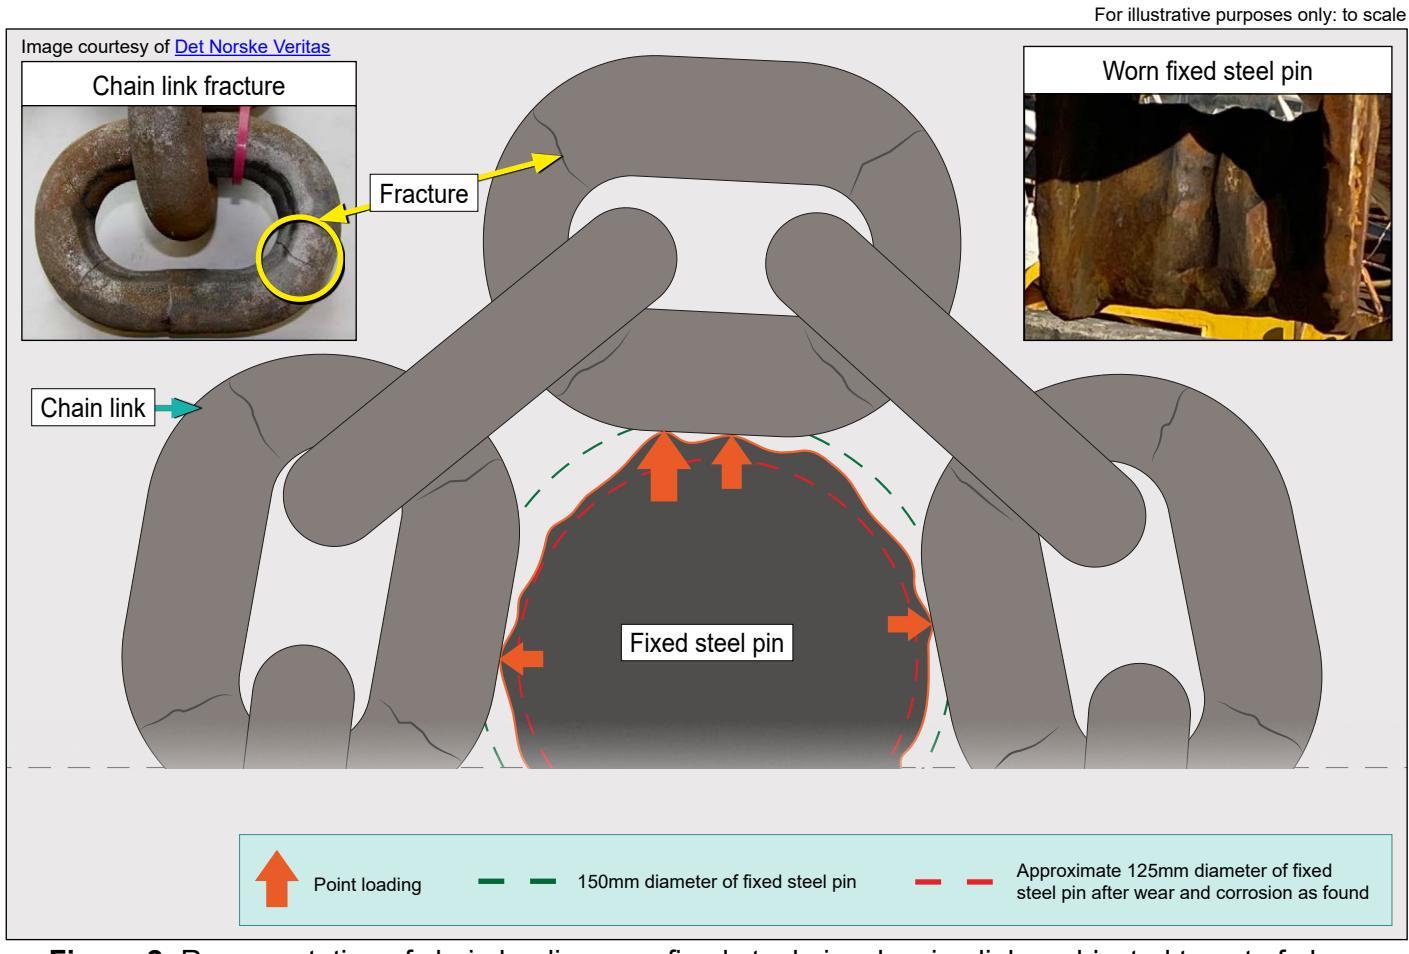
- 1. *Cornishman*'s chain over fixed pin arrangement resulted in side loading and bending stress of individual chain links due to the low ratio between the diameters of the 150mm fixed pin and the 32mm chain link, known as the D/d ratio (Figure 2).
- 2. High alloy Grade 8 chains are not recommended for offshore use due to their susceptiblility to envrionmental cracking, resulting in loss of strength and risk of catastrophic failure while loaded.

- 3. Chains are primarily intended for straight line point-to-point loading. Where a change in direction is required a chain lifter, such as found on an anchor windlass, or a high D/d ratio arrangement is necessary.
- 4. The side loading of individual chain links on *Cornishman* resulted in out of plane stresses, which the chain was not designed to withstand. This caused heavy wear on the fixed pin and chain links as the links were operating under dynamic loads. Alternative quick-release designs are available and should be considered as a safety improvement to minimise the opportunity for sudden failure. A safety bulletin, issued by MAIB in February 2024, provides more details <u>https://www.gov.uk/maib-reports/safety-warning-issued-following-a-chain-failure-on-scallop-dredger-honeybourne-iii-with-loss-of-1-life</u>

Figure 2: Representation of chain loading over fixed steel pin, showing links subjected to out of plane bending stress point loads
