AAIB Bulletin:	G-CFHG	AAIB-30096		
Accident				
Aircraft Type and Registration:	Mini Nimbus C, G-CFHG			
No & Type of Engines:	None			
Year of Manufacture:	1981 (Serial no: 140)			
Date & Time (UTC):	5 June 2024 at 1013 hrs			
Location:	Barlavington, Sussex			
Type of Flight:	Private			
Persons on Board:	Crew - 1	Passengers - None		
Injuries:	Crew - 1 (Fatal)	Passengers - N/A		
Nature of Damage:	Destroyed			
Commander's Licence:	BGA Bronze plus cross-country			
Commander's Age:	73 years			
Commander's Flying Experience:	100 hours (of which 19 hours 43 mins were on type) Last 90 days - 25 hours Last 28 days - 13 hours			
Information Source:	AAIB Field Investigation

Synopsis

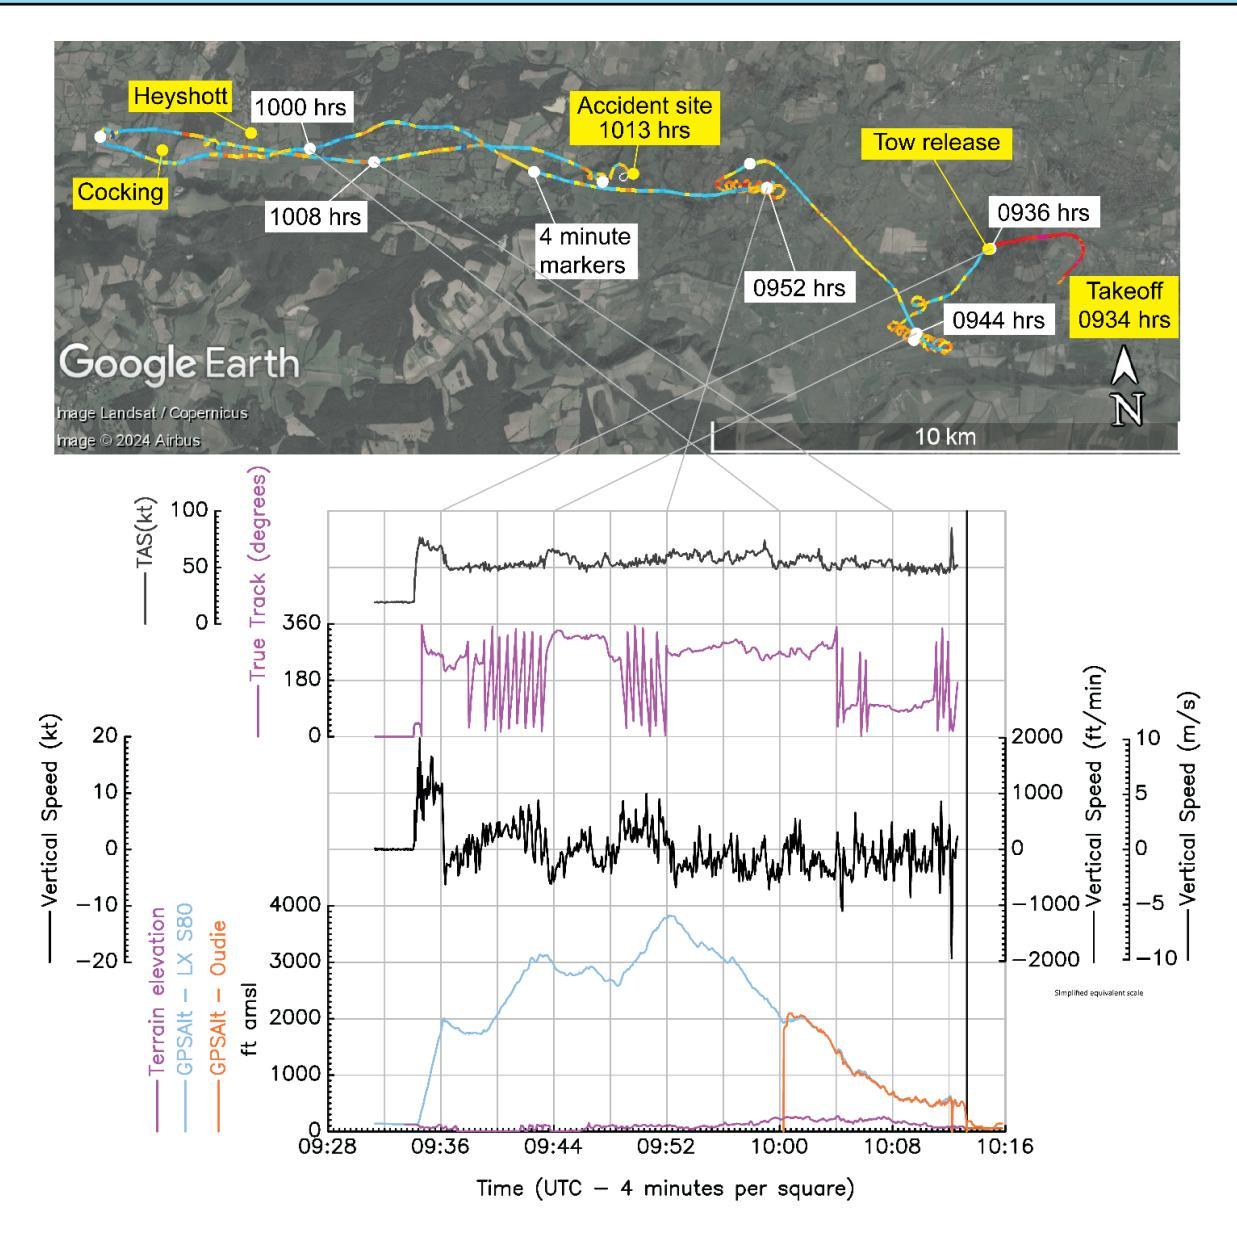
The top half of Figure 1 shows the flightpath of G-CFHG, coloured³ to indicate the areas and degree of lift and sink⁴ the pilot encountered. The bottom plot shows the various other parameters for the flight. The pilot launched using an aerotow at 0934 hrs. After being released from the aerotow at about 2,000 ft amsl, he then tracked south-west before entering a thermal. The pilot completed eight orbits to stay within the rising airflow, climbing from approximately 1,700 ft amsl to about 3,100 ft amsl. He then tracked north-west for about 4 minutes before entering a second thermal at about 2,600 ft amsl. The aircraft climbed to

its peak altitude of 3,800 ft amsl before continuing west. The pilot flew approximately west for a further 12 minutes. The average rate of descent encountered was slightly less than -2 kt (about -200 ft/min or -1 m/s). There were periods where the glider transitioned through areas of occasional lift, however, the pilot did not make any further orbits as he flew west.

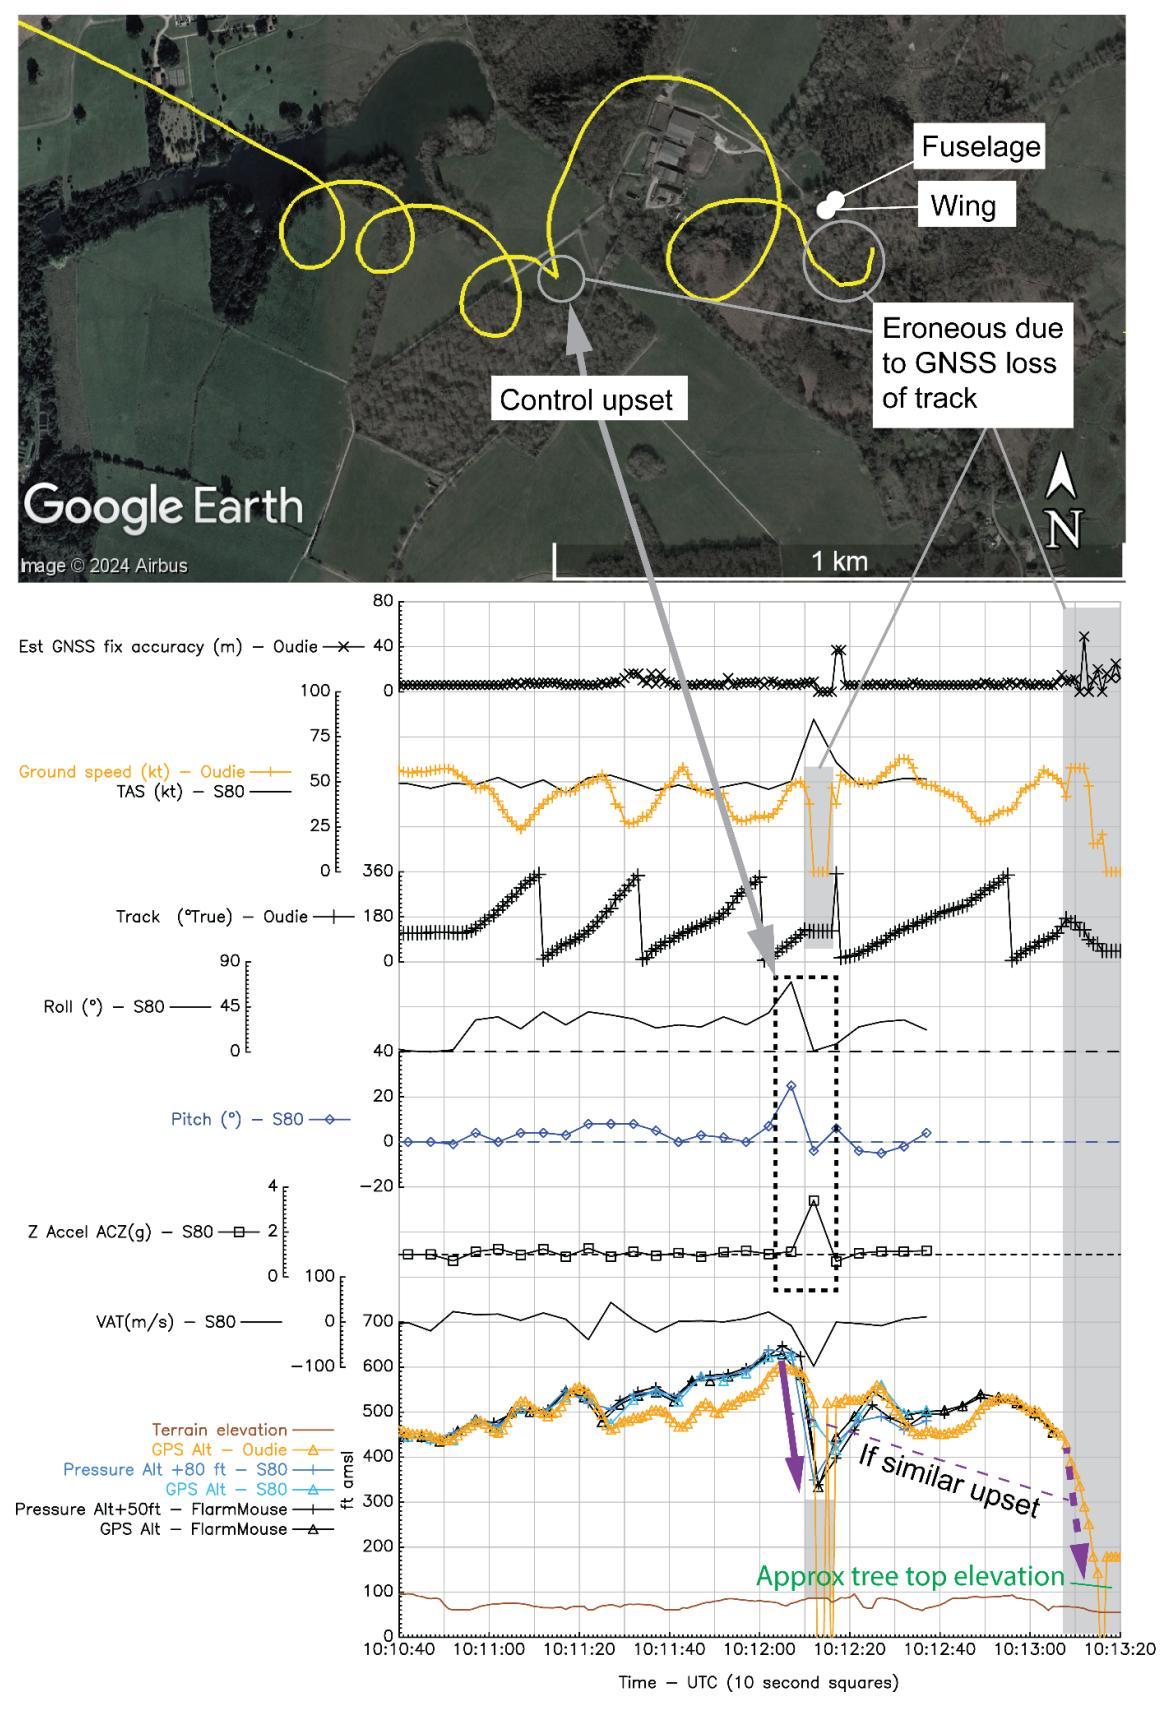
Figure 2

In the final phase of the flight, a sequence of turns was initiated at a height of 400 ft agl. After completing three turns, having gained approximately 200 ft in altitude, the data indicates a dynamic event occurred. Maximum values of 25° pitch and 70° right roll were recorded. However, the pitch and roll parameters were only sampled once every 5 seconds. As such, it was not possible to identify the relative sequence of these parameters nor is it likely that these were the absolute peak values achieved. The pressure altitude parameters recorded a drop of approximately 280 ft in four seconds, though again sample rate limitations indicate it's likely more altitude was lost. The next recorded value of TAS showed an increase from the initial 50 KTAS prior to the event to 85 KTAS. The recorded GNSS data was erratic, indicating the system had lost track of the satellite signals required to accurately calculate its location. This can typically be due to masking of the antenna when the fuselage reaches an extreme attitude. Prior to the dynamic event the glider was in a right orbit, afterwards the flightpath had abruptly changed to the left, which was inconsistent with normal flight manoeuvres. A high normal acceleration was also recorded, likely during an exchange of speed for height during the upset recovery.

The recovery manoeuvre from the event was followed by the glider flying a wide right hand turn that then tightened. There was no recorded pitch or roll data for this final turn but soon after the glider track passed through an easterly heading, the recorded GNSS track became erratic once more. The GNSS fix accuracy parameter, though not always a robust indicator of a problem, started degrading at 1013:07 hrs with the aircraft below 400 ft agl and descending (as recorded by the FlarmMouse pressure altitude). This was followed by anomalous GNSS data, a sign of the system having trouble fixing the aircraft location, again associated with dynamic manoeuvres such as the one experienced a minute earlier.

Flightpath of the end of the flight and associated data plot

The GNSS track carried on recording a path that indicated the glider flew away from the direction of the accident site before a turn to the left. However, this was unreliable data, as demonstrated by the issues recorded during the earlier dynamic manoeuvre and the direction of travel after the recovery. A similar recovery flightpath to the previous dynamic manoeuvre, if also assumed for this manoeuvre, is consistent with the orientation of the wreckage and the direction of travel indicated by the location of the detached wing relative to the fuselage final location. The aircraft likely reached the accident site at approximately 1013:15 hrs, which is consistent with the GPS altitude approaching the terrain elevation.

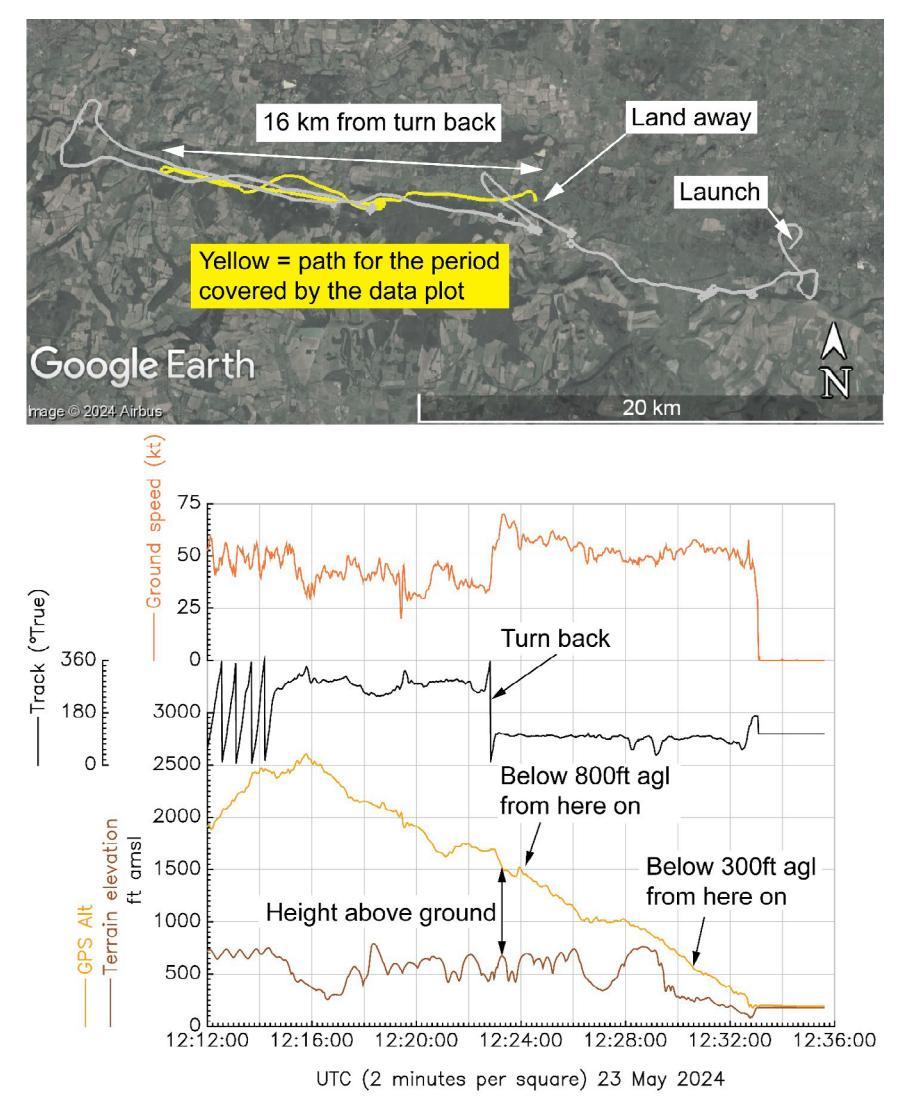
Figure 3 Previous land away flight (23 May 2024) and associated data plot

The data recovered for a flight on 23 May 2024, involved a landing away from an airfield. This is shown in Figure 3. The flight profile prior to the landing has similarities to the accident flight profile prior to the upset events. The final phase of the flight from the last time the glider gained height in a thermal is highlighted in yellow. This is the sequence shown in detail in the data plot below.

The final descent was from a height of more than 2,000 ft agl whilst heading in a westerly direction. At just above 1,000 ft agl, an orbit was flown and then an easterly flightpath back towards the launch site. Descending through approximately 150 ft agl, the glider turned south and landed in a field. The field was approximately 2 km west of the accident site.

The pilot's previous field landing on 23 May 2024 did not follow the BGA recommended guidance to fly a circuit pattern staying above 300 ft until the final approach to land into wind. At just above 1,000 ft agl, an orbit was flown followed by a downwind easterly flightpath back towards the launch site. The glider continued to descend downwind until approximately 150 ft agl, when the pilot was forced to turn south due to a hazard in his originally selected landing field. It appears likely that the pilot committed to the field landing relatively late in the flight and witness evidence suggests he was aware that an earlier decision to land may have been a better option.

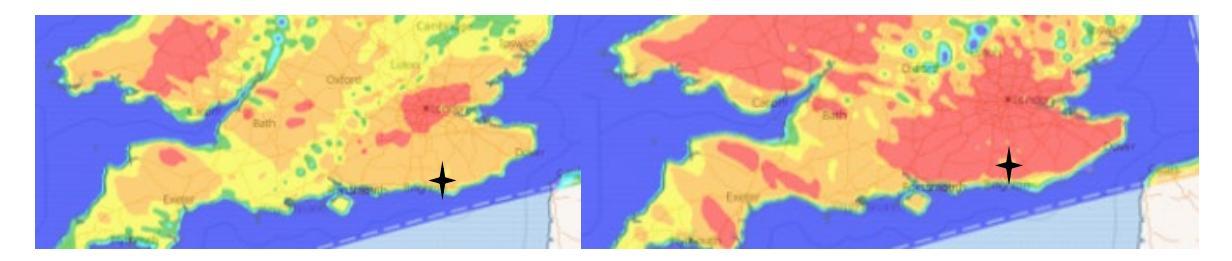
RASP forecast for convective activity (STAR Rating), valid 5 June 2024 at 1000 hrs (left) and 1300 hrs (right)

Figure 4 shows a picture of the RASP forecast on the day of the accident. It could not be established which, if any, sources the pilot had used to review the weather forecast, but witnesses stated the RASP website was routinely used at the gliding club.

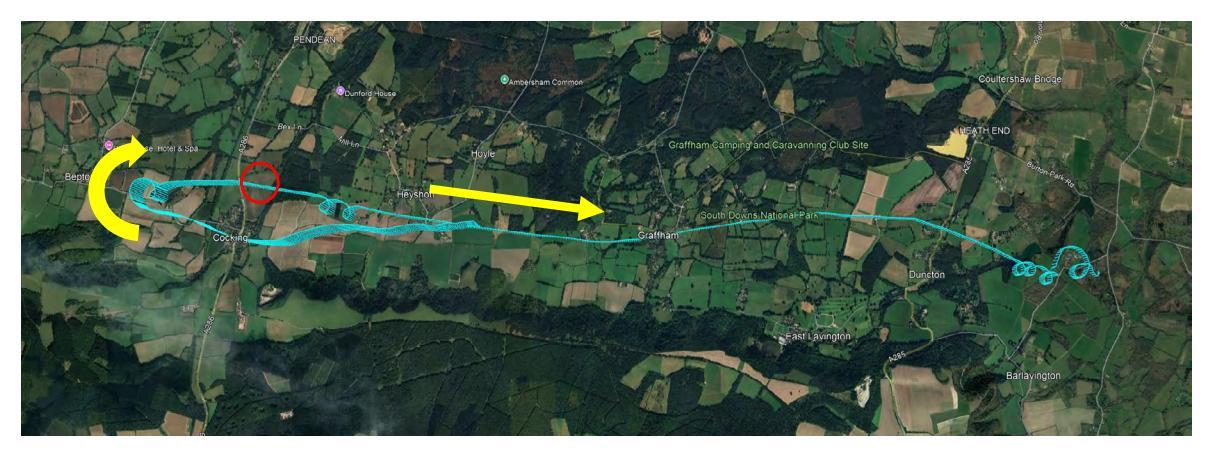
Figure 7

During the accident flight, the glider reached the BGA recommended land out circuit entry height of 800-900 ft agl at the point shown approximately by the red marker in Figure 7.

Image showing approximately where G-CFHG passed the BGA recommended 'High Key' point (red marker) and potential options for landing fields after this point. (Image courtesy of Google Maps)
