UNIVERSAL DESTINATIONS & EXPERIENCES UK PROJECT

Former Kempston Hardwick Brickworks
and adjoining land, Bedford

Environmental Statement Volume 3

Appendix 6.10 - Bat Roost Appraisal Report

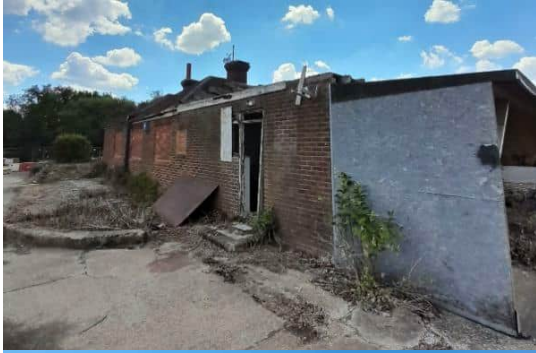
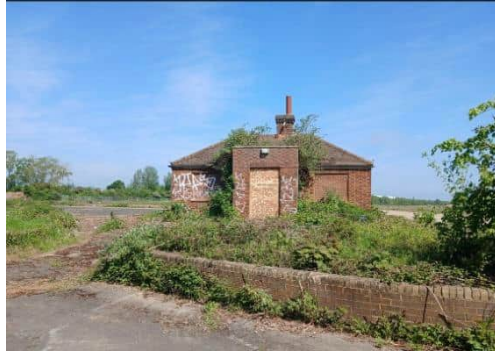
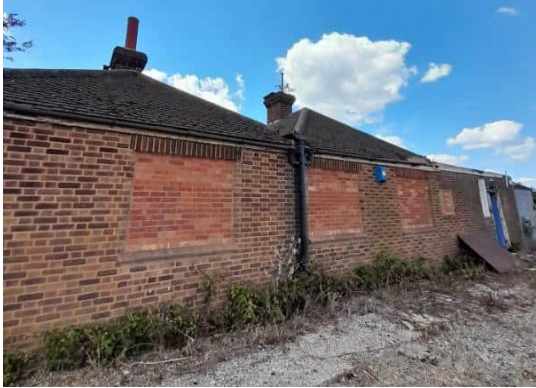
Figure B-1 - Building A - Former Guardhouse, Lake Zone

Building/ Structure Ref	Location/Description	Suitability Category Assigned	Hibernation Suitability?	Photo
Within the Site boundary				
A	Former Guardhouse, Lake Zone. Single storey bricked built with pitched tiled roof and partially derelict in disrepair. Windows and doors apertures some bricked up/blocked and roof voids with missing/slipped tiles in main section with single flat roof extension to one side. Two chimney stacks present. Fascia board partially present.	High Suitability	Moderate Suitability	B-1, Annex 2

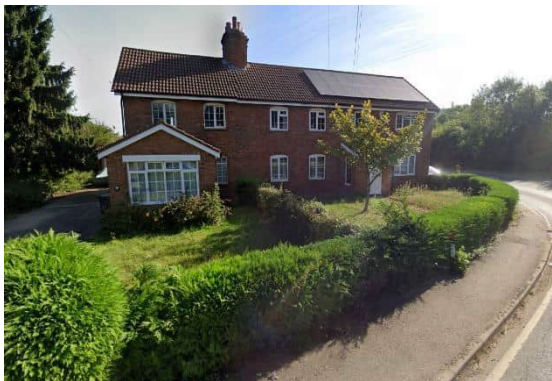
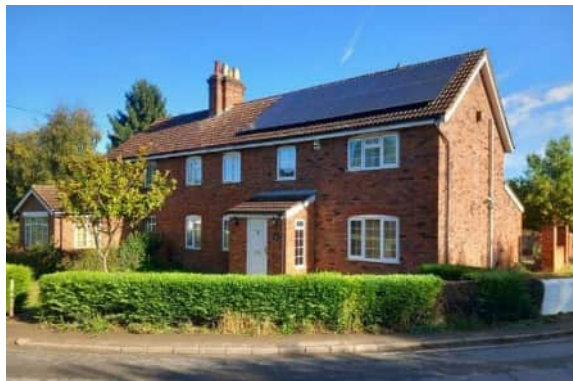
Figure B-2 - Building B - Vine Cottages Number 1 and 2 on Manor Road, adjacent to East Gateway Zone

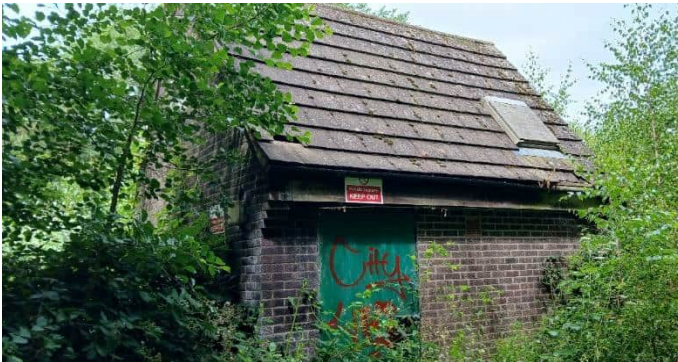
Figure B-11 - Building I - Small single storey brick building, outside Site boundary off Broadmead Road. Appears to be a sub station type building.

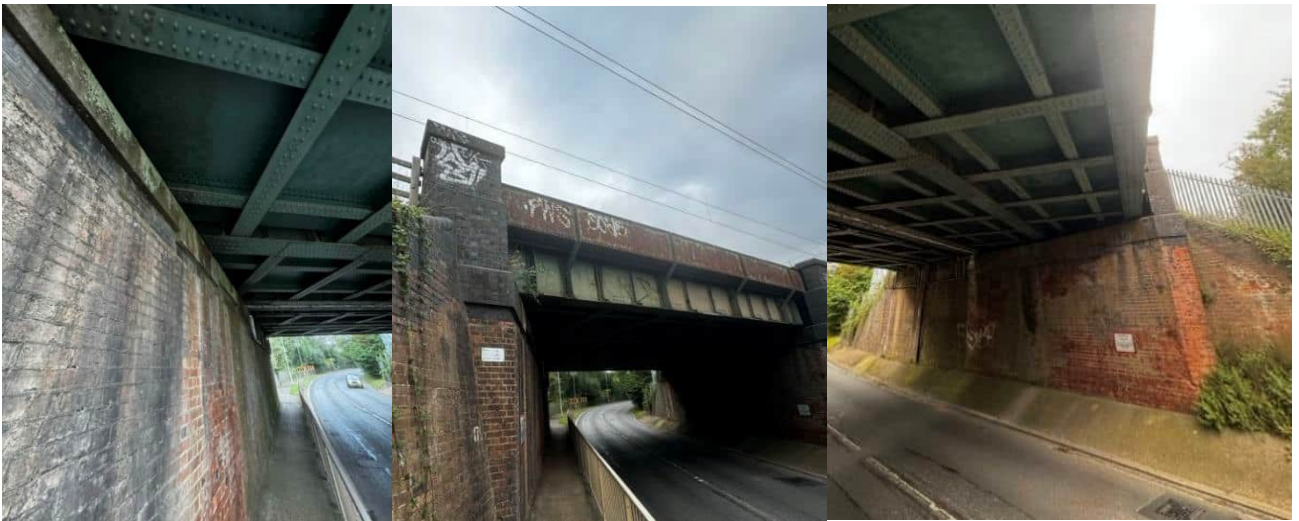
Figure B-13 - Structure K - Underbridge - SPC1/176 Bedford Road B530

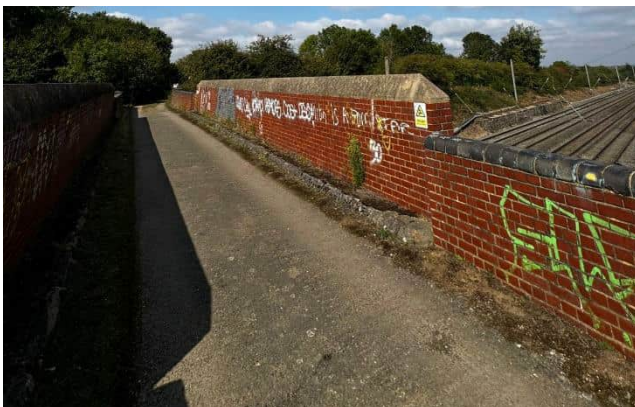
Figure B-14- Structure M - Overbridge - SPC1/178 Hardwick Overbridge

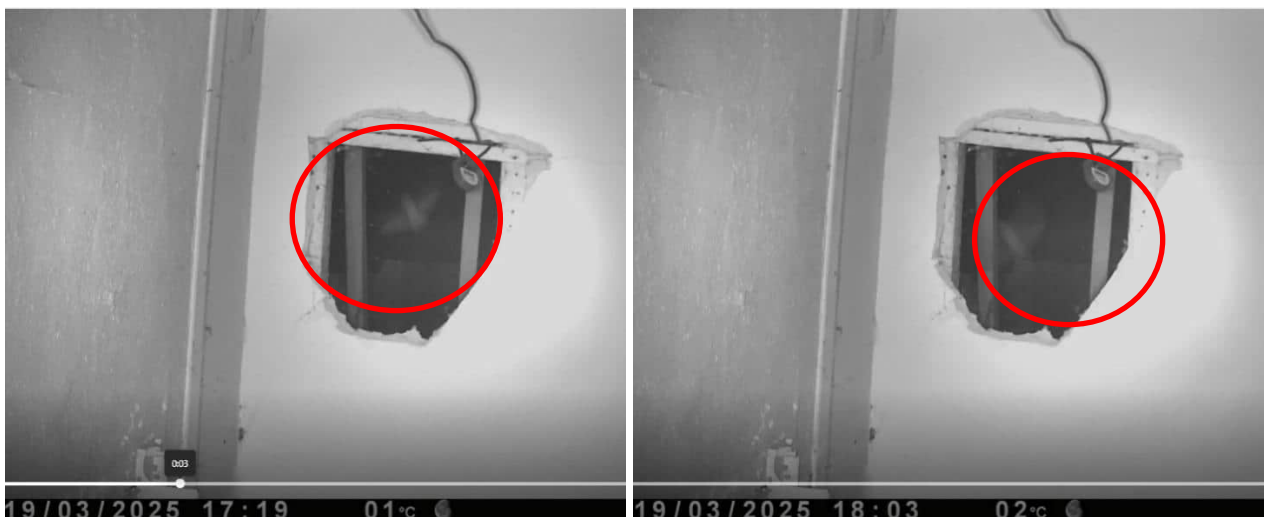
Figure B-17 - Guardhouse Southwest – Camera 2. Still taken from video footage of bat flying in void.
