Rail Accident Investigation Branch

Rail Accident Report

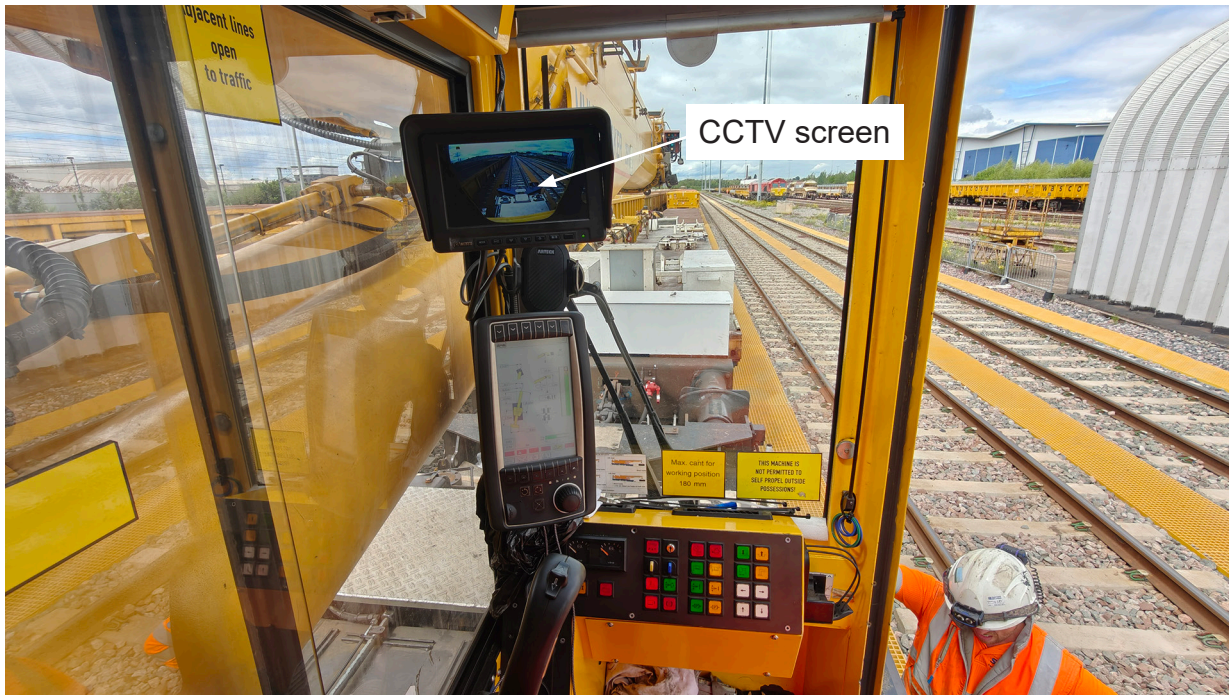
Figure 11: CCTV screen in cab of crane 26.

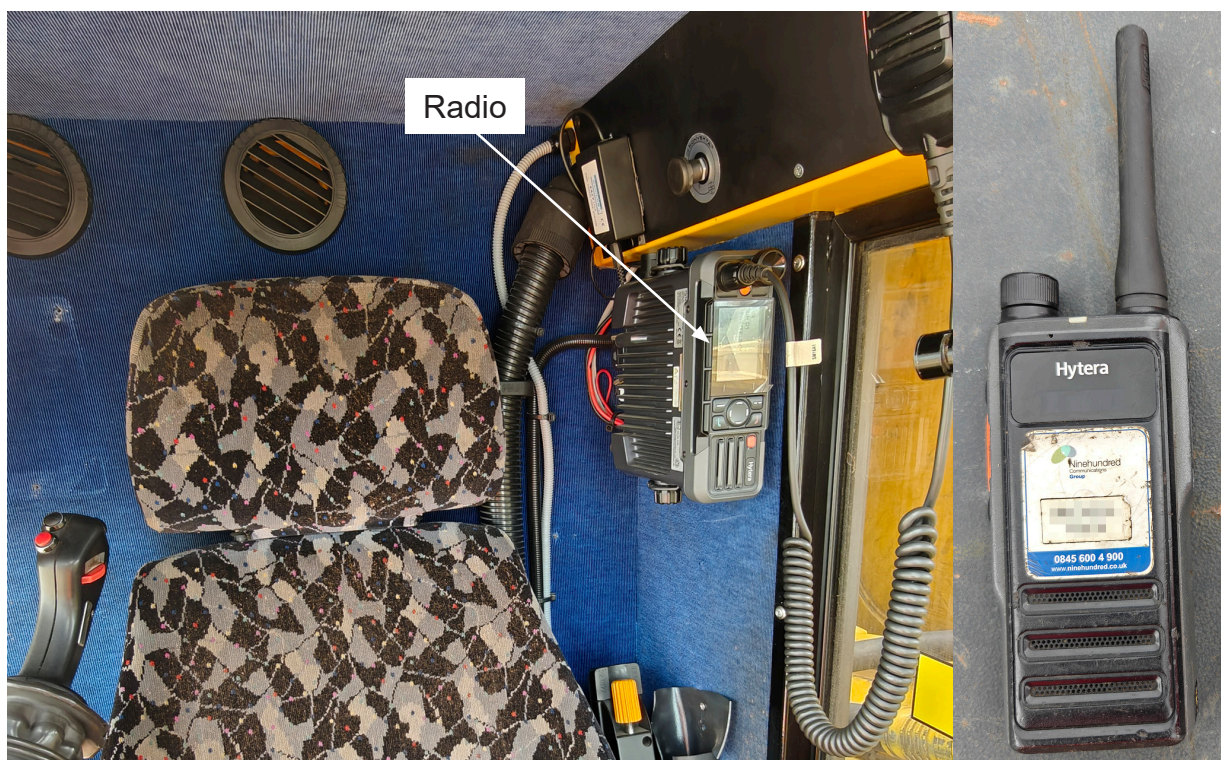
Figure 12: Radio fitted to the cab of crane 26, and that used by the staff on the ground.
