Sealant Suitability

HSS4H: 5147/06/2021 (Var. 3)

Final Report v6.0

Client: DESNZ
Project code: 316
Date: 18th June 2024
Authors: [REDACTED] [REDACTED]
[REDACTED] [REDACTED]
Technical Partner: [REDACTED] DNV

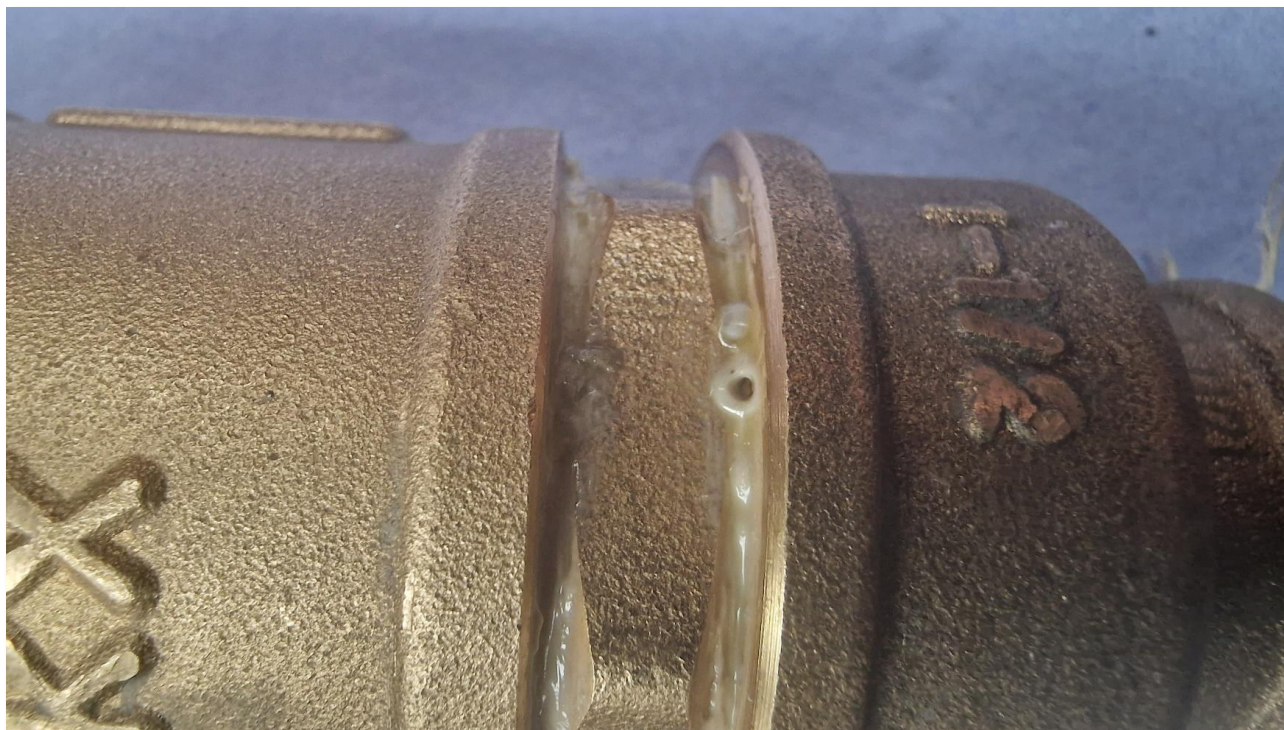
Figure 21: 6202 leak path after one week

There was generally no clear indication why the strings had developed leaks, but 6202 had an obvious leak through a visible hole in the compound. This is shown in Figure 21.

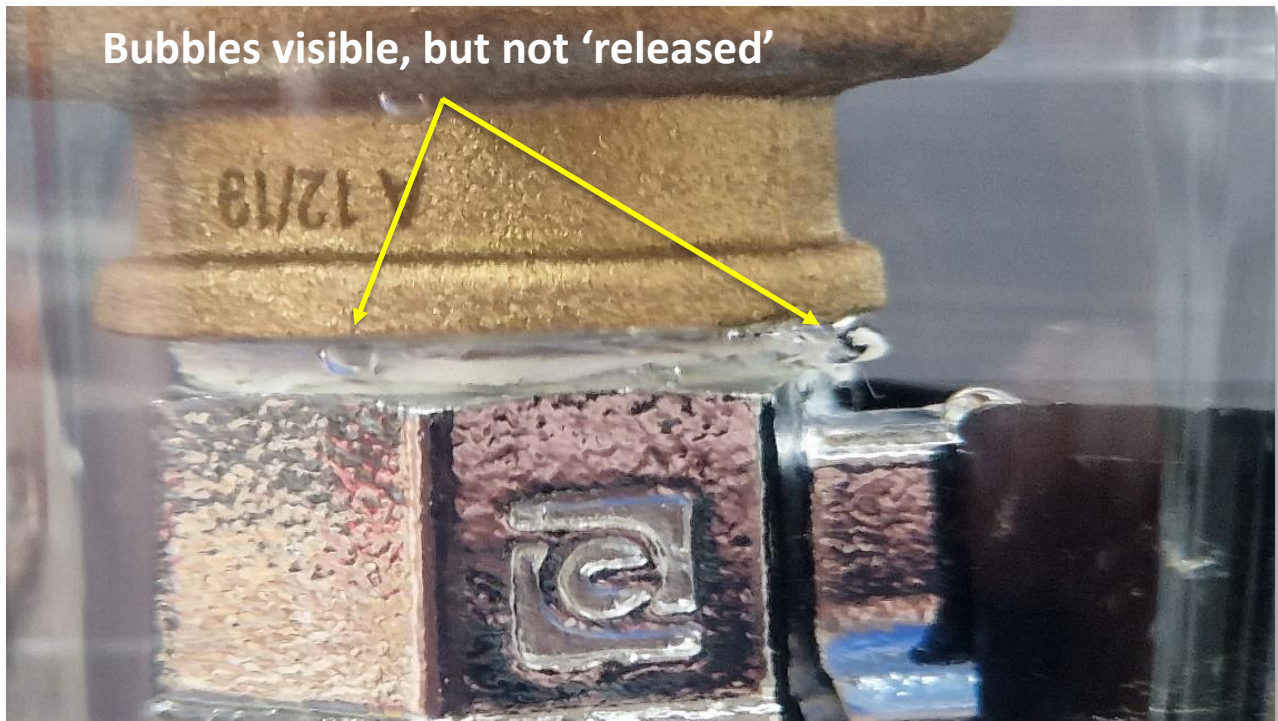
Figure 23: Observing bubbles from submerged valve connection on string 2303

A closer view of this experiment on string 2303 is shown in Figure 23. Two bubbles did appear, seeming to come from the joint that had been identified as leaking. These bubbles did not detach and float to the surface however.

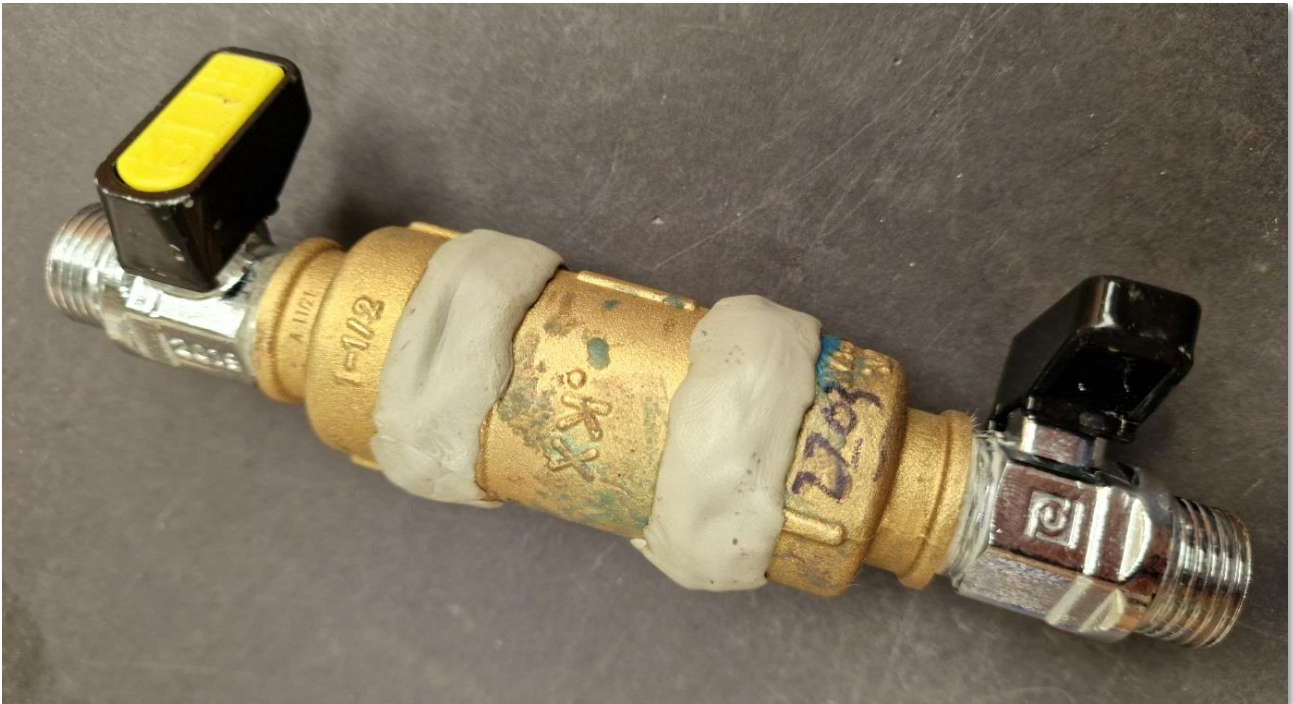
Figure 29: Temporary external wrapping on leaky string 2203

None of the options prevented the escape of hydrogen at low pressure, and were therefore deemed to not be sealing sufficiently to prevent the exchange of gases. The most effective solution was using vacuum putty over aluminium tape. Ultimately the option used was a paper liner cut to fit between the shoulders of two joints, to protect the joint and any protruding fibres. This was covered with aluminium insulating tape sealed to the shoulder of the joint on both sides. Test pieces with particularly large leaks or a high rate of hydrogen concentration decay were also covered with vacuum putty. This is shown in Figure 29 on string 2203. The improvement in concentration retention when this was applied is clear in Figure 30.

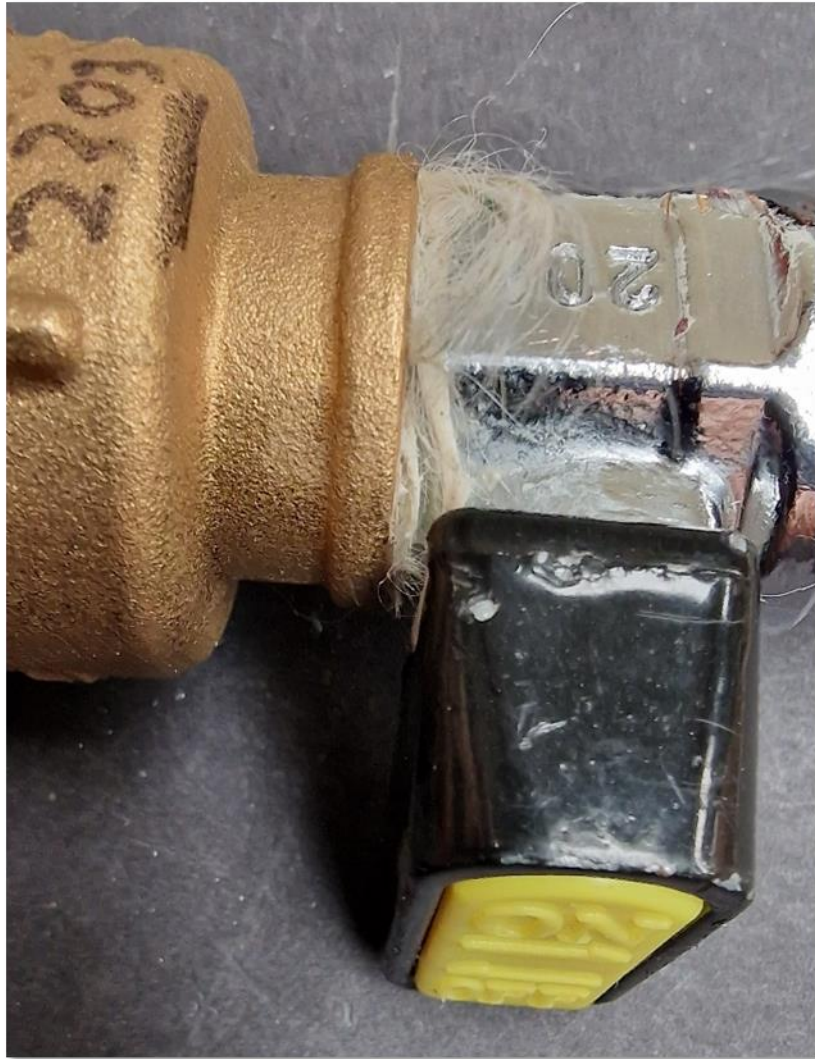
Figure 37: Valve connection

It was evident that the valve connection could not be sealed externally due to the shape of the connection, with valve stem protrusion, and was further complicated by the presence of extruded sealant materials. Figure 37 shows 2303 as an example.

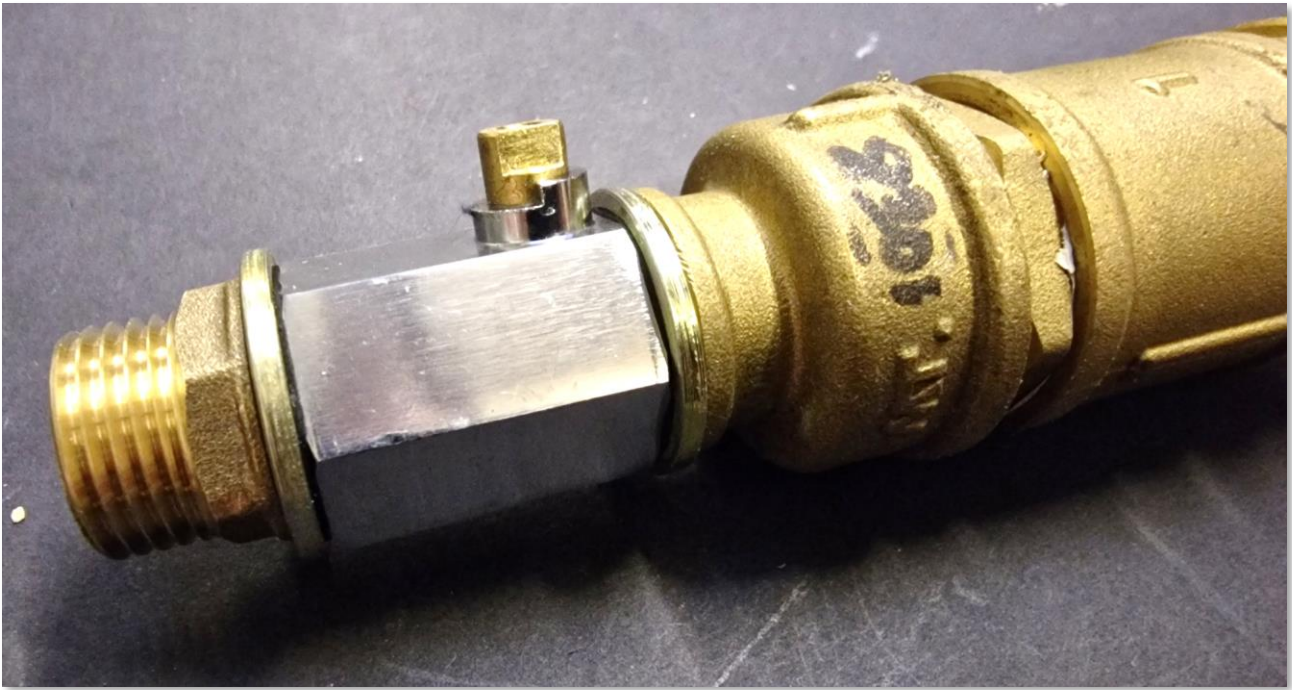
Figure 38: Replacement valve with bonded washers

The timing coincided with the realisation that the leakage attributed to the valve connection threads was often through the valve stem seals. New valves were required, so valves with a flat face that could be sealed with a bonded washer were procured. The new style of valve on string 8301 is shown in Figure 38.

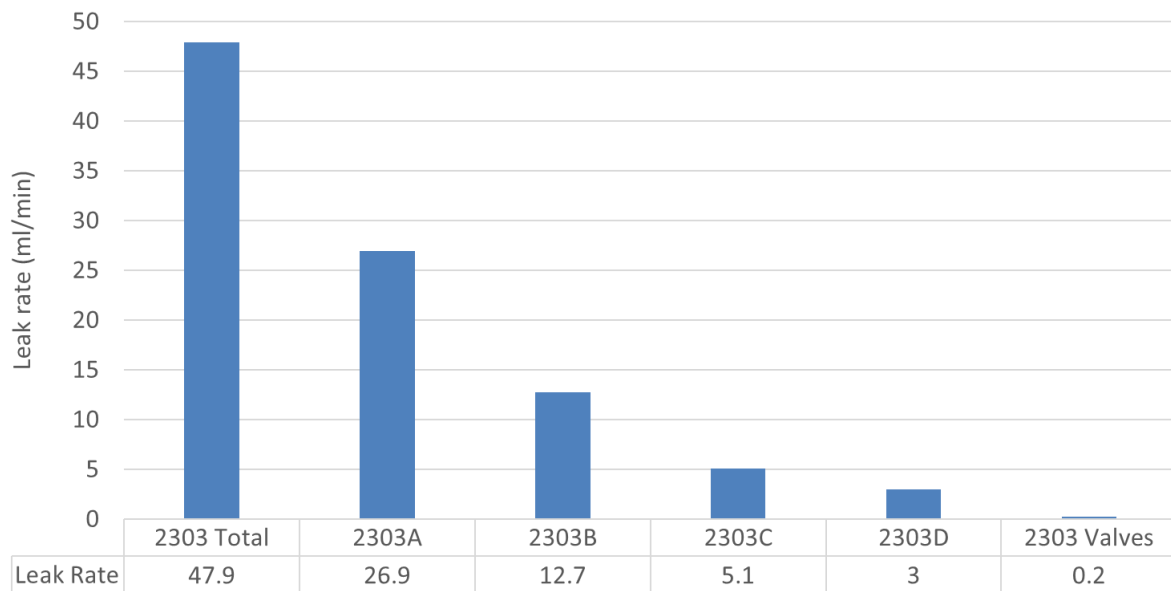
Figure 40: Joint by joint retirement of string 2303

2303 Retirement leakage by joint

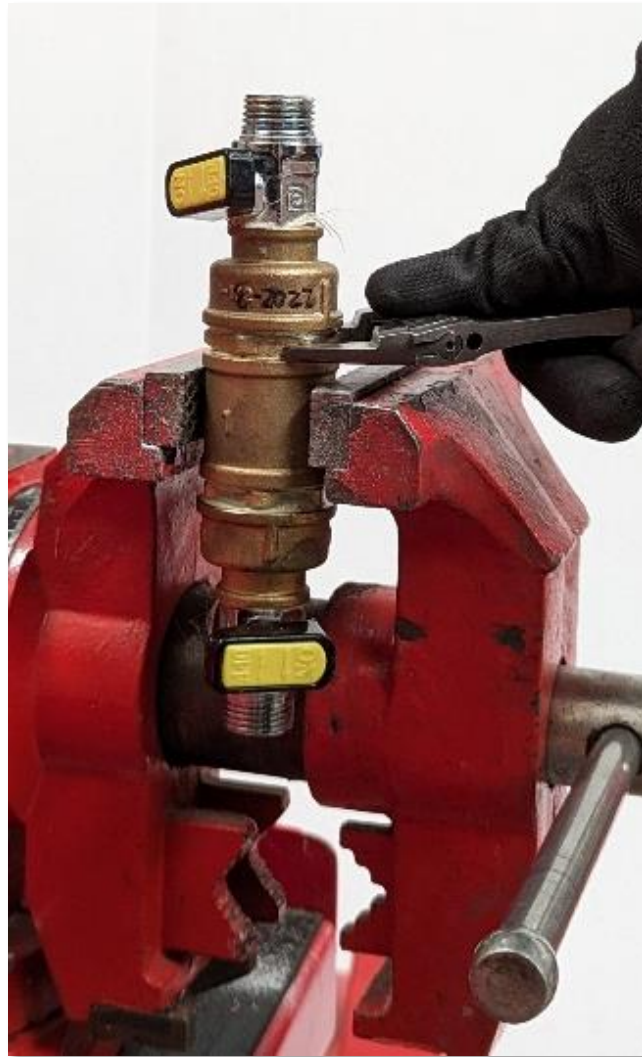
Figure 41: Loosening joint B of 2202-3

The retirement method was reviewed and amended, and the decision made to carefully disassemble and remake the joints that had already been retired, using PTFE cord and compound. Care was taken to only use the flats on the joint being disassembled, to prevent affecting the remaining joints. Thin bladed adjustable spanners were used for this purpose. The barrel and 1" part of the reducer could be held loosely in a vice, with only the grip protrusions preventing rotation rather than clamping. This avoided compressing the fitting, which may have affected the non-retired joints. This process is demonstrated in Figure 41 for joint B of string 2202-3.

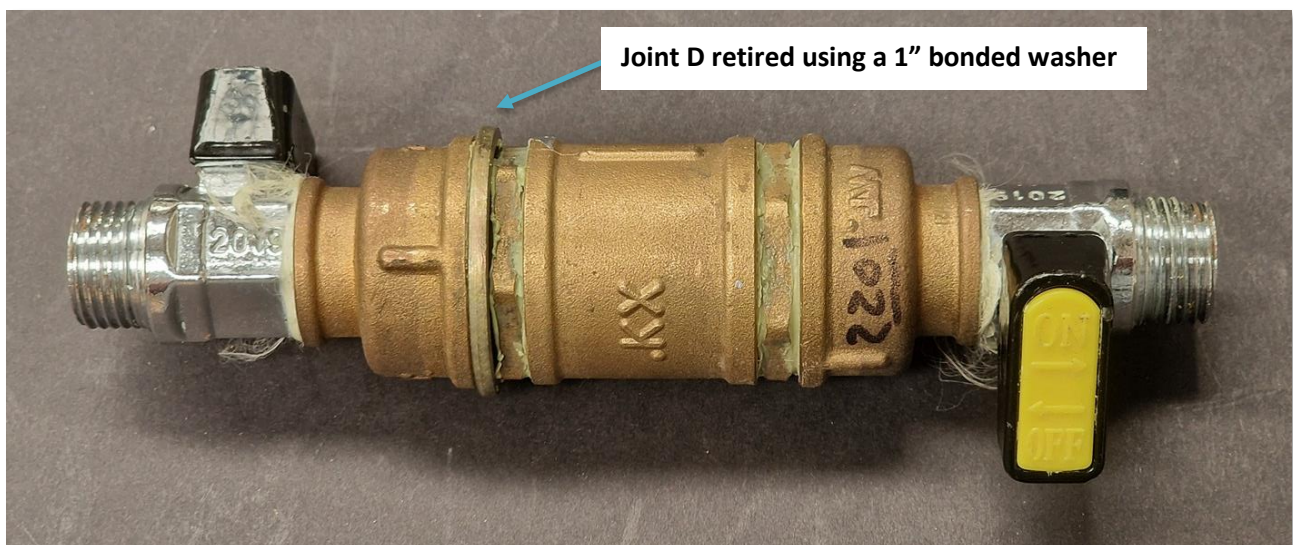
Figure 44: String 2201 after final leak test, with joint D retired

As an example, string 2201 was included for retirement of a joint, as the final leak rate recorded was 24.7 ml/min (0.001482 m³/hr). Prior to the retirement on the following day, the leak rate had decreased to 19.5 ml/min. Retiring joint D reduced the total leakage to 0.2 ml/min (0.00012 m³/hr), demonstrating the success of this method. String 2201 after the retirement of joint D is shown in Figure 44.

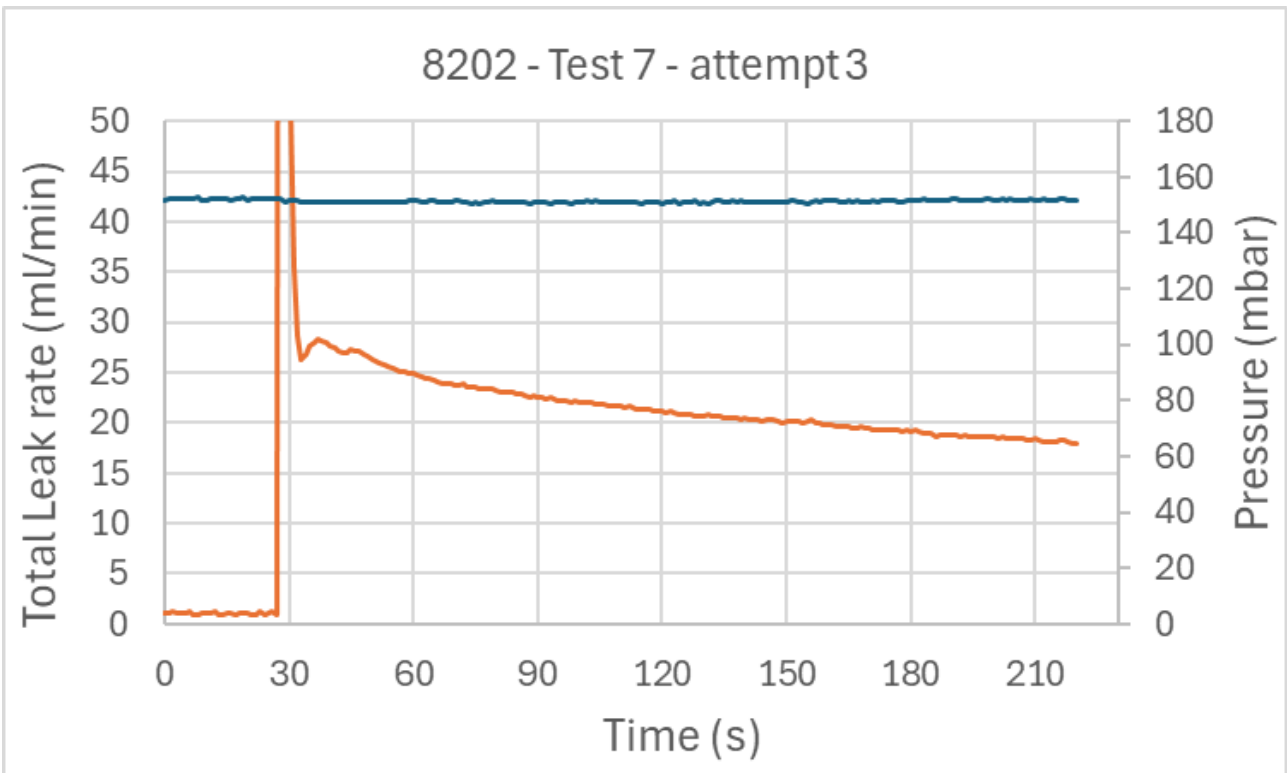
Figure 66: 78202-3 - String 8202 Test 7, attempt 3

While 8202 demonstrated no leakage at the final test, the leak rate during the test programme peaked at 92.6 ml/min (0.0056 m³/hr). This leakage is believed to be from valves and from test joints. Notes taken during test 4 (23 years) indicate that leakage was from valve 2 and joint C or D. Similar notes for test 5 (30 years) indicate leakage from mostly C and D, with some from A or B. No change was made for test 6, when the leakage decreased to 17.5 l/min (0.0011 m³/hr). In test 7 the initial leak rate for 8202 was 55 ml/min, with leakage detected from the stem of valve 1. The string was rotated 180° to use valve 2 as the input. The leak rate increased to 130 ml/min. Both valves were removed and replaced. When tested again in the normal orientation (valve 1 upstream), the leak rate was initially 27 ml/min, which dropped to 18 ml/min over the course of around three minutes. Note that this was still decreasing at this point. The raw pressure and flow trace for this final attempt is provided in Figure 66.

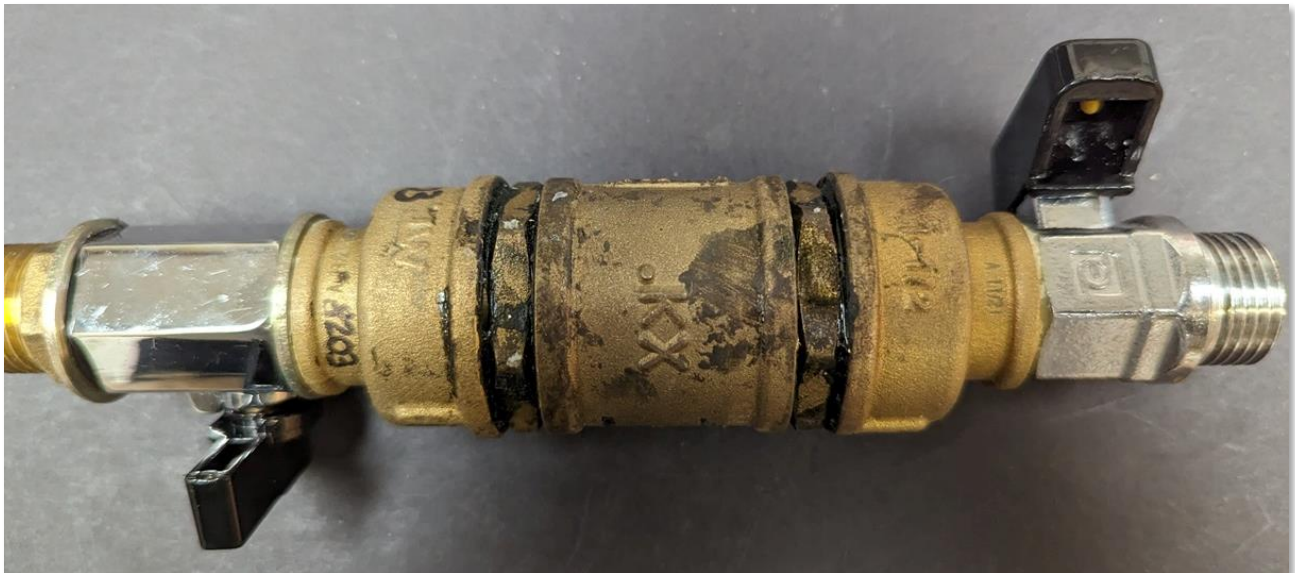
Figure 70: 8203 non-hardening sealant that cured hard

During the final test, leakage was noted as emanating from joint C. An attempt to undo and retire joint C was made, but the sealant had cured very hard, and the lugs on the brass barrel were rounded while trying to loosen. This string is shown in Figure 70. No further attempts to disassemble 8203 have been made.

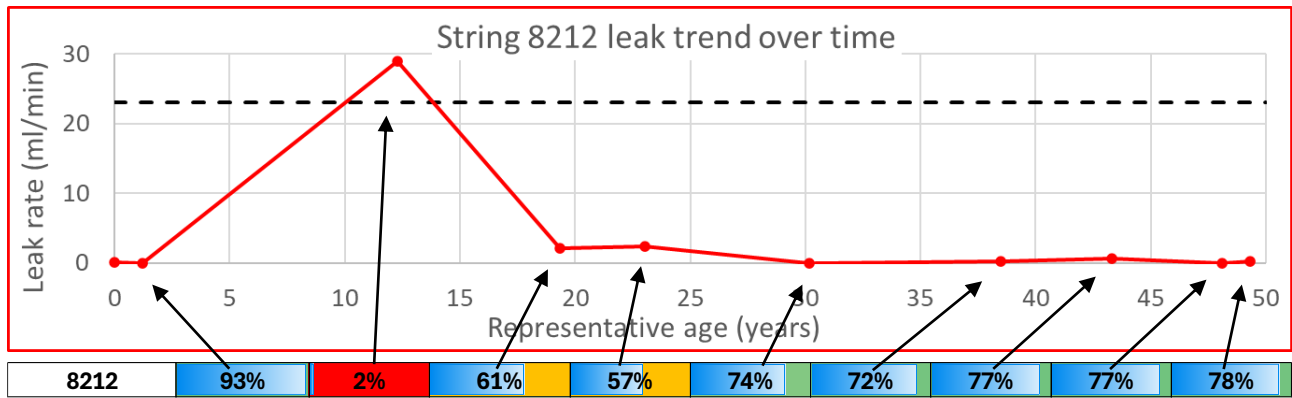
Figure 73: 8212 leak development over time

8212 leaked at a rate of 89.9 ml/min (0.0054 m³/hr) at test 2, when it was the equivalent of 12.3 years aged. This leakage reduced to 2.1 and 2.4 ml/min in the subsequent tests, before reducing further. The valves were not changed, and the reason for the change is not known. The hydrogen concentration recorded at these leak tests was low, indicating it was more likely to be joint leaks than a valve stem leak – a valve stem leak is generally only present when the valve is open, so would not manifest while the string is in the oven between tests. The results for string 8212 are shown in Figure 73, including the concentrations recorded.
