Catastrophic engine failure and subsequent fire on board the site investigation vessel *Kommandor Susan* in the Firth of Forth, Scotland on 25 January 2025

The vessel's owner, Gardline Shipping Limited, has since rebuilt the affected engine, and overhauled all other generator engines on board *Kommandor Susan*, with original equipment manufacturer parts.

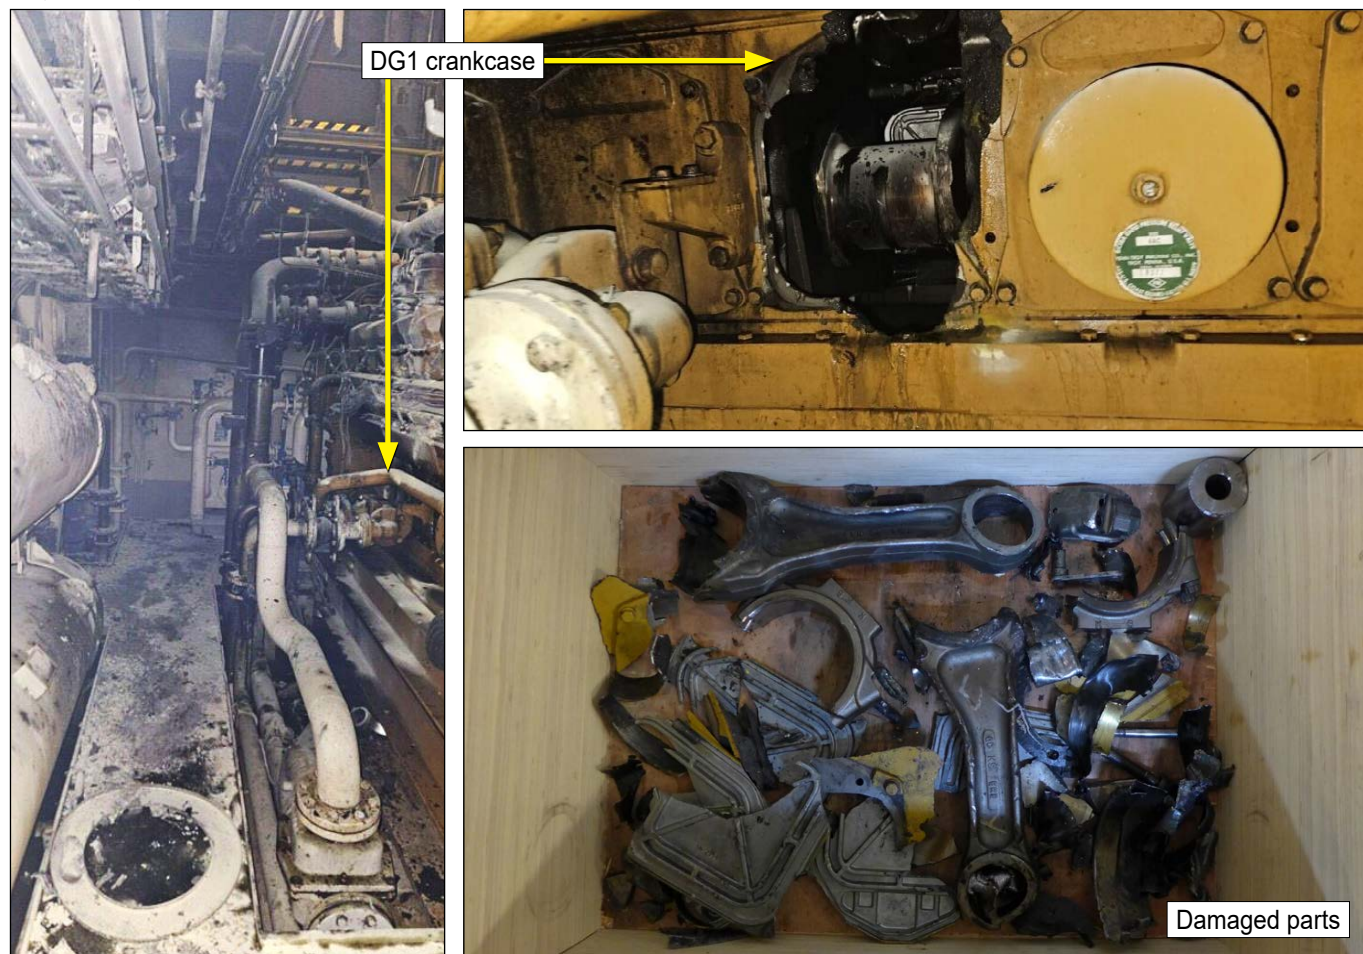
Figure 2: Damage to DG1

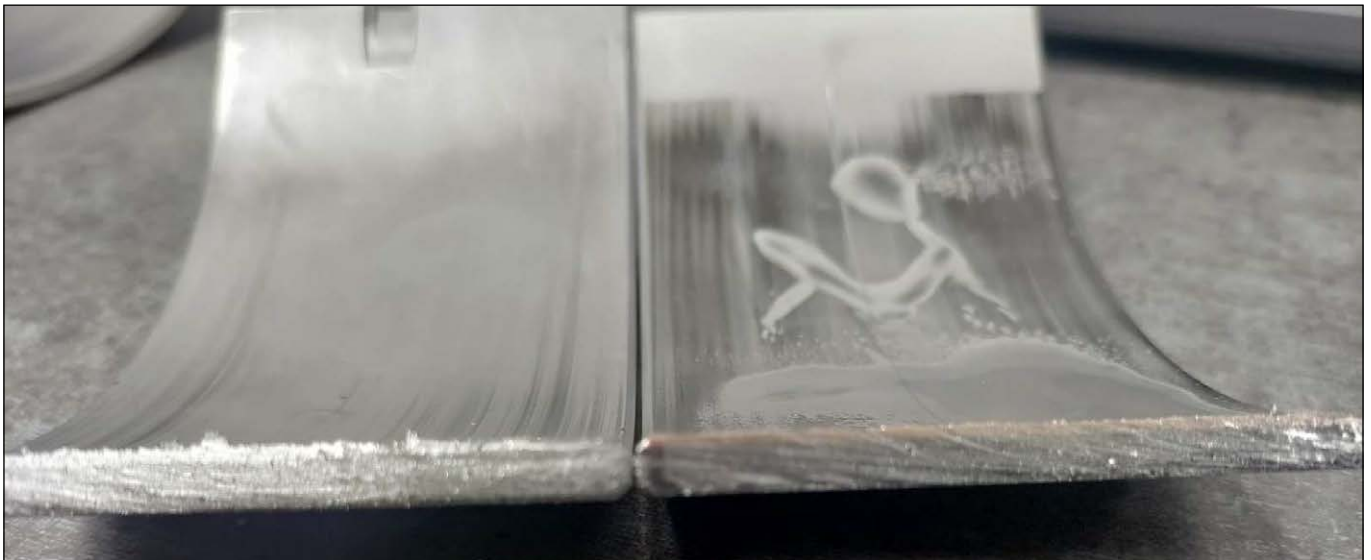
Figure 3: Comparison between genuine OEM (left) and CTP bottom end bearings (right)

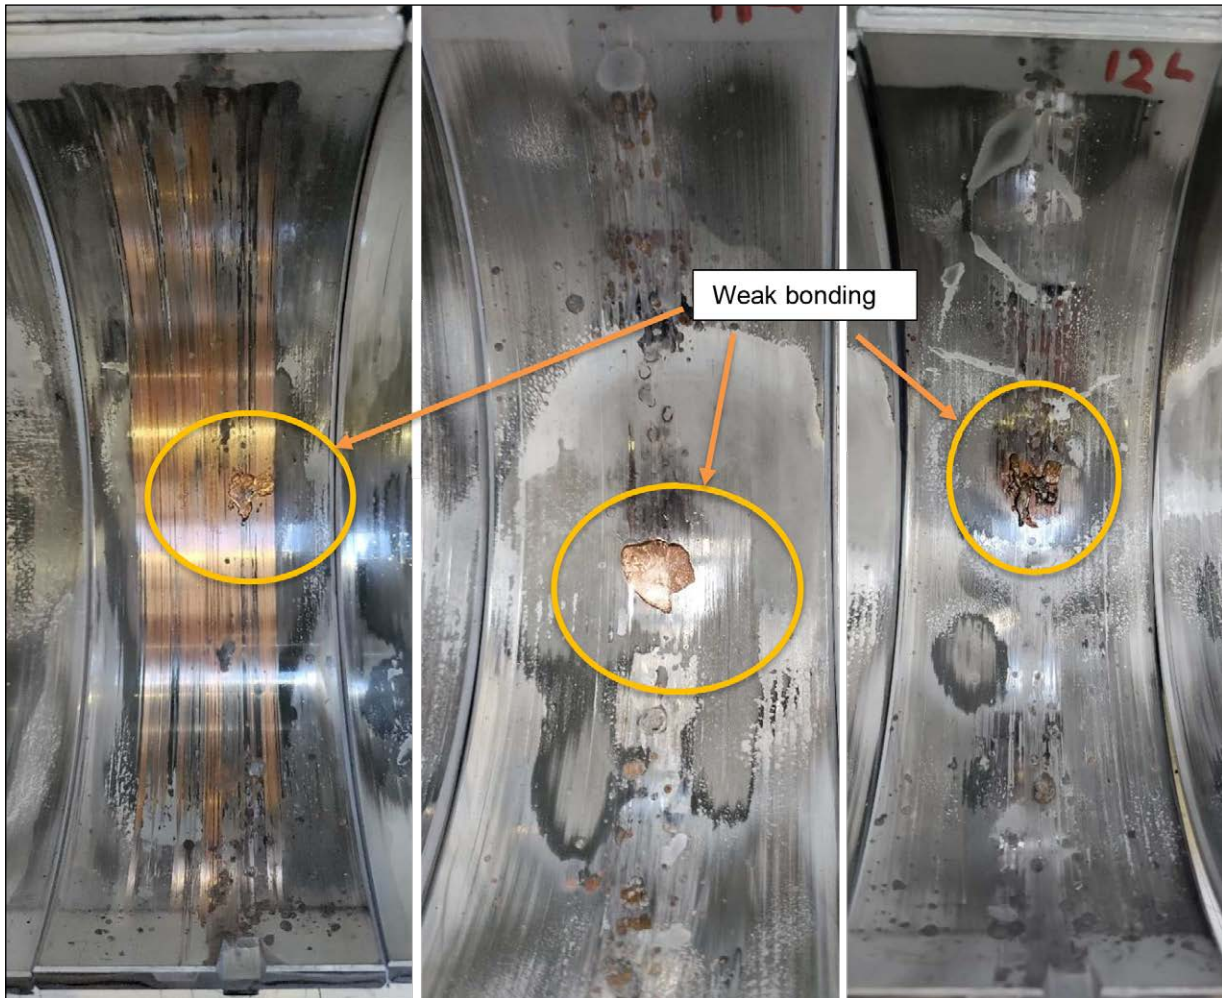
Figure 4: Evidence of weak material bonding on several bottom end bearings
