# Bartlett Consulting

## **Supplementary Arboricultural Impact Assessment for UKHMLC Planning Application 19/00114/FULL**

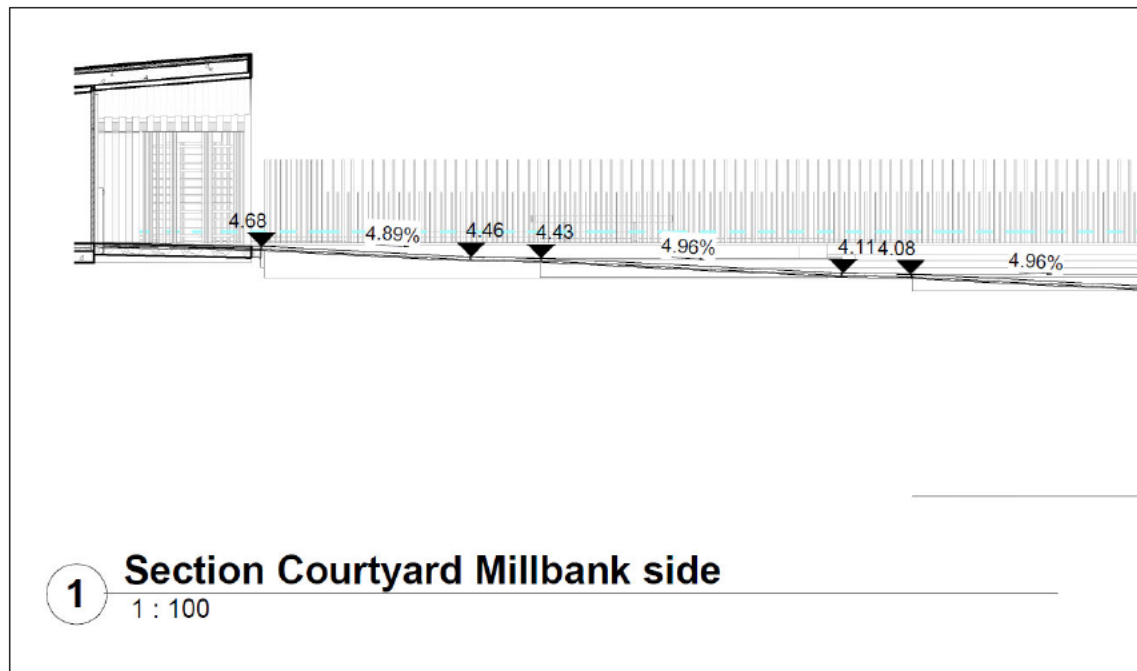
Figure 1: Snipped Image from Courtyard Long Sections Drawing

| Tree Ref | Root Ref | Diameter & Depth | Aspect of Memorial | Implications |
| T71022 | R25 | <ul style="list-style-type: none"> <li>50 mm</li> <li>900 mm</li> </ul> | Entrance Pavilion | <ul style="list-style-type: none"> <li>Pruned during excavations (no change from original application)</li> </ul> |
| T71021 | R24 – R22 | <ul style="list-style-type: none"> <li>40 mm – 30 mm</li> <li>900 mm – 1.0 metre</li> </ul> | Entrance Pavilion | <ul style="list-style-type: none"> <li>Retained</li> <li>100 – 300 millimetre excavation for foundations</li> <li>Above existing roots</li> <li>No pruning or direct damage anticipated (no change from original application)</li> </ul> |
| T71020 | R21 – R19 | <ul style="list-style-type: none"> <li>60 mm – 20 mm</li> <li>800 mm – 900 mm</li> </ul> | Pavilion Courtyard | <ul style="list-style-type: none"> <li>Retained</li> <li>Sloping courtyard 2<sup>o</sup> gradient</li> <li>300 – 500 millimetre cut for levels</li> <li>Proposed changes to incorporate roots</li> <li>Root R19 dead at time of investigation (no change from original application)</li> </ul> |
| T71019 | R18 - R16 | <ul style="list-style-type: none"> <li>15 mm – 40 mm</li> <li>800 mm – 1.0 metre</li> </ul> | Pavilion Courtyard | <ul style="list-style-type: none"> <li>To Be Retained</li> <li>Sloping courtyard 2<sup>o</sup> gradient</li> <li>300 – 600 millimetre cut for levels anticipated</li> <li>Proposed change to incorporate roots (no change from original application)</li> </ul> |

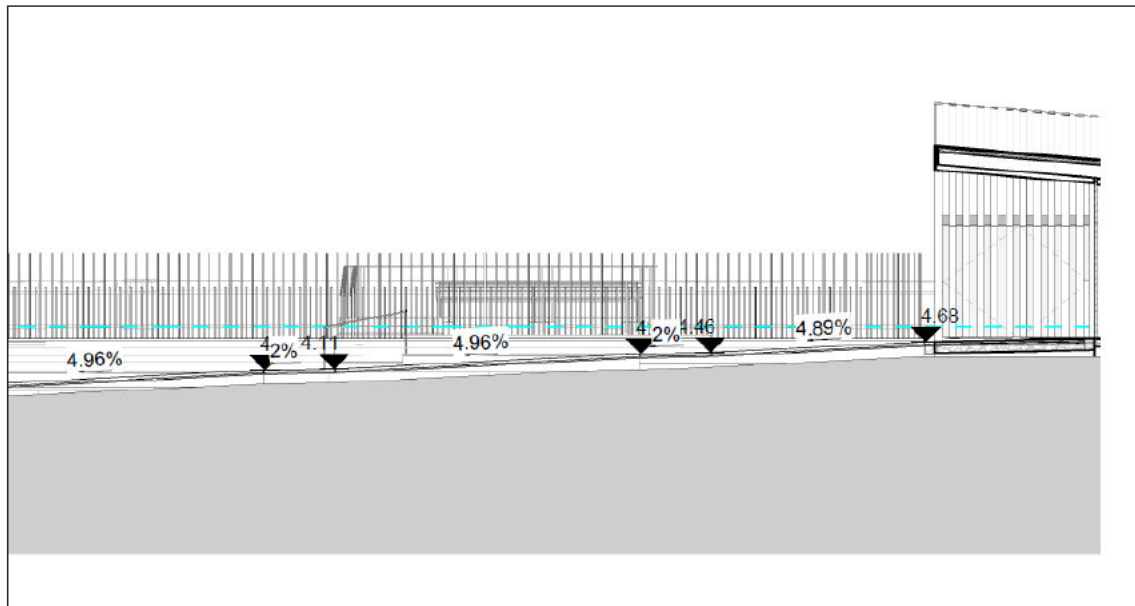
Figure 2: Snipped Image from Courtyard Long Sections Drawing Showing Thames River Elevation

| Tree Ref | Root Ref | Diameter & Depth | Aspect of Memorial | Implications |
| T70006 | R26 – R27 | · 50 mm – 20 mm<br>· 400 mm – 600 mm | · Pavilion Courtyard | · Sloping courtyard 2 <sup>o</sup> gradient<br>· 300 – 500 millimetre cut for levels<br>· Root 26 likely need to be pruned<br>· Root 27 likely retained<br>(change from original application) |
| T70007 | R28 | · 30 mm<br>· 1.0 metre | · Pavilion Courtyard | Retained<br>· Shallow building foundations above roots<br>· <b>No pruning or direct damage</b><br>(no change from original application) |
| T70008 | R29 – R30 | · 35 mm – 40 mm<br>· 700 mm | · Pavilion Courtyard<br>Basement Box | · Pruning required to facilitate development<br>(no change from original application) |

5.1.3 Further to this detailed study and review, there are two material changes from the original application:

- pruning of root R26 as a result of excavations required for the courtyard
- pruning of root R28 as a result of excavations required for the courtyard

5.1.5 As per the original impact assessment, and confirmed by the project engineer at the time of writing this report, drainage and construction of the pavilion courtyard will look at ways to ensure rainwater filters through to the soil and rooting environment below, as well continued gaseous exchange to the soil for continued root growth and development; and pruned roots and the trees will be subject to compensation & mitigation.

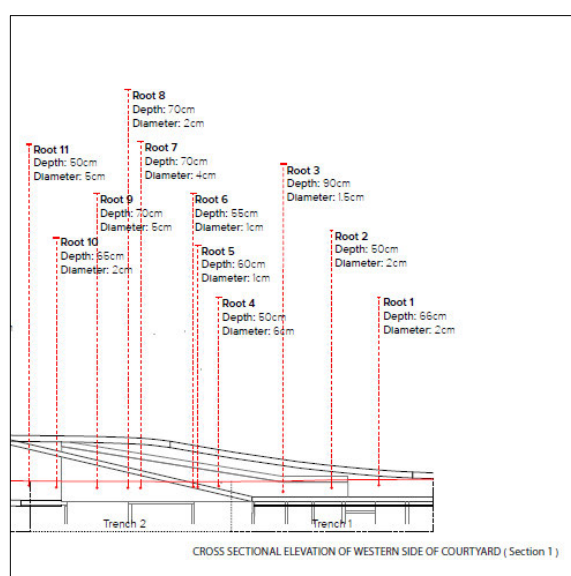
Figure 3: Snipped Image from Root Investigations Showing Location, Depth and Diameter of Roots

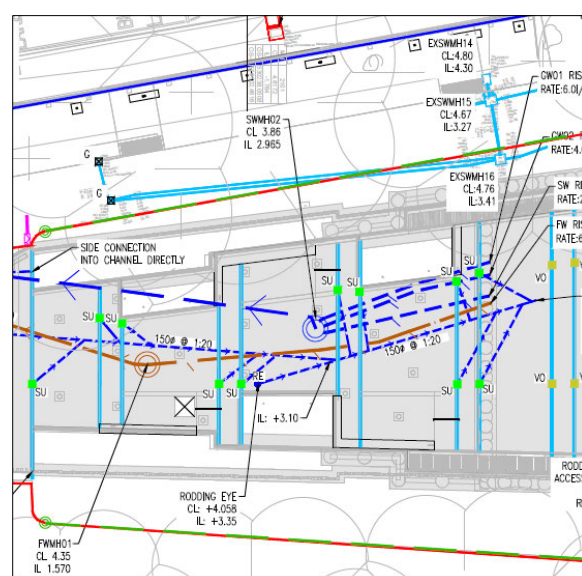
- 5.3.3 With regards to drawing UKHM.WSP.ZZ.ZZ.DR.DR.900102, Revision P02, although service runs and corresponding inspection chambers are proposed and sited within the root protection area and known rooting location, they are broadly below the roots.

- 5.3.7 With regards to the same drawing UKHM.WSP.ZZ.ZZ.DR.DR.900101, proposed service runs are currently sited and trespassing through the root protection area and knowing rooting locations. As stated above, final positioning and location of these runs will need to be determined and finalised following supplementary investigations detailed as part of the arboricultural method statement.

Figure 4: Snipped Image from Service Plan Highlighting Overlap and Trespass with Known Rooting Locations

- 5.3.4 Final layout and siting of services will need to be guided and informed by supplementary investigations detailed as part of the arboricultural method statement; and installation methods including trenchless techniques such as thrust-boring and / or impact-moling will need to be specified to prevent root damage and severance.

- 5.3.8 It is my professional recommendation that service runs are shared to minimised intrusion and working within the rooting environment; with final working methodologies to be detailed in the arboricultural method statement.
