Archaeological Sites within Ringmoor Training
Area, Dartmoor National Park, Devon:
A condition survey on behalf of Defence
Infrastructure Organisation

March 2018

(SX 5711 6618)

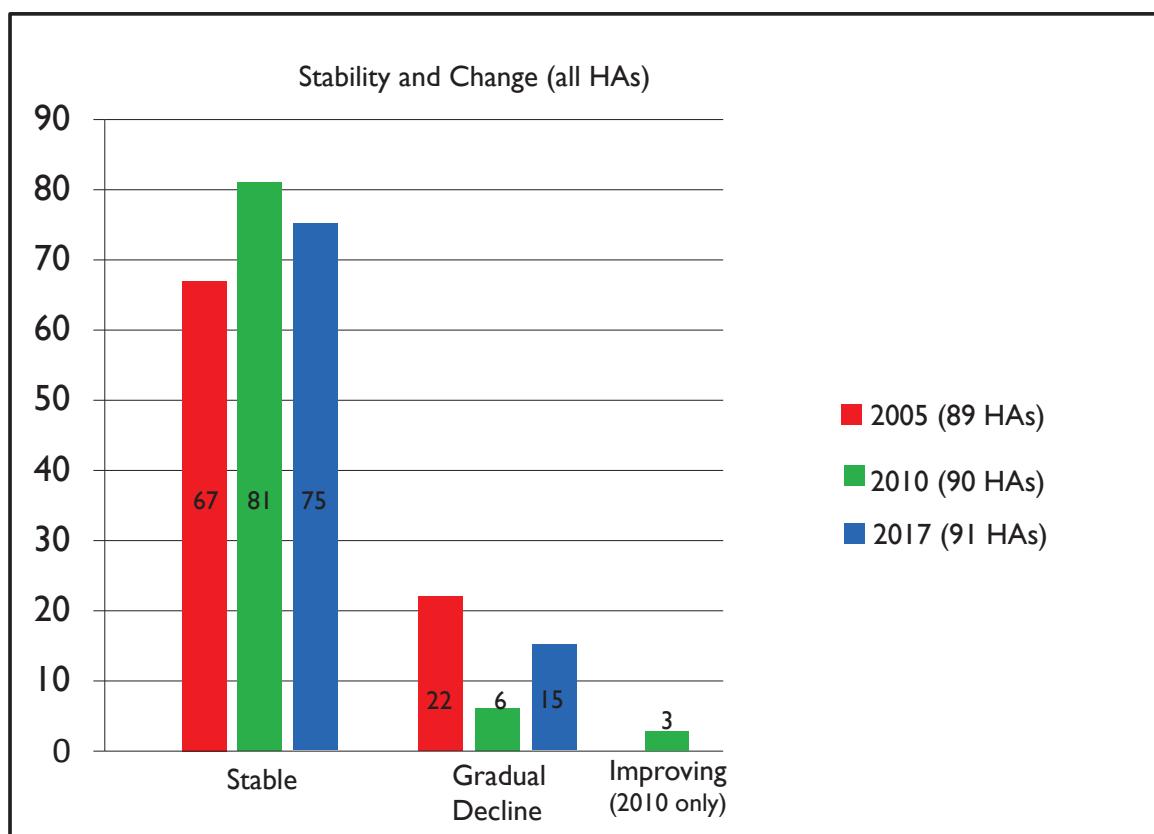
Under this measurement, 75 (82% - down 6% on 2010) of the total sample remain in a stable condition, while fifteen (16% - up 10% on 2010) are reported as in gradual decline (Table 2; Fig 2), in most cases this is due to very insignificant patches of erosion or minor threats.

2017 survey of 91 heritage assets assessed		No.	% of total
Stable		75	82.5
Gradual Decline		15	16.5
Rapid Decline		0	0
Improving		0	0
Unknown		1	1
2010 survey of 90 heritage assets assessed			
Stable		81	89
Gradual Decline		6	6.6
Rapid Decline		0	0
Improving		3	3.3
2005 baseline survey of 89 heritage assets			
Stable		67	75.5
Gradual Decline		22	24.5
Rapid Decline		0	0
Improving		0	0

Fig. 2 Graph presenting the statistics for stability and change for all heritage assets (HA) recorded in Ringmoor TA.

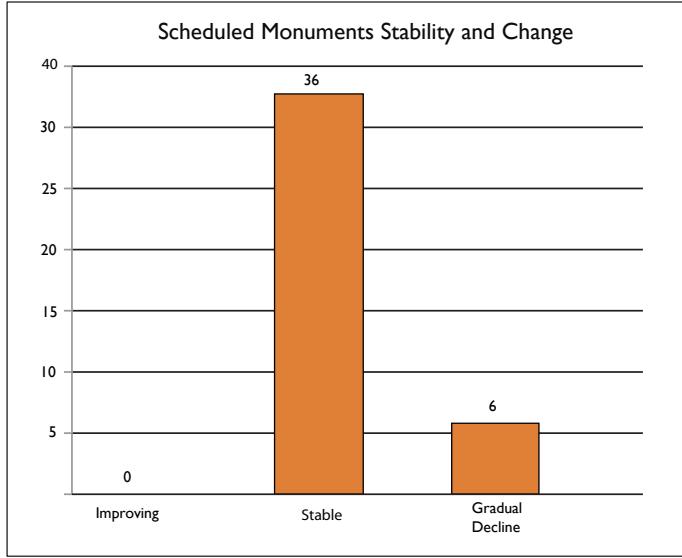
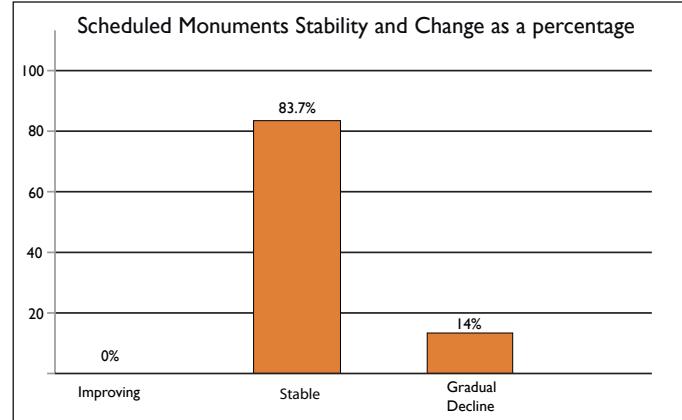
However, of the 43 SMs, only eight (18.6%) can be stated to be in good condition in 2017, while fifteen (34.8%) are in a poor condition and 20 (46.5%) are fair condition. This compares with the 2010 statistics of 14 good (34%), 17 fair (41.5%), 7 poor (17%). The variation in these statistics is due, in the most part, to the subjectivity of this form of assessment (which has to include varying degrees of legacy damage) rather than any actual change in condition since 2010.

Fig. 3 (left) Graph showing the number of scheduled monuments in defined categories, March 2018.

Fig. 4 (right) The same information expressed as a percentage.

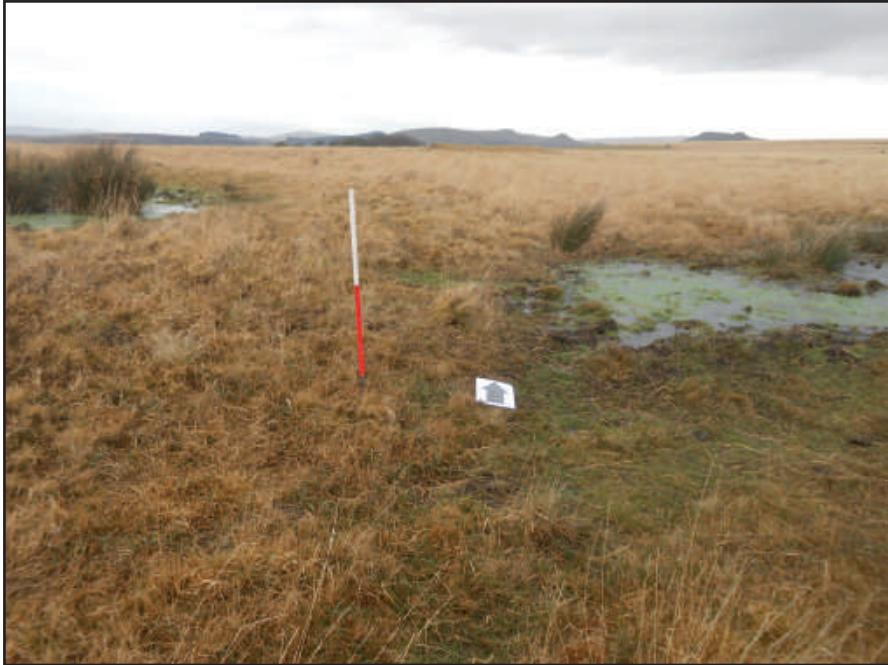
438668 (SM No: 1012254) The southern of two flat-topped round cairns on Ringmoor Down is threatened by cattle poaching and seasonal water erosion around its base, especially on the eastern side. Water is also accumulating in a hollow on top of the monument, creating a seasonal aquatic habitat, though clearly this has been occurring for a very long time.

Fig 5. 438668 (SM No: 1012254) The southern of two flat-topped round cairns on Ringmoor Down is threatened by cattle poaching and seasonal water erosion around its base, especially on the eastern side.

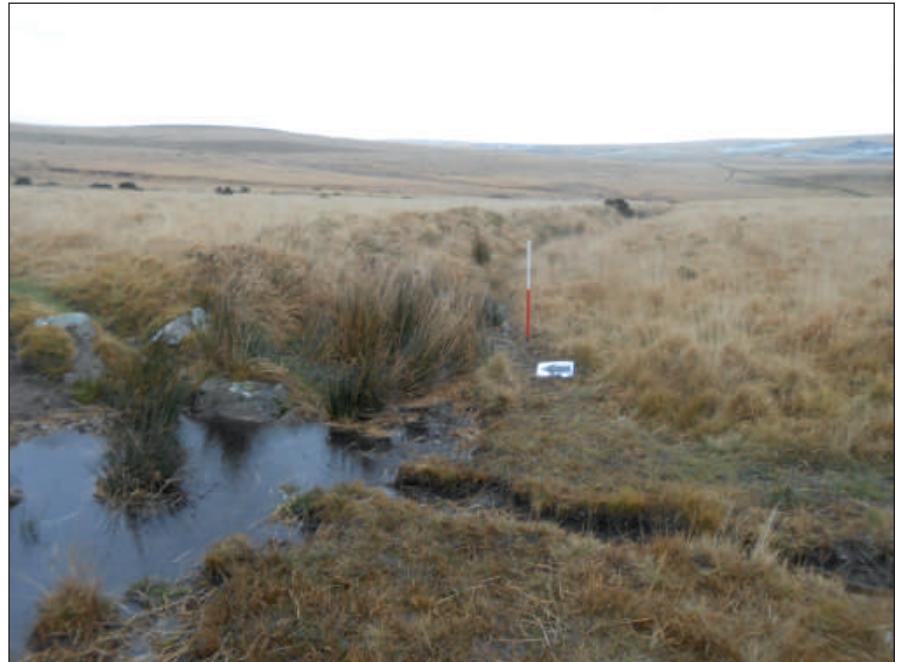
438671 (SM No: 1012246) The Ringmoor stone row has declined notably in condition since 2010. Several of the stones have suffered livestock poaching around their base and the ensuing hollows have accumulated water, which in turn has eroded more soil. None of the stones are believed to be in danger of toppling at the time of survey, but this will be a risk if mitigation is not undertaken soon. In the 2010 condition survey it was reported that these hollows were regenerating but the situation now seems to have reversed.

Fig 6. 438671 (SM No: 1012246) The Ringmoor stone row has declined notably in condition since 2010. The point where the row meets the later boundary wall is very eroded.

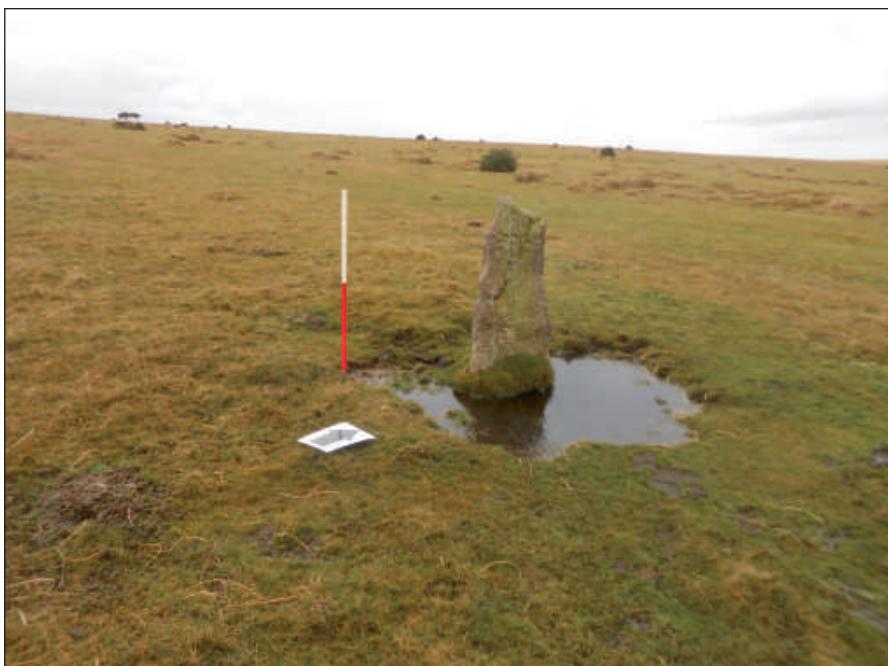
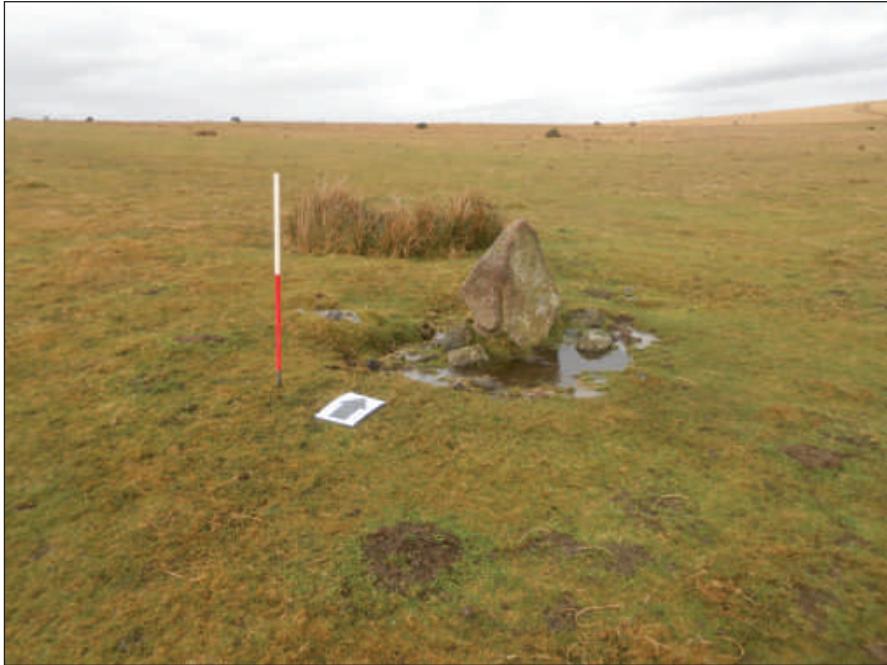
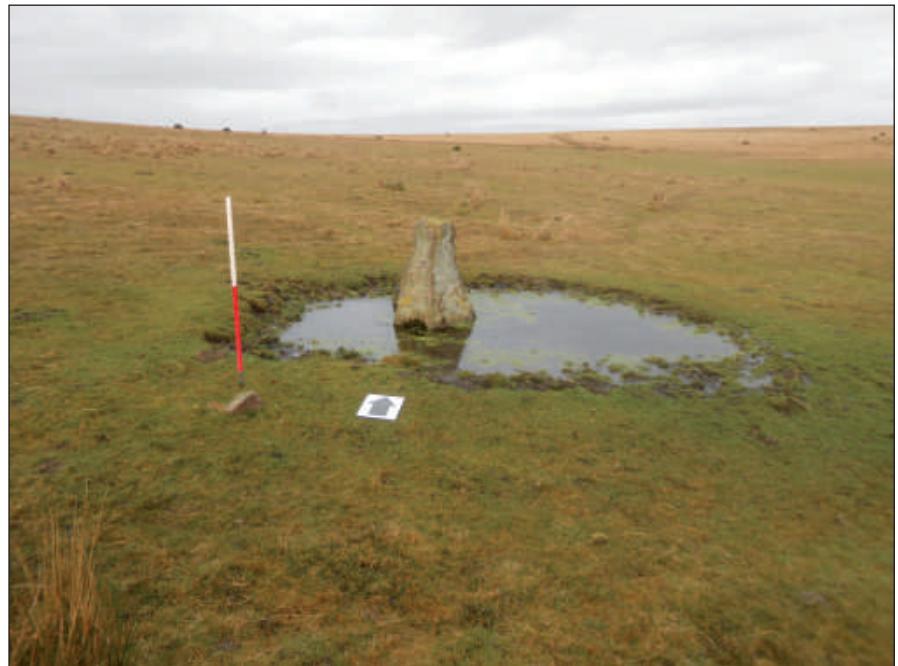
Fig 7. 438671 (SM No: 1012246) The Ringmoor stone row. Poaching and water erosion around the base of the upright stones.

Fig 8. 438671 (SM No: 1012246) The Ringmoor stone row. Poaching and water erosion around the base of the upright stones.

Fig 9. 438671 (SM No: 1012246) The Ringmoor stone row. Poaching and water erosion around the base of the upright stones.

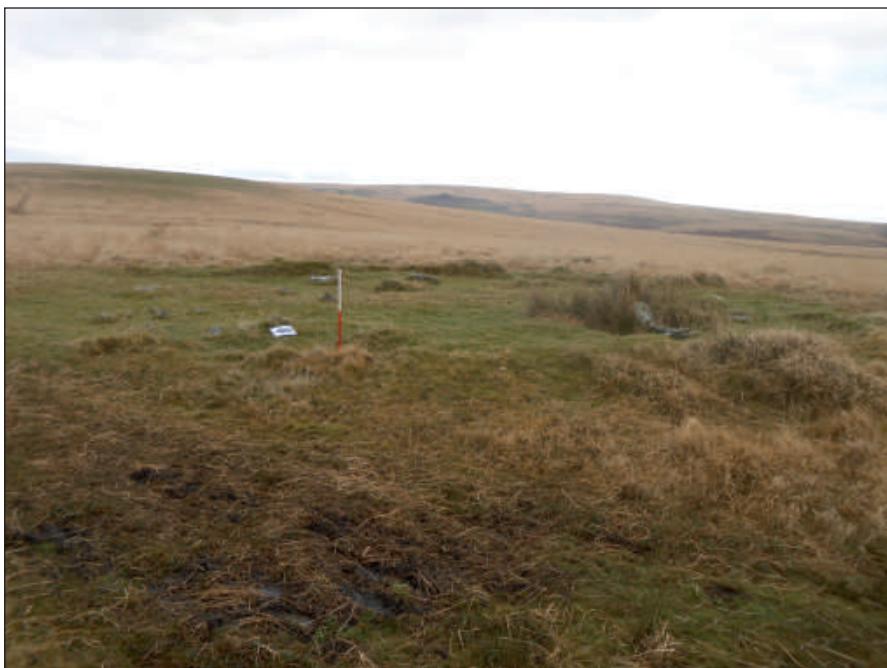
438959 (SM No: 1012281) A ring cairn adjacent to the Eylesbarrow reave. Use of the reave as a trail for walkers is causing churning of the ground at the very edge of the cairn, especially during wet weather. A potential threat if the trail expands.

Fig 10. 438959 (SM No: 1012281) A ring cairn adjacent to the Eylesbarrow reave. A track way (bottom left) is very close to the monument.

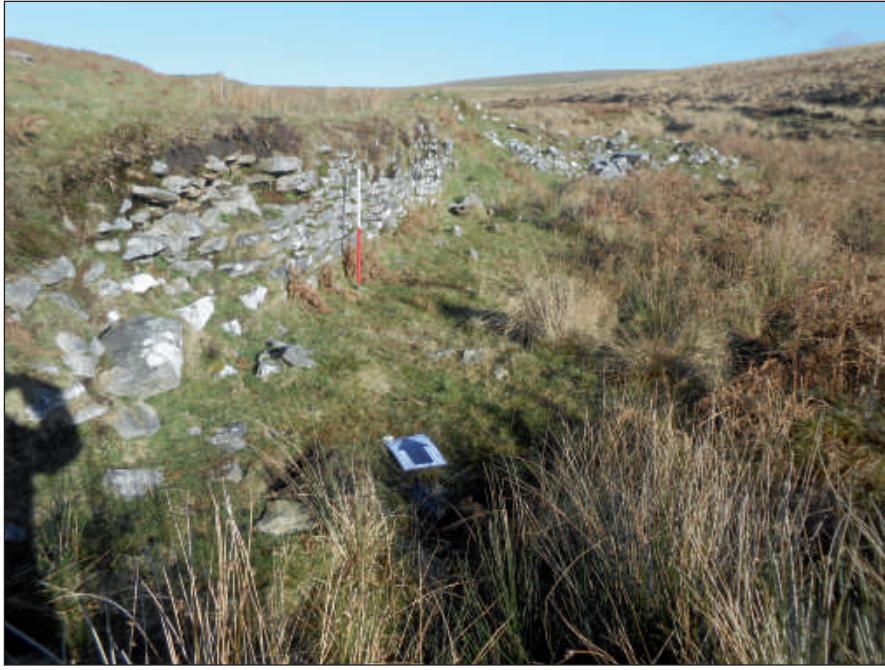
1318967 (SM No: 1021055) Stamping mill no 6 of Eylesbarrow Mine. The revetment wall of the tin dressing floor has suffered some collapse in recent years. Although beginning to stabilise, the damage requires further monitoring, to ensure that further sections do not also collapse.

Fig 11. 1318967 (SM No: 1021055) Stamping mill no 6 of Eylesbarrow Mine. The revetment wall of the tin dressing floor has suffered some collapse in recent years. Although beginning to stabilize.

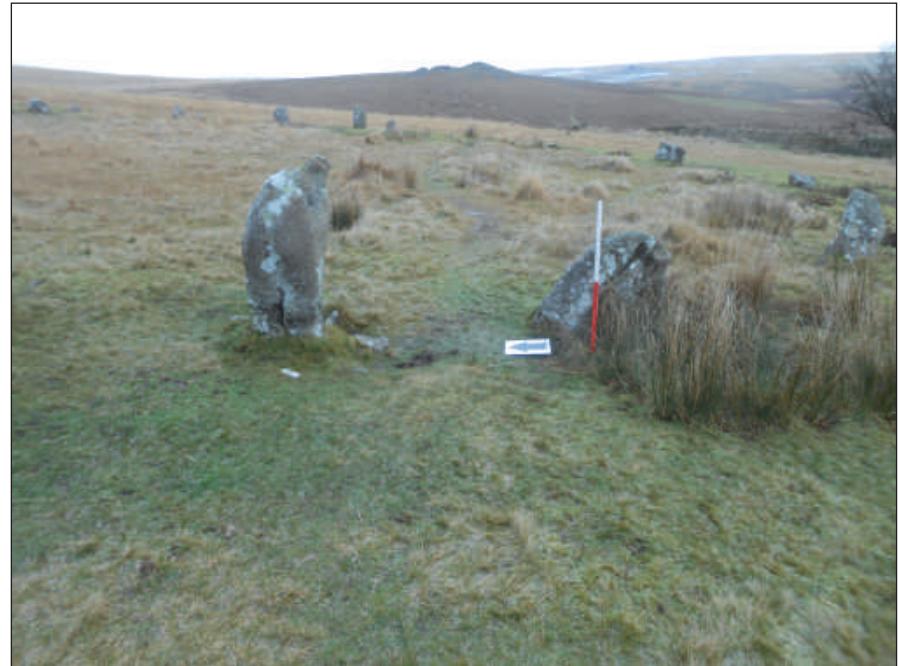
438683 (SM No: 1012227) Brisworthy Stone Circle. Minor livestock poaching at the base of several of the stones and a footpath through the centre of the circle are not currently significant, but require monitoring to check any escalation of the effects.

Fig 12. 438683 (SM No: 1012227) Briseworthy Stone Circle. A footpath through the monuments is apparently in regular use.

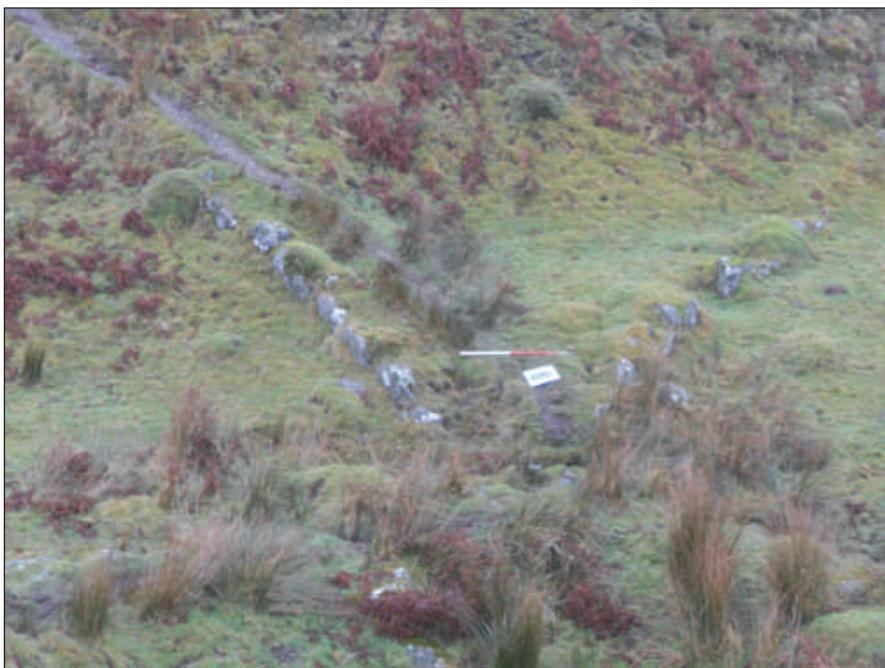
1311114 A vermin trap which straddles the base of a tinwork is being eroded by a footpath across the gully.

Fig 13. 1311114 A vermin trap which straddles the base of a tinwork is being eroded by a footpath across the gully.
