Defence Infrastructure Organisation

Technical Bulletin

Subject: Underside Fuel Tank Corrosion

Number: TB 2022/01

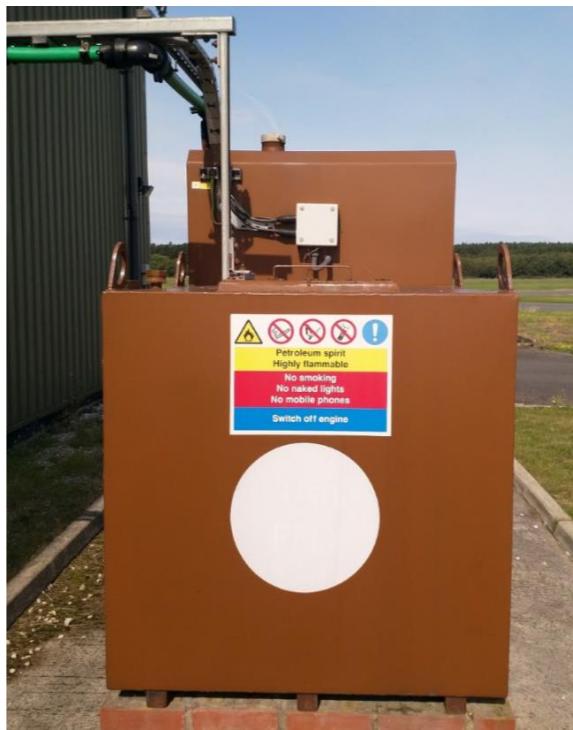
Figure 1: Example of a typical above ground metallic rectangular integrally bunded storage tank

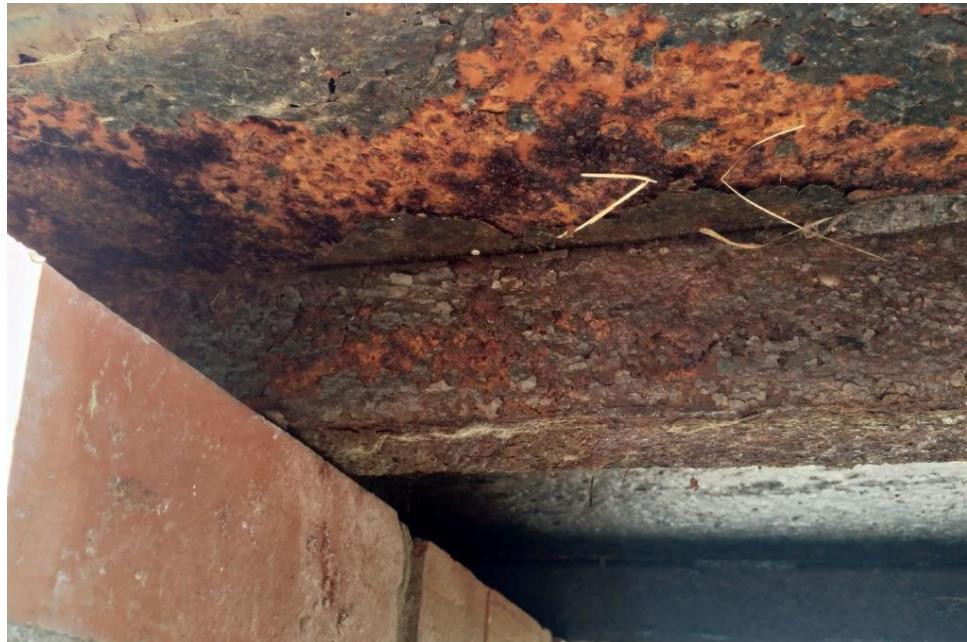
8. There are many of rectangular metallic tanks across the estate. These may be either single skin or double skin integrally bunded tanks. It has become evident that these tanks may be susceptible to corrosion on the underside which may not be visible during a routine visual inspection.
9. The figures below show a typical metallic rectangular integrally bunded tank and the corrosion failure is evident on the underside of the tank.

Figure 2: Underside corrosion of secondary tank skin

10. For single skin tanks, failure of the primary containment will lead to immediate release of product into the environment.
11. For double skin tanks, the risk is that the corrosion goes unnoticed and leads to a failure of the secondary tank skin. As the primary containment cannot be easily inspected, a failure of this would not be detected through the interstitial monitoring and thus could lead to product entering the local environment.

12. The flowchart below should be followed to assess the tanks ongoing suitability for use:
