Kittiwake SAL Export System Decommissioning Programme

Close Out Report

Incorporating Decommissioning Programmes for
Pipeline PL2205 and Kittiwake SAL Structure

Document ID:	CEU-PRJ-GKA0028-REP-003		
Date of Document:	03/05/12	<i>Signature</i>	<i>Date</i>
Prepared by:	Stewart Ford		06/07/12
Reviewed by:	Jacek Krawaczynski

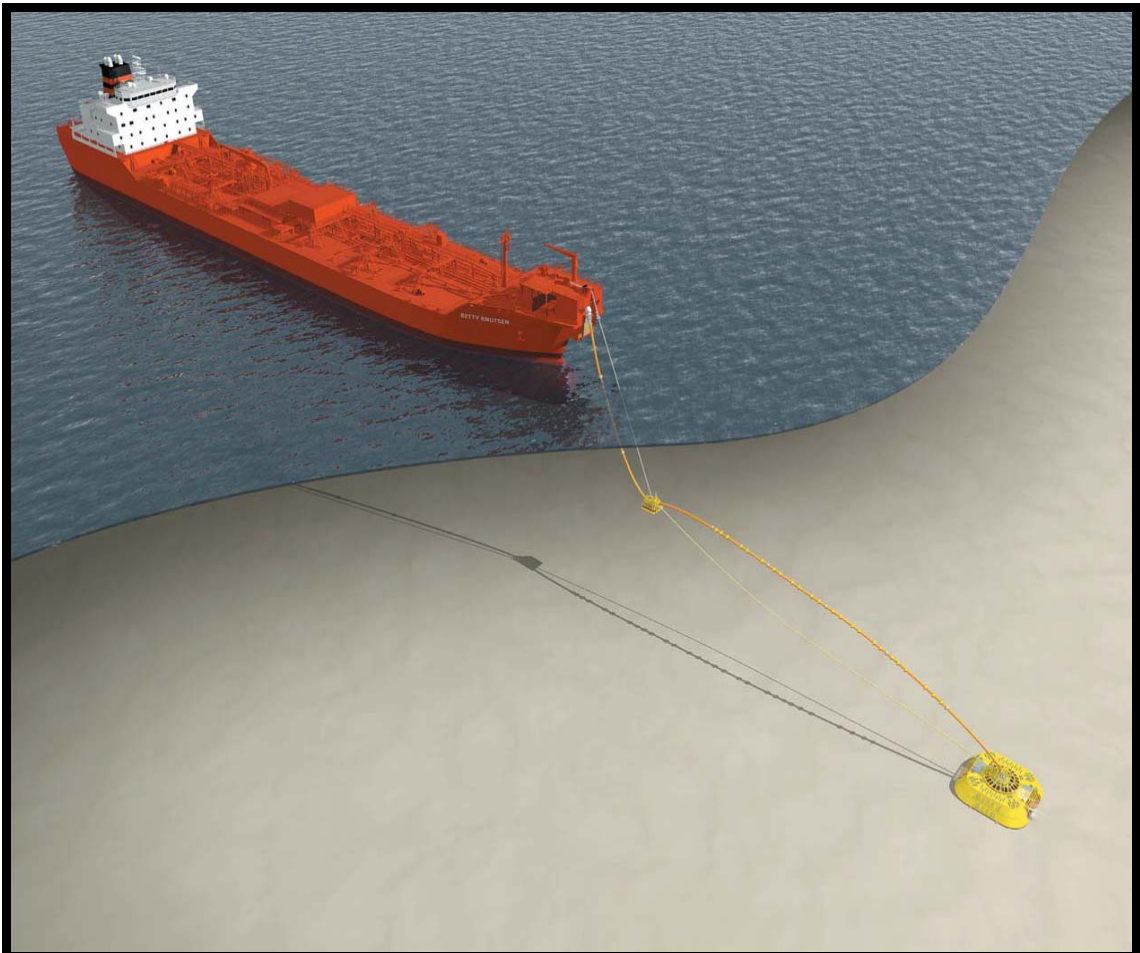
Schematic of a SAL in Operation

The Kittiwake SAL Export System comprised a Single Anchor Loading (SAL) structure anchored to the seabed by four integral suction anchors and a 3km flexible pipeline. Both of these components were leased items and were therefore returned to the owner for potential rehire.

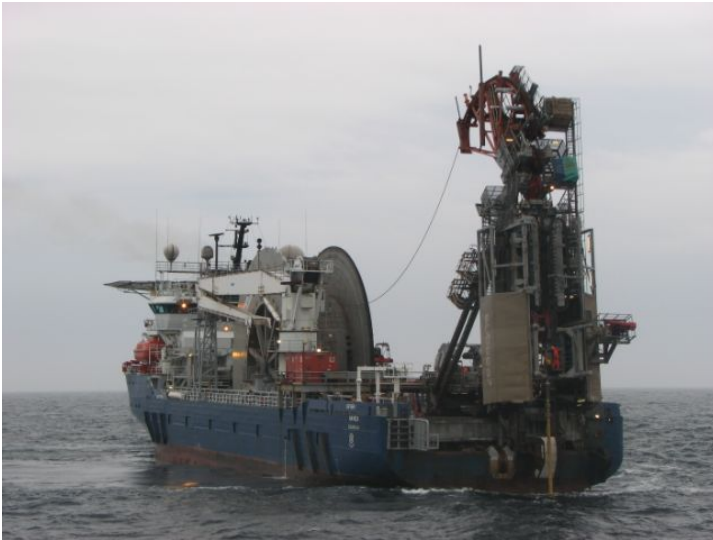
Seven Navica Recovering the SAL Flowline at Kitiwake.

The pipeline was recovered using the reel ship Seven Navica. This was essentially a reverse lay process and was completed without incident.

The pipeline was offloaded onto two Aquatic reels in Peterhead harbour. Unfortunately an extreme storm passed through at the time of the transfer to shore and the onshore mobile crane could not operate. As a result a significant period of “waiting on weather” resulted whilst Seven Navica was docked.

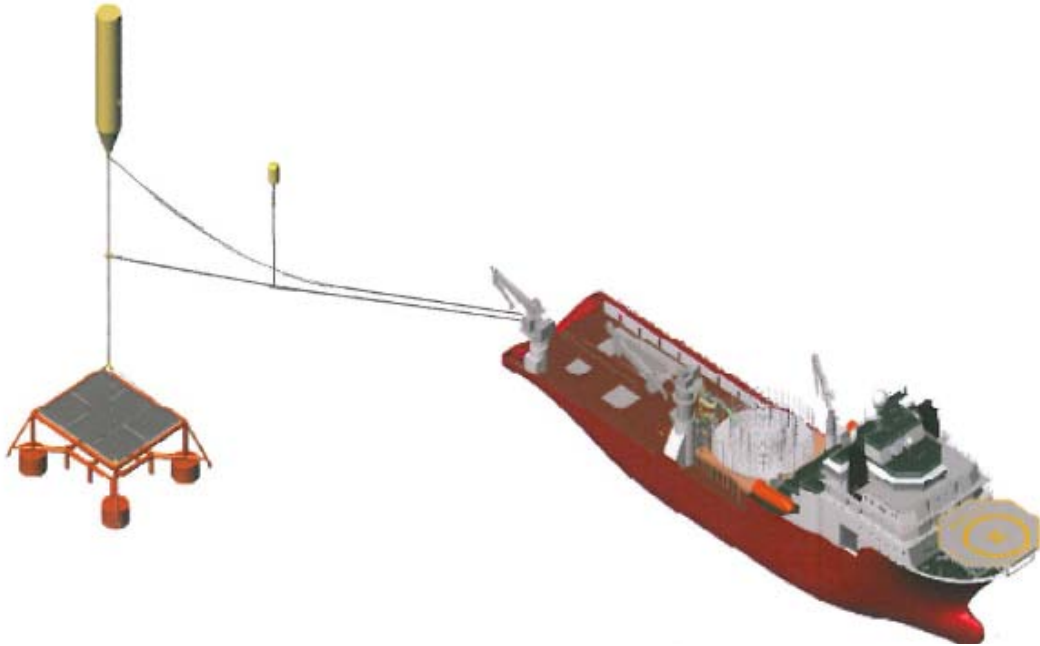
The Pencil Buoy Concept

Although it was considered likely that the SAL structure could be refloated, a different recovery method was adopted to eliminate uncertainty. The alternative method involved suspending the structure from a buoy during the tow. This method required the structure to be negatively buoyant and was therefore not sensitive to the weight variations caused by adhered clay. It is also less weather critical than the conventional tow envisaged by the SAL designers. However this method requires a deep harbour and a suitable “hard” bottom on which to park the structure before it is lifted inshore by a shear leg crane vessel.

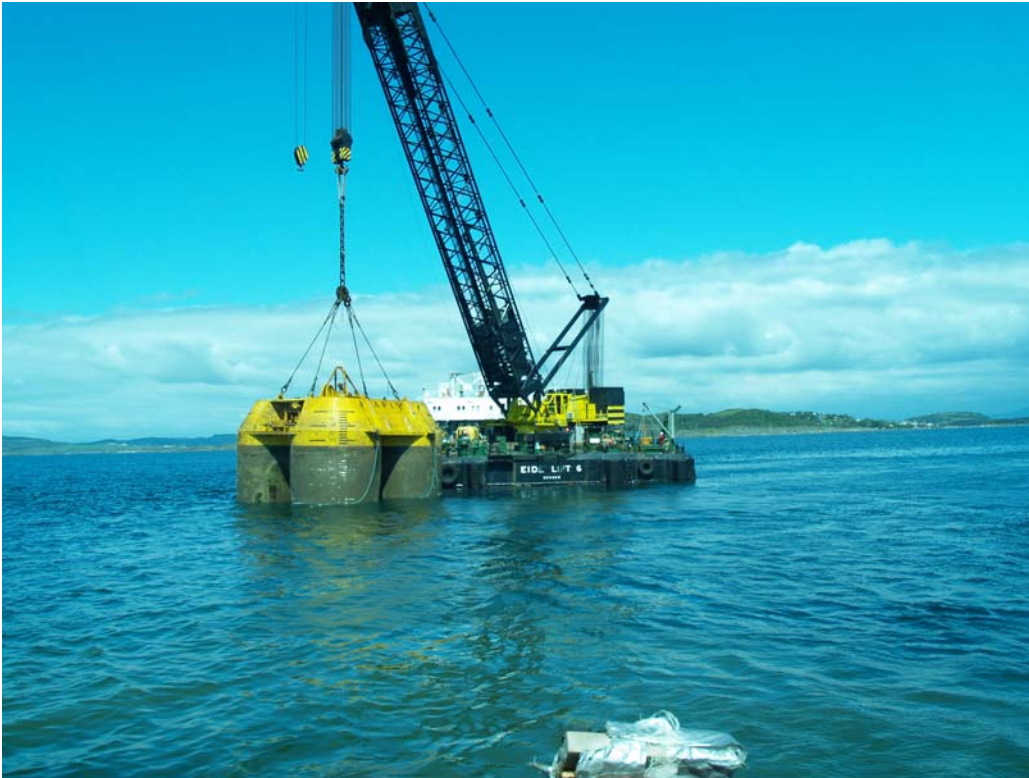
Kittiwake SAL coming ashore at Mekjarvik

The first attempt to recover the SAL structure took place in July 2010. This attempt was unsuccessful and a second, successful campaign was undertaken in April 2011. The SAL was towed to Mekjarvik in Norway where it was placed on the quayside and handed over to the owner.

The alternative operation was successfully completed in April 2011 and the SAL formally handed over to its owners.
