**ANNEX to TG2022-06**

Example House

External Wall Investigation Report

ref: 123/456/78 rev A

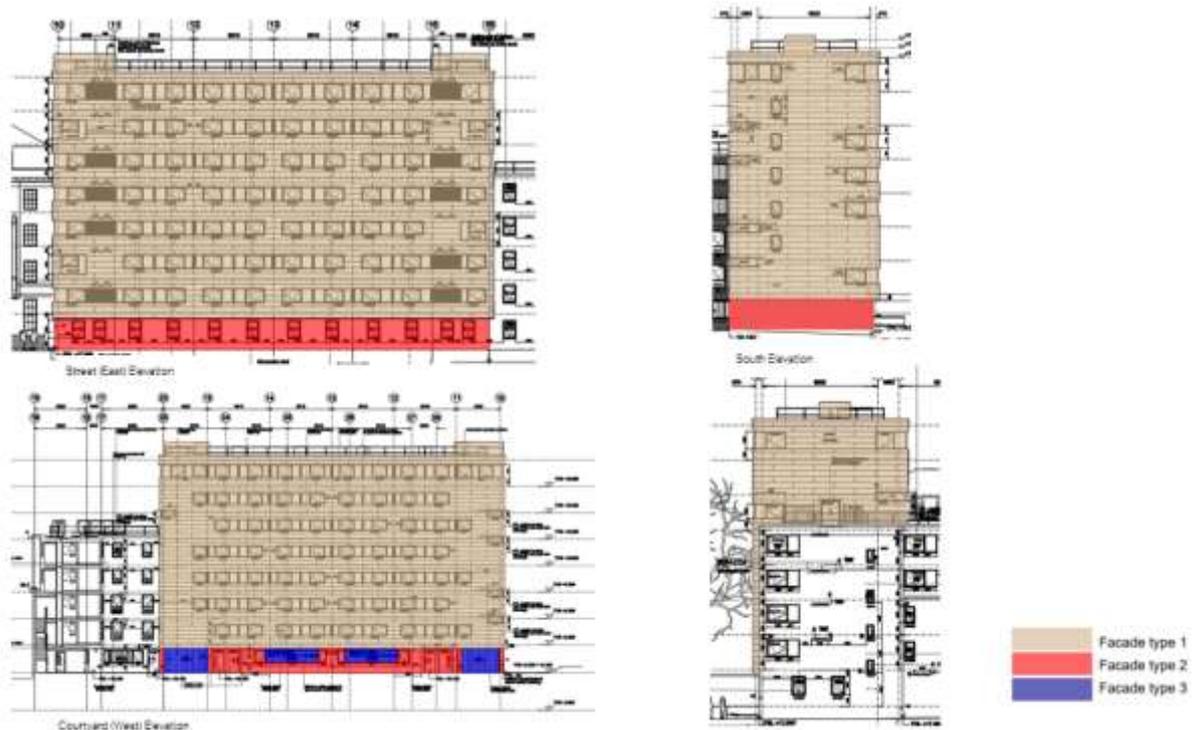
Figure 1. External Wall Type Location Plan

Produce a diagram indicating the location of each faced type, for example:

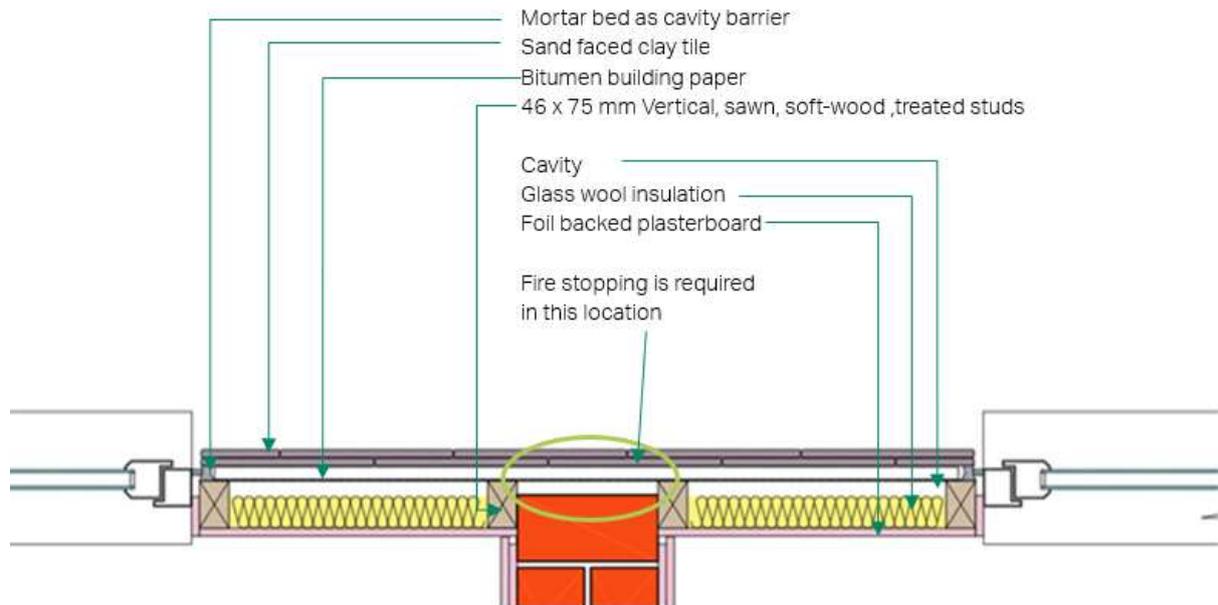
Figure 2. Plan View

*Contractor Q made 4 separate intrusive investigations, (investigations 1 through 4) and has produced the drawings in figure x and Y to illustrate the wall build up as observed at those two locations. Both inspections 3 & 4 were the same but in different locations.*

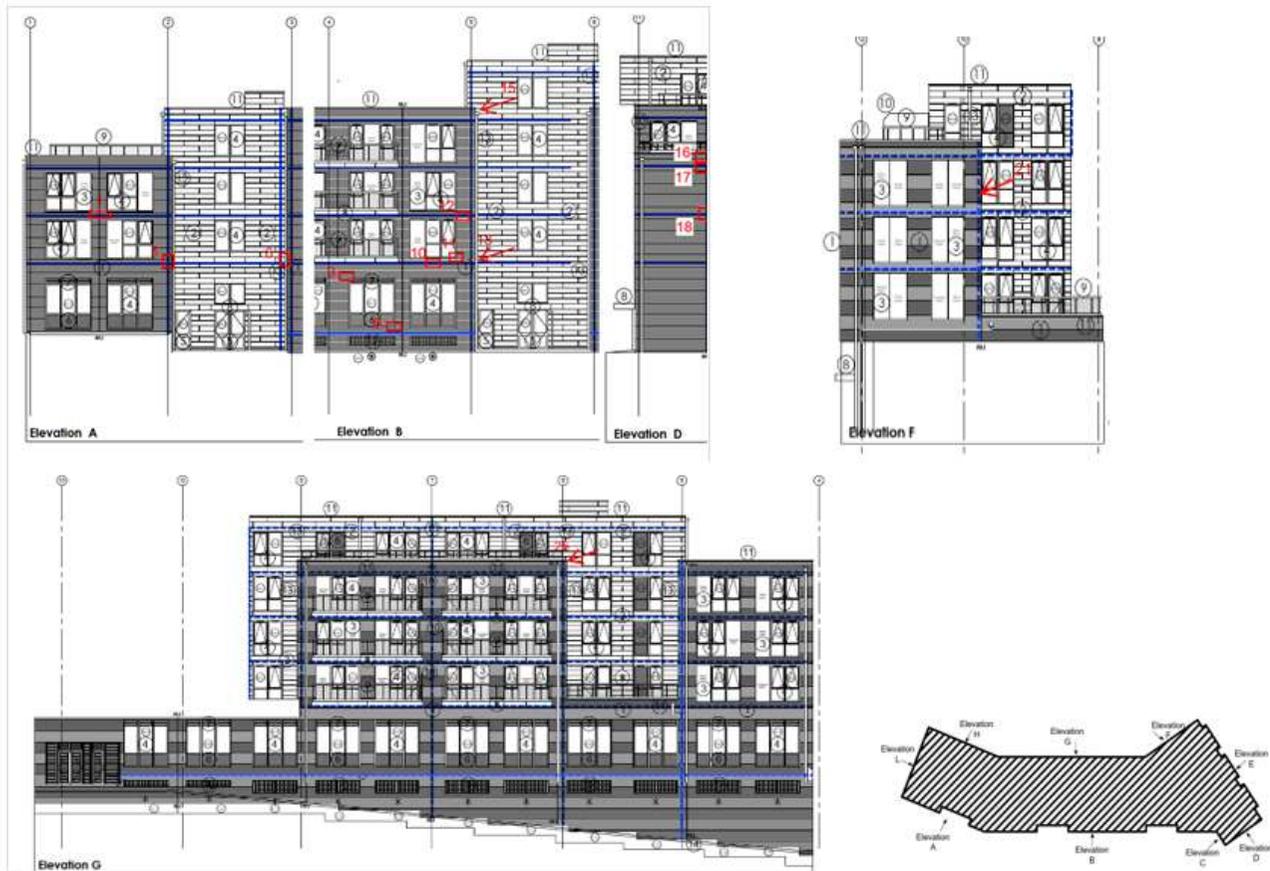
Figure 4 Inspection Location Plan

Provide a reference plan indicating the location of the inspection, for example

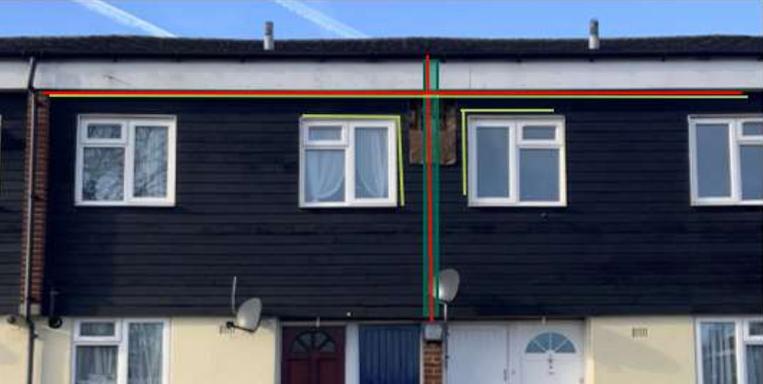
R	Y	G	Location	Photographs	Observations / Comments	Detail
1	1		Timber clad External wall East Elevation

<ul style="list-style-type: none"> <li>Location Photograph. Inspection situated on party wall line between Flat 60 &amp; 58.</li> <li>Fire stopping and cavity barriers which were to be inspected during the investigation are as indicated on the photograph and detail drawing in light and dark green.</li> <li>Red lines indicate cavity barriers / fire stops were <b>not</b> found in these areas,</li> </ul>

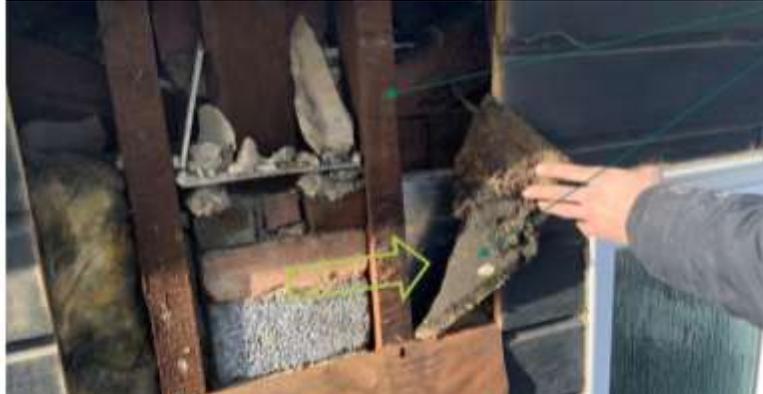
3	1		Timber clad External wall East Elevation

<ul style="list-style-type: none"> <li>Insulation moved aside to reveal the foil face of the plasterboard.</li> <li>Next photograph seen from the direction of the large arrow.</li> <li>46 x 75 mm Vertical, sawn, soft wood treated studs.</li> <li>partial-fill glass wool insulation.</li> </ul>

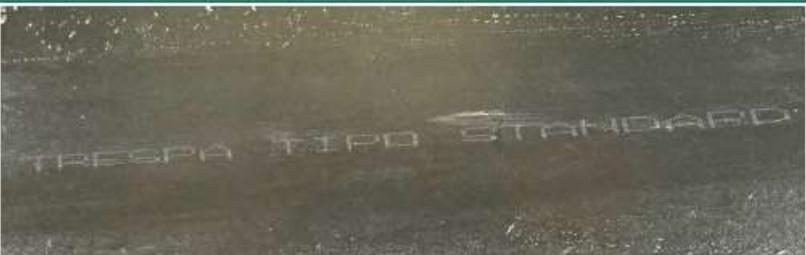
Location	Photographs	Observations / Comments	Detail							
87 Elevation A First floor

HPL (Trespa) panel does not achieve required fire rating. Identification mark on back of panel reads TRESPA TIPO STANDARD	Extract from Trespa Data Sheet <table border="1"><tr><td>Grade: ED5 (Meteor<sup>®</sup>)</td></tr><tr><td>Standard: EN 438-6</td></tr><tr><td>Colour/Decor: All</td></tr></table> <table border="1"><tr><td>Euroclass</td><td>D-s2, d0</td></tr><tr><td>Euroclass</td><td>D-s2, d0</td></tr></table>	Grade: ED5 (Meteor <sup>®</sup> )	Standard: EN 438-6	Colour/Decor: All	Euroclass	D-s2, d0	Euroclass	D-s2, d0
Grade: ED5 (Meteor <sup>®</sup> )										
Standard: EN 438-6										
Colour/Decor: All										
Euroclass	D-s2, d0									
Euroclass	D-s2, d0

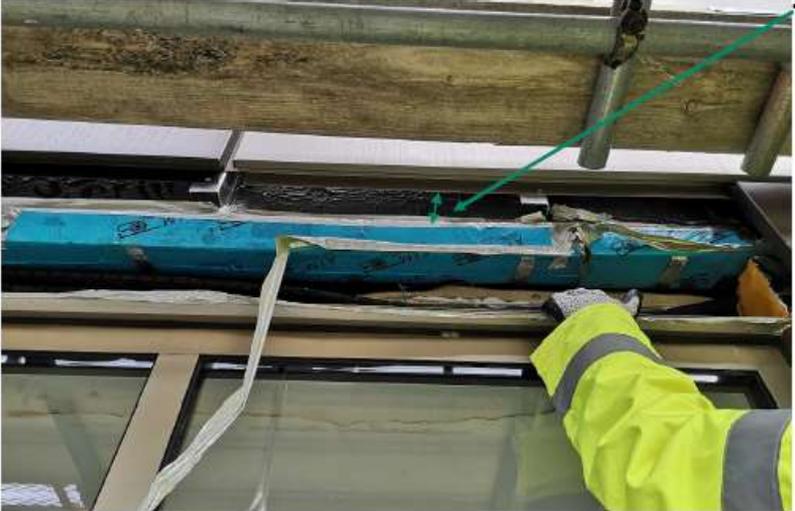
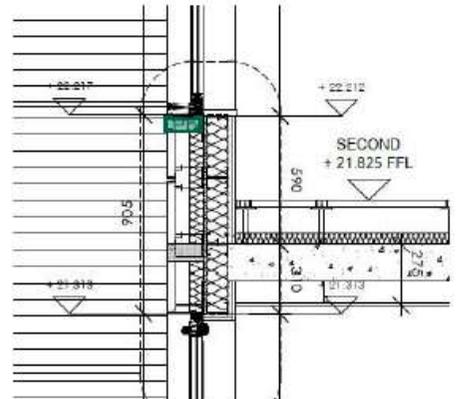
89 Roof level – above door

Horizontal cavity barrier installed incorrectly. Excessive (7.3mm) gap between front face of cavity barrier and front face of rain screen.	Extract from Architect's vertical aluminium panel detail 10365_430. Cavity barriers have been indicated where omitted from detail.
