Apache

N11 WHPS Decommissioning Close out Report

06/09/2022

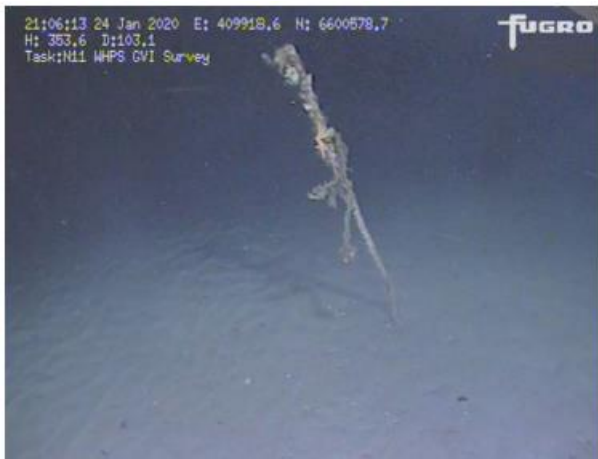
1. Scaffold Debris

An ROV as-left seabed clearance survey was conducted in April 2018. The as-left seabed clearance survey is provided in Appendix A. No anomalies were found. The debris identified during this survey are included below for reference.. Apache will remove any identified oil and gas debris upon completion of full field decommissioning.

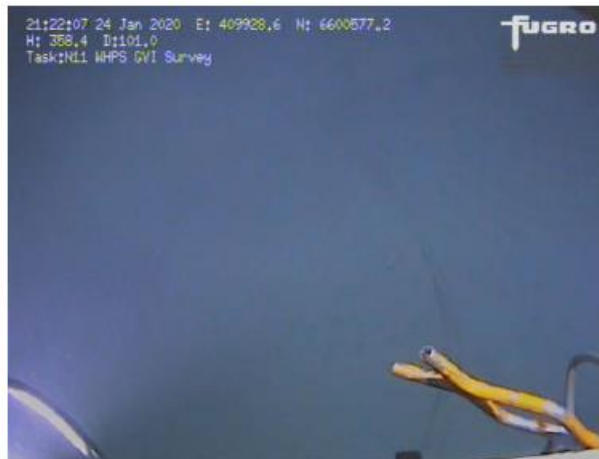
2. Wire

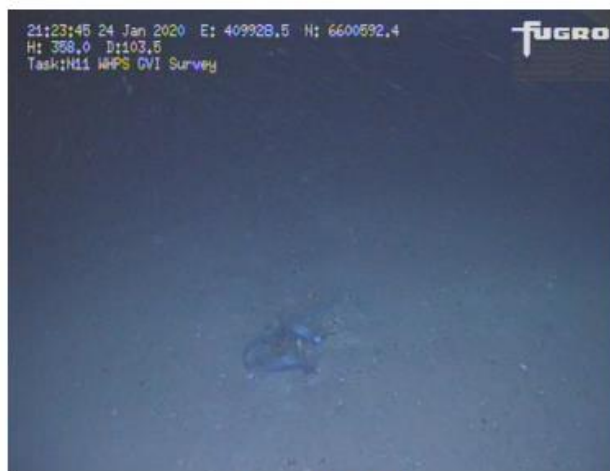
3. Cargo Strap

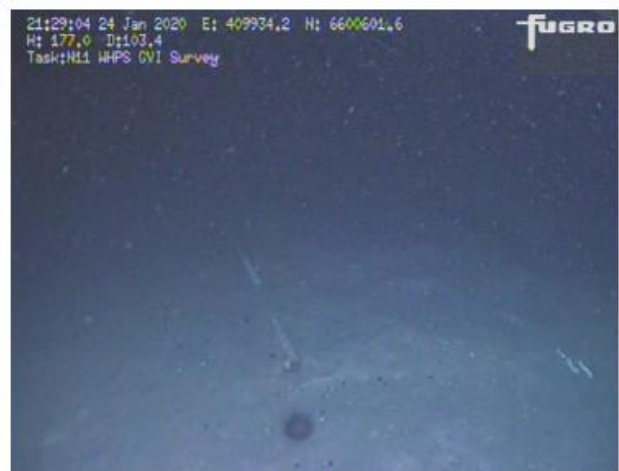
4. Scaffold Debris

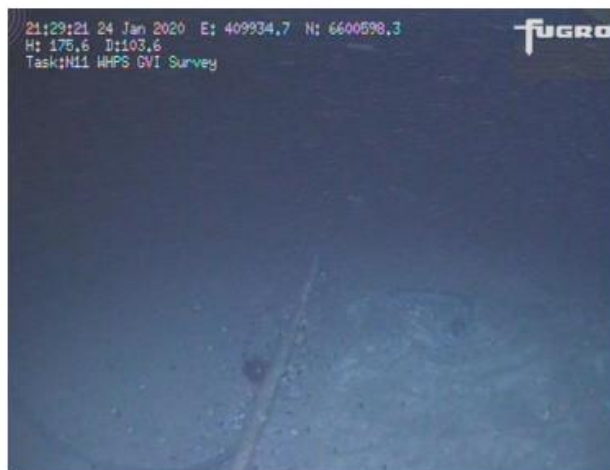
5. Scaffold Debris and Cargo Strap

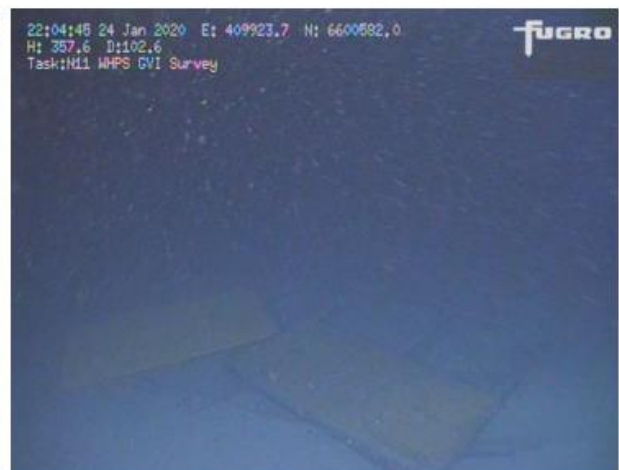
6. Doors

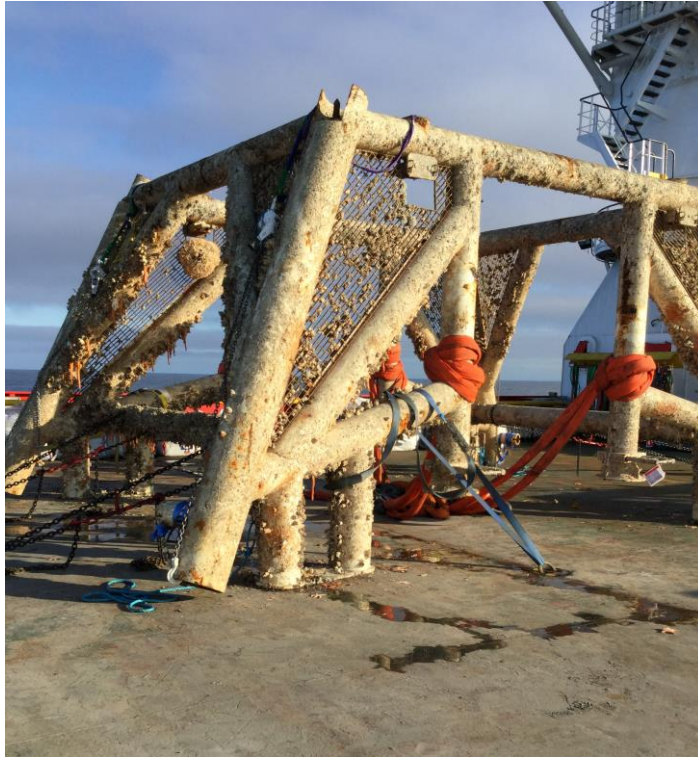
The following photograph of the N11 WHPS was taken on the back deck of the vessel Seven Atlantic in June 2019.

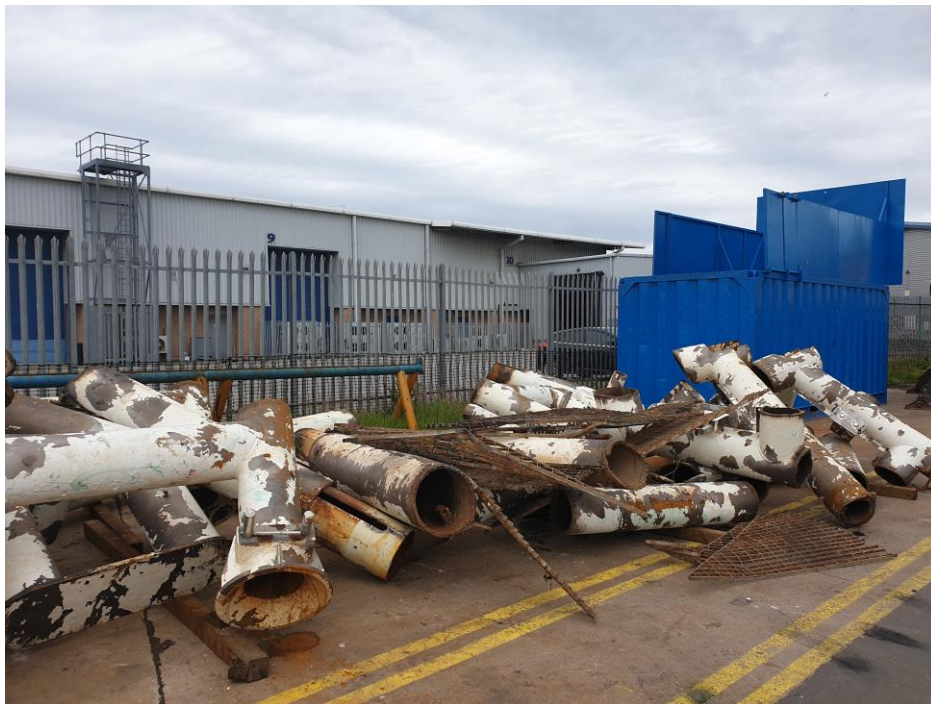
The WHPS was then reduced in size, sent to Scotoil in Aberdeen for marine growth removal, and sent offsite for recycling (metal) and disposal (marine growth) – as per below photo.

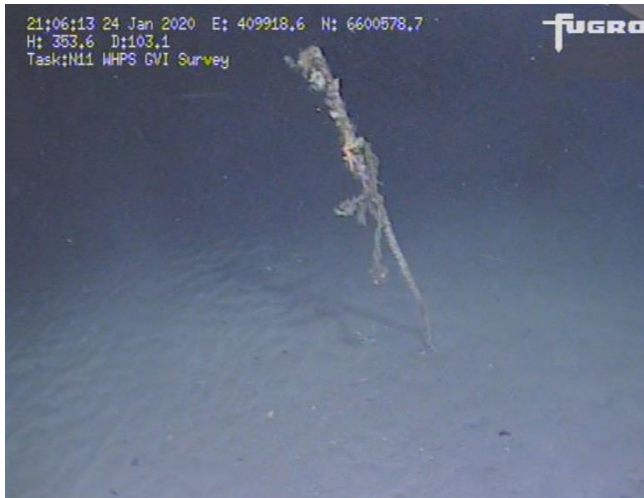
1. Scaffold Debris

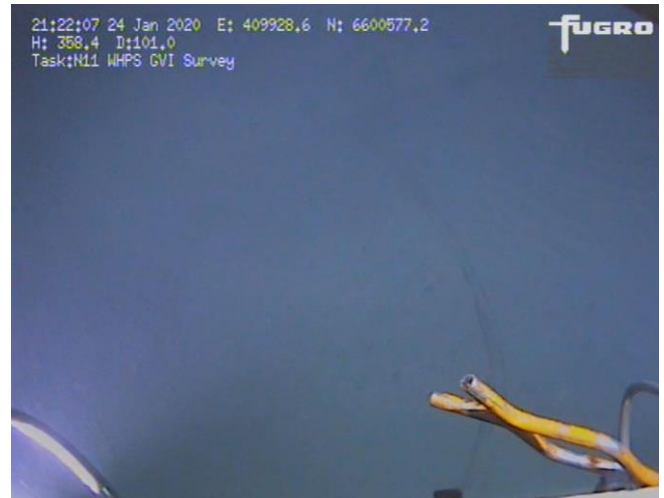
2. Wire

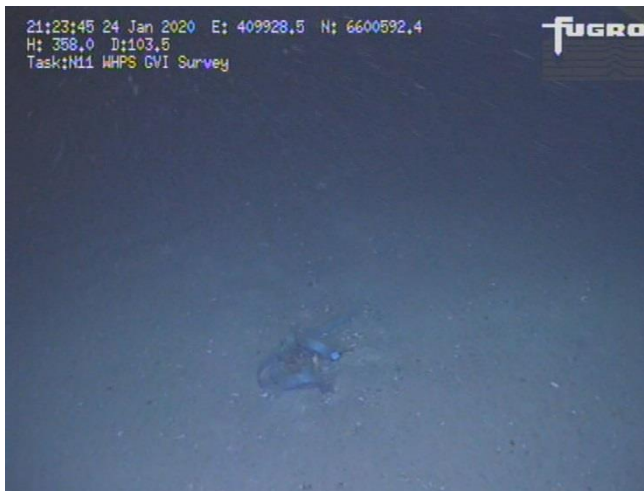
3. Cargo Strap

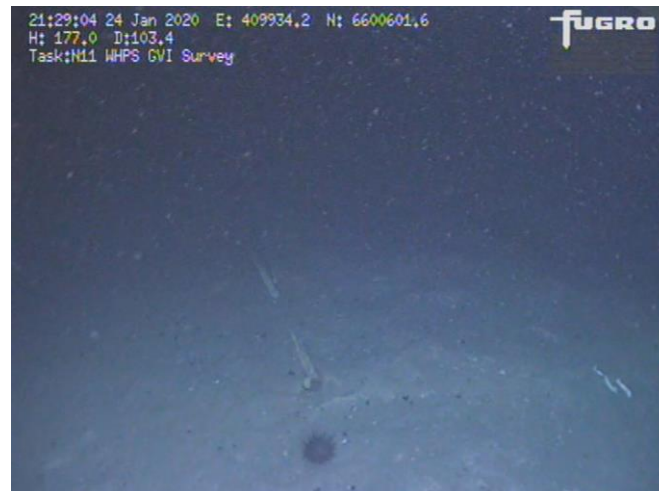
4. Scaffold Debris

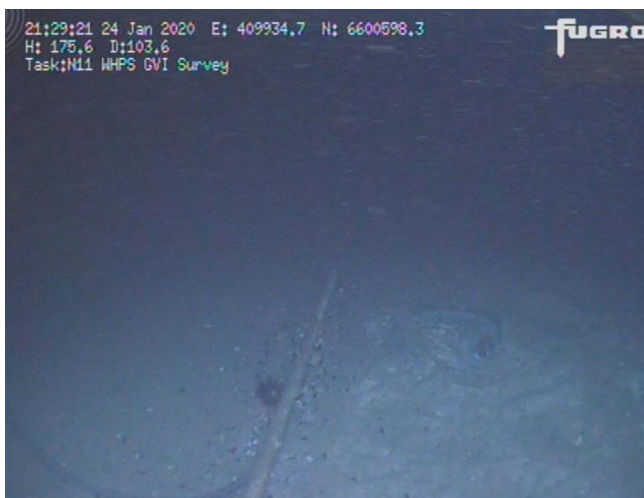
5. Scaffold Debris and Cargo Strap

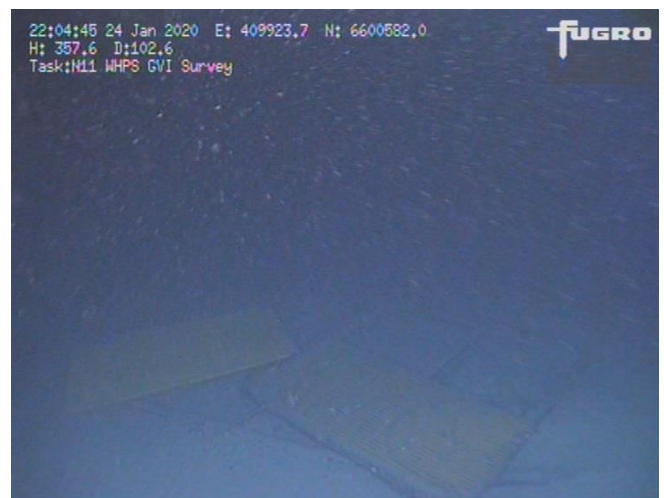
6. Doors
