RSK

APPENDIX E
PHOTOGRAPHIC RECORD

ELSENHAM PHASE 2 SITE RECONNAISSANCE PHOTOGRAPHS

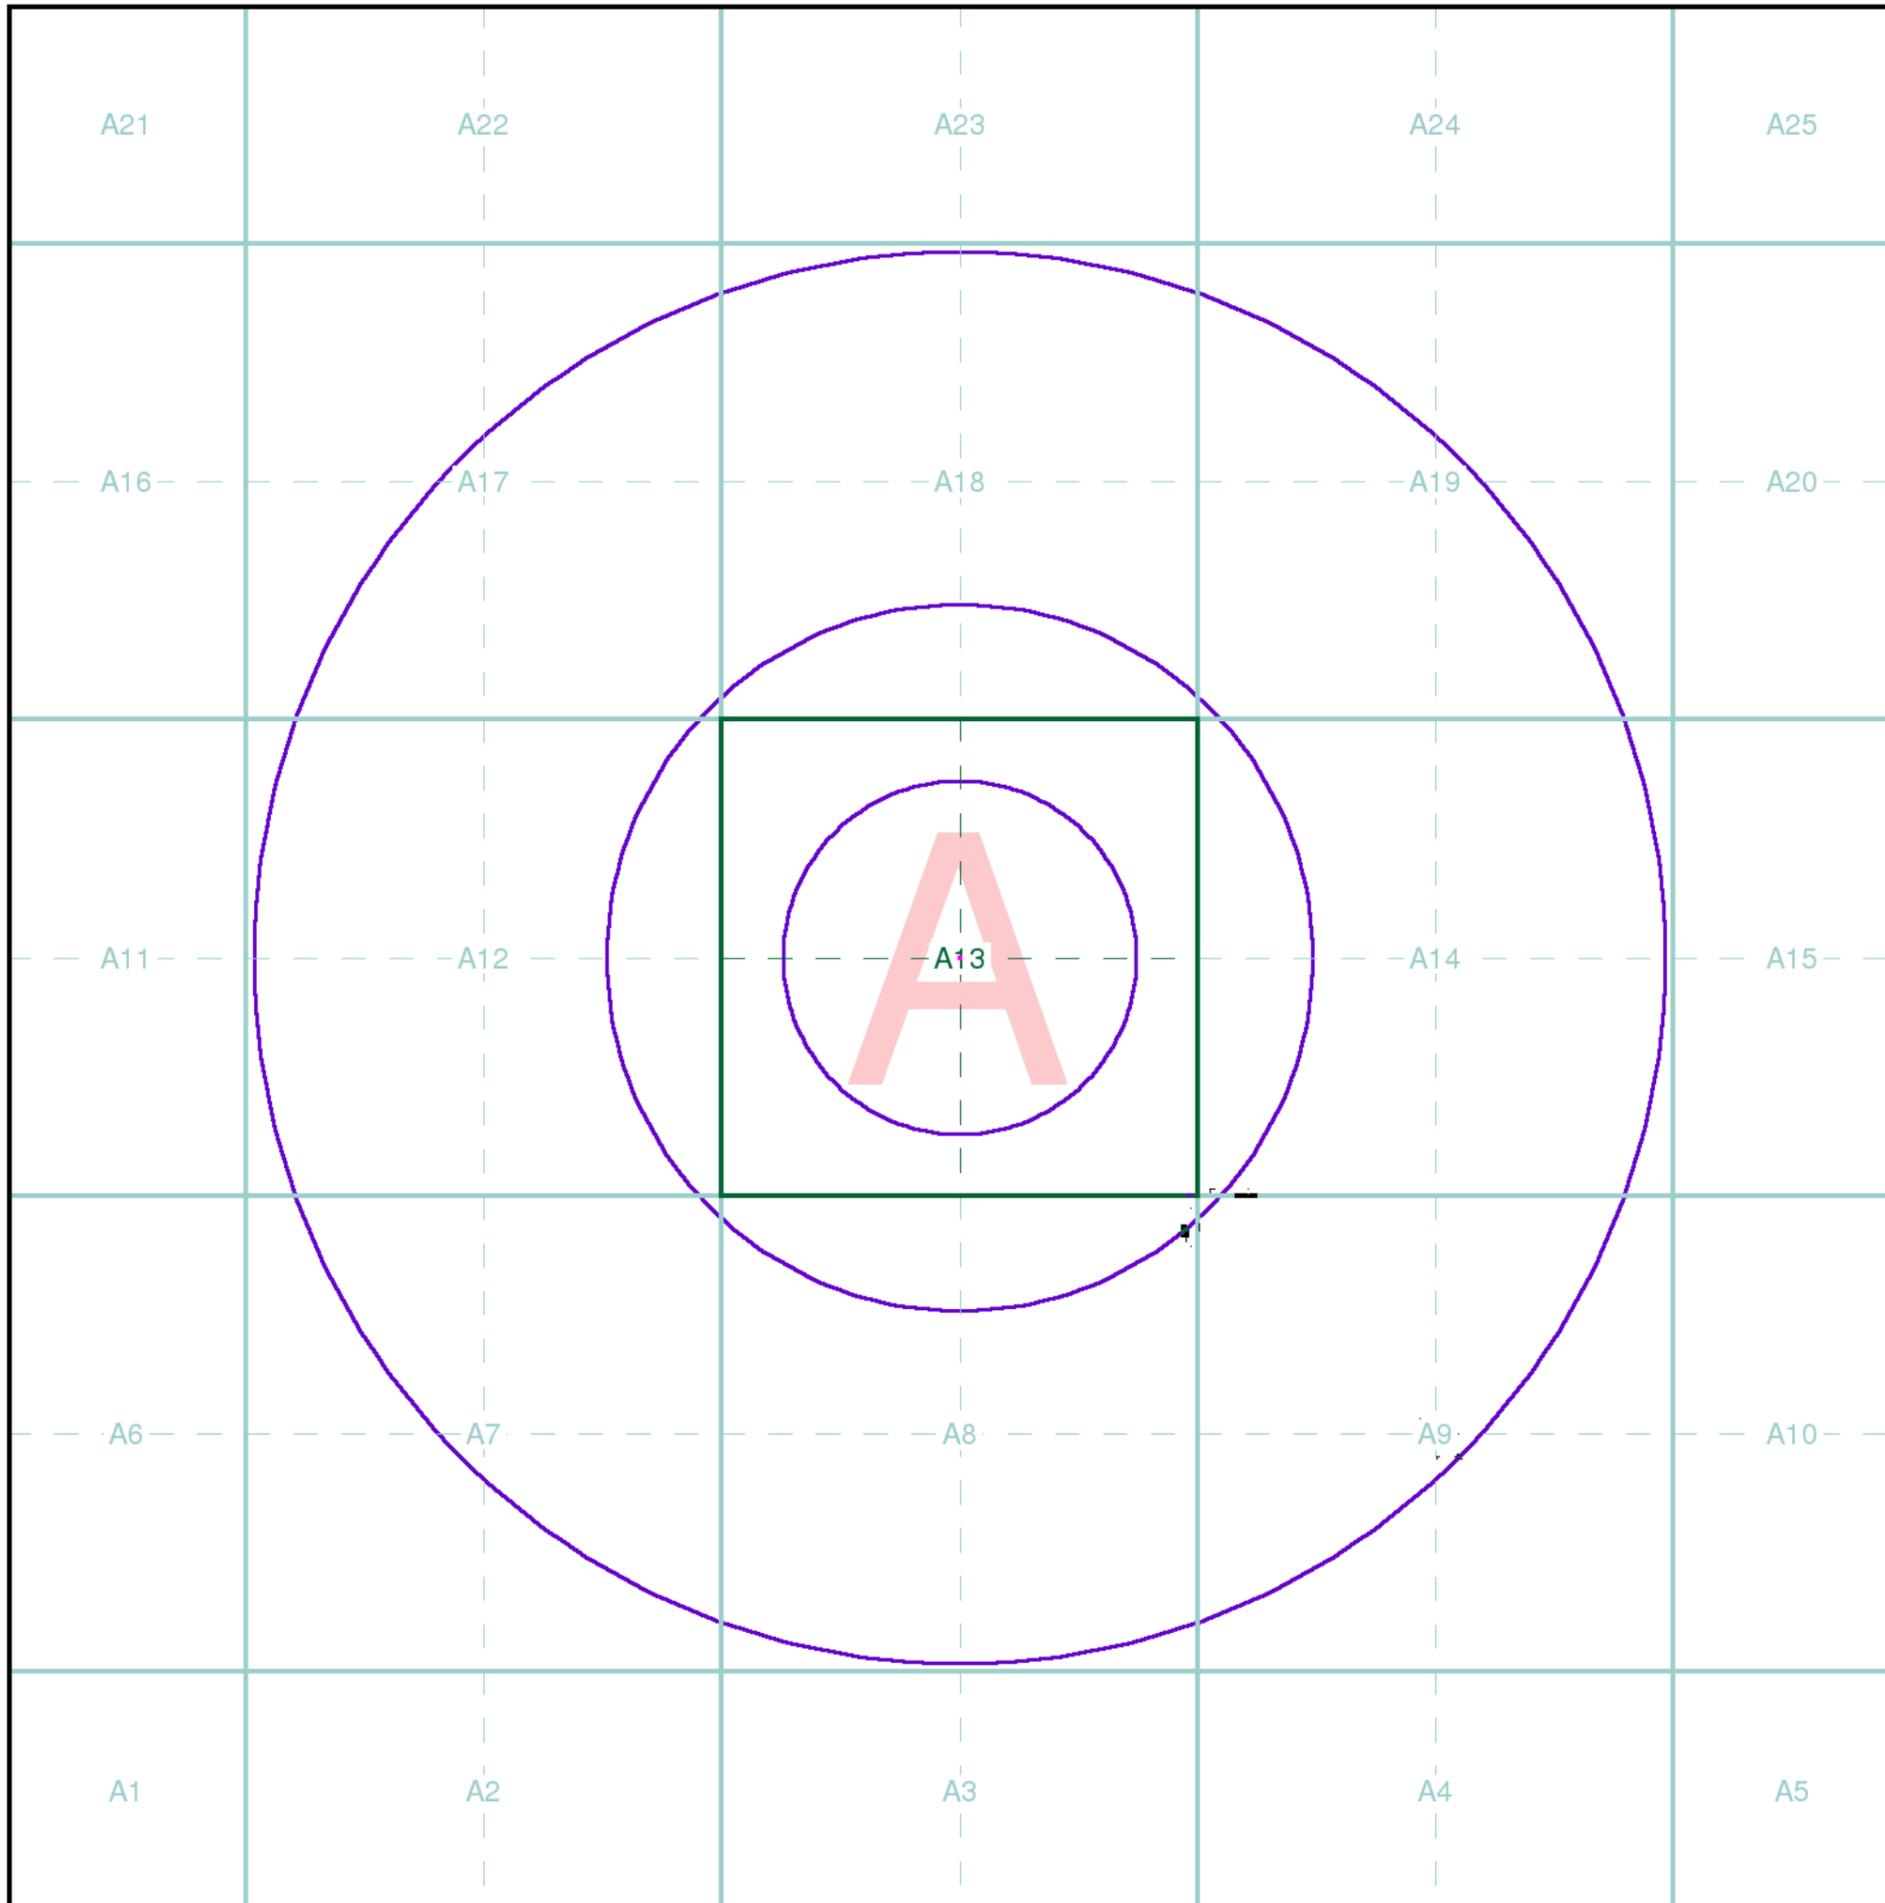
For ease of identification, your site and buffer have been split into Slices, Segments and Quadrants. These are illustrated on the Index Map opposite and explained further below.

Each slice represents a 1:10,000 plot area (2.7km x 2.7km) for your site and buffer. A large site and buffer may be made up of several slices (represented by a red outline), that are referenced by letters of the alphabet, starting from the bottom left corner of the slice "grid". This grid does not relate to National Grid lines but is designed to give best fit over the site and buffer.

A segment represents a 1:2,500 plot area. Segments that have plot files associated with them are shown in dark green, others in light blue. These are numbered from the bottom left hand corner within each slice.

A quadrant is a quarter of a segment. These are labelled as NW, NE, SW, SE and are referenced in the datasheet to allow features to be quickly located on plots. Therefore a feature that has a quadrant reference of A7NW will be in Slice A, Segment 7 and the NW Quadrant.

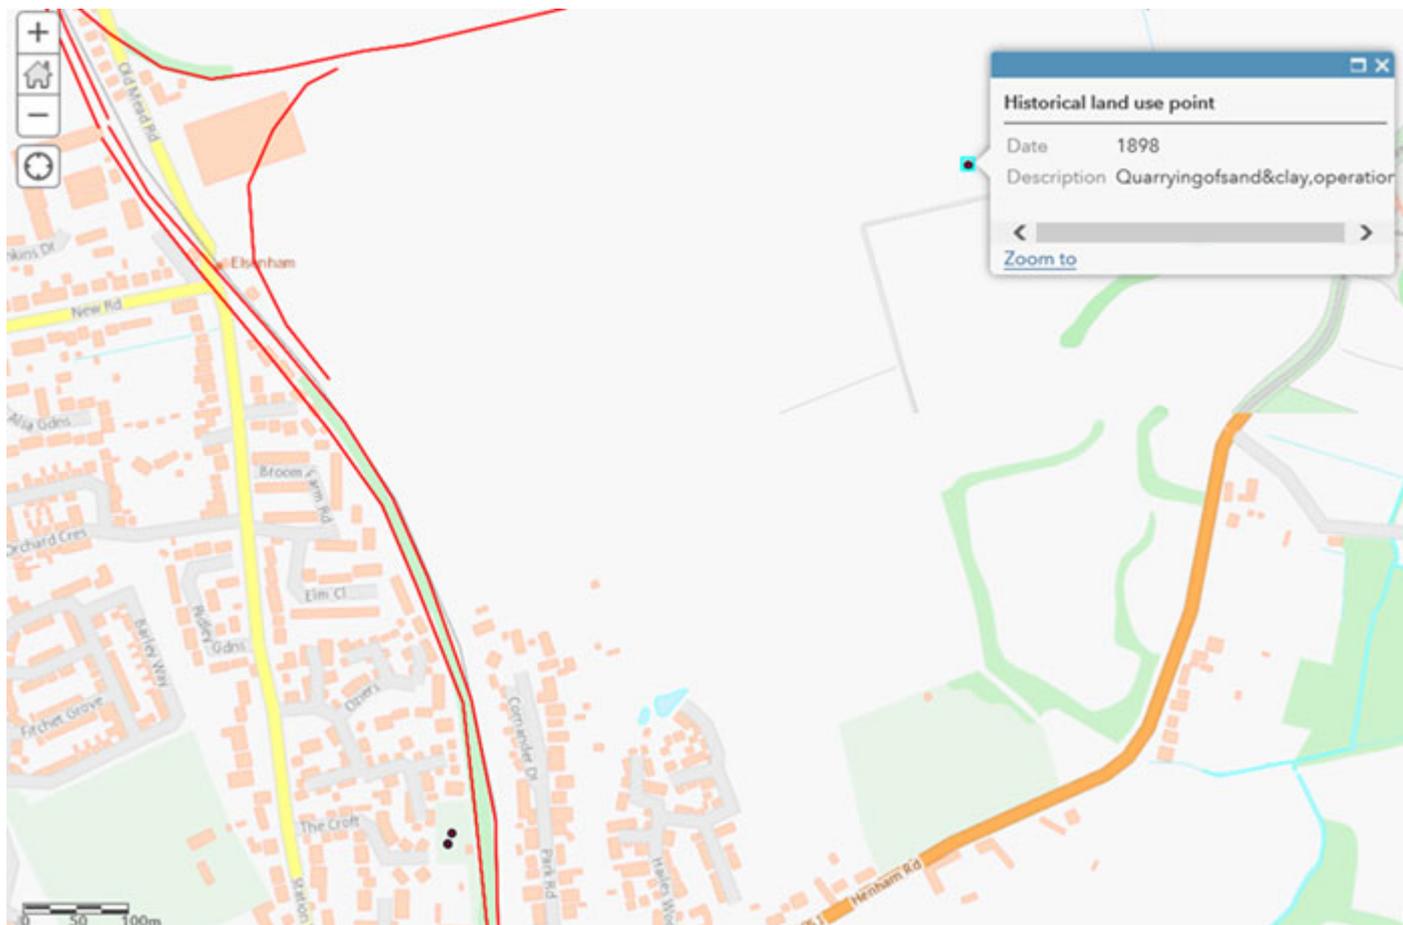
Plan:

No Part IIA designation or contamination complaints.
Old railway line to the NWest of the site, see red line in plan below.
Cemetery to the SWest of site- at the end of The Croft.

1898 Quarry- Sand & Clay to the NEast, see point on plan below.

There is a Gravel Pit East of the site, Elsenham Sand & Gravel LTD (dark green on plan)

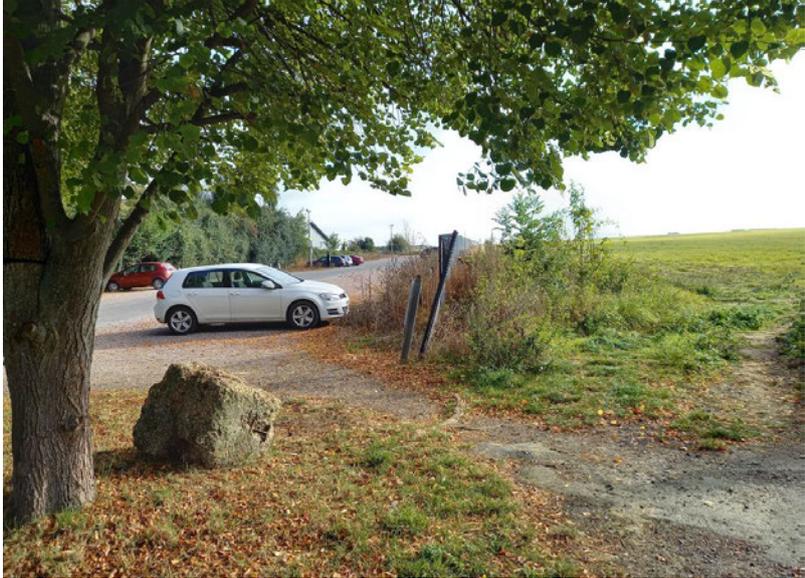
| Photo No. 1 | Date: 24/09/21 | |

| Description: Unsecured access from Old Mead Rd for light vehicles in north western corner (indicated by green arrow in photo 1) | | |

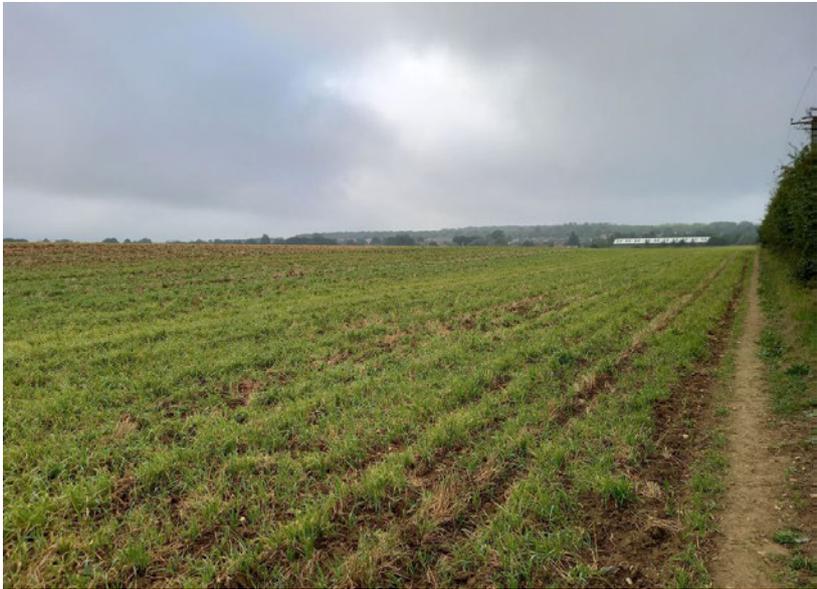
| Photo No. 2 | Date: 24/09/21 | |

| Description: Northern boundary facing west showing walking path, powerlines and freight forwarding warehouse on western corner | | |

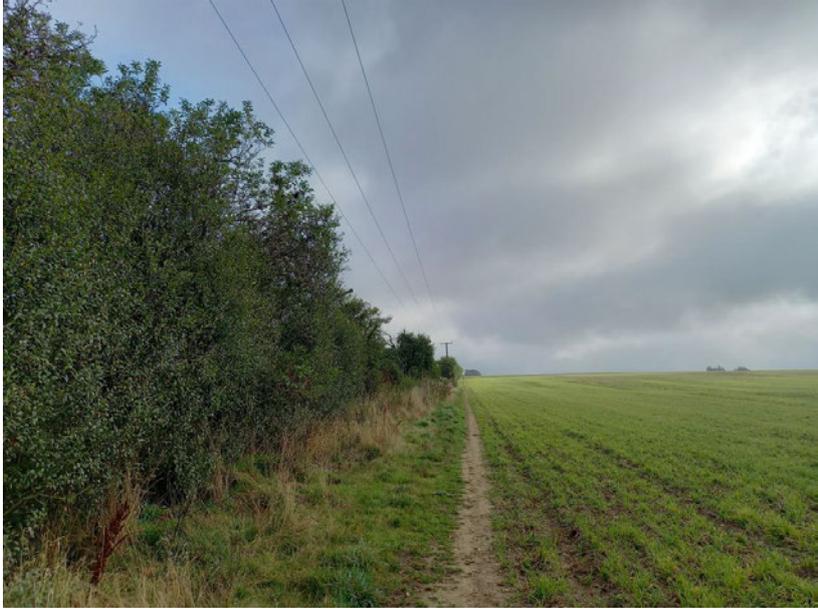
| Photo No. 3 | Date: 24/09/21 | |

| Description: Northern boundary facing east showing walking path and overhead powerlines | | |

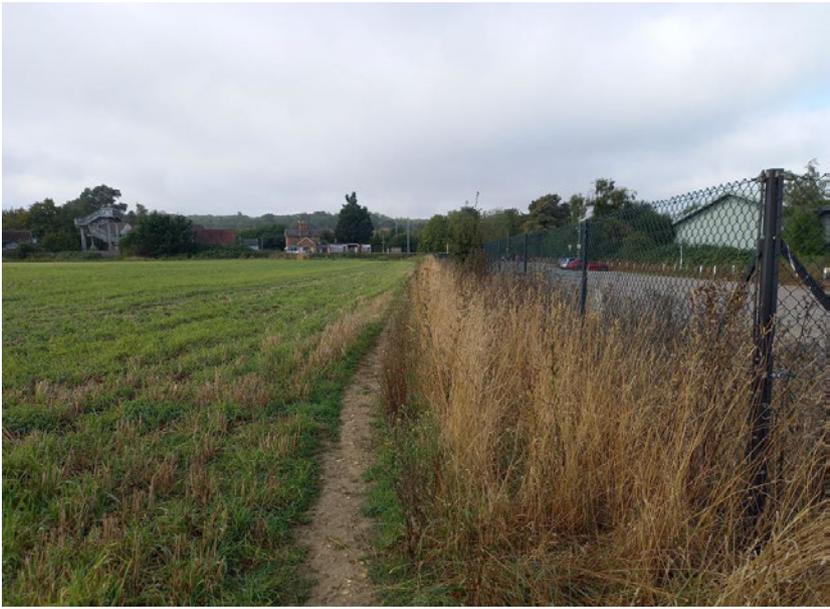
| Photo No. 4 | Date: 24/09/21 | |

| Description: North western corner showing station, station car park & warehouse | | |

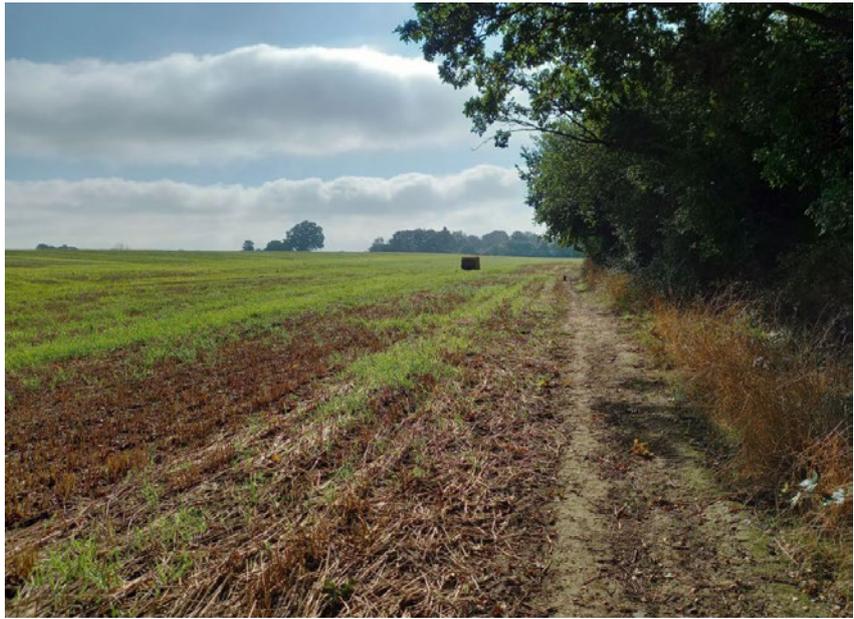
| Photo No. 5 | Date: 24/09/21 |

Description:
Western edge facing south –
train platform and rail cutting
runs adjacent to site edge

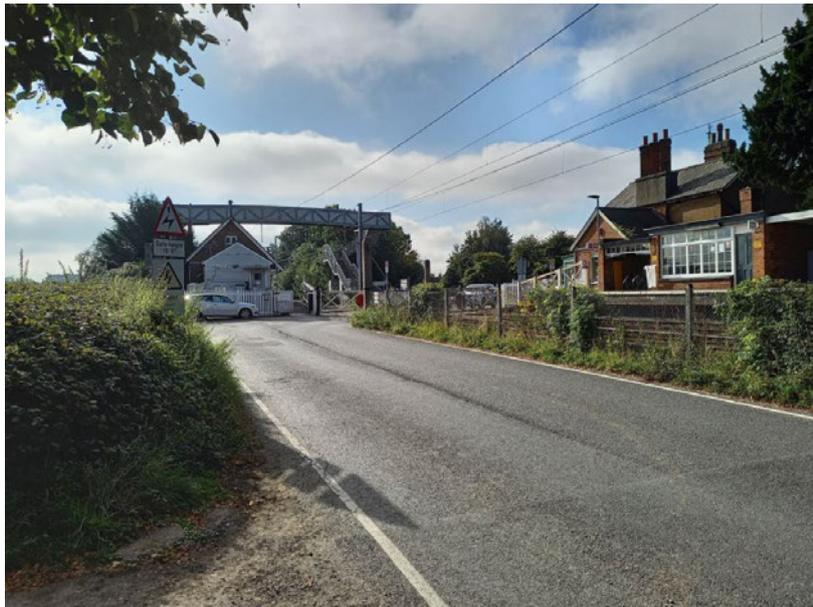
| Photo No. 6 | Date: 24/09/21 |

Description:
Manned railways crossing
and Elsenham station
opposite site entrance
shown in Photo 2
