HS2

October 2022

Construction Noise and Vibration Monthly Report – August 2022

London Borough of Camden

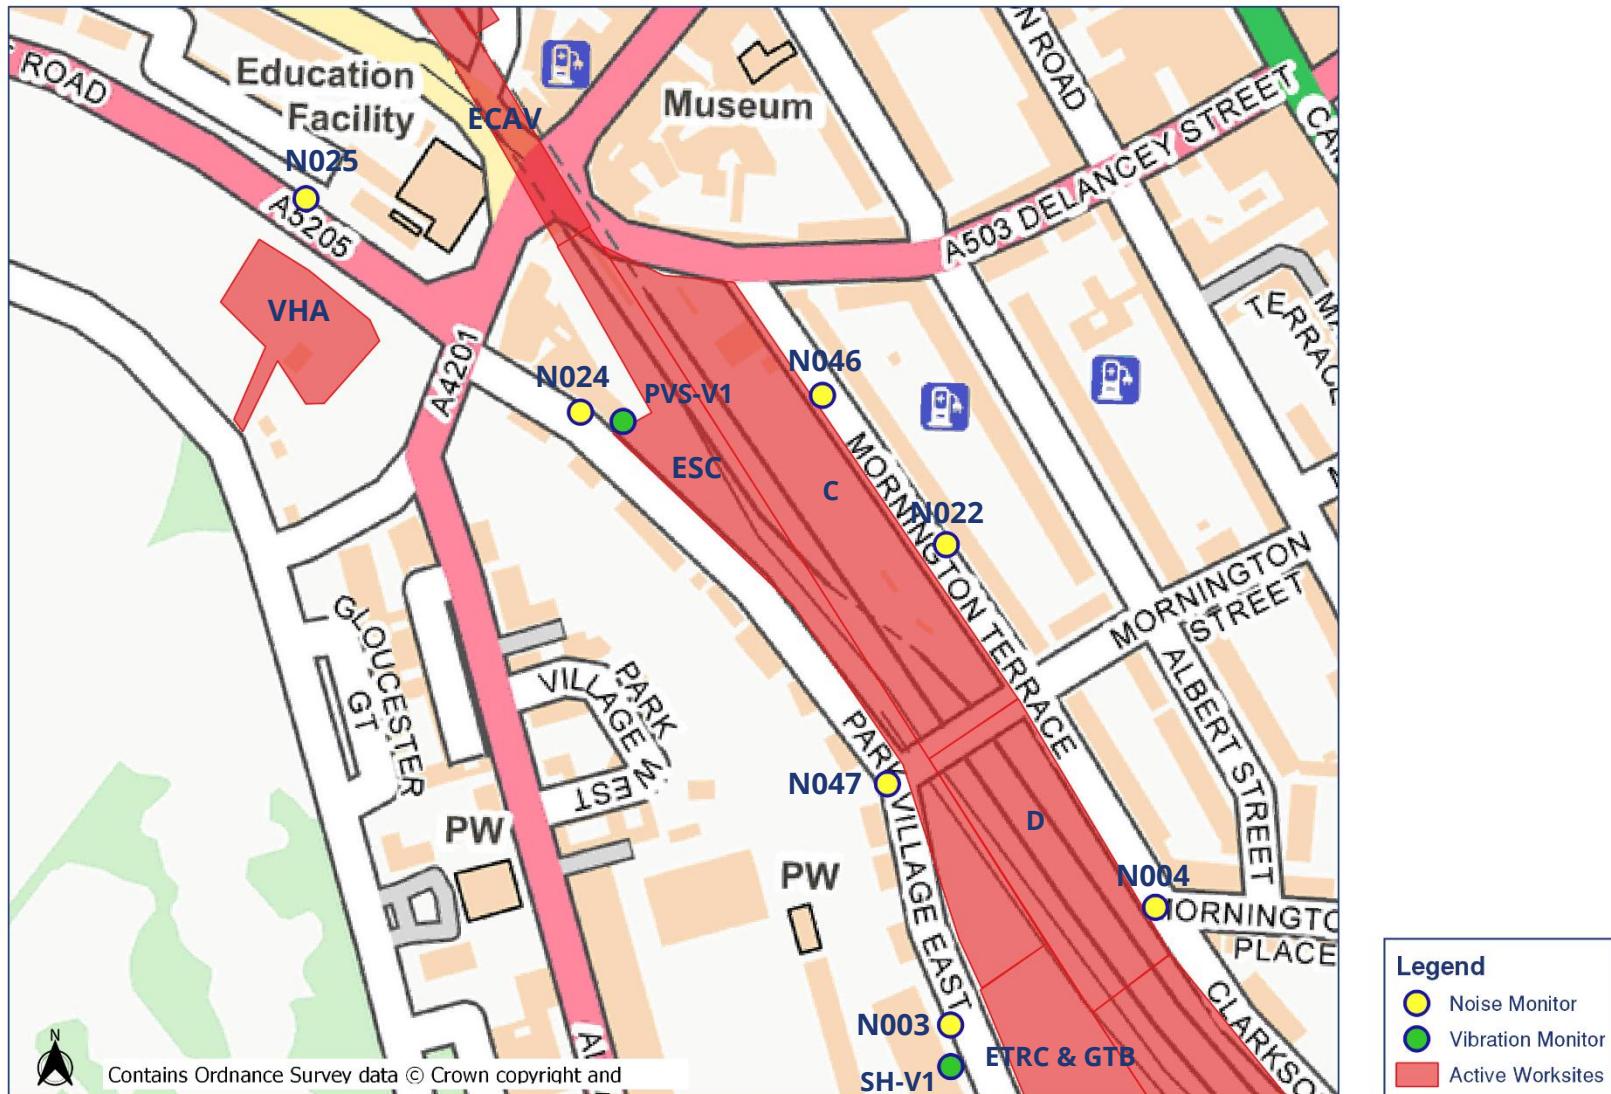
Noise and vibration monitoring plan - 3

- Noise Monitor
- Vibration Monitor
- Active Worksites

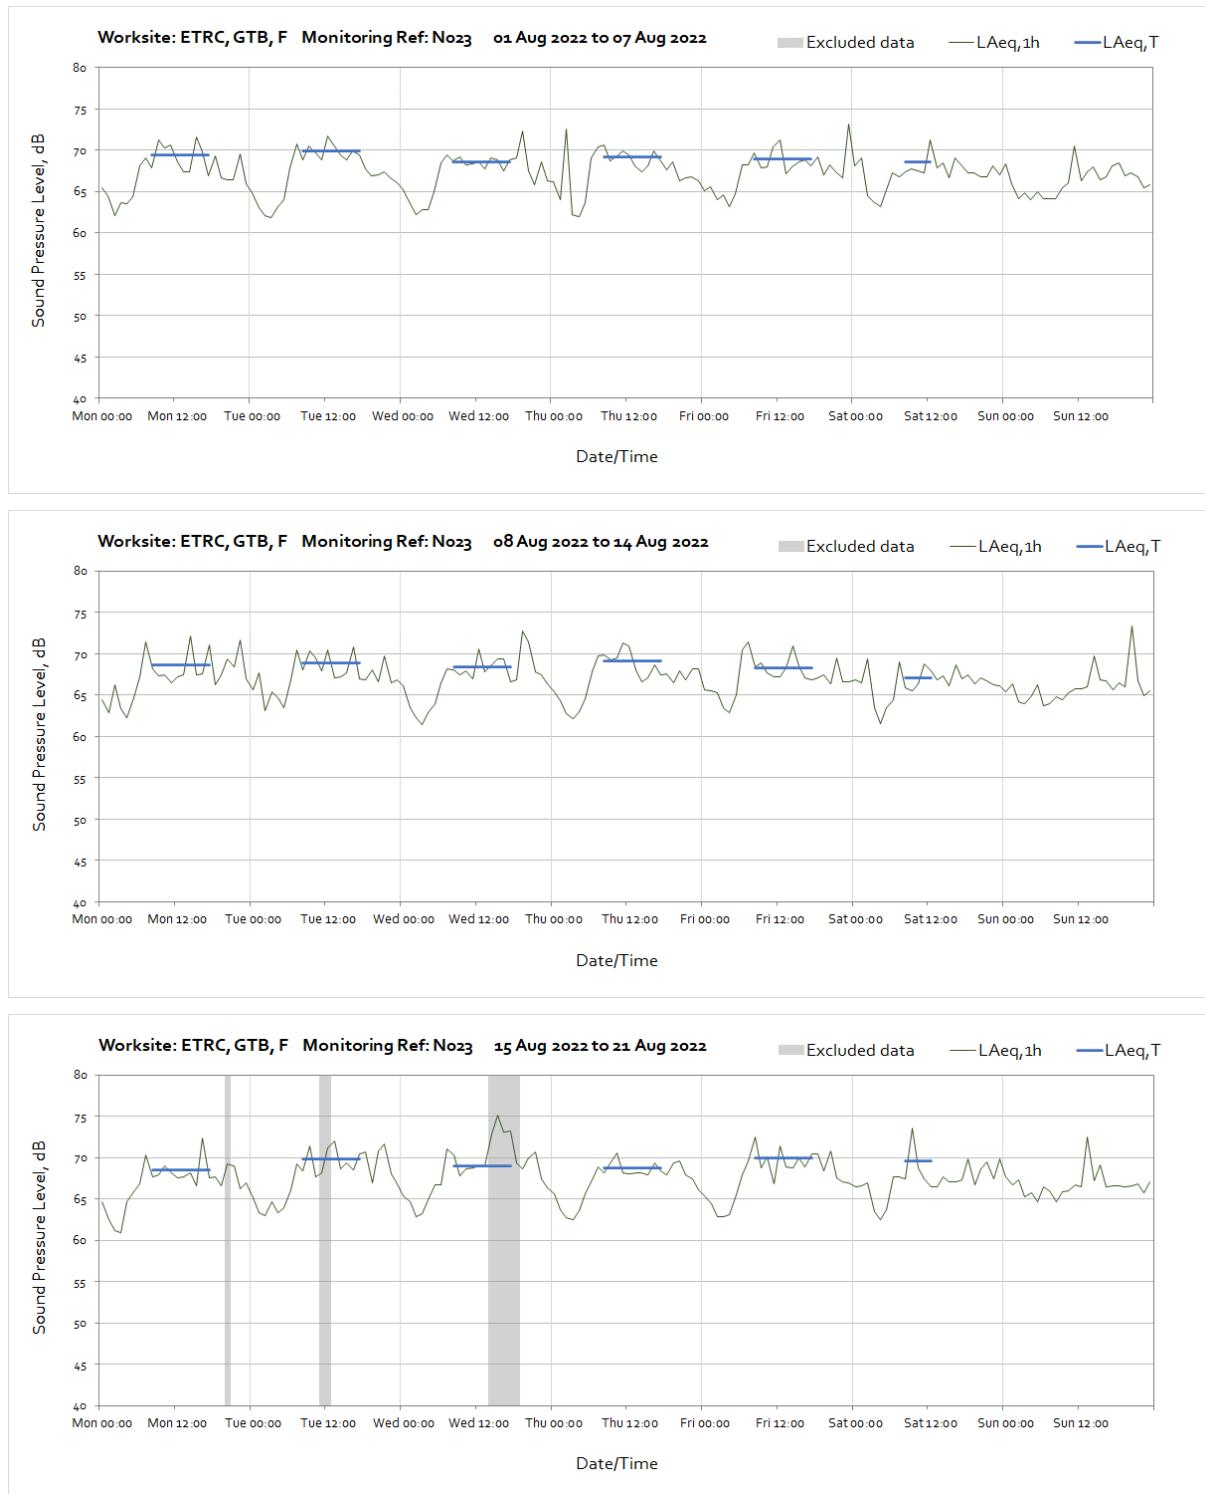
Worksite: ETRC & GTB, F - Monitoring Ref: N023

- 2.1.3 Appendix C presents graphs of the noise and vibration monitoring data over the month for each of the measurement locations. Noise data presented consists of the hourly L_{Aeq} values and, where relevant, the $L_{Aeq,T}$ values (where the time period T has been taken to be the averaging period as specified in Table 1 of HS2 Information Paper E23). Vibration data presented consist of hourly PPV values. The full data set for the monitoring equipment can be found at the following location:
<https://data.gov.uk/dataset/24542ae7-dd44-444f-b259-871c4cc43b5e/environmental-monitoring-data>.

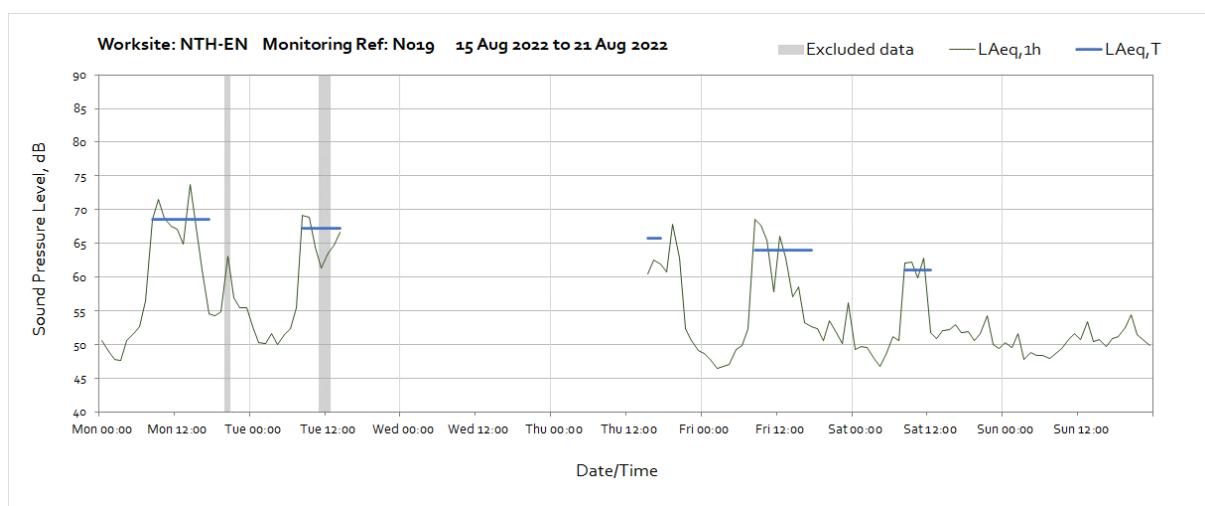
Note: Missing data from 15:00 on Tuesday 16th August until 15:00 on Thursday 18th August was due to loss of power to the monitoring station.
