Construction Noise and Vibration Monthly Report – September 2022

London Borough of Camden

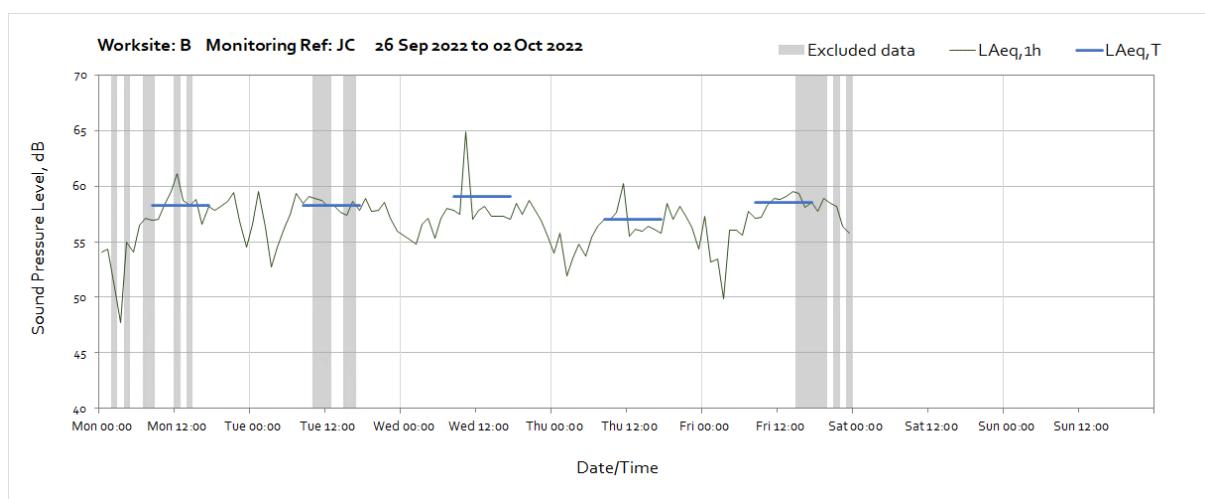
Worksite: B – Monitoring Ref: JC

The following graphs show the hourly measured ambient noise level $L_{Aeq,1h}$ and, where relevant, the averaged noise level $L_{Aeq,T}$ values, where the time period T is as specified in Table 1 of HS2 Information Paper E23. Periods with adversely weather affected noise levels are greyed out and have been excluded from the calculation of the $L_{Aeq,T}$ values in Table 3 of the main report.
