## **Construction Noise and Vibration Monthly Report – September 2022**

**Warwick District Council**

# Non-Technical Summary

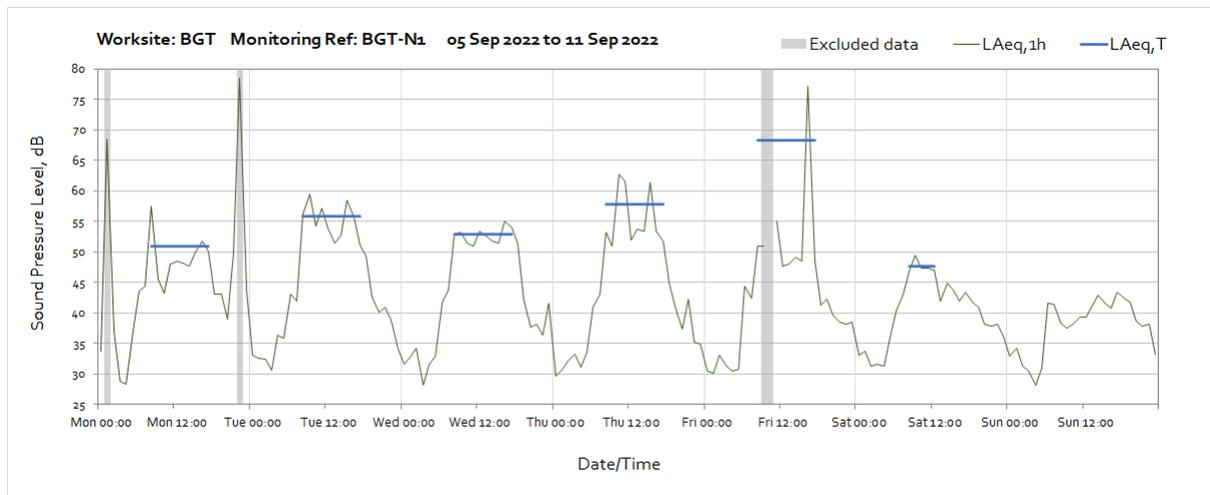
### Worksite: BGT - Monitoring Ref: BGT-N1

The following graphs show the hourly measured ambient noise level  $L_{Aeq,1h}$  and, where relevant, the averaged noise level  $L_{Aeq,T}$  values, where the time period T is as specified in Table 1 of HS2 Information Paper E23. Periods with adversely weather affected noise levels are greyed out and have been excluded from the calculation of the  $L_{Aeq,T}$  values in Table 3 of the main report.

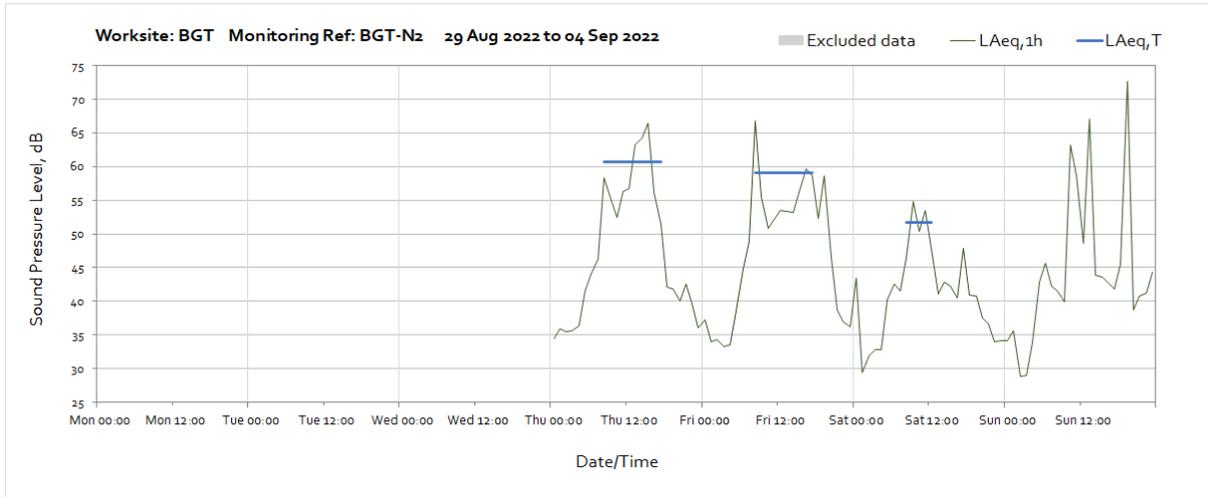
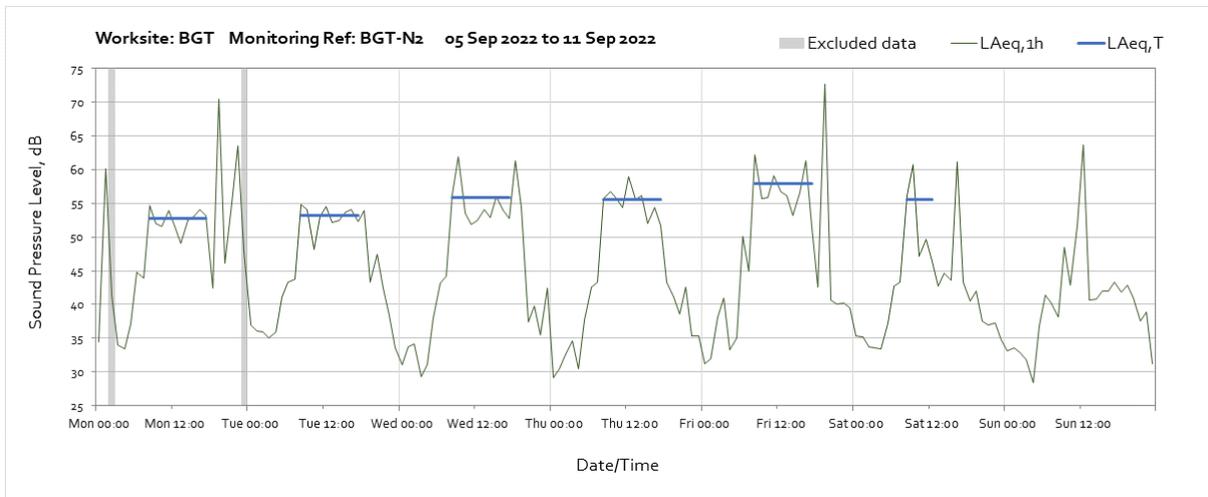
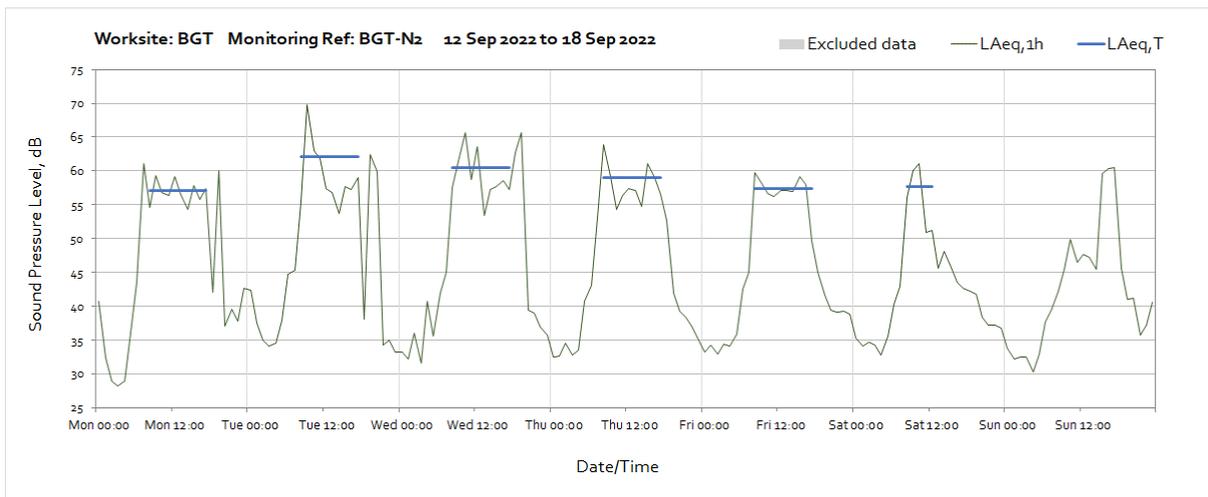
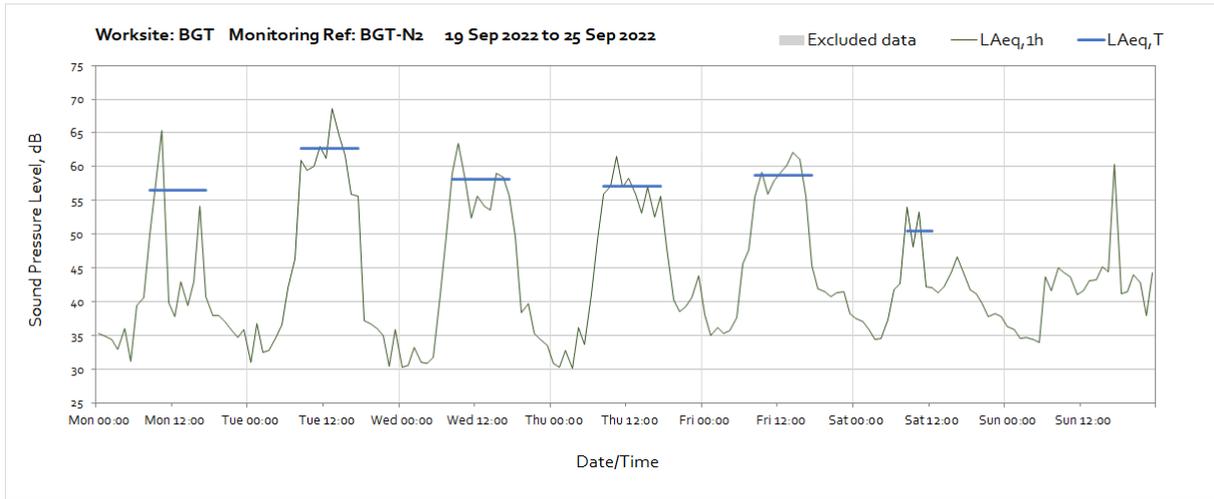
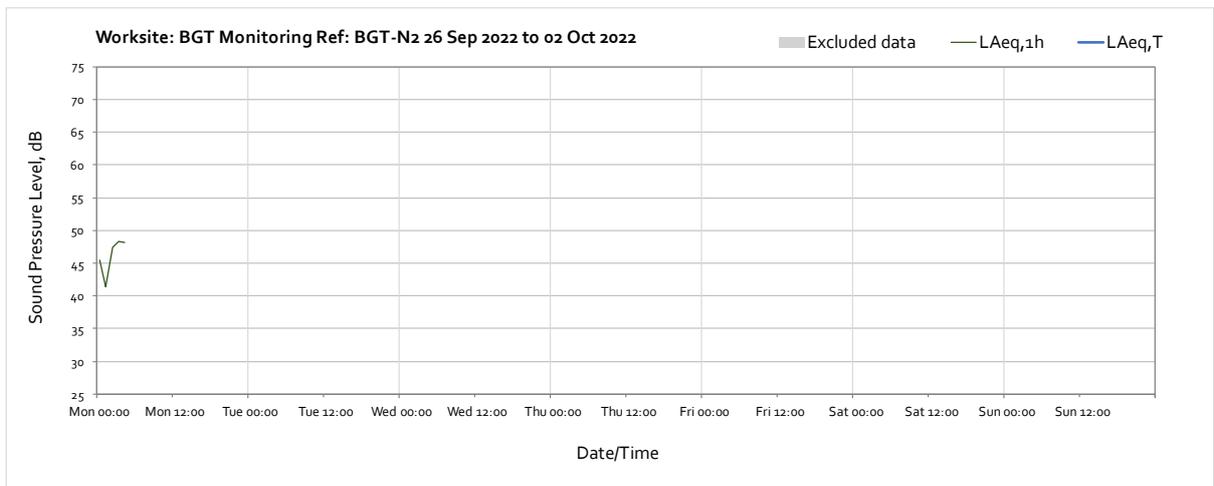
## Worksite: BGT - Monitoring Ref: BGT-N2

Note: Missing data from 05:00 on the 26<sup>th</sup> September until the end of the month was due an interruption of mains power to the monitor caused.

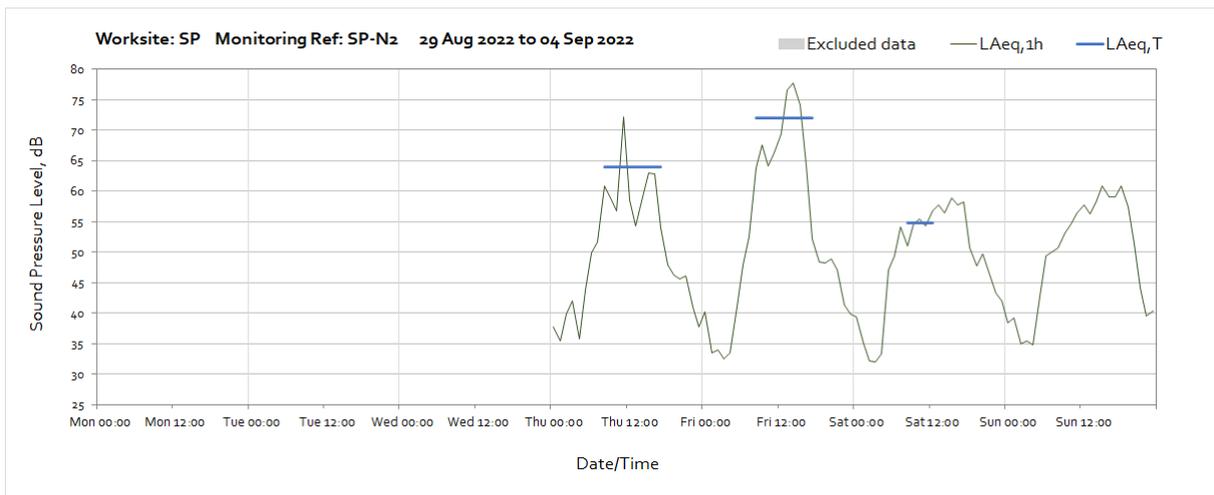
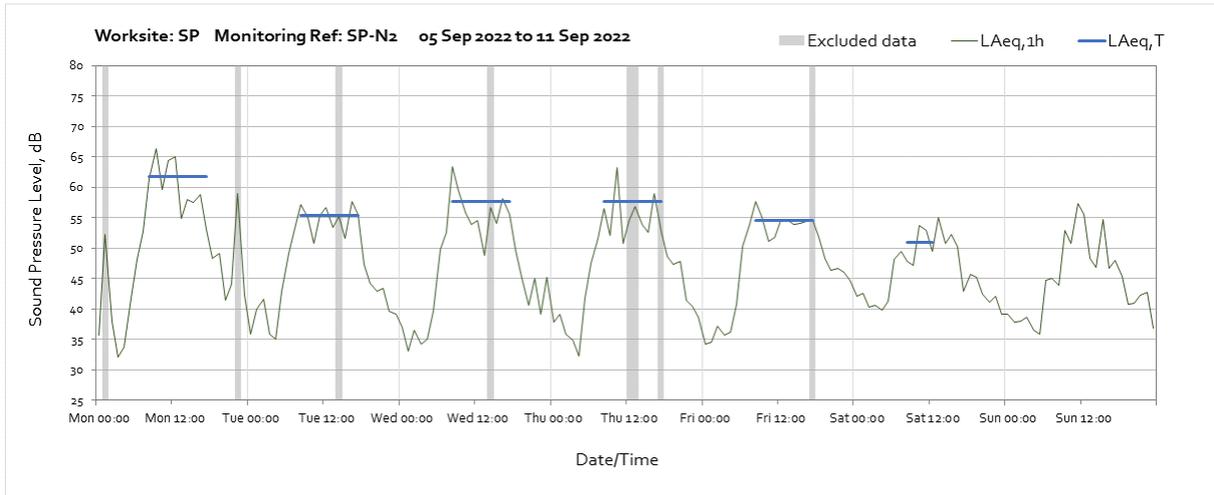
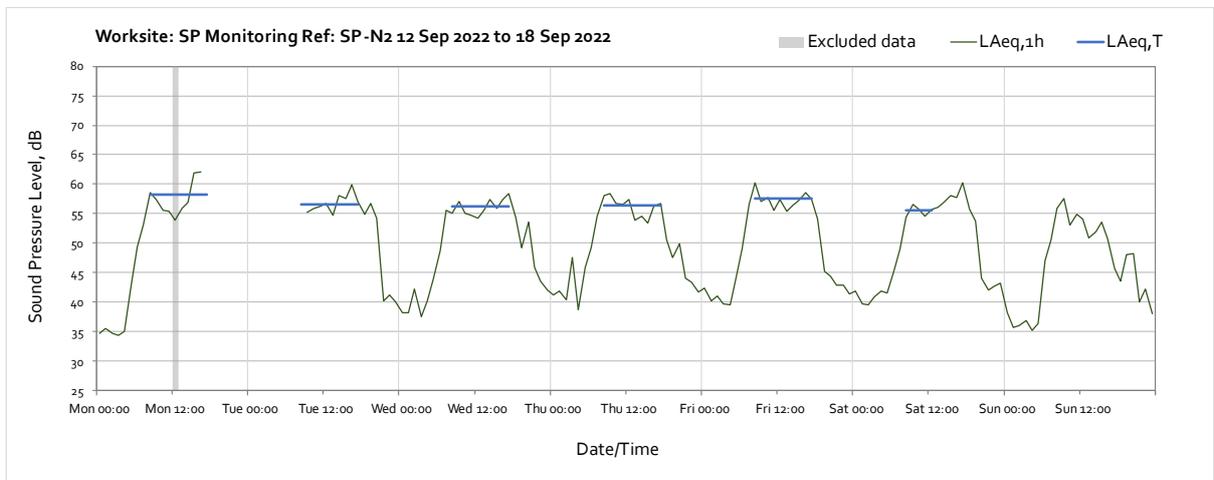
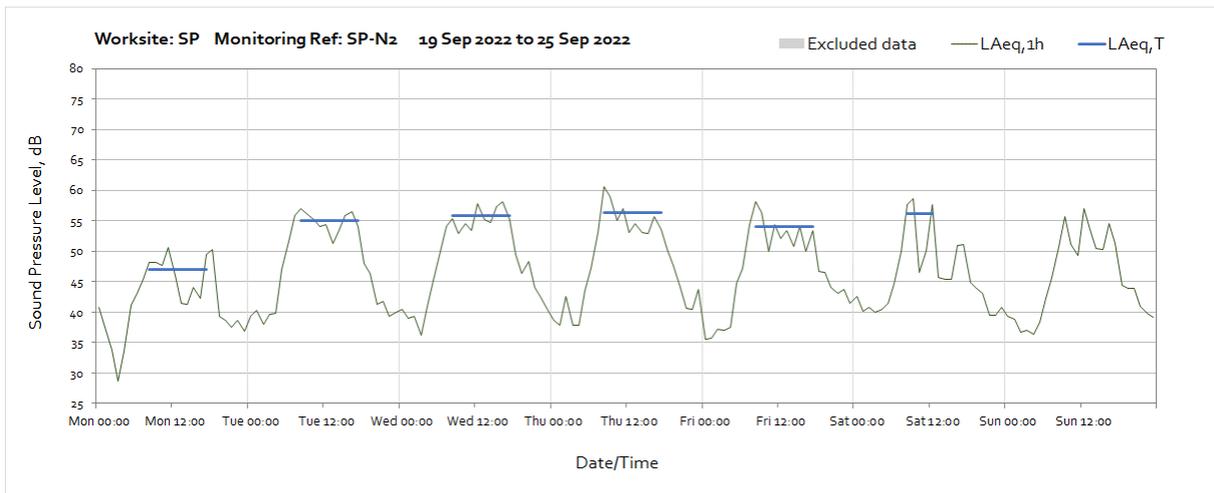
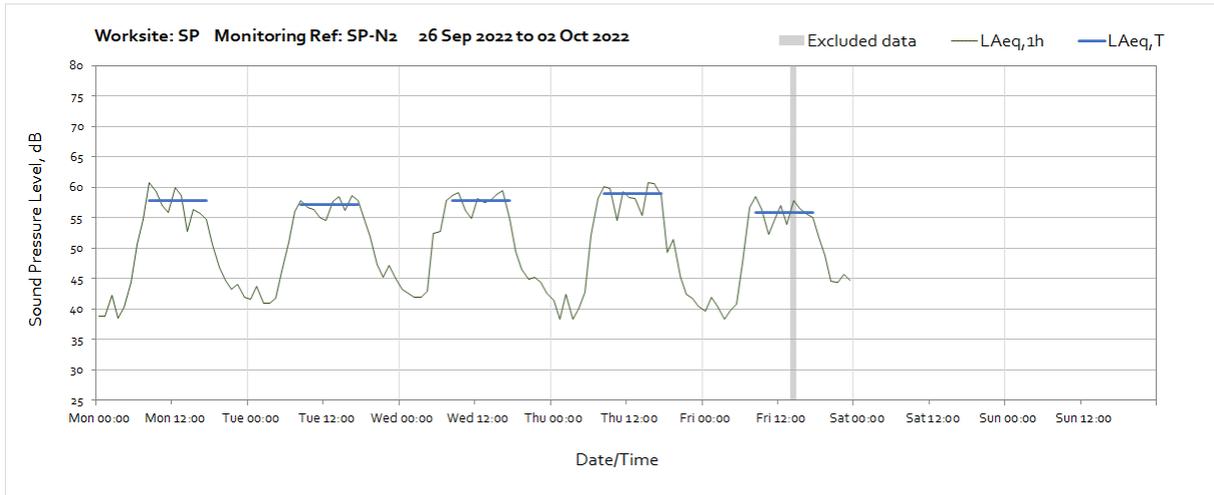
### Worksite: SP – Monitoring Ref: SP-N2

Note: Missing data between 17:00 on the 12<sup>th</sup> September and 09:00 on the 13<sup>th</sup> September was due to a temporary system fault.

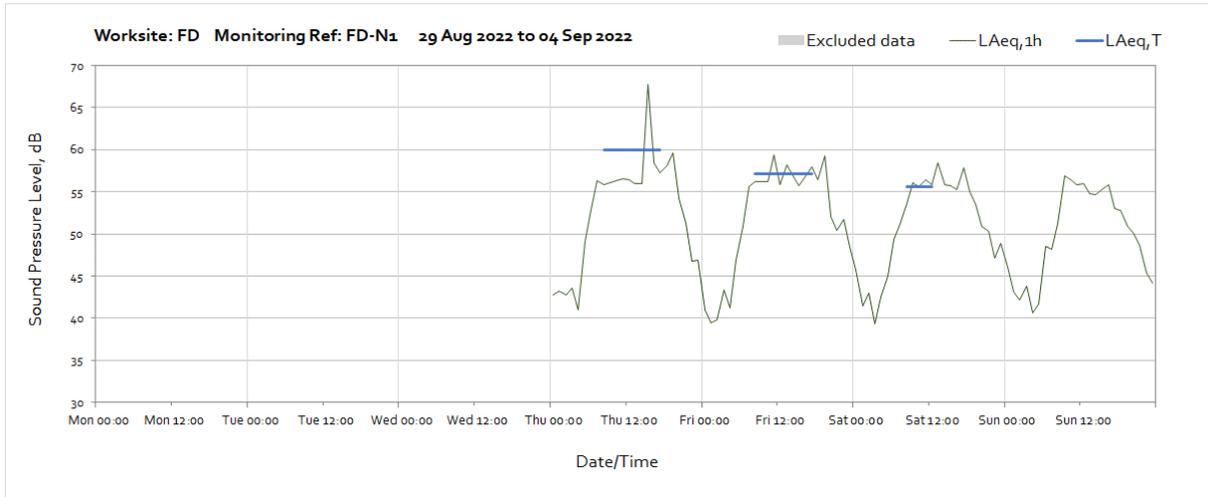
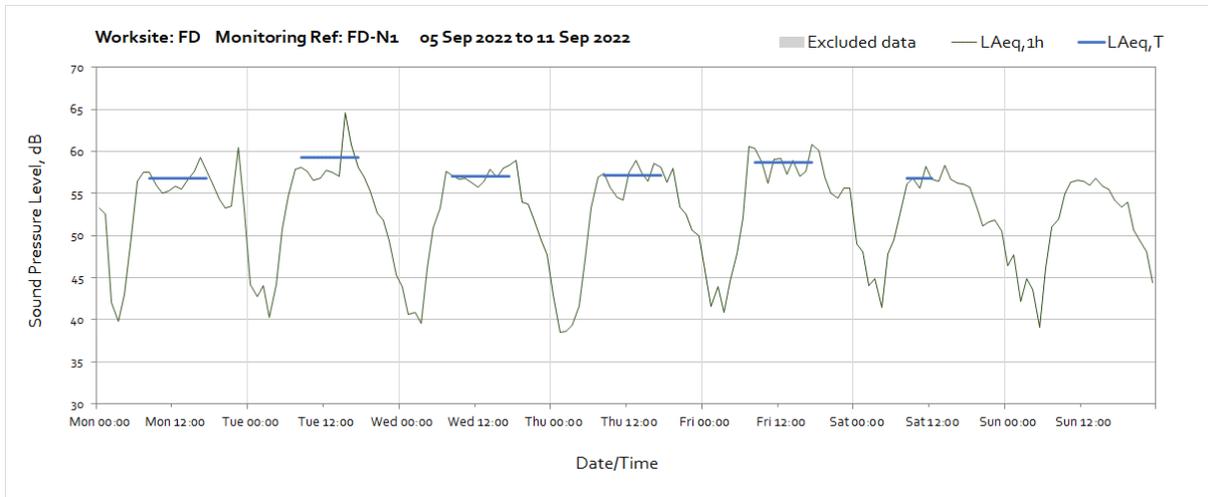
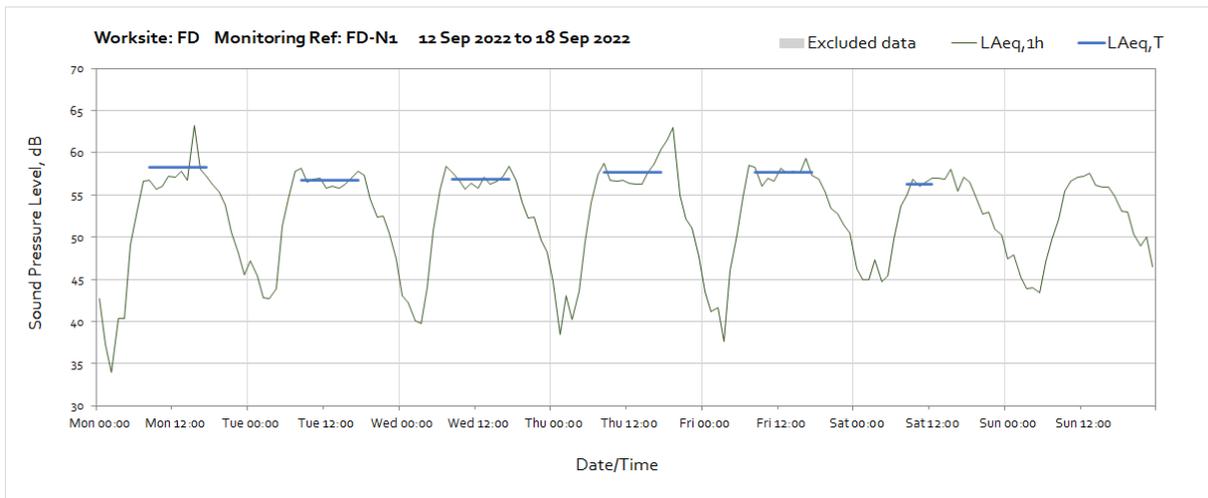
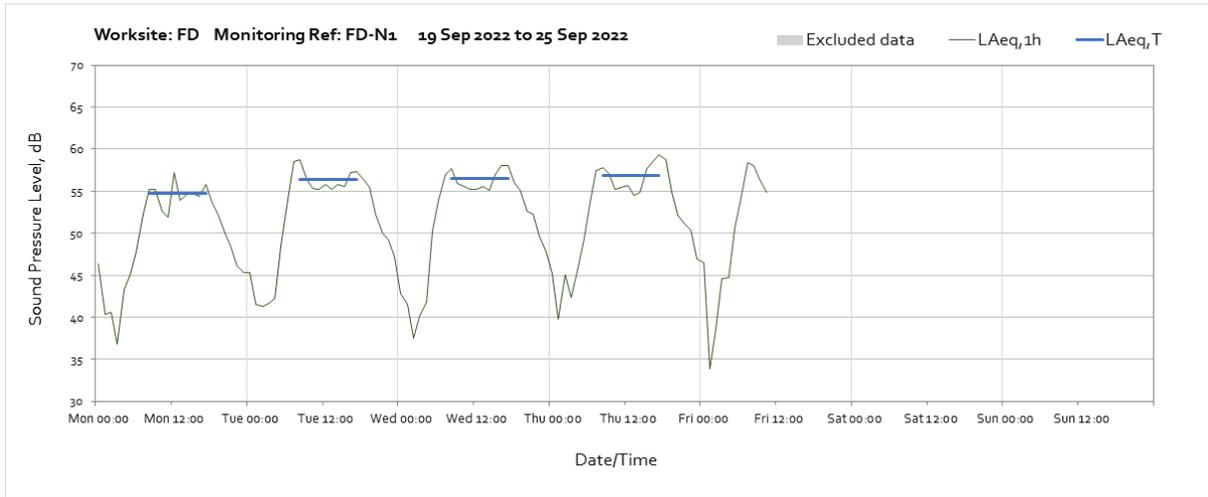
## Worksite: FD – Monitoring Ref: FD-N1

Note: The monitor was removed from site after 11:00 on 23 September 2022.

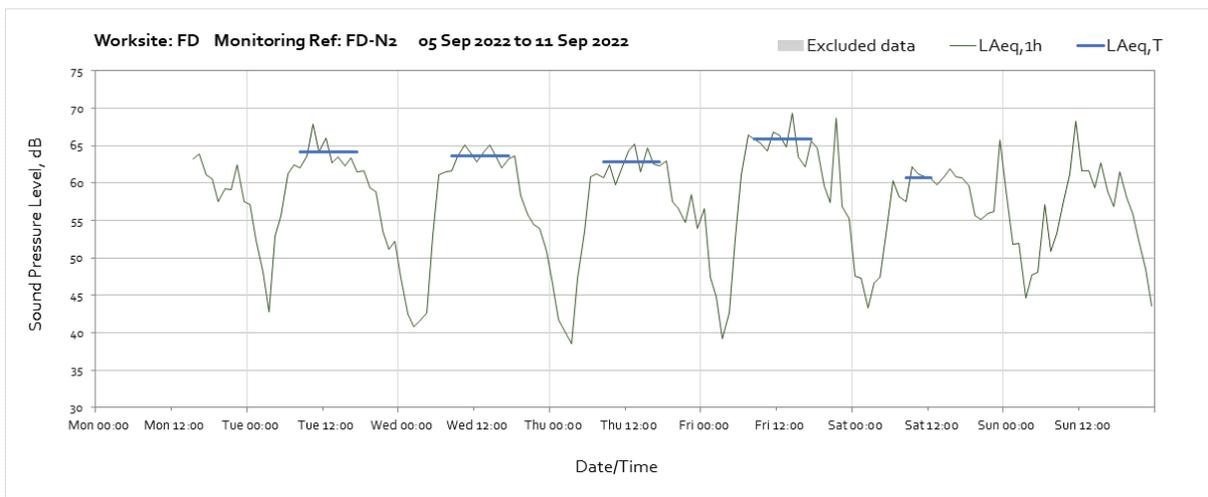
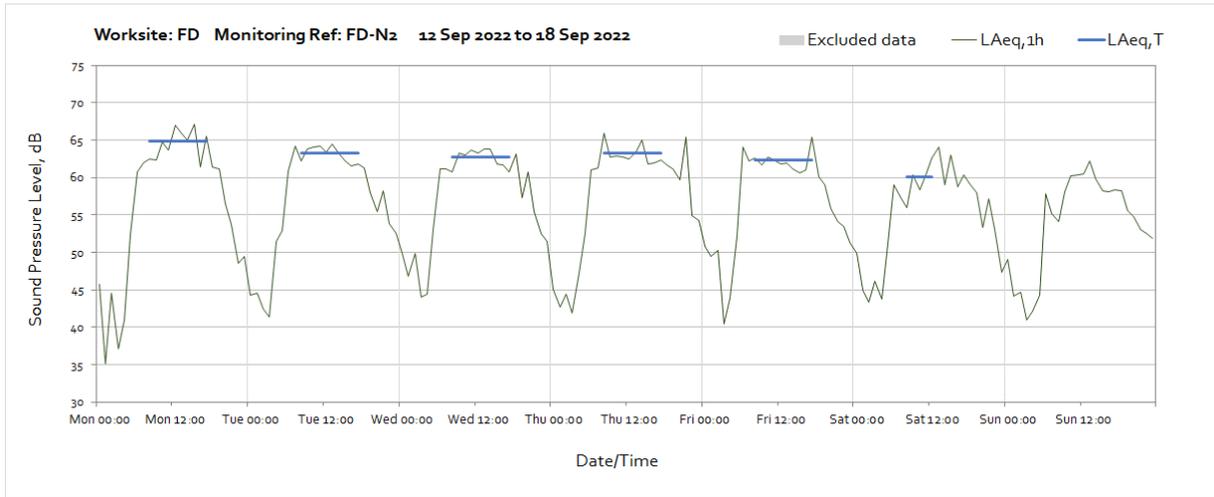
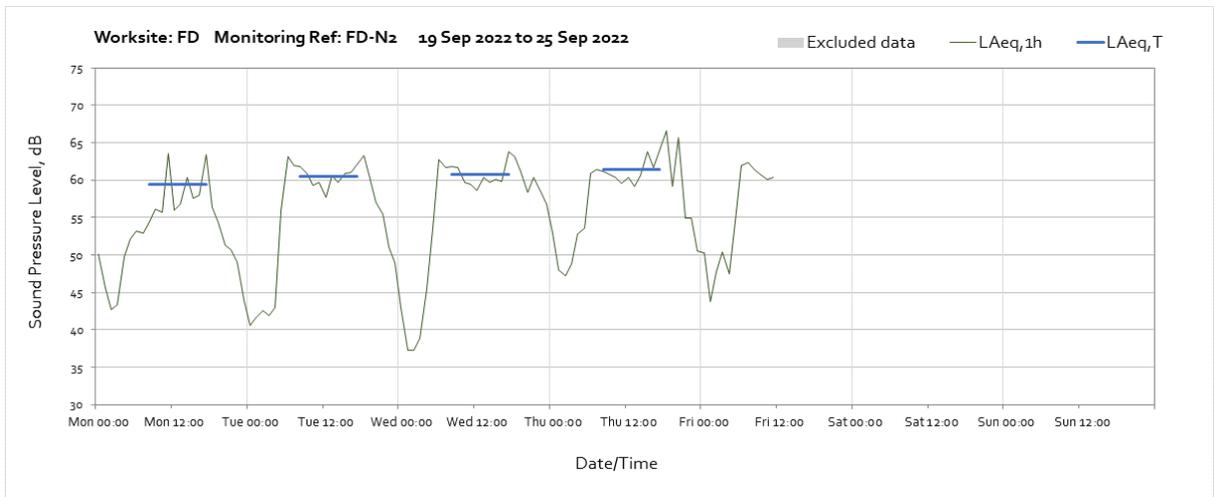
### Worksite: FD – Monitoring Ref: FD-N2

Note: Prior to 15:00 on 5<sup>th</sup> September there was a logger fault and corrupting data recorded from the beginning of the month.

Note: The monitor was removed from site after midday on 23 September 2022.

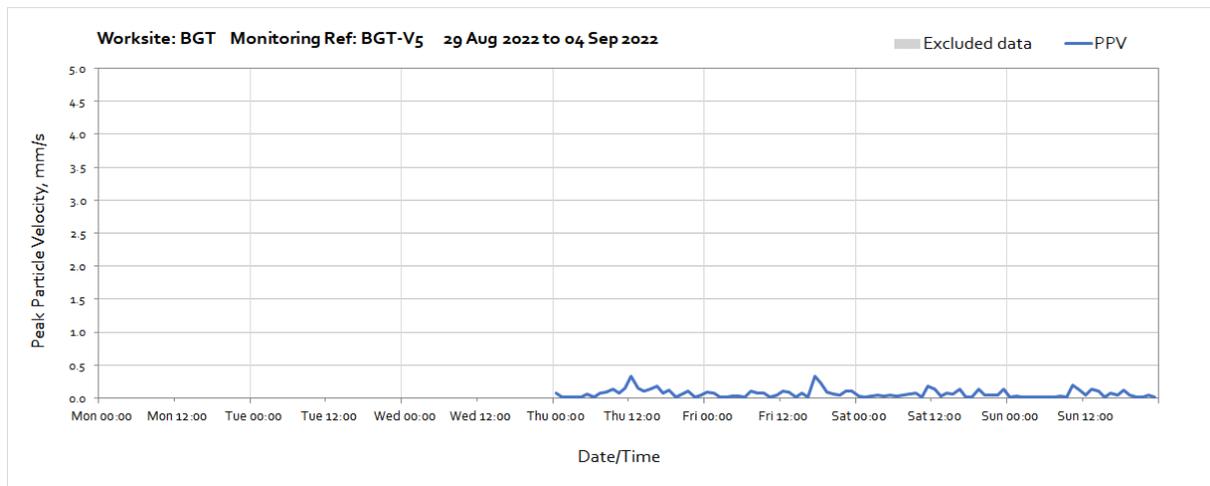
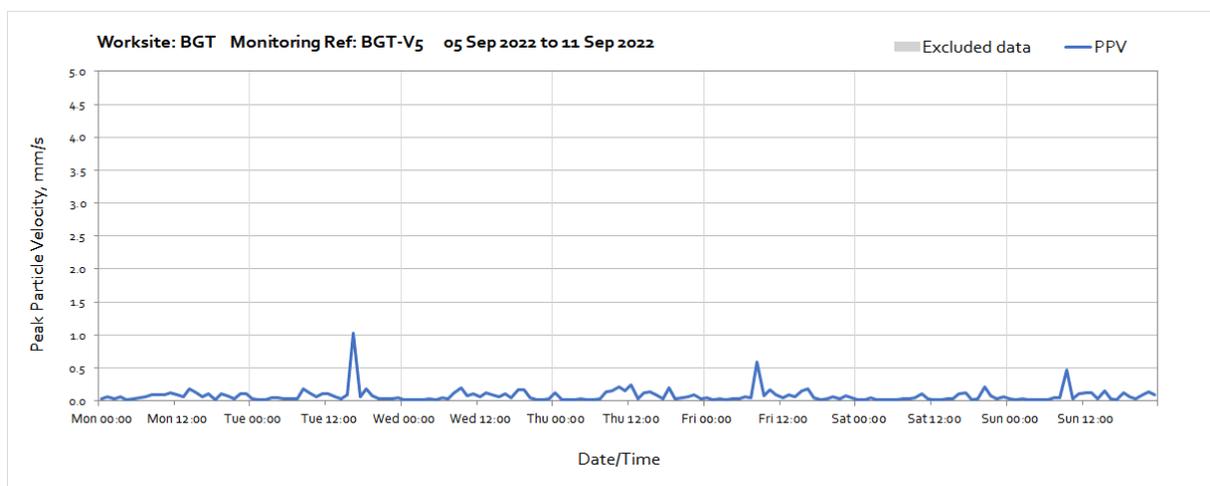
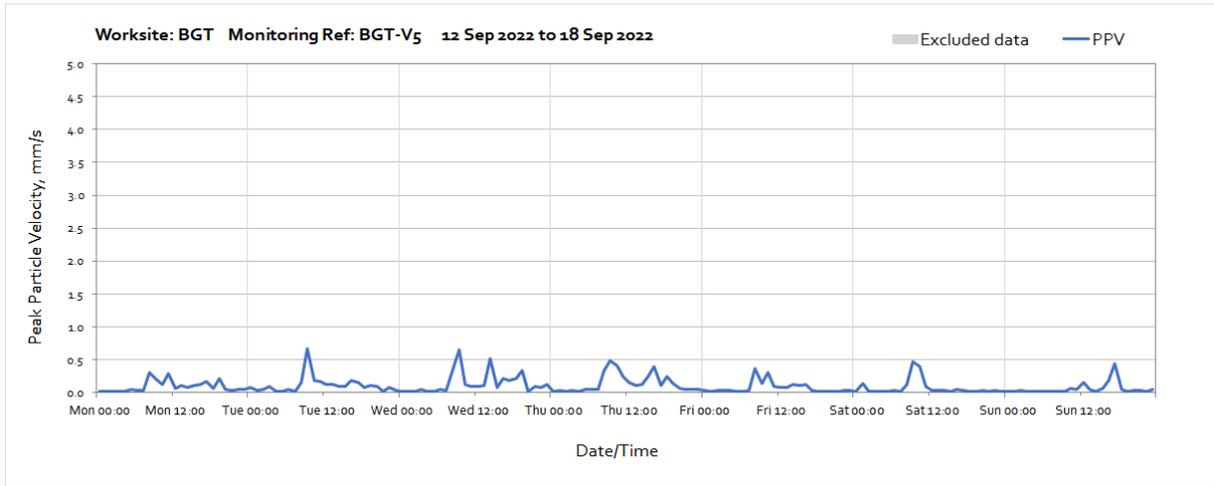
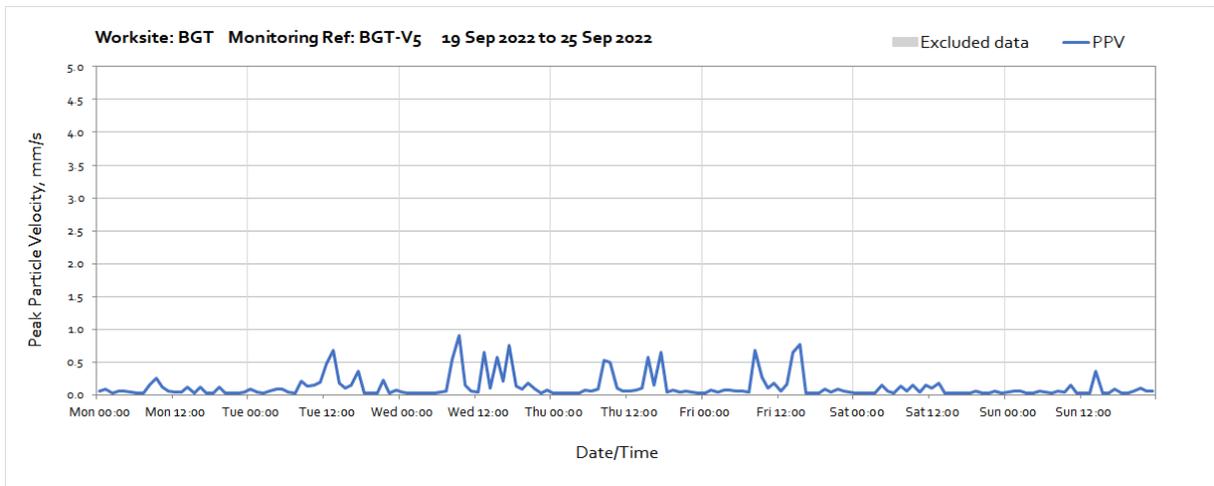
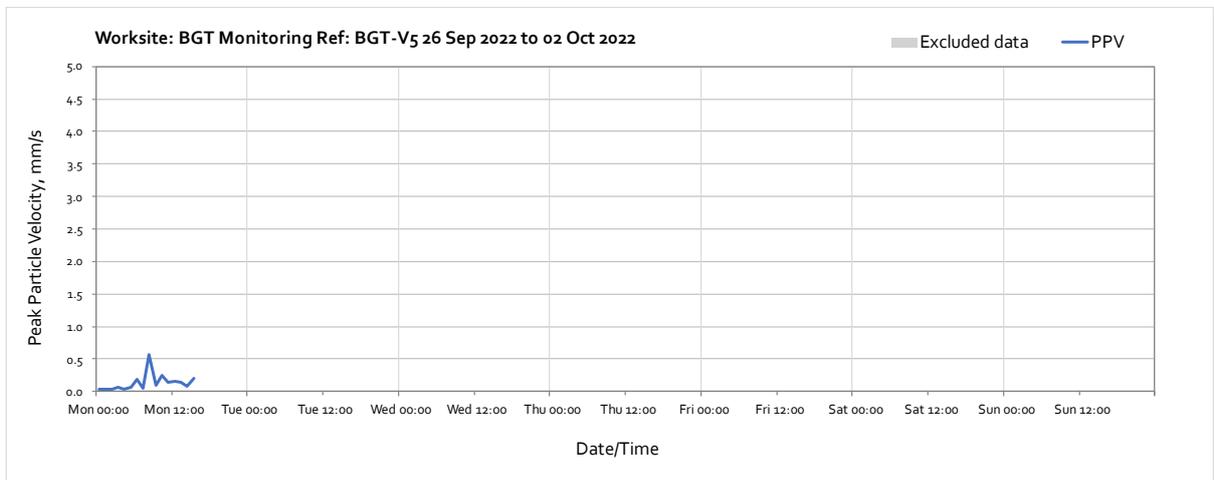
### Worksite: BGT – Monitoring Ref: BGT-V5

The following graphs show the hourly measured peak particle velocity PPV recorded during the monitoring period. The graphs show the resultant PPV due to vibration components on three orthogonal axes x, y and z. Where resultant PPV data is not available, the highest vibration component in either of the three axes is presented for each 1hr measurement period respectively. Where high values of PPV were caused by local interference with the vibration monitor, which are not representative of HS2 construction works, these values have been greyed out in the following charts and have been excluded to calculate values in Table 4 of the main report.

Note: Missing data from 16:00 on the 26<sup>th</sup> September until the end of the month was due an interruption of mains power to the monitor.

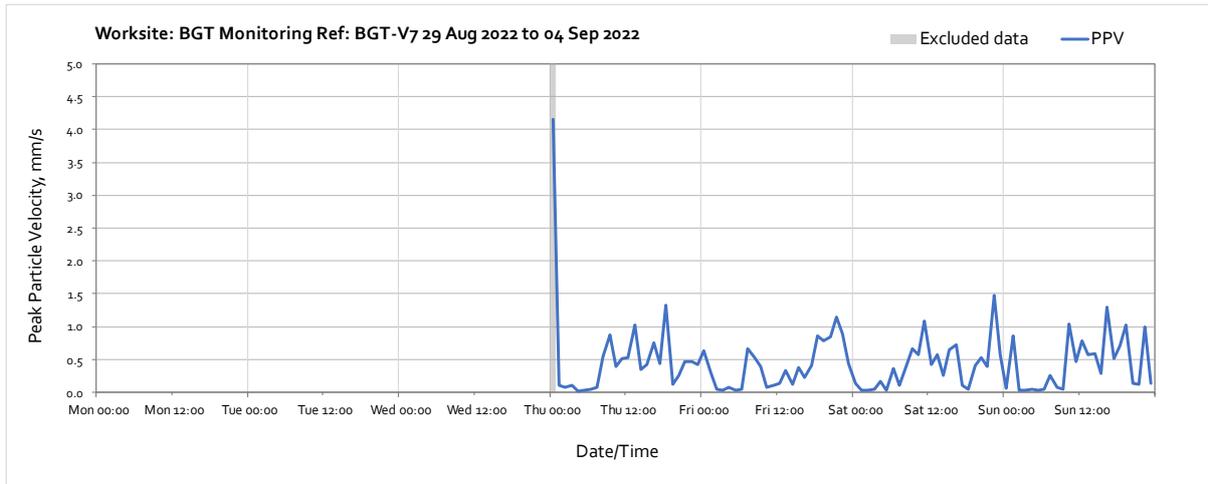
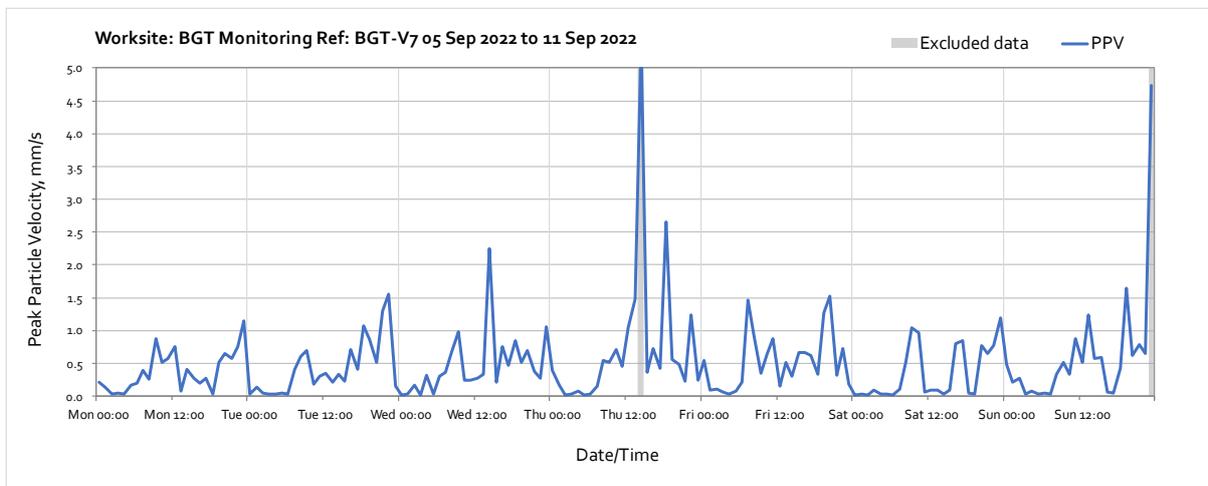
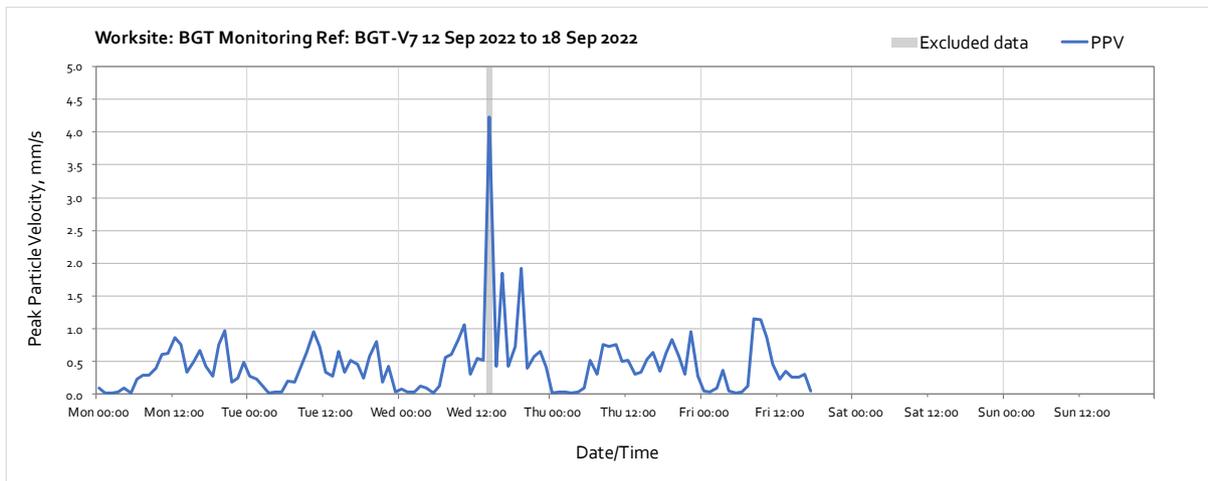
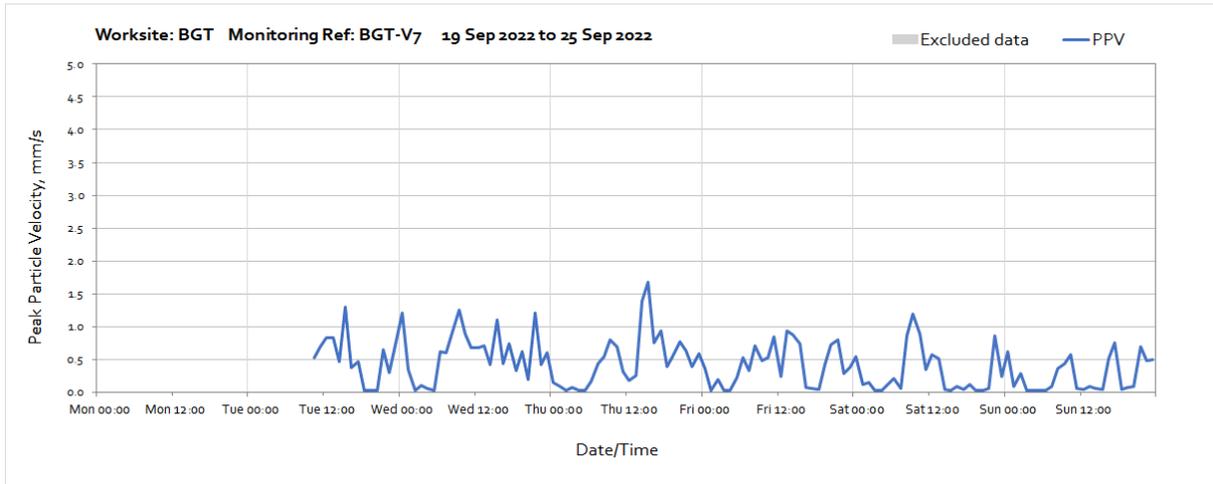
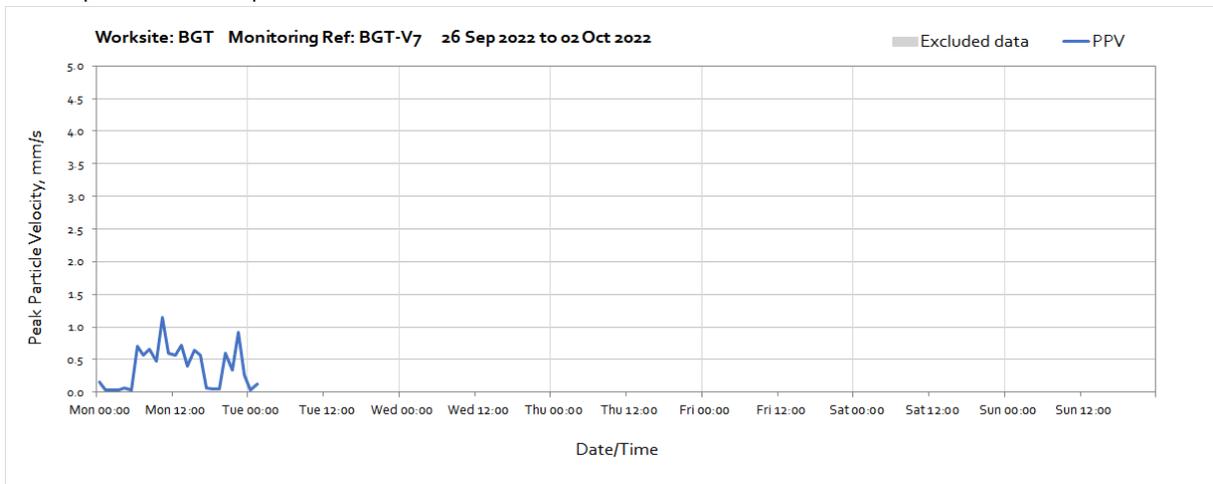
## Worksite: BGT - Monitoring Ref: BGT-V7

Note: Missing data from 18:00 on the 16th September until 10:00 on the 20th September was due an interruption of mains power to the monitor.

Note: Missing data from 18:00 on the 16<sup>th</sup> September until 10:00 on the 20<sup>th</sup> September was due an interruption of mains power to the monitor.

Note: Missing data from 02:00 on the 27<sup>th</sup> September until the end of the month was due an interruption of mains power to the monitor.

\*Note: Monitor BGT-V7 is installed within a residential premise and is subject to interference from normal activities within the property. Most of the elevated vibration levels at monitor BGT-V7 are not correlated with levels at monitor BGT-V5 installed outside of the property during the monitoring period, which demonstrates that these internal vibration levels are not due to external vibration levels due HS2.

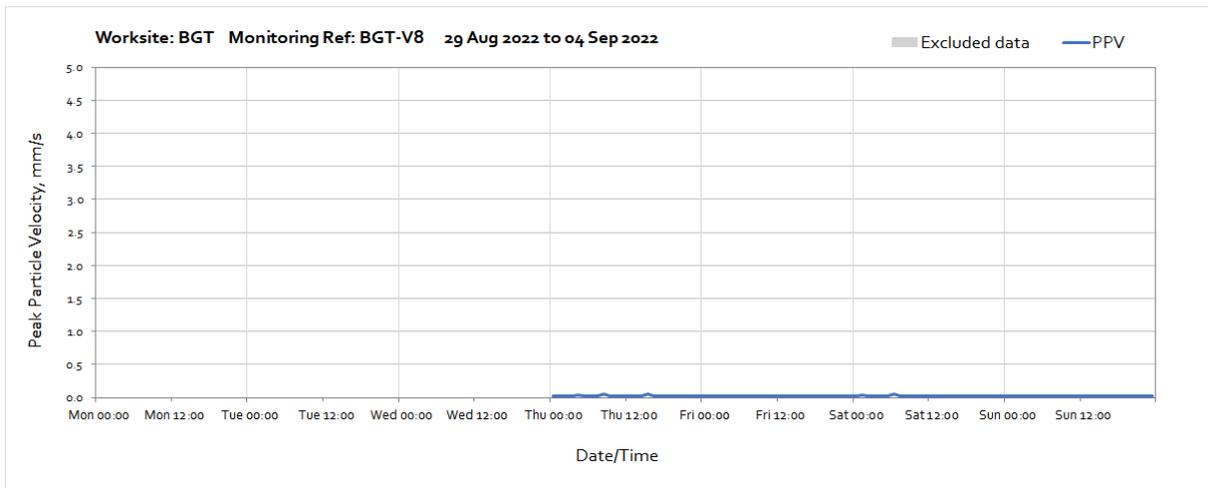
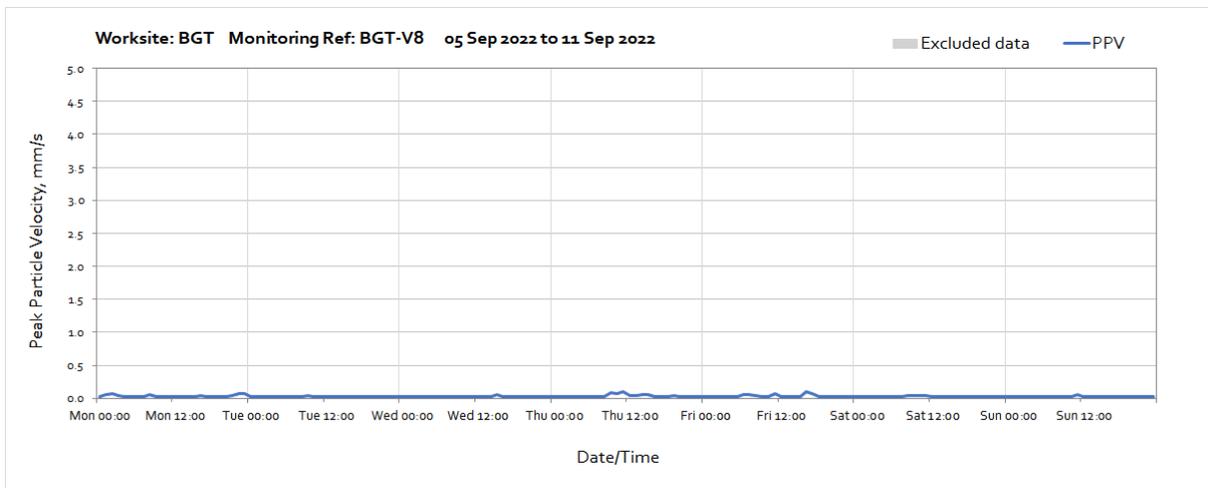
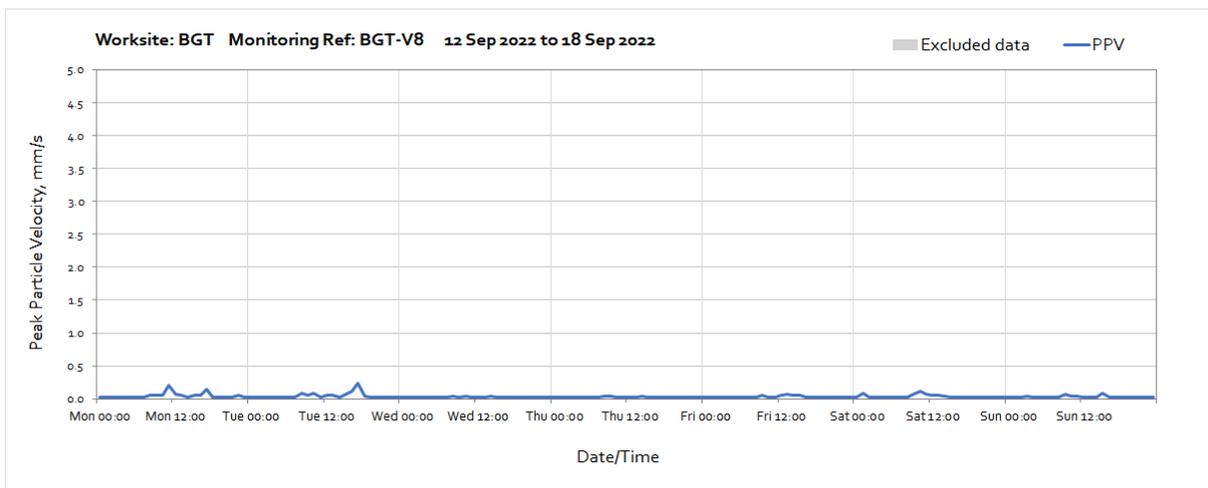
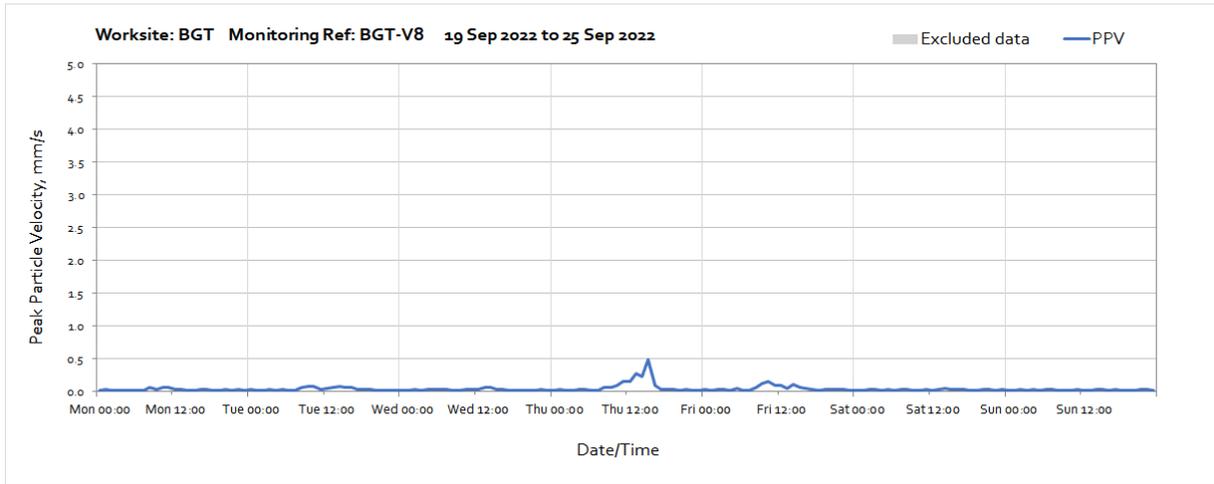
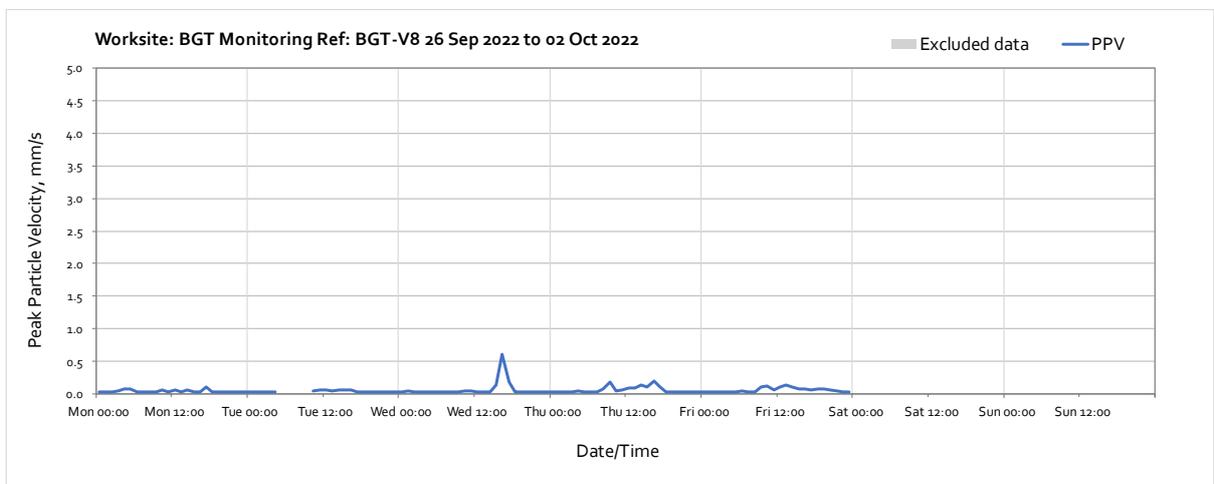
## Worksite: BGT - Monitoring Ref: BGT-V8

Note: Missing data between 05:00 and 10:00 on the 27<sup>th</sup> September was due to a temporary system fault.
