# OUTLINE WRITTEN SCHEME OF INVESTIGATION

Berden Hall Solar Farm, Pelham

JAC27783  
Berden Hall Solar Farm,  
Pelham  
1  
05 October 2022

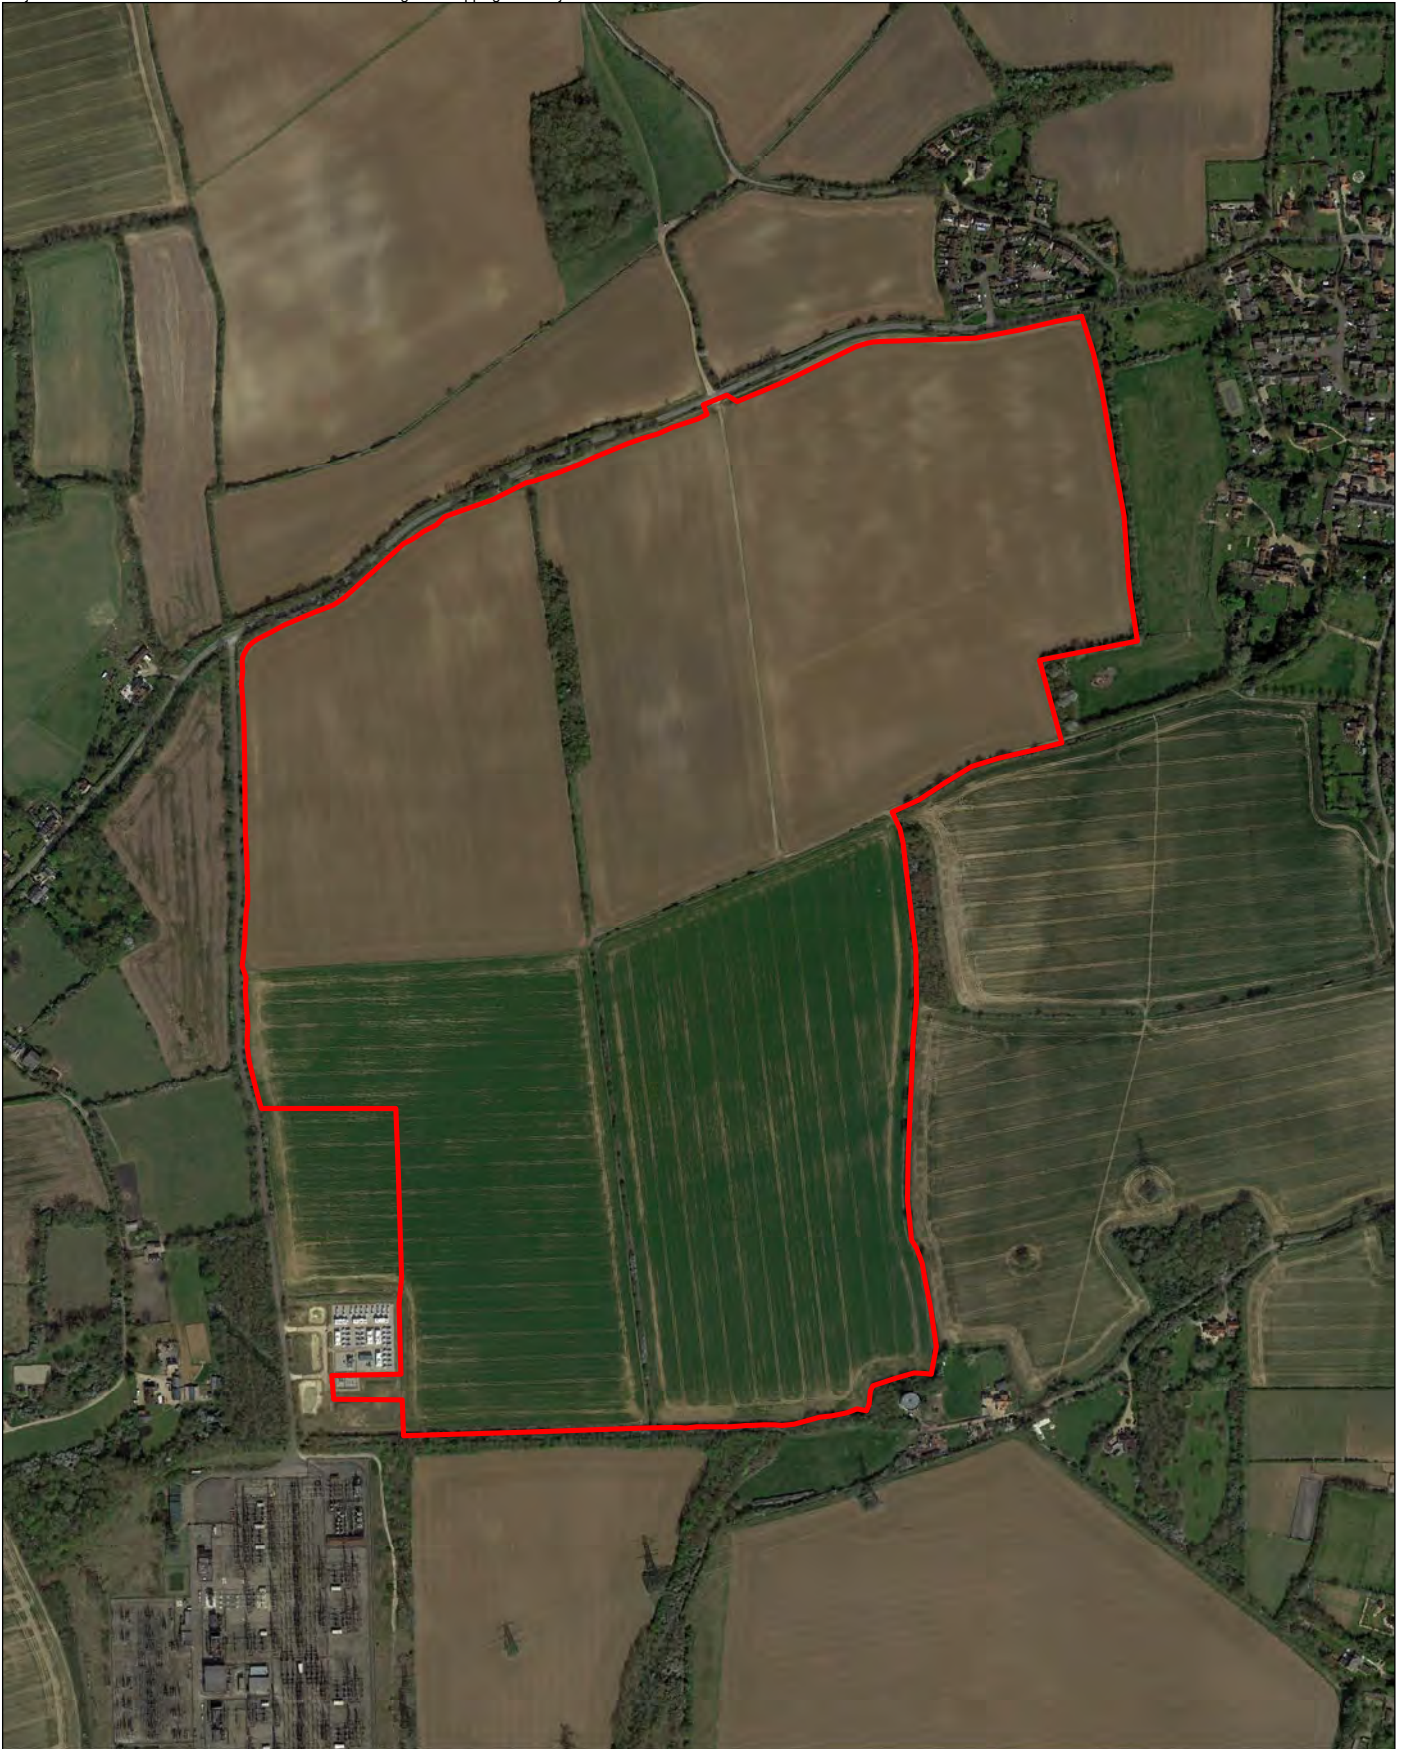
Figure 15

Historic Landscape Characterisation

- 1.25 A programme of Historic Landscape Characterisation (HLC) has been undertaken for this area (**Figure 15**). HLC is an aspect of more general landscape characterisation that seeks to provide an additional element of ‘time-depth’, allowing the historic evolution of the landscape to be perceived and understood.

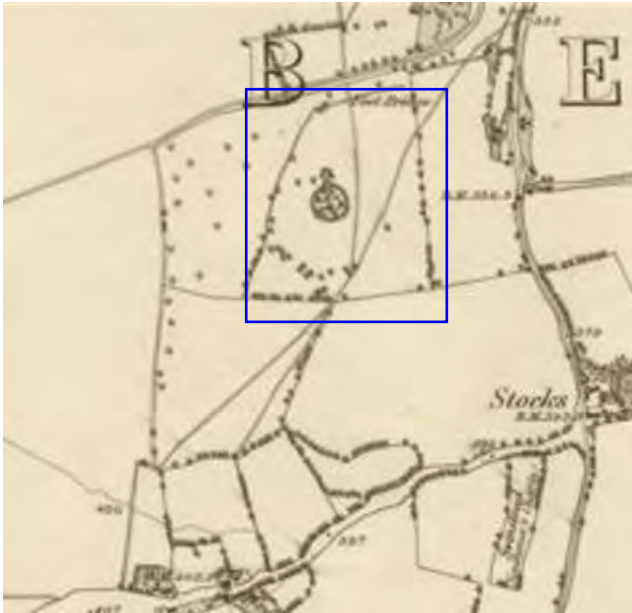
**Plate 1** Essex OS sheet XIII 6" to one mile 1881 (source: National Library of Scotland)

4.11. The 'ringwork' was shown as an extant curvilinear enclosure with a cut feature on its north side, and vegetation within, on the First Edition OS mapping which was surveyed in 1881 (**Plate 1**). The feature was recorded on RAF aerial photos in the 1940s and 1960s, when it was still extant as a vegetated enclosure, shown on **Plate 2**.

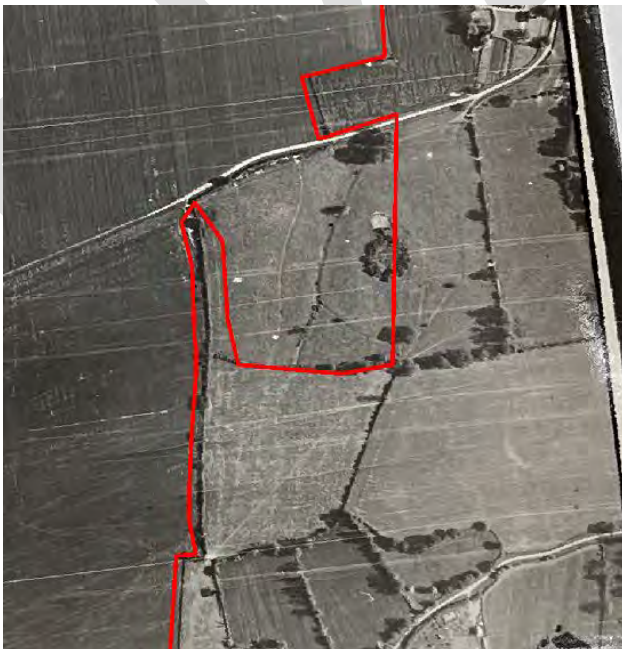
**Plate 2** Part of RAF 106G UK 1635 frame 5248 ©Historic England Archive, taken in 1946, with the site redline boundary which bisects the feature.

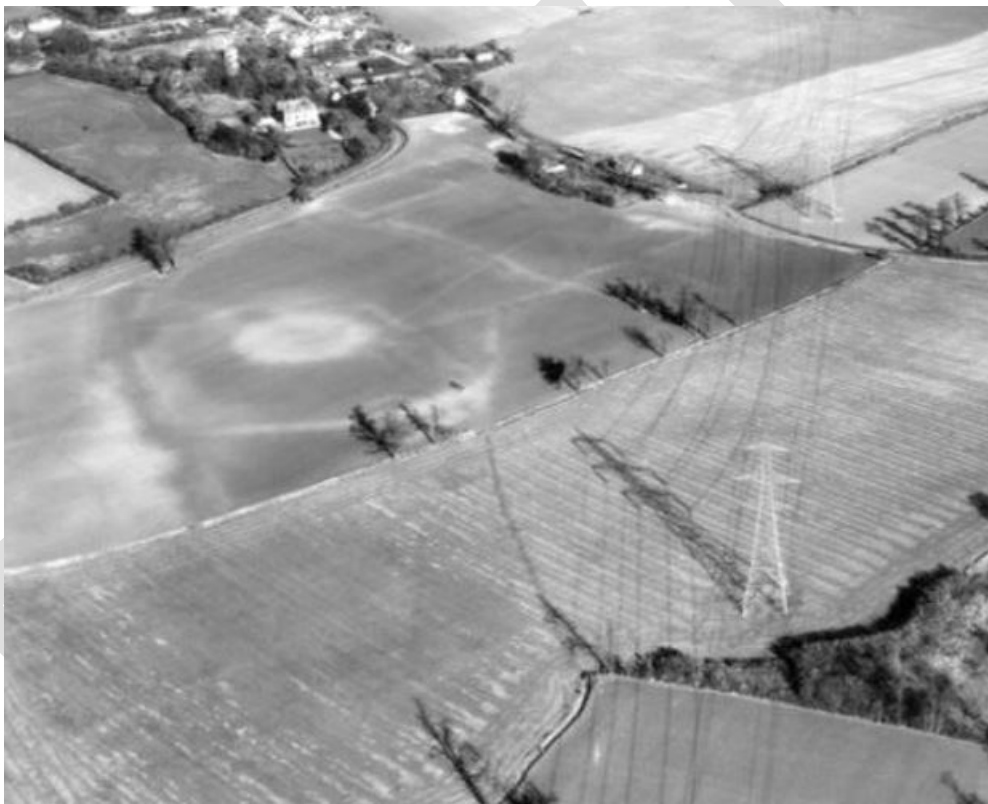
**Plate 3** Cambridge University Collection of Aerial Photography © copyright reserved

- 4.12. The site was again recorded in 1970, by Dr JK St Joseph at CUCAP, when the features had been ploughed out and were visible as a clear mark in soil over the residual motte and surrounding boundaries and drains.
- 4.13. Oblique aerial photographs BEN68-71 were taken in the afternoon of the 11<sup>th</sup> April 1970, and are available to view as lower resolution thumbnails on the CUCAP online catalogue. **Plate 3** shows part of BEN68, which clearly shows the ploughed out mound and its surrounding features. It was not possible to rectify this image for mapping as it is very oblique, but is an instructive illustration. Features within the area have been mapped from additional sources.

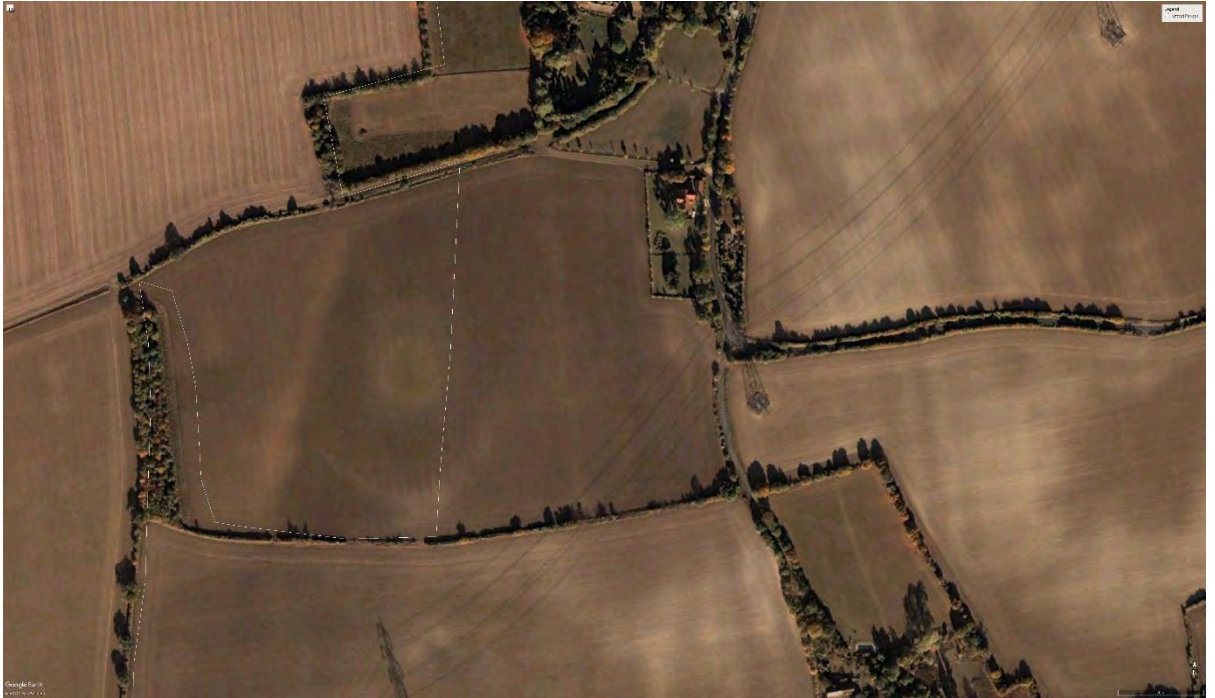
4.14. **Plate 4** shows the site when it was recorded in 2003 as a soilmark by Maxar Technologies satellite imagery, as shown at Google Earth.

**Plate 4** Map data, Google: Maxar Technologies, October 2003

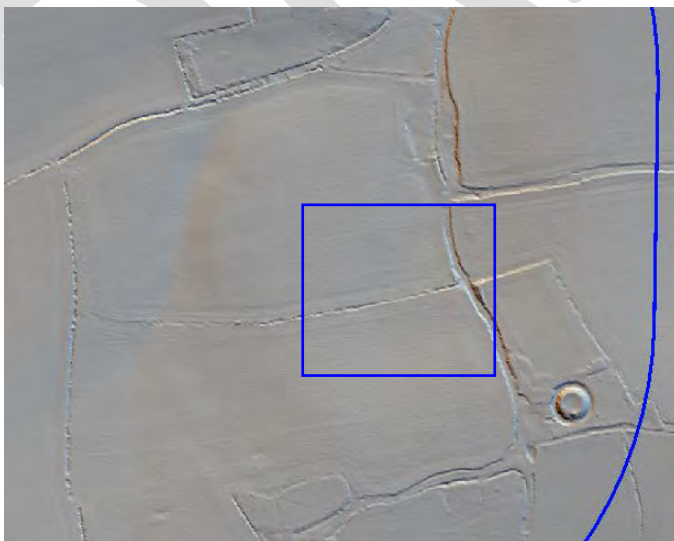
**Plate 6** the Hillshade visualisation does not show the very residual topography at the ringwork motte.

4.15. By 2019, The site is visible as a microtopographic feature *via* visualised LiDAR data which is shown over the page at **Plates 5 and 6**.

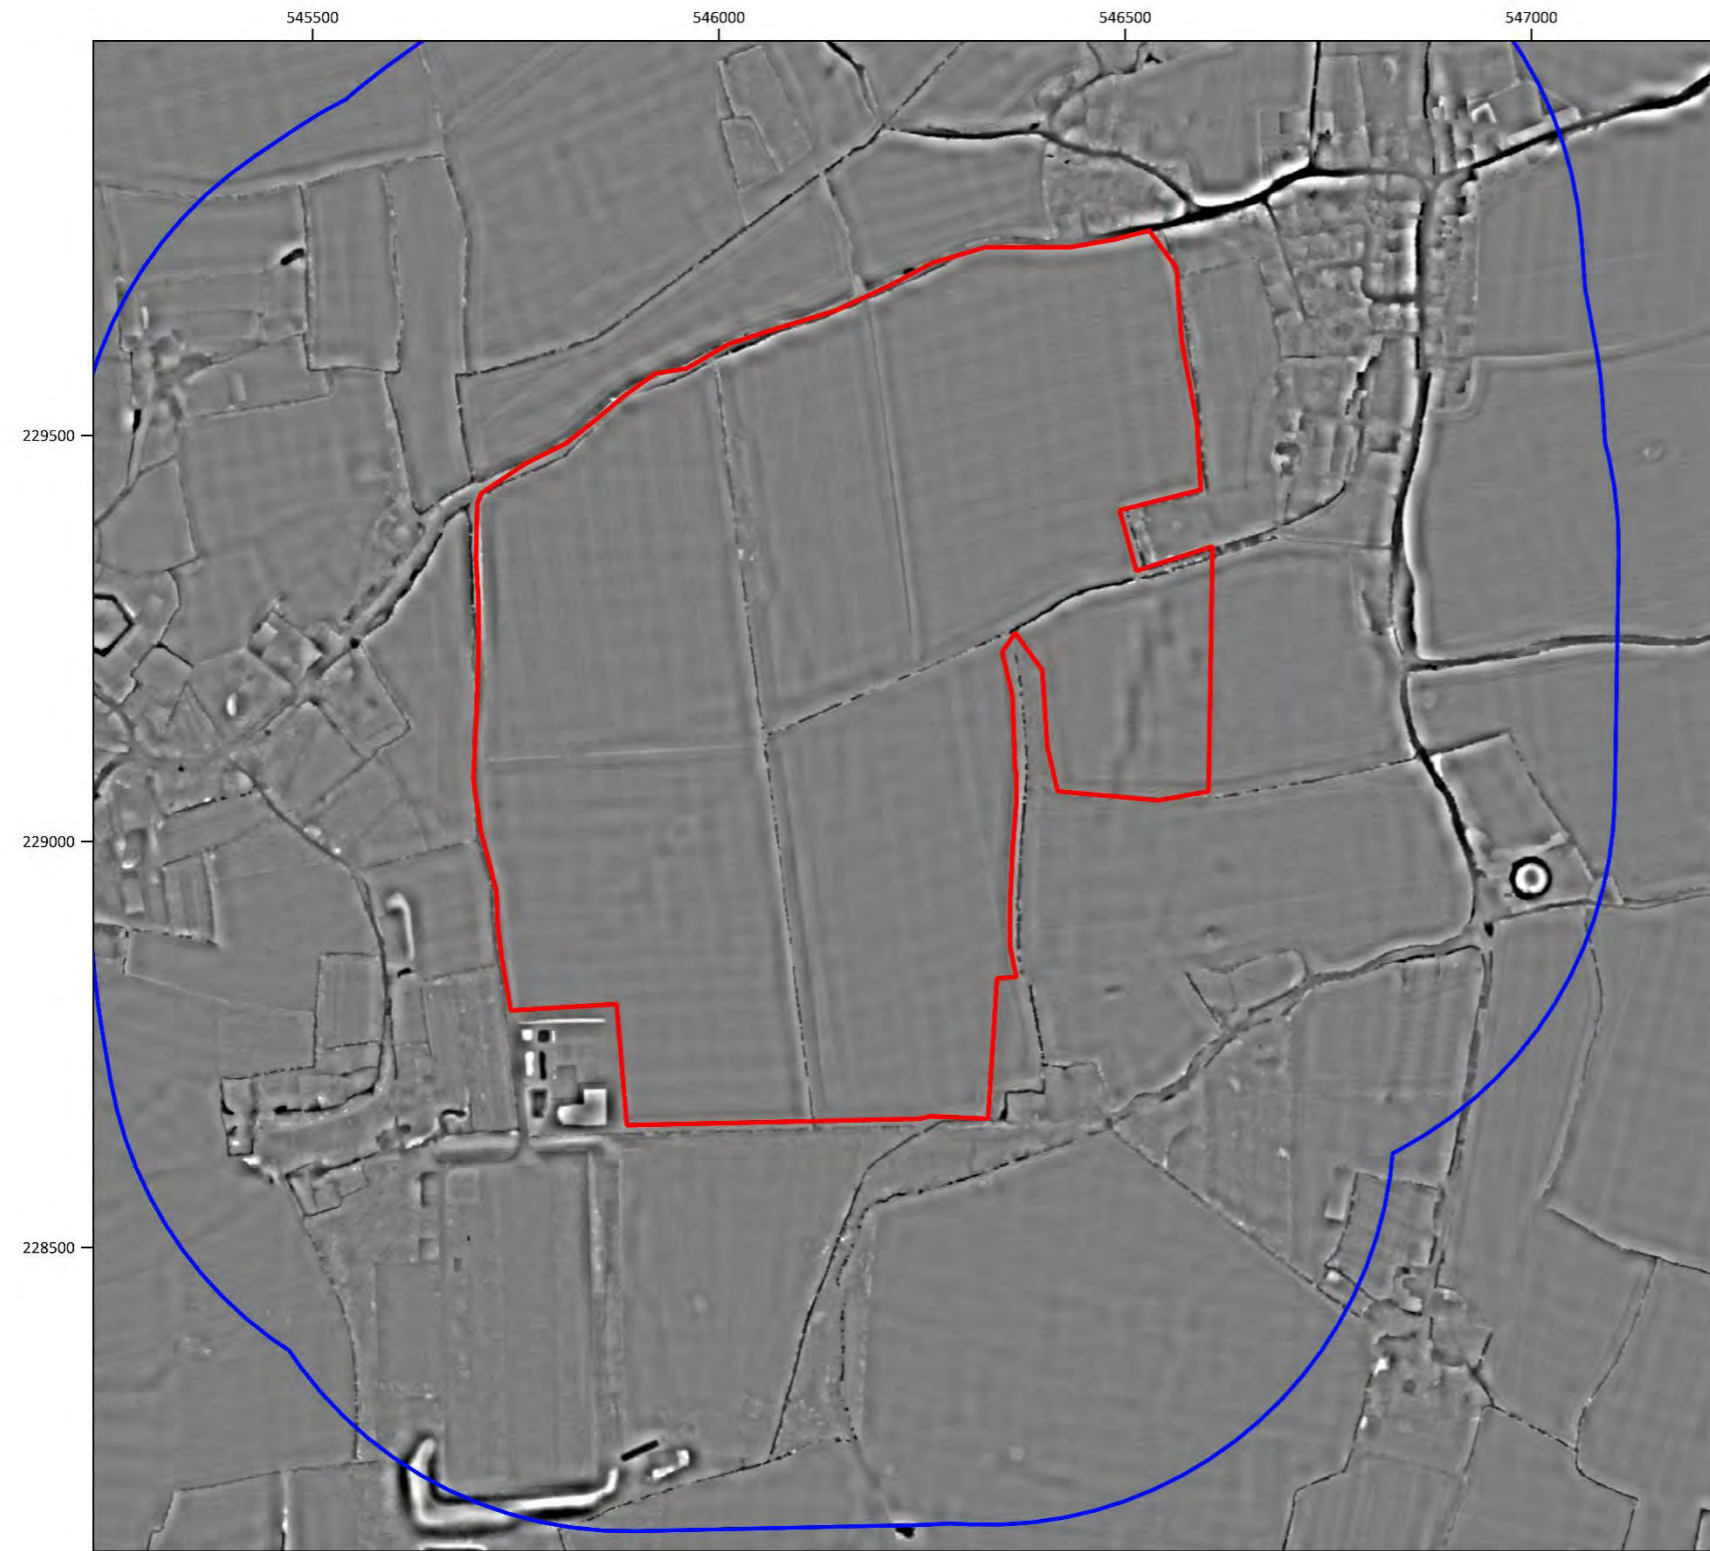
**Figure 6**  
LiDAR SLRM visualisation, 2019 1m DTM

4.16. Visualised LiDAR data shown at **Figures 6 and 7** indicates the levels of erosion over the features mapped within the site and environs.

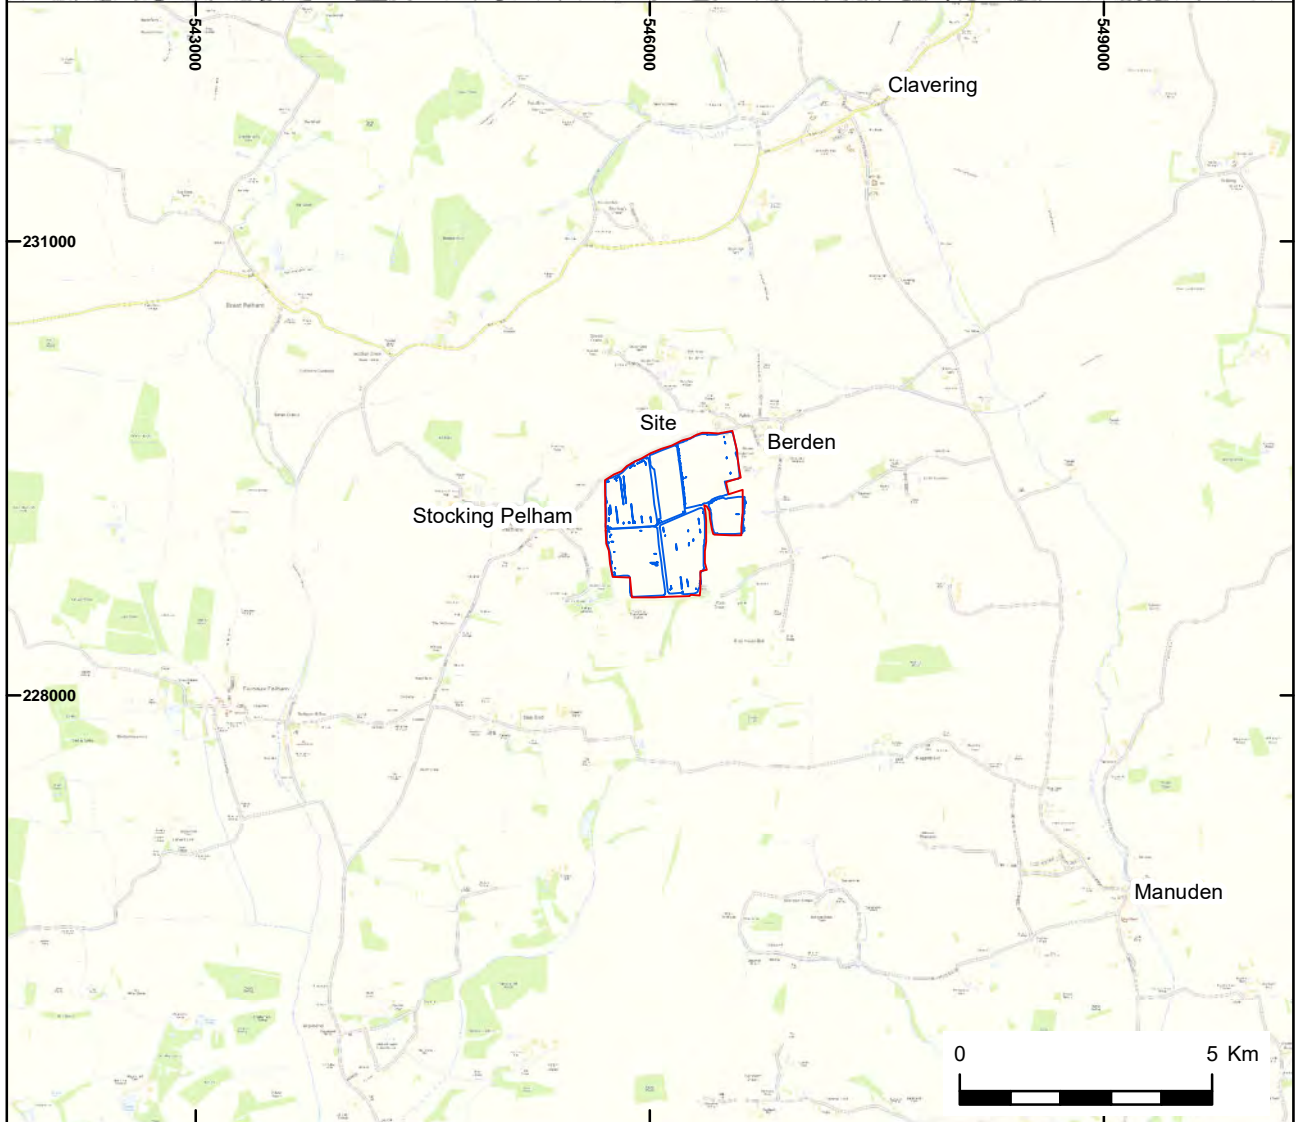
Site location and survey extents

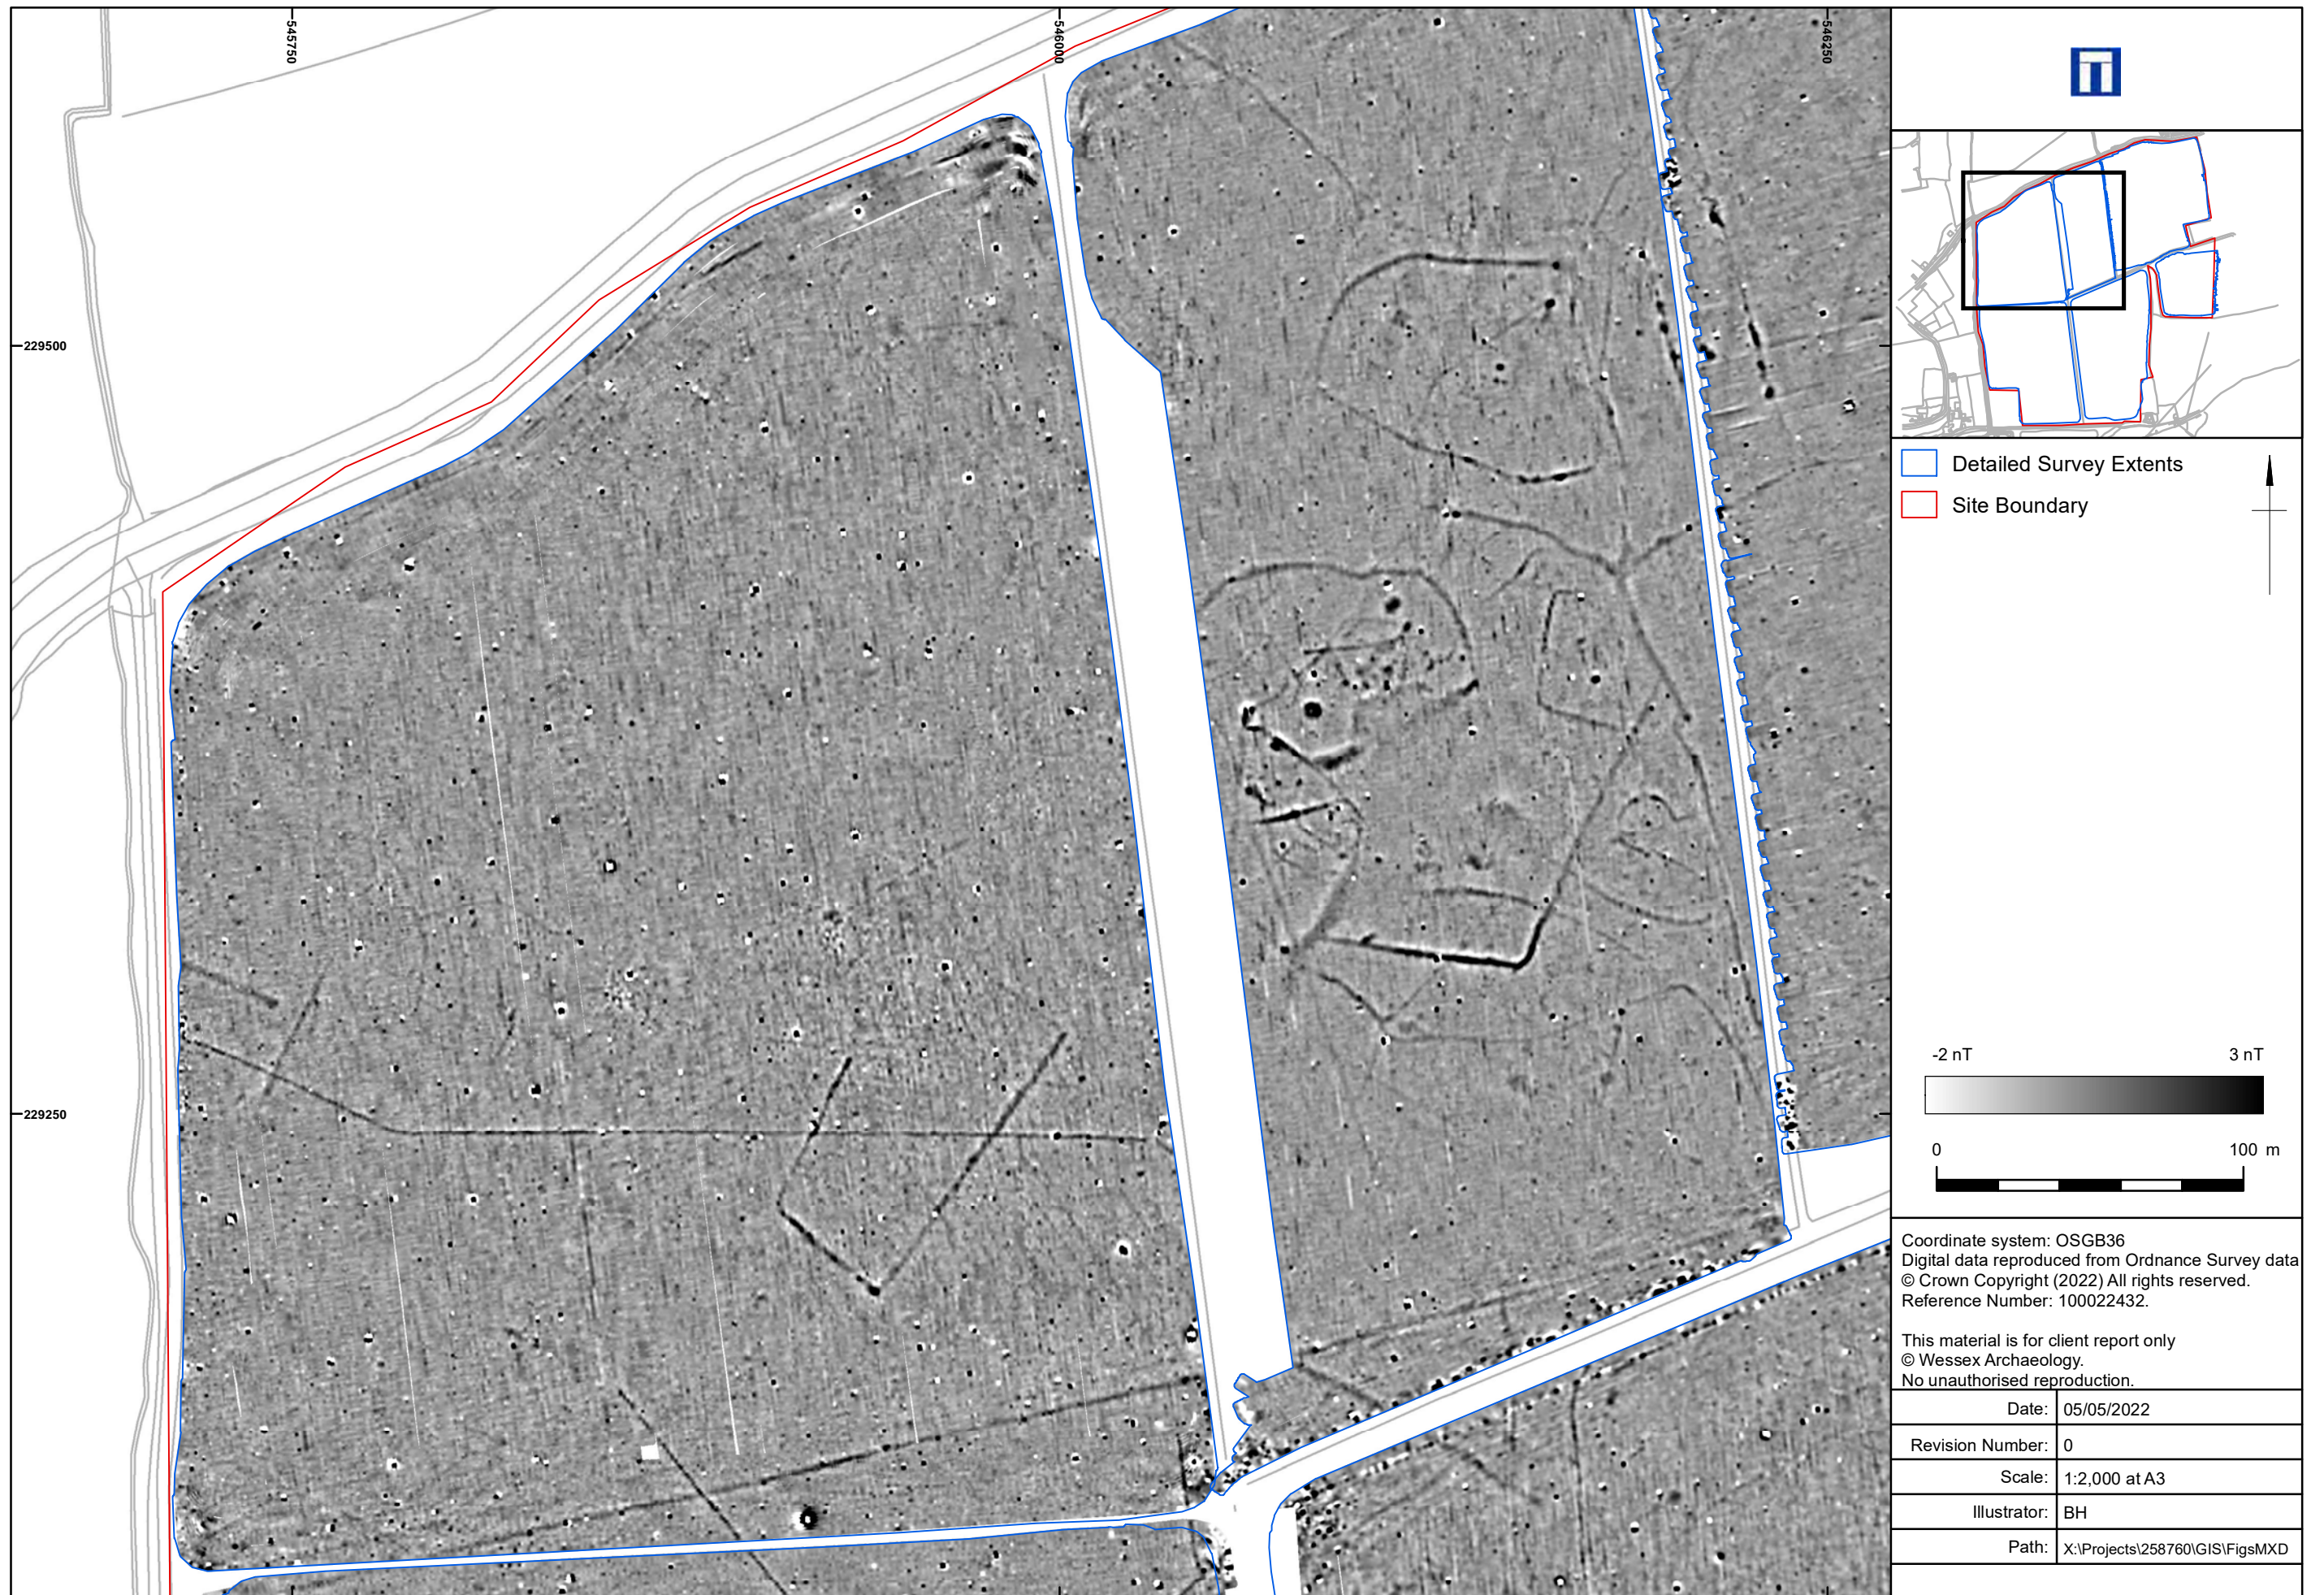
Figure 7

Detailed gradiometer survey results: interpretation (south-east)

- 4.2.20 In the east of the site a weak positive semi-circular anomaly (**4029**) and circular anomaly (**4030**) have been identified (**Figure 7**). The anomaly at **4029** is 38 m in diameter, with a break towards the north-east, and has an anomaly width of 2 m. The anomaly at **4030** is 20 m in diameter and 2 m wide. These indicate ditches that may relate to enclosures. Where the anomaly at **4030** forms a clearer circle it has the potential to relate to a prehistoric round barrow. However, due to the weak character this may be a product of modern agricultural practices or variation in natural geology.

- 4.2.26 A weak positive linear anomaly is present to the east of the site at **4036 (Fig. 7, 11, and 13)**. The anomaly is 246 m in length, bisecting the eastern land parcel broadly north to south, and is 6 m in width. This anomaly corresponds to a former field boundary identified on OS maps from 1862 to 1896.
