HS2

Construction Noise and Vibration Monthly Report – November 2022

London Borough of Camden

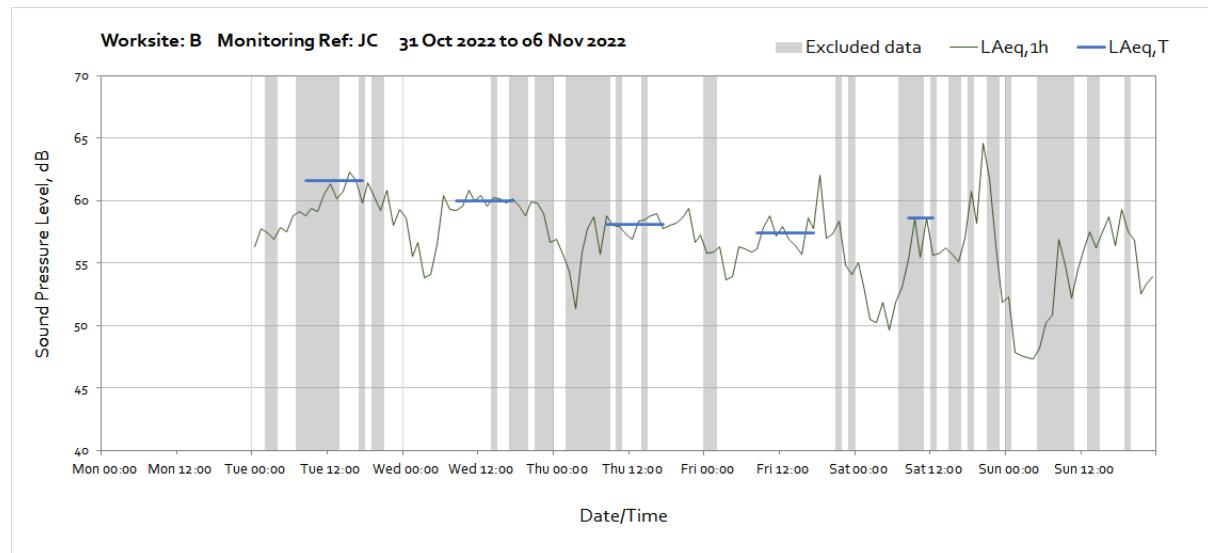
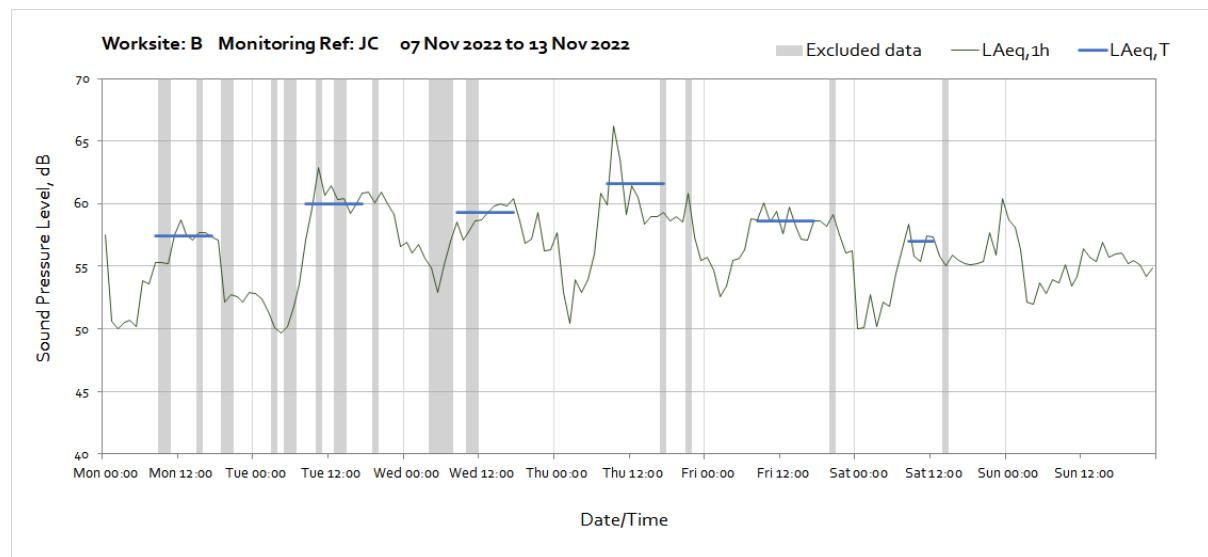
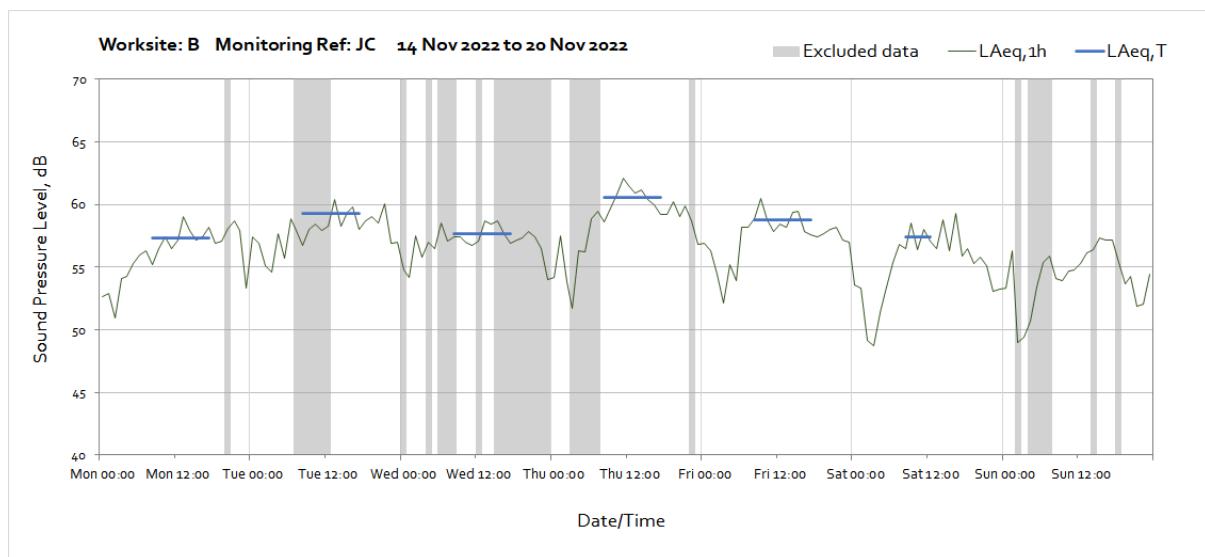
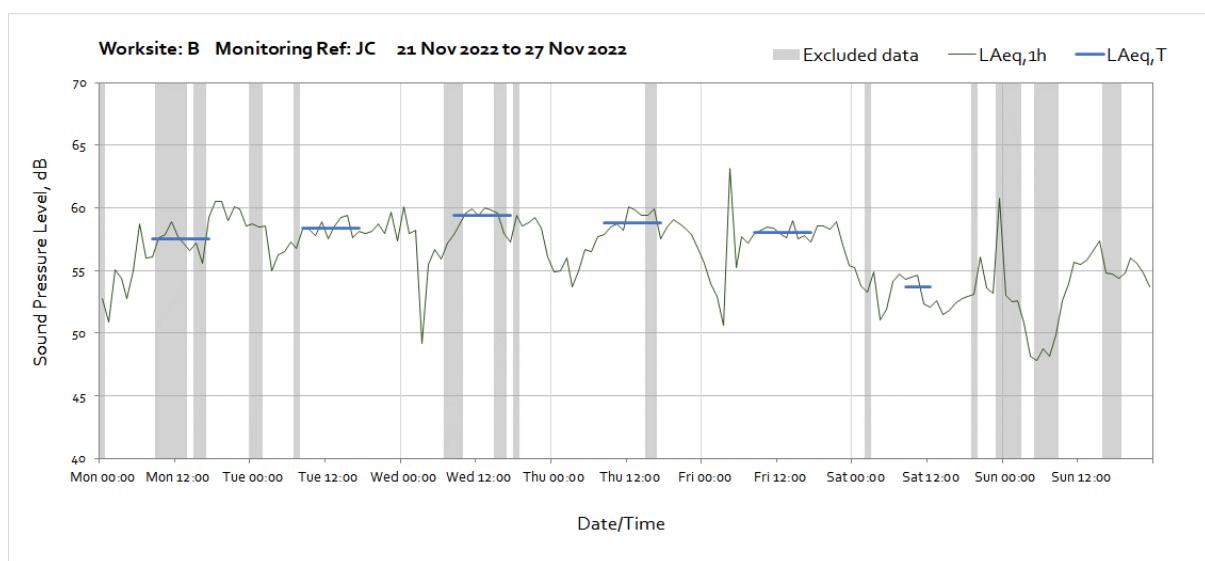
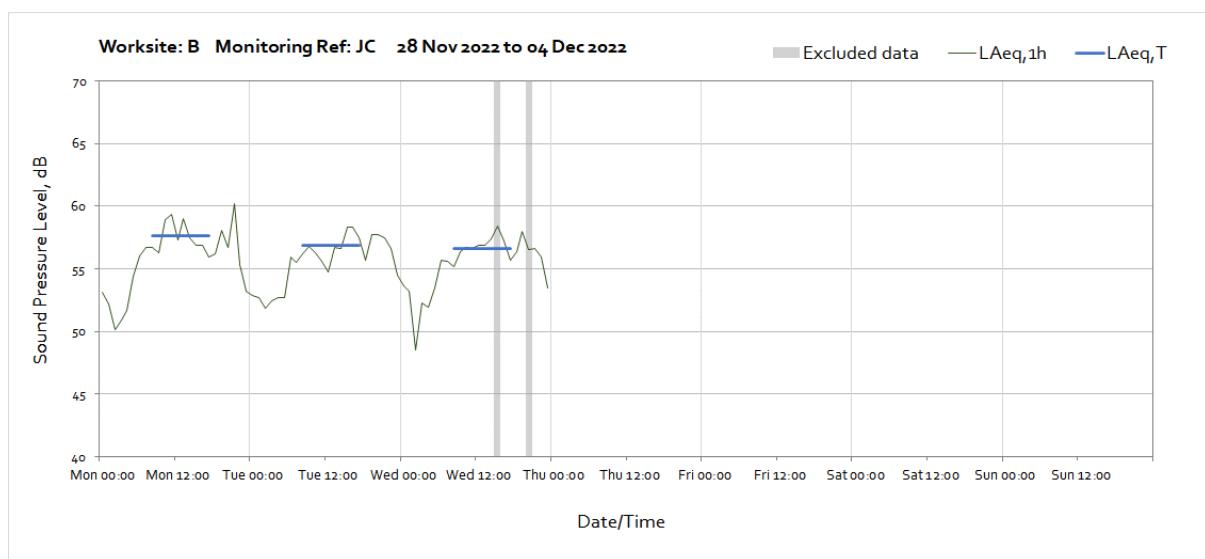
Worksite: B – Monitoring Ref: JC

The following graphs show the hourly measured ambient noise level $L_{Aeq,1h}$ and, where relevant, the averaged noise level $L_{Aeq,T}$ values, where the time period T is as specified in Table 1 of HS2 Information Paper E23. Periods with adversely weather affected noise levels are greyed out and have been excluded from the calculation of the $L_{Aeq,T}$ values in Table 3 of the main report.

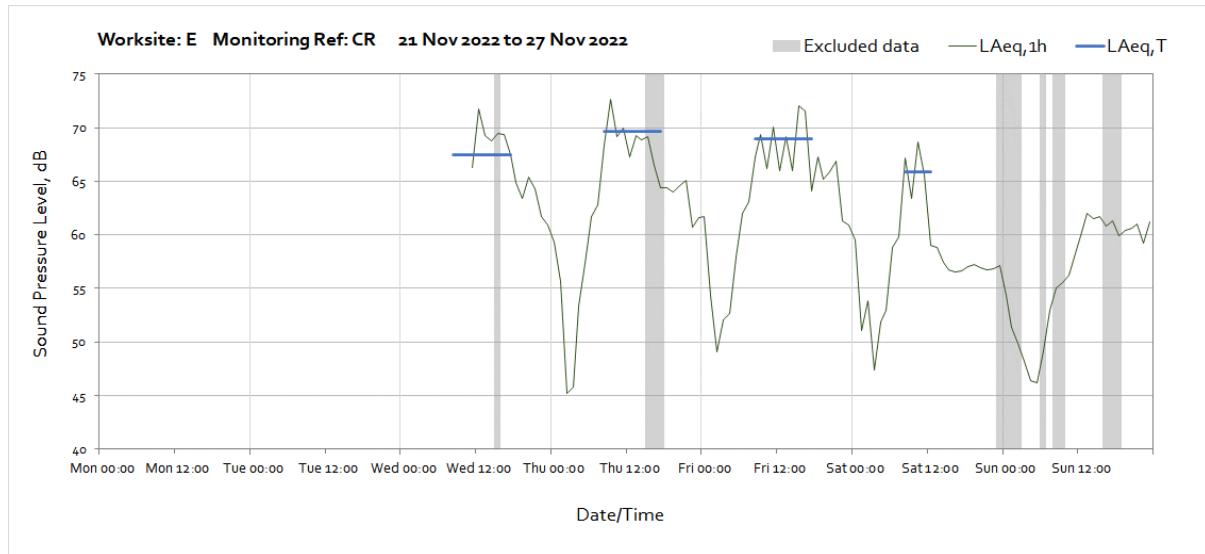
Worksite: E - Monitoring Ref: CR

Note: Missing data from the beginning of the month until 11:00 on Wednesday 23rd November was due a power failure on the lighting column where the monitor is installed that was later repaired.

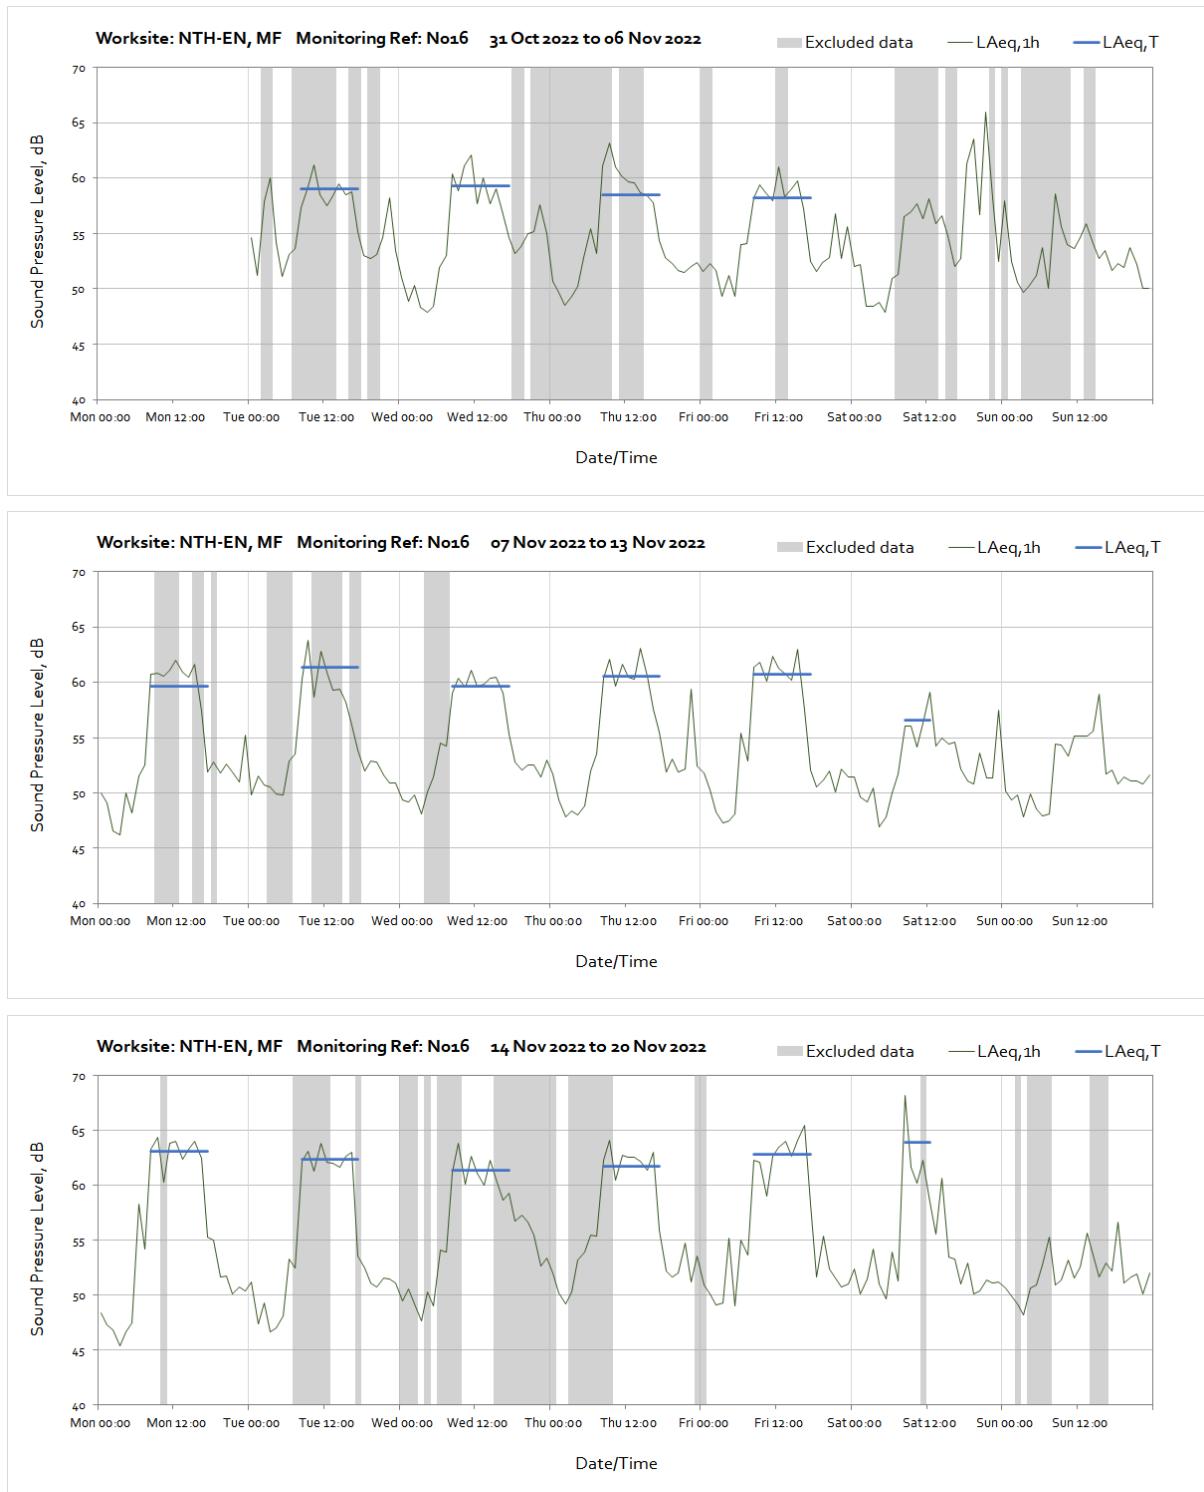
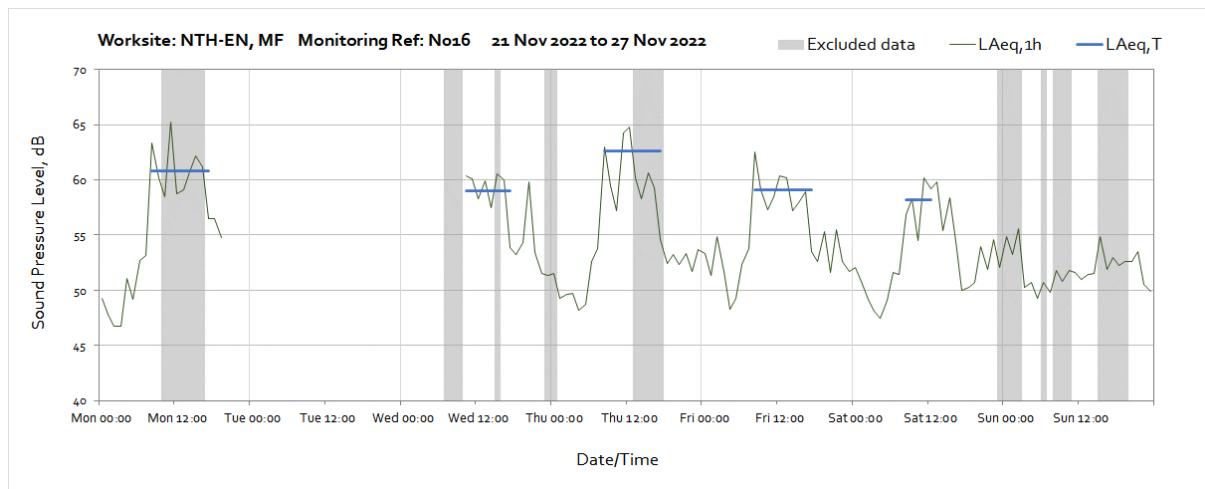
Worksite: NTH-EN, MF – Monitoring Ref: N016

Note: Missing data between 20:00 on Monday 21st November and 10:00 on Wednesday 23rd November was due to a battery power failure which was resolved upon access being granted to the monitoring location.

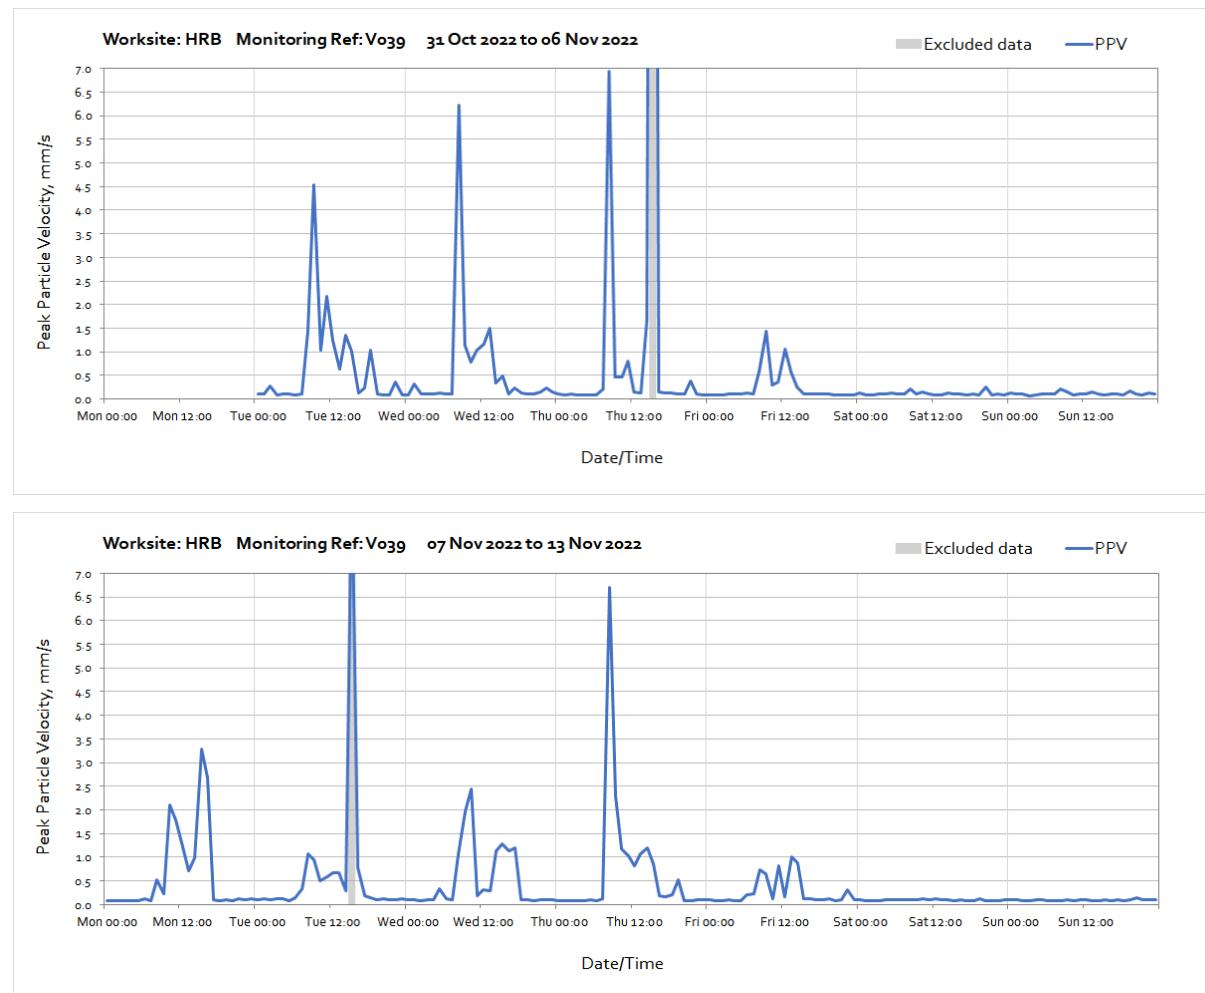
Worksite: HRB – Monitoring Ref: V039

*Note: Vibration levels at monitoring locations V039 and V043 are affected by restrictive mounting/location conditions causing amplification of vibration levels from nearby plant that are not representative of HS2 works at nearby receptors.

The following graphs show the hourly measured peak particle velocity PPV recorded during the monitoring period. The graphs show the resultant PPV due to vibration components on three orthogonal axes x, y and z. Where resultant PPV data is not available (monitors V039 and V043), the highest vibration component in either of the three axes is presented for each 1hr measurement period respectively. Where high values of PPV were caused by local interference with the vibration monitor, which are not representative of HS2 construction works, these values have been greyed out in the following charts and have been excluded to calculate values in Table 4 of the main report.

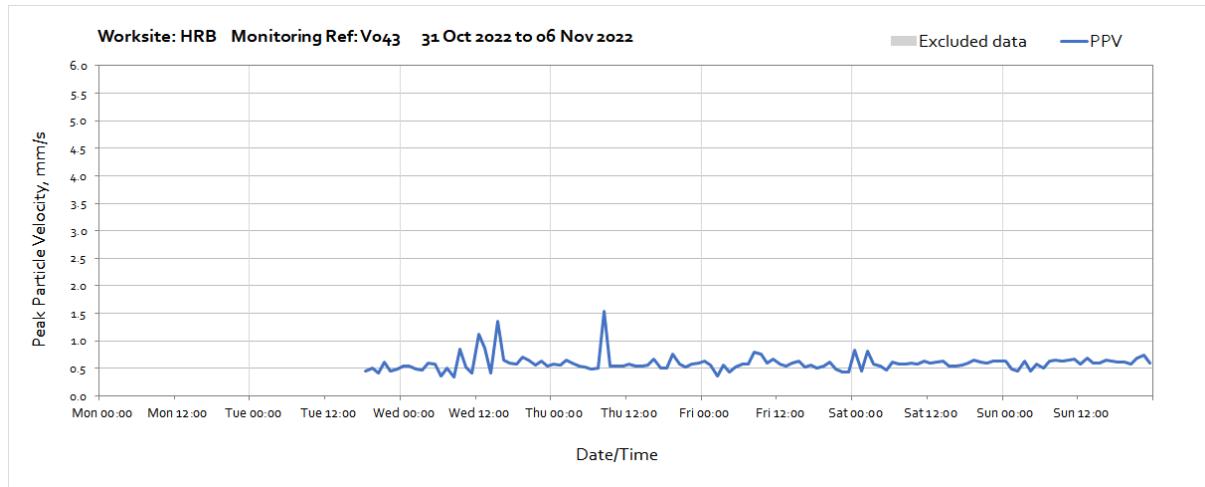
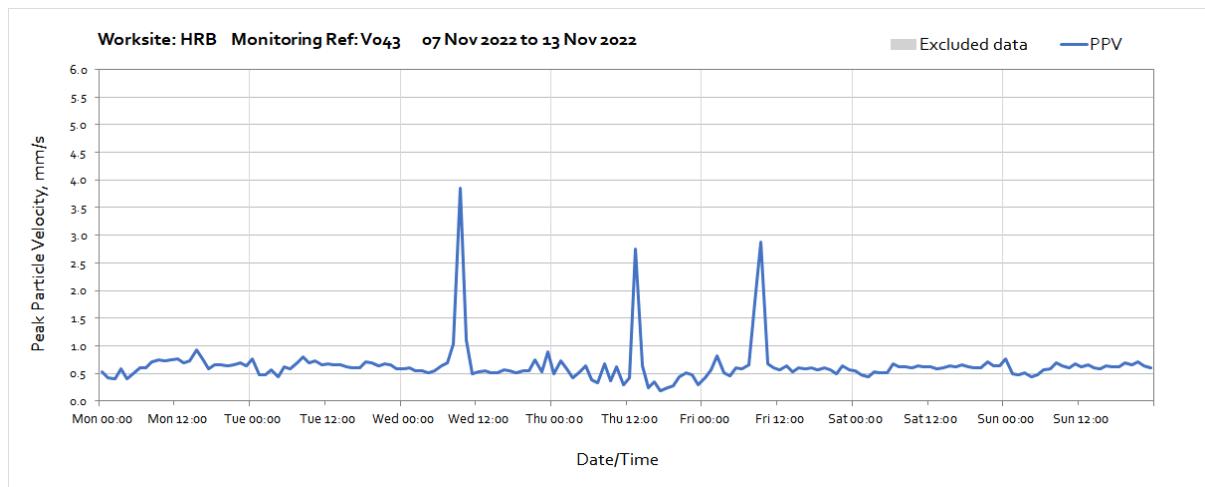
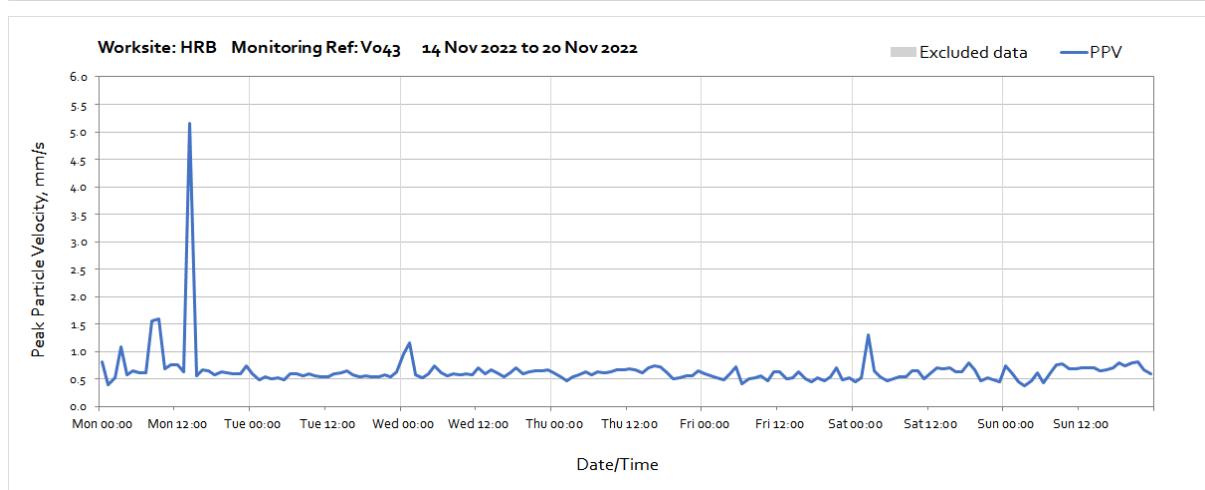
Worksite: HRB – Monitoring Ref: V043

Note: Missing data from the beginning of the month until 18:00 on Tuesday 1st November was due to a loss of power caused by a depleted battery which were subsequently replaced.
