## **Construction Noise and Vibration Monthly Report – November 2022**

**Lichfield District Council**

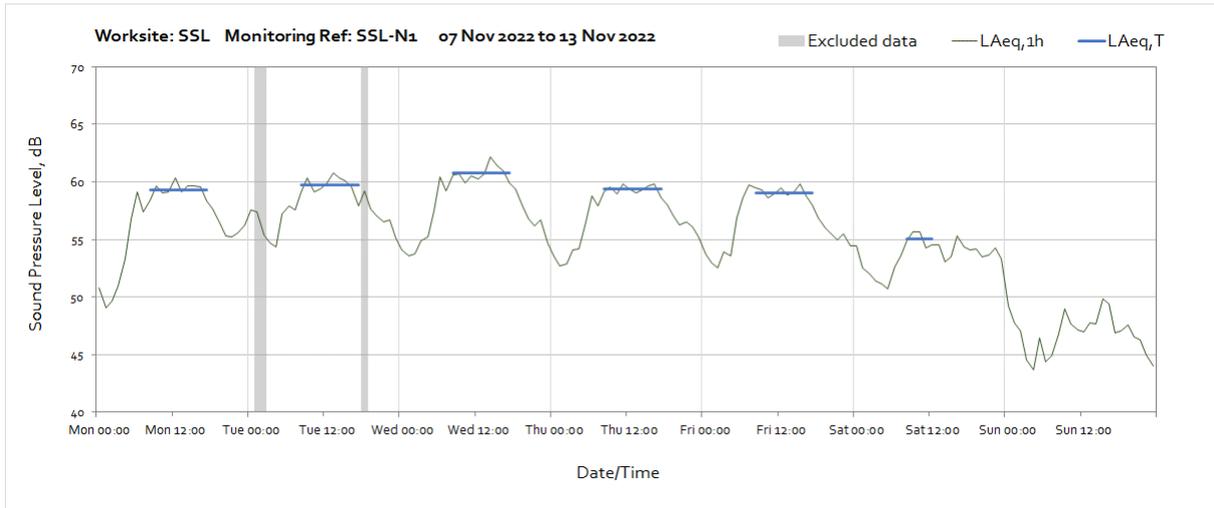
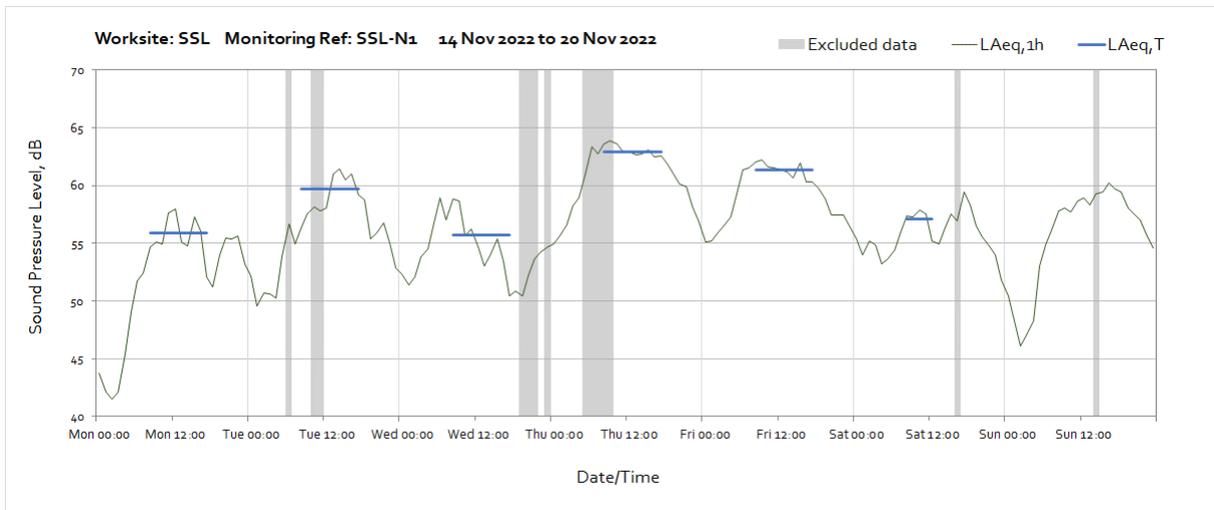
**Worksite: SCRS – Monitoring Ref: SSL-N1**

Note: Missing data between 17:00 on Monday 21<sup>st</sup> November and 10:00 on Tuesday 22<sup>nd</sup> November was due to loss of data connection to the monitor.

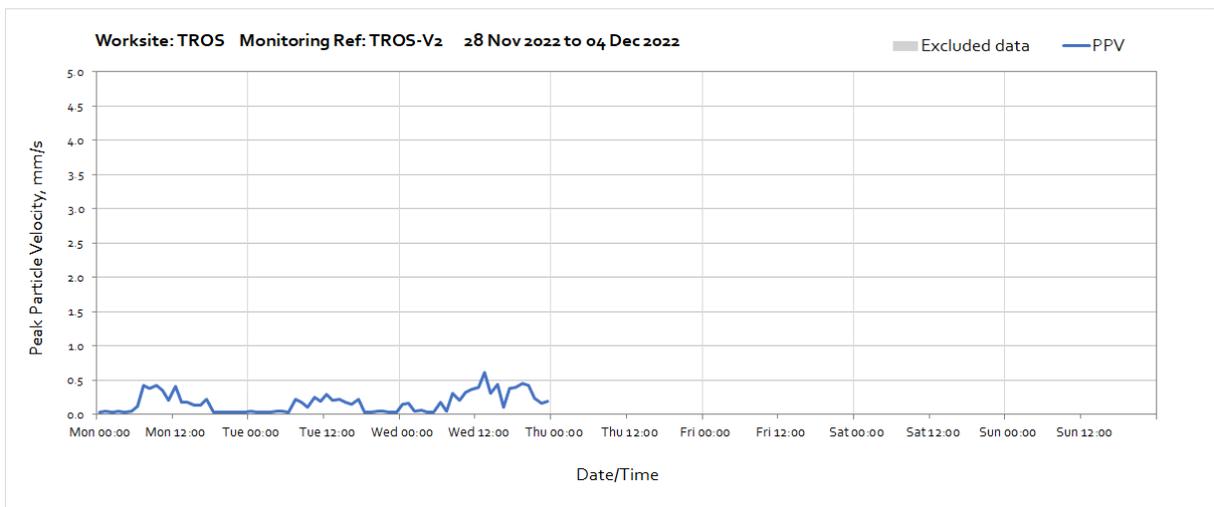
### Worksite: TROS – Monitoring Ref: TROS-V2

Note: Monitor was installed at 10:00 on Wednesday 23<sup>rd</sup> November 2022.
