**CANFIELD MOAT, HIGH CROSS LANE  
LITTLE CANFIELD  
ESSEX**

**ARCHAEOLOGICAL MONITORING**

**Essex County Council  
Field Archaeology Unit**

**February 2010**

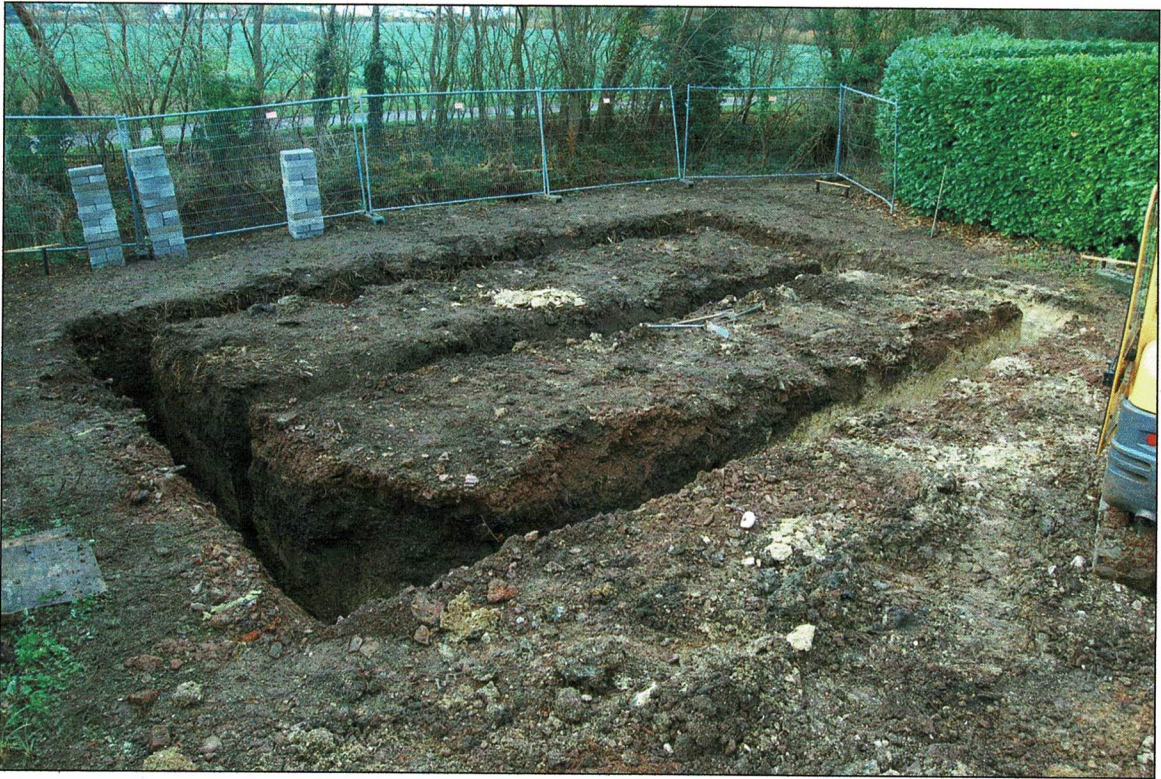
Plate 1 View to north-east of backfilled moat deposits in new garage area with the moat and northern spur cutting natural chalk on the right side of the photograph

The northern edge of the moat (context 7) was recorded on the line of the earthwork seen in the garden to the east, but slightly to the south of the line plotted on the current OS map (fig. 1). The moat extends at least 5m to the south, with the opposing edge beneath the existing outbuilding (fig. 1). The moat was filled with a series of four substantial silty clay backfill deposits containing ceramics dating to the late 19th or early 20th century (contexts 2-5). The bottom fill, context 5, was especially water-logged and contained decayed vegetable matter and part of a square-toed leather boot, as well as pottery of the same date, indicating backfilling as a single event. The flat base of the feature was recorded at a depth of 2m, cut into the natural chalk (plate 1).

A 'spur' extends to the north (context 8), to the same depth beyond the limit of excavation. It may represent a short irregularity in the north-west corner that with limited excavation cannot be clearly understood, and there is no map evidence for it. This was also cut through the natural chalk (plate 1) and backfilled with the same deposits as the moat, plus a fifth deposit

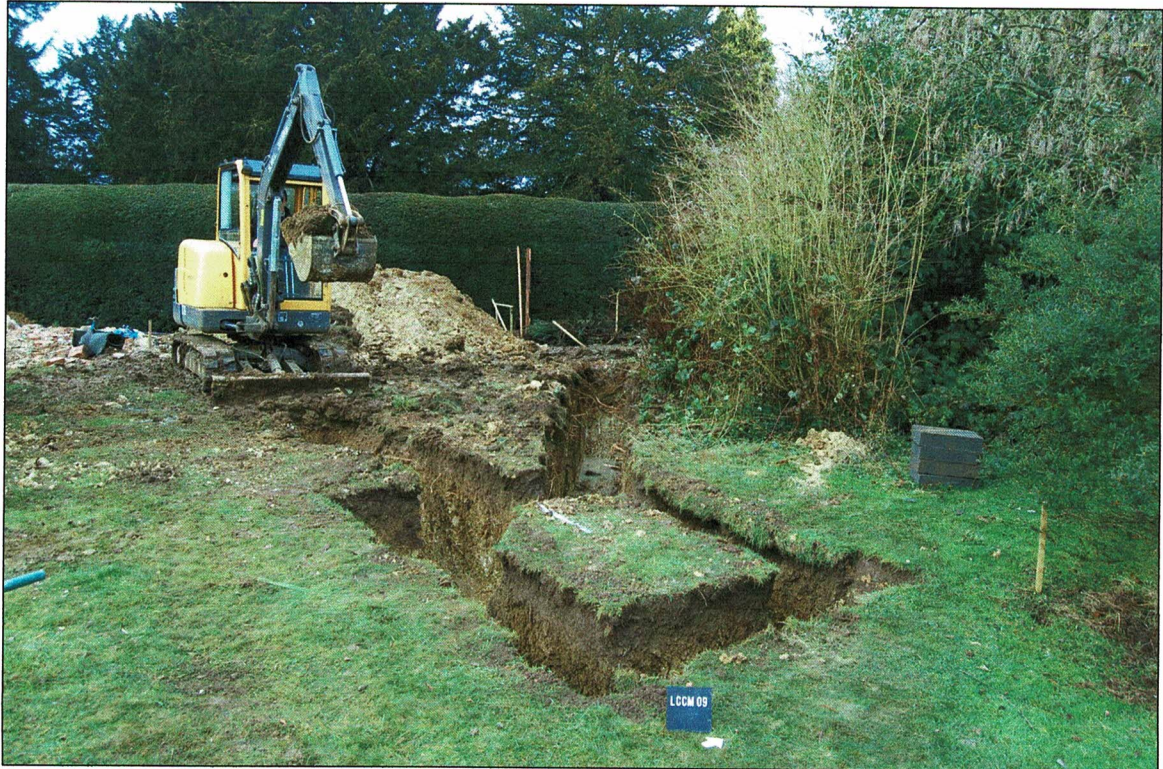
Plate 2 Excavation for pool house on undisturbed ground to the east of the moat

The location of the new pool house was repositioned from the north side to the north-east side of the swimming pool, which appears to be on the eastern arm of the moat (fig. 1). Excavations were carried out to a depth of 1.2m and found undisturbed deposits of clay subsoil beneath the topsoil/turf layer and natural chalky boulder clay 0.5m below ground level (plate 2). There was no evidence of the moat, which is likely to be a short distance to the west, on the line of the swimming pool.
