December 2022

# Air Quality and Dust Monitoring Monthly Report – December 2022 London Borough of Hillingdon

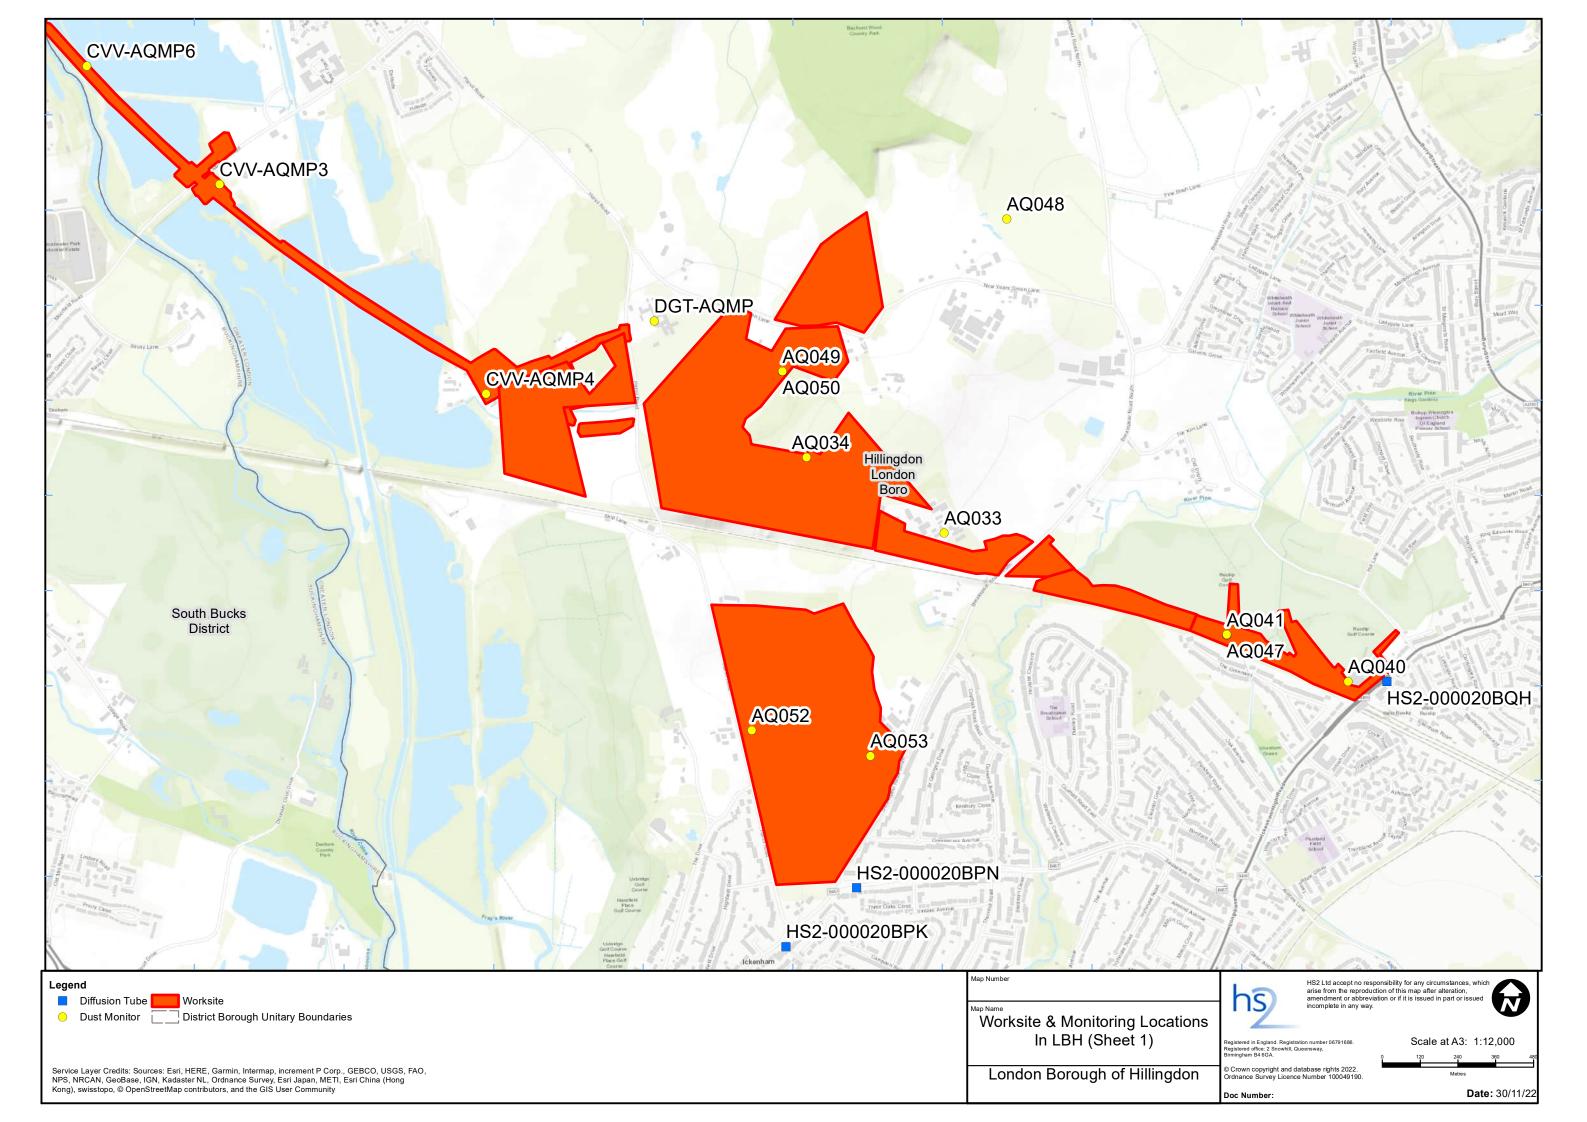
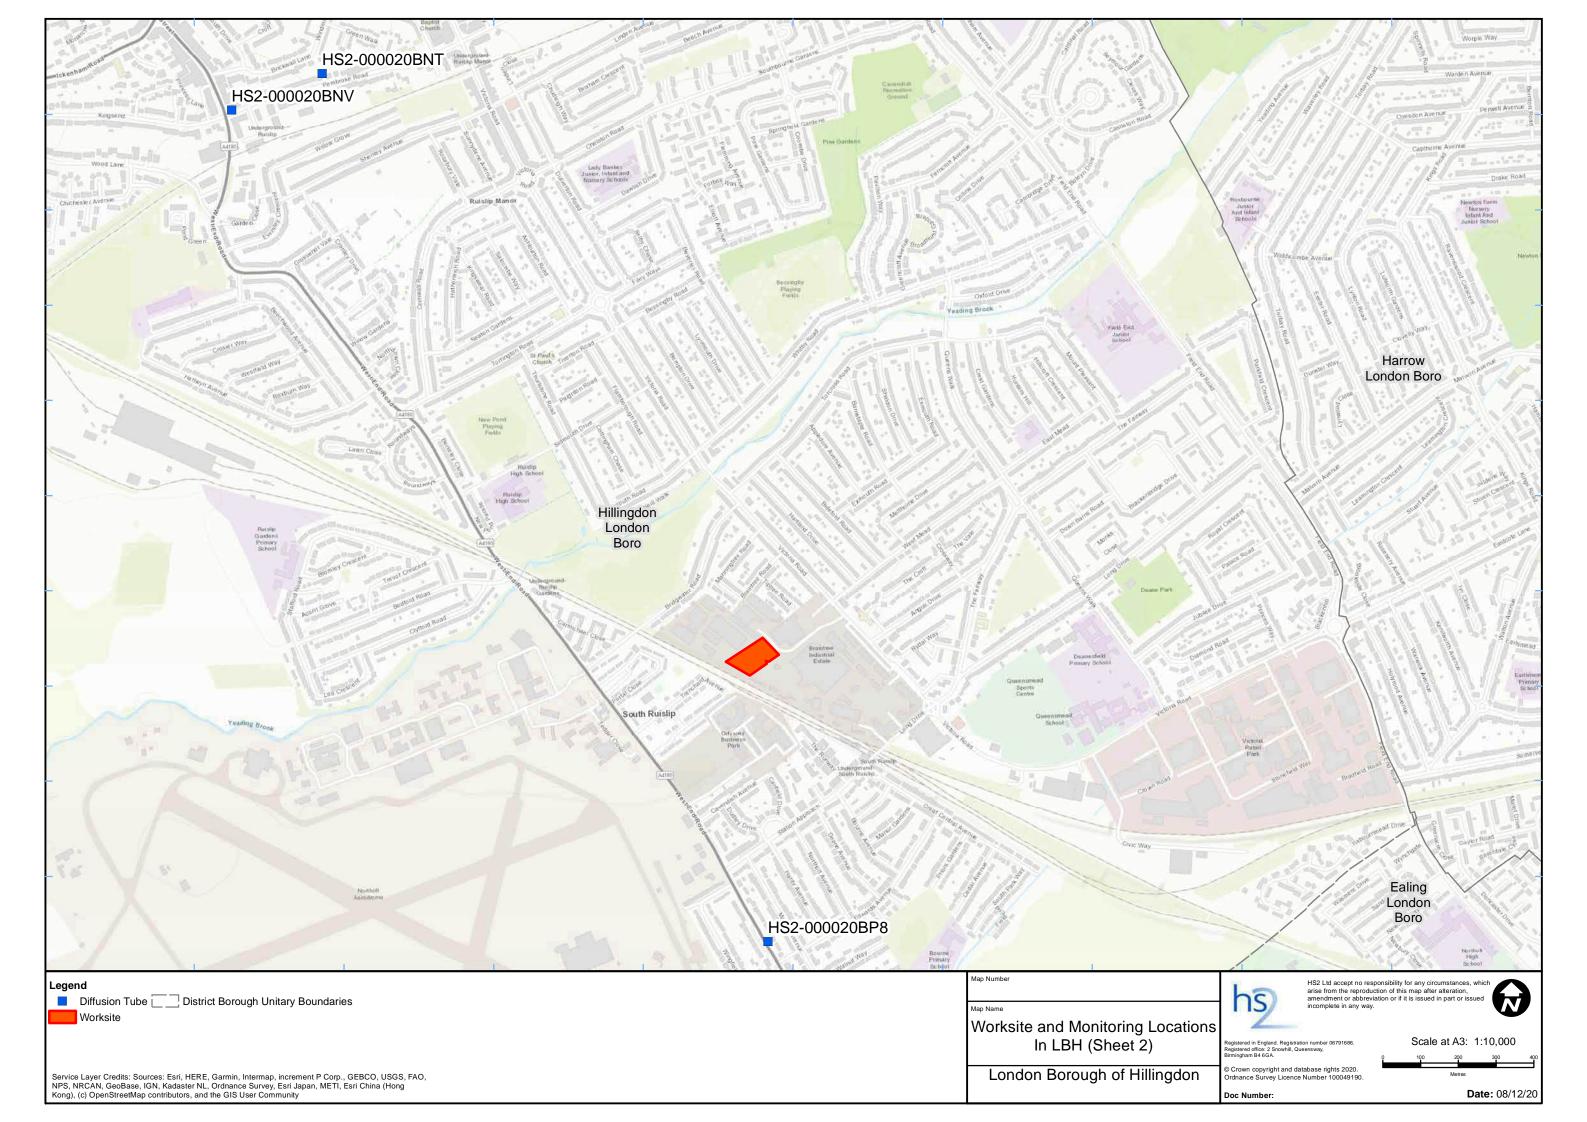
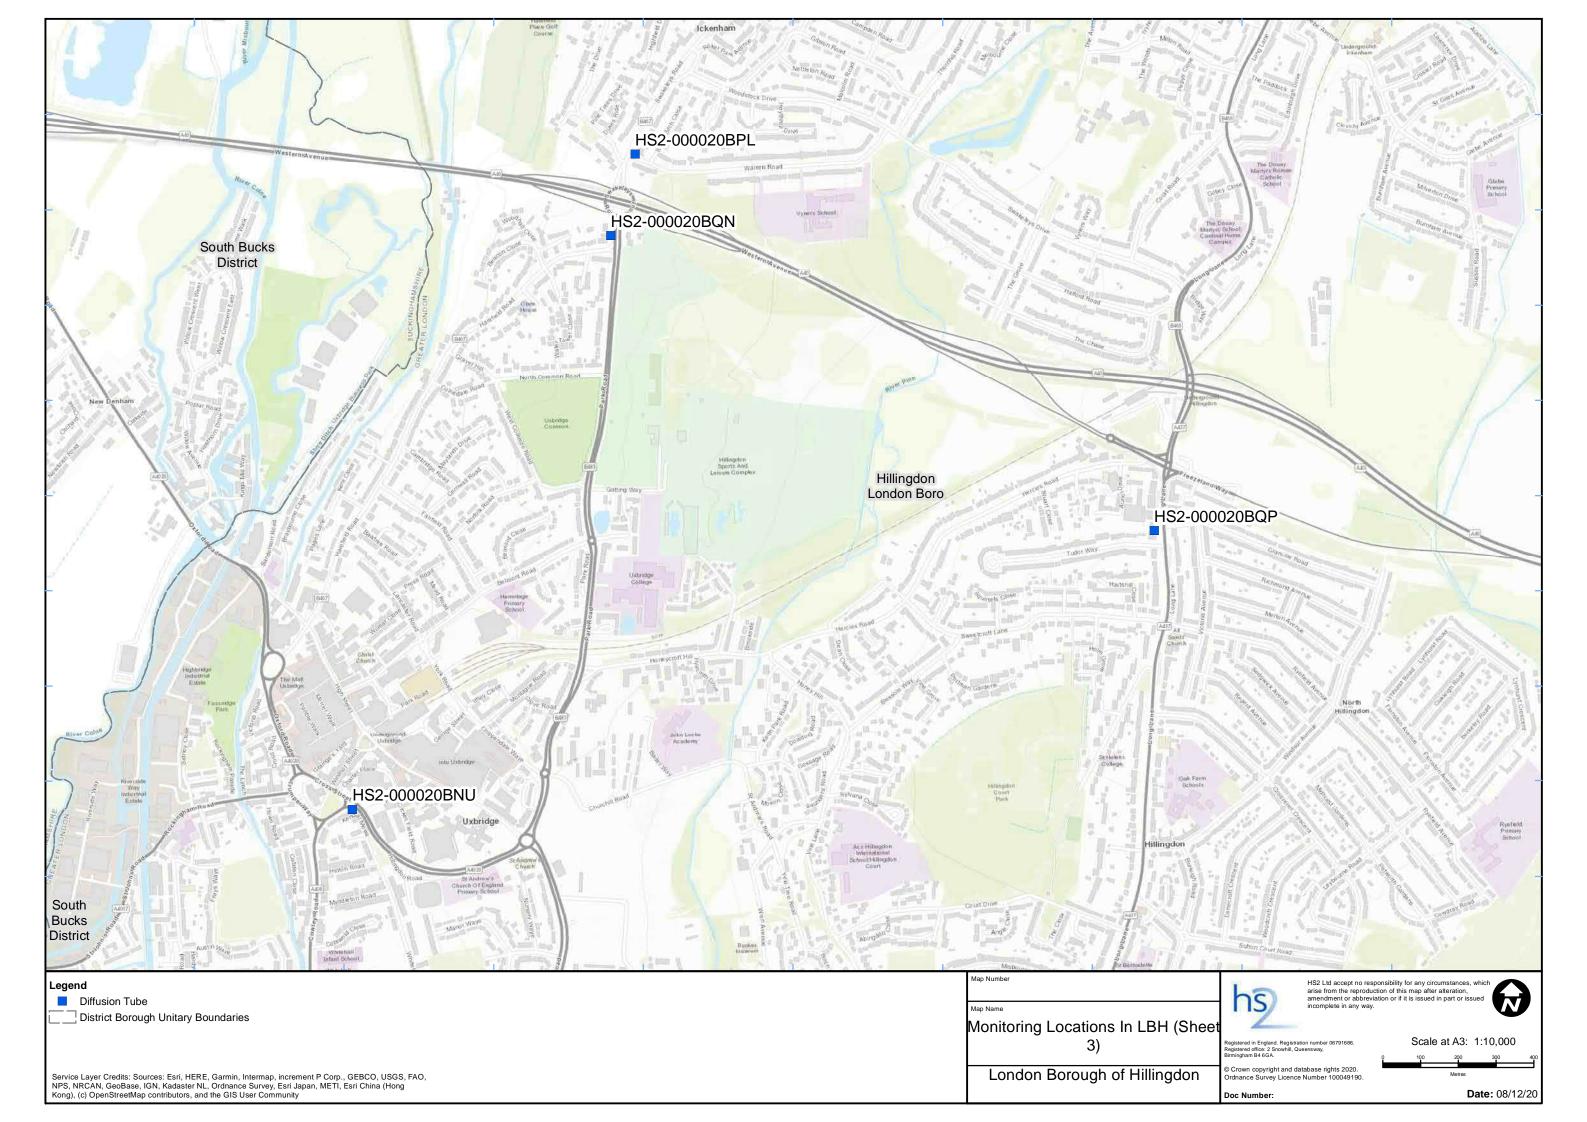
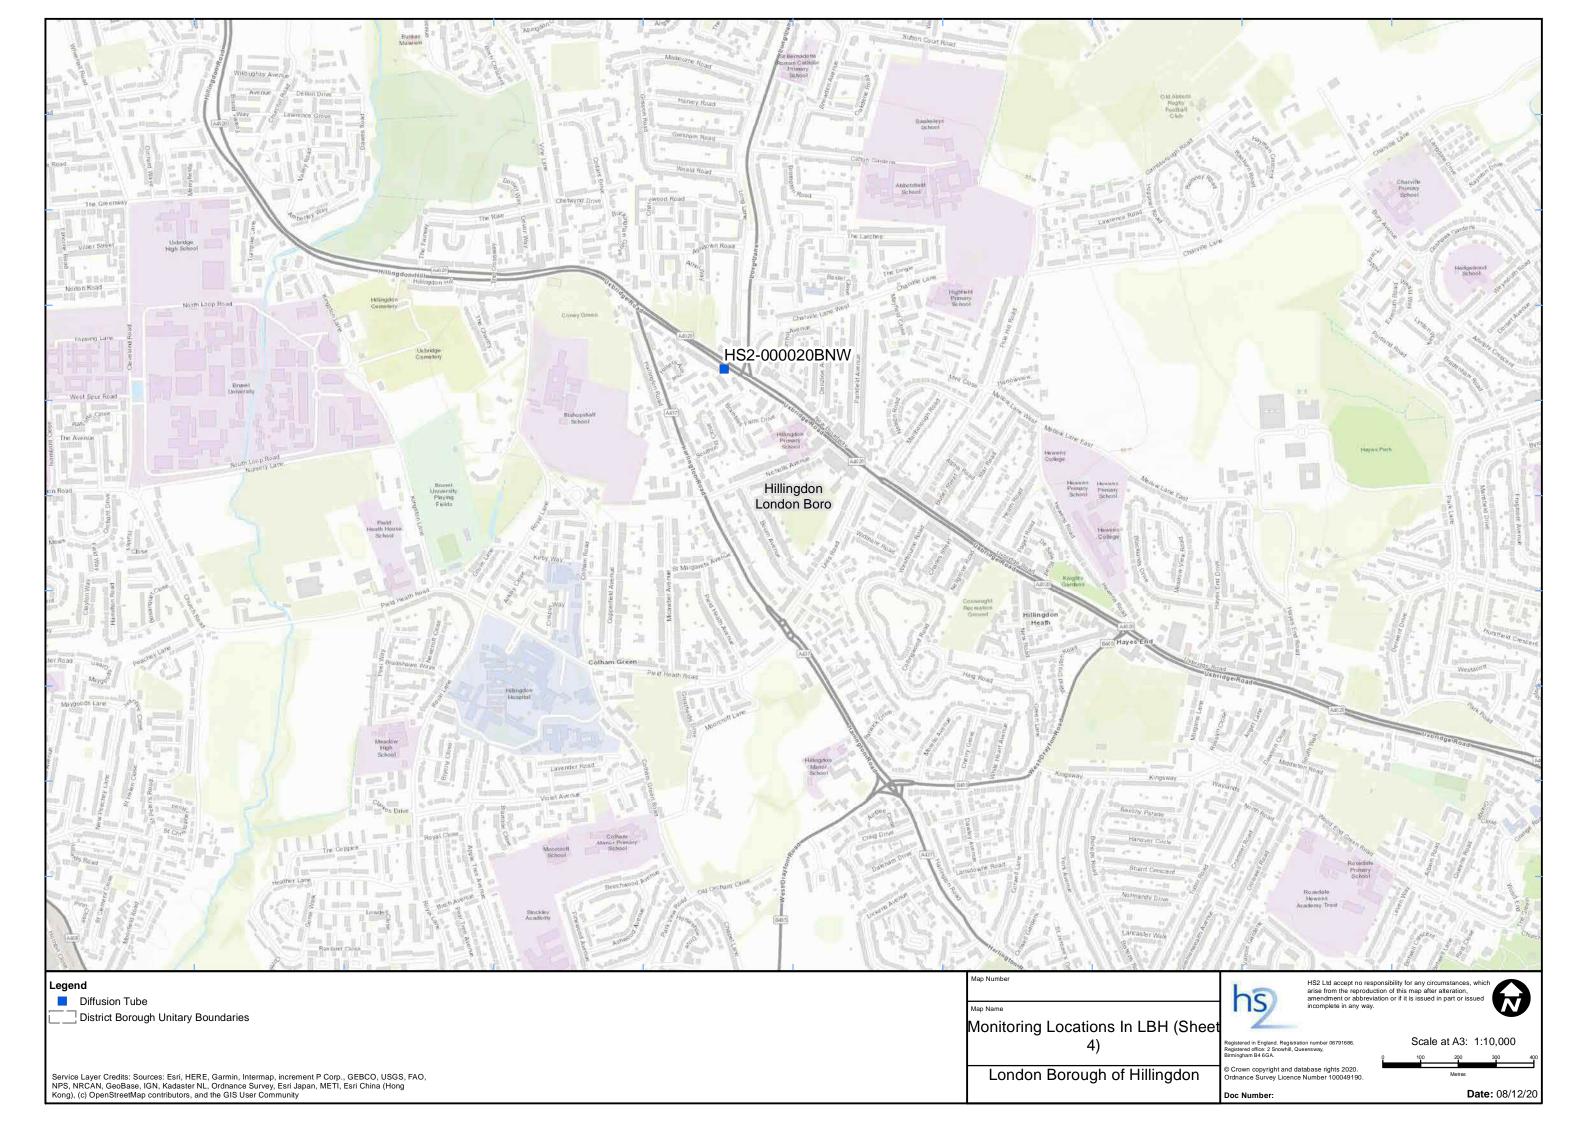
Figure 1 to Figure 4: Current monitoring locations within the LBH

- 1.1.2 Figure 1 to Figure 4 in Appendix A indicate the current worksites, together with air quality monitoring locations.
- 1.1.3 This summary should be read in conjunction with the overview monitoring report available from <a href="www.gov.uk/government/collections/monitoring-the-environmental-effects-of-hs2">www.gov.uk/government/collections/monitoring-the-environmental-effects-of-hs2</a>, which highlights: the applicable standards and guidance, as well as the air quality and dust monitoring methodologies to be implemented by nominated undertakers throughout construction.

- 1.1.4 The current phase of works commenced in November 2019 and is expected to be completed by 2025. The current worksites, as presented in Appendix A, Figure 1 to Figure 4, include:

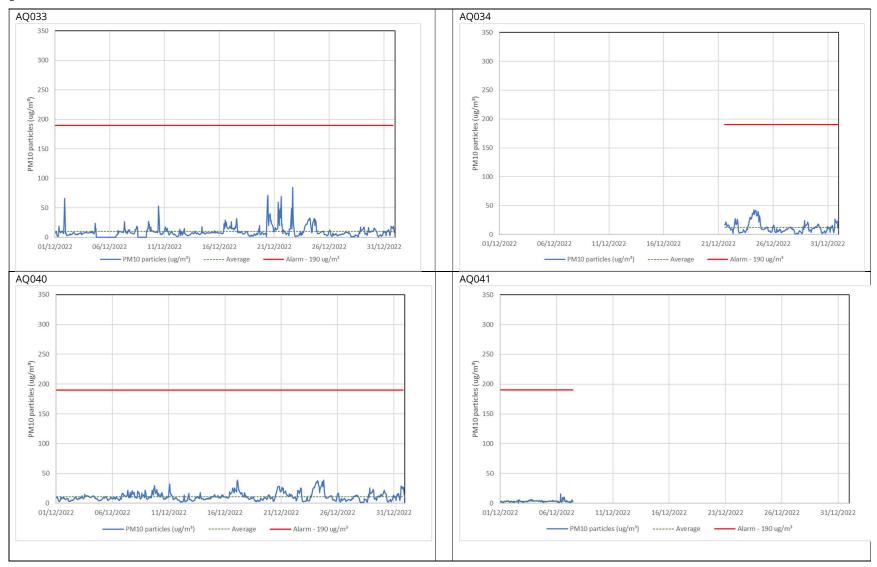
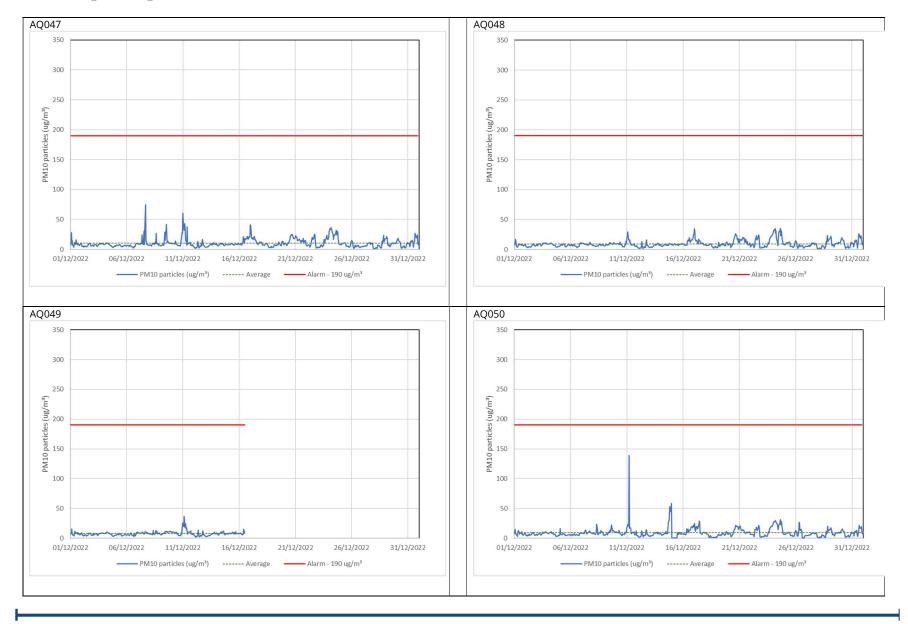
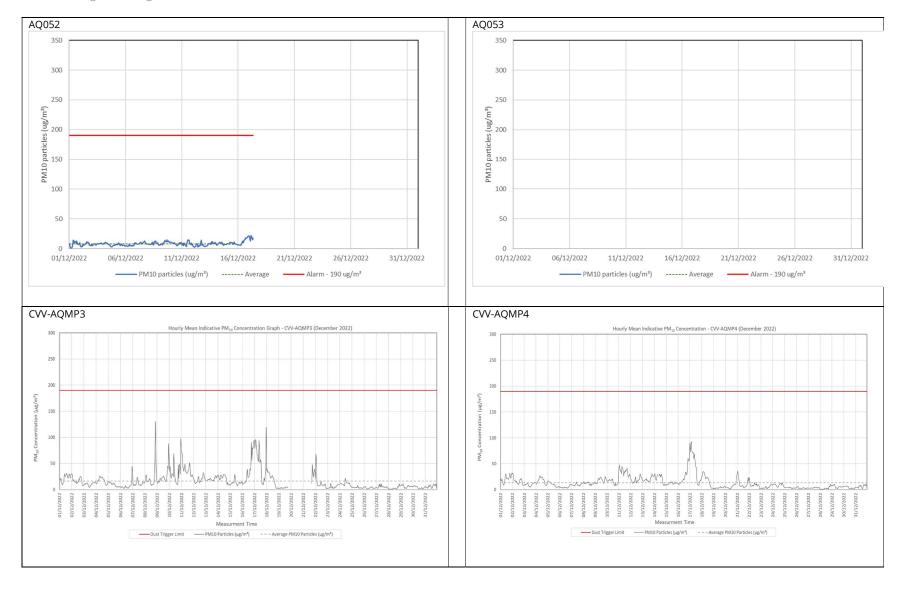
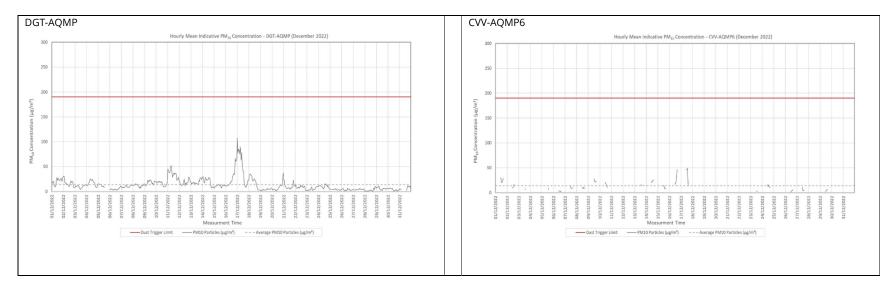
Figure 5: Construction dust 1-hour mean indicative PM<sub>10</sub> concentration for dust monitors

- 1.1.5 Fourteen (14) dust monitors are installed around worksites. The sites returned a low to high risk dust risk rating.
- 1.1.6 Dust monitoring locations and results are presented in Appendix B, Table 1, together with line charts of monthly data from each dust monitor in Figure 5. All continuous dust monitoring is undertaken using indicative monitors. Despite being Environment Agency (MCERTS) certified, indicative monitors carry a higher level of uncertainty than reference monitors, and therefore cannot be strictly compared with Air Quality Standards for

- human health and the environment. The purpose of the monitoring undertaken is to ensure the effectiveness of the on-site mitigation.
- 1.1.7 The trigger level for  $PM_{10}$  concentrations of  $190\mu g/m^3$ , over a 1-hour period, in accordance with the updated guidance document 'Guidance on Monitoring in the Vicinity of Demolition and Construction Sites (October 2018)' has been applied.

- 1.1.8 No (0) dust trigger alerts were recorded during the monitoring period (December 2022).
- 1.1.9 Data capture was below 90% for multiple monitors in December 2022 due to power supply issues, hydrogen generator faults and temporary disconnection and monitor relocation as a result of works. All issues have since been resolved.
