# Proposed Residential Development – Land West of Thaxted Road, Saffron Walden

## Stage 1 Road Safety Audit / Designers Response

**ROAD SAFETY AUDIT  
STAGE 1**

**REPORT REF: BN/MTP/22-119**

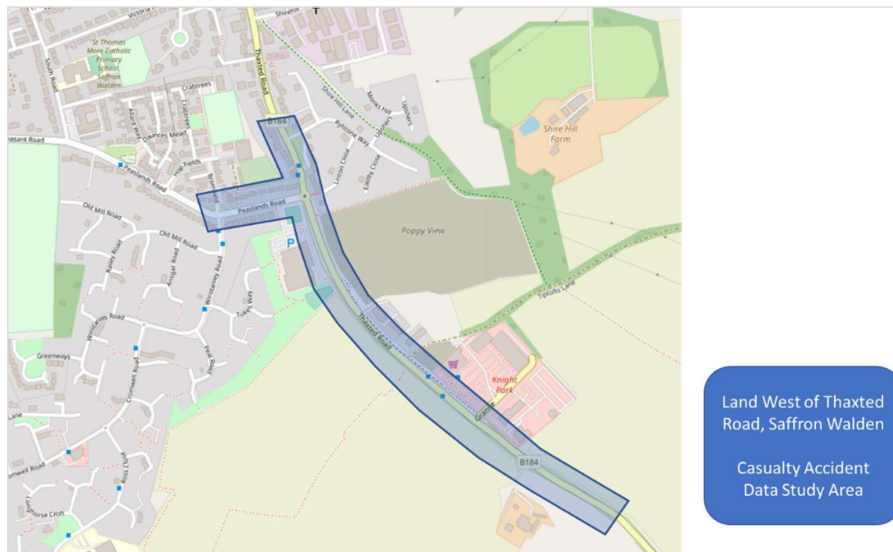
Figure 1 PIA Study Area

Personal Injury Accident (PIA) data, recorded by the police, has been obtained from ECC for the section of the B184 Thaxted Road from south of the Knight Park access, along the Site frontage and then stretching northwards to beyond the mini-roundabout junction with Peaslands Road and including Peaslands Road, west to the junction with Winstanley Road. The PIA study area is shown in **Figure 1**.

The PIA data obtained relates to the most recent 5-year period from 1 July 2017 to 30 June 2022 which shows that there have been only two recorded accidents over the period under consideration. A full copy of the PIA data is provided as in Appendix 2 of Transport Assessment report (document reference 22-078/Reports/Transport Assessment).

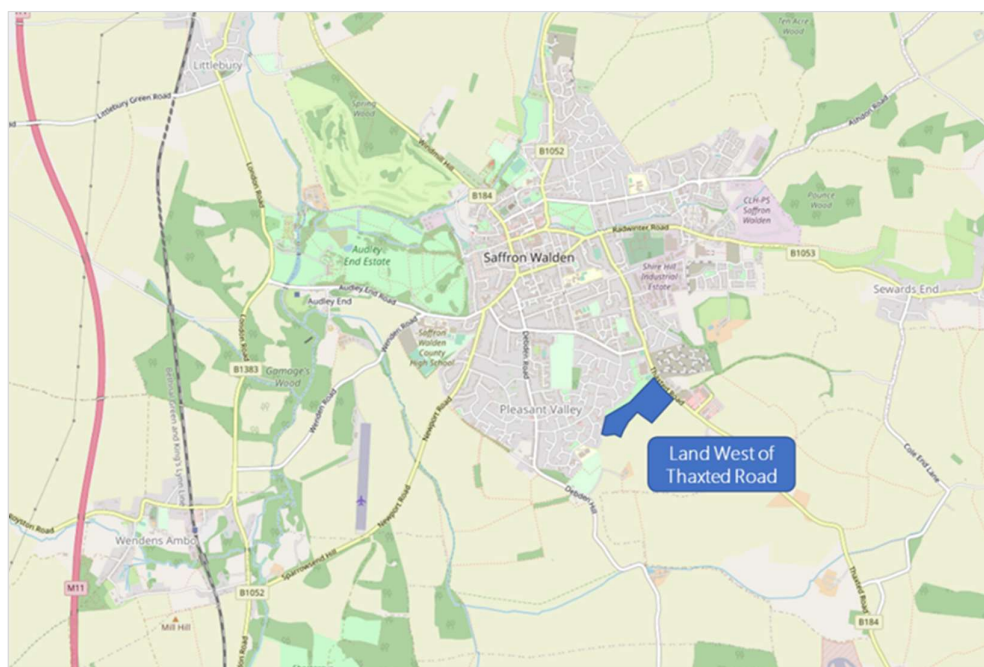
Figure 2 Location of Proposed Residential Development

This scheme relates to highway works associated with the Proposed Residential Development, Land West of Thaxted Road, Saffron Walden, see **Figure 2** for location of the proposed residential development. The proposals comprise provision of up to 170 dwellings, alongside other amenities.

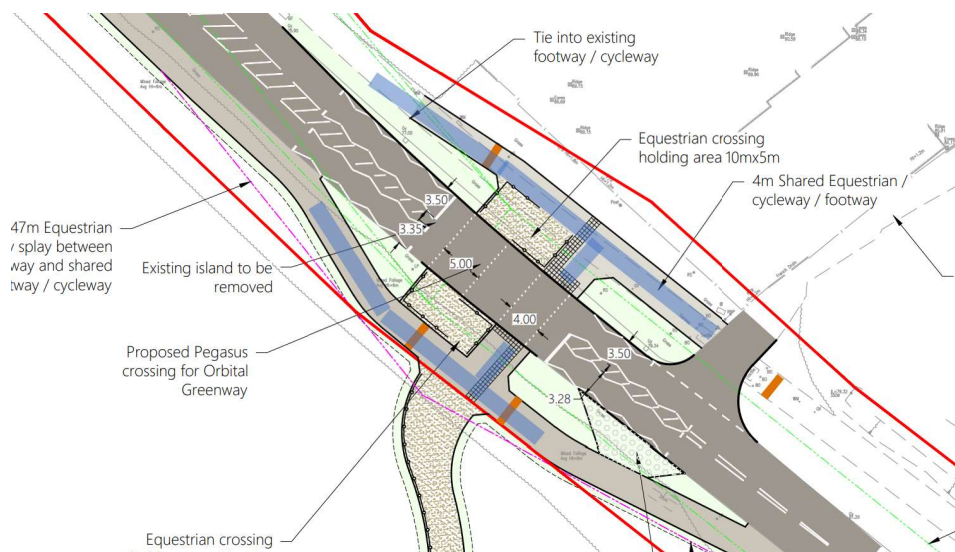
**Location:** F – Shared Use area to the North-West of TipTofts Lane  
**Summary:** Use of Corduroy Paving as shown may confuse visually impaired pedestrians and cyclists as to the facility they have entered.

The drawings provided show several orange bands located within the vicinity of the Pegasus/Toucan Crossing. Due to the location of the orange bands, it has been assumed that these notate an area of corduroy paving. Corduroy paving is usually introduced to detail the change in a facility, for example the end of a shared use facility. As shown below, the areas marked in blue are all shown as shared use facilities.

Within the area that these have been proposed the facility for visually impaired pedestrians (which the corduroy paving is primarily introduced for) the facility has not changed. By providing this band of corduroy paving a visually impaired pedestrian may think that they have now entered an area of footway only and that the risk of strike from cyclists is no longer a concern, making them vulnerable to strike by approaching cyclists.

**RECOMMENDATION:** It is recommended that corduroy paving at these locations are removed.

<p>RSA Recommendation</p>	<p>It is recommended that corduroy paving at these locations are removed.</p>
<p>Design Organisation Response</p>	<p>Agreed - Corduroy paving removed. Back to back signs to Diag. 956 (shared footway/ cycleway) and 956.1 (shared footway/ cycleway/ equestrian) added.</p>
<p>Overseeing Organisation Response</p>	
<p>Agreed RSA Action</p>

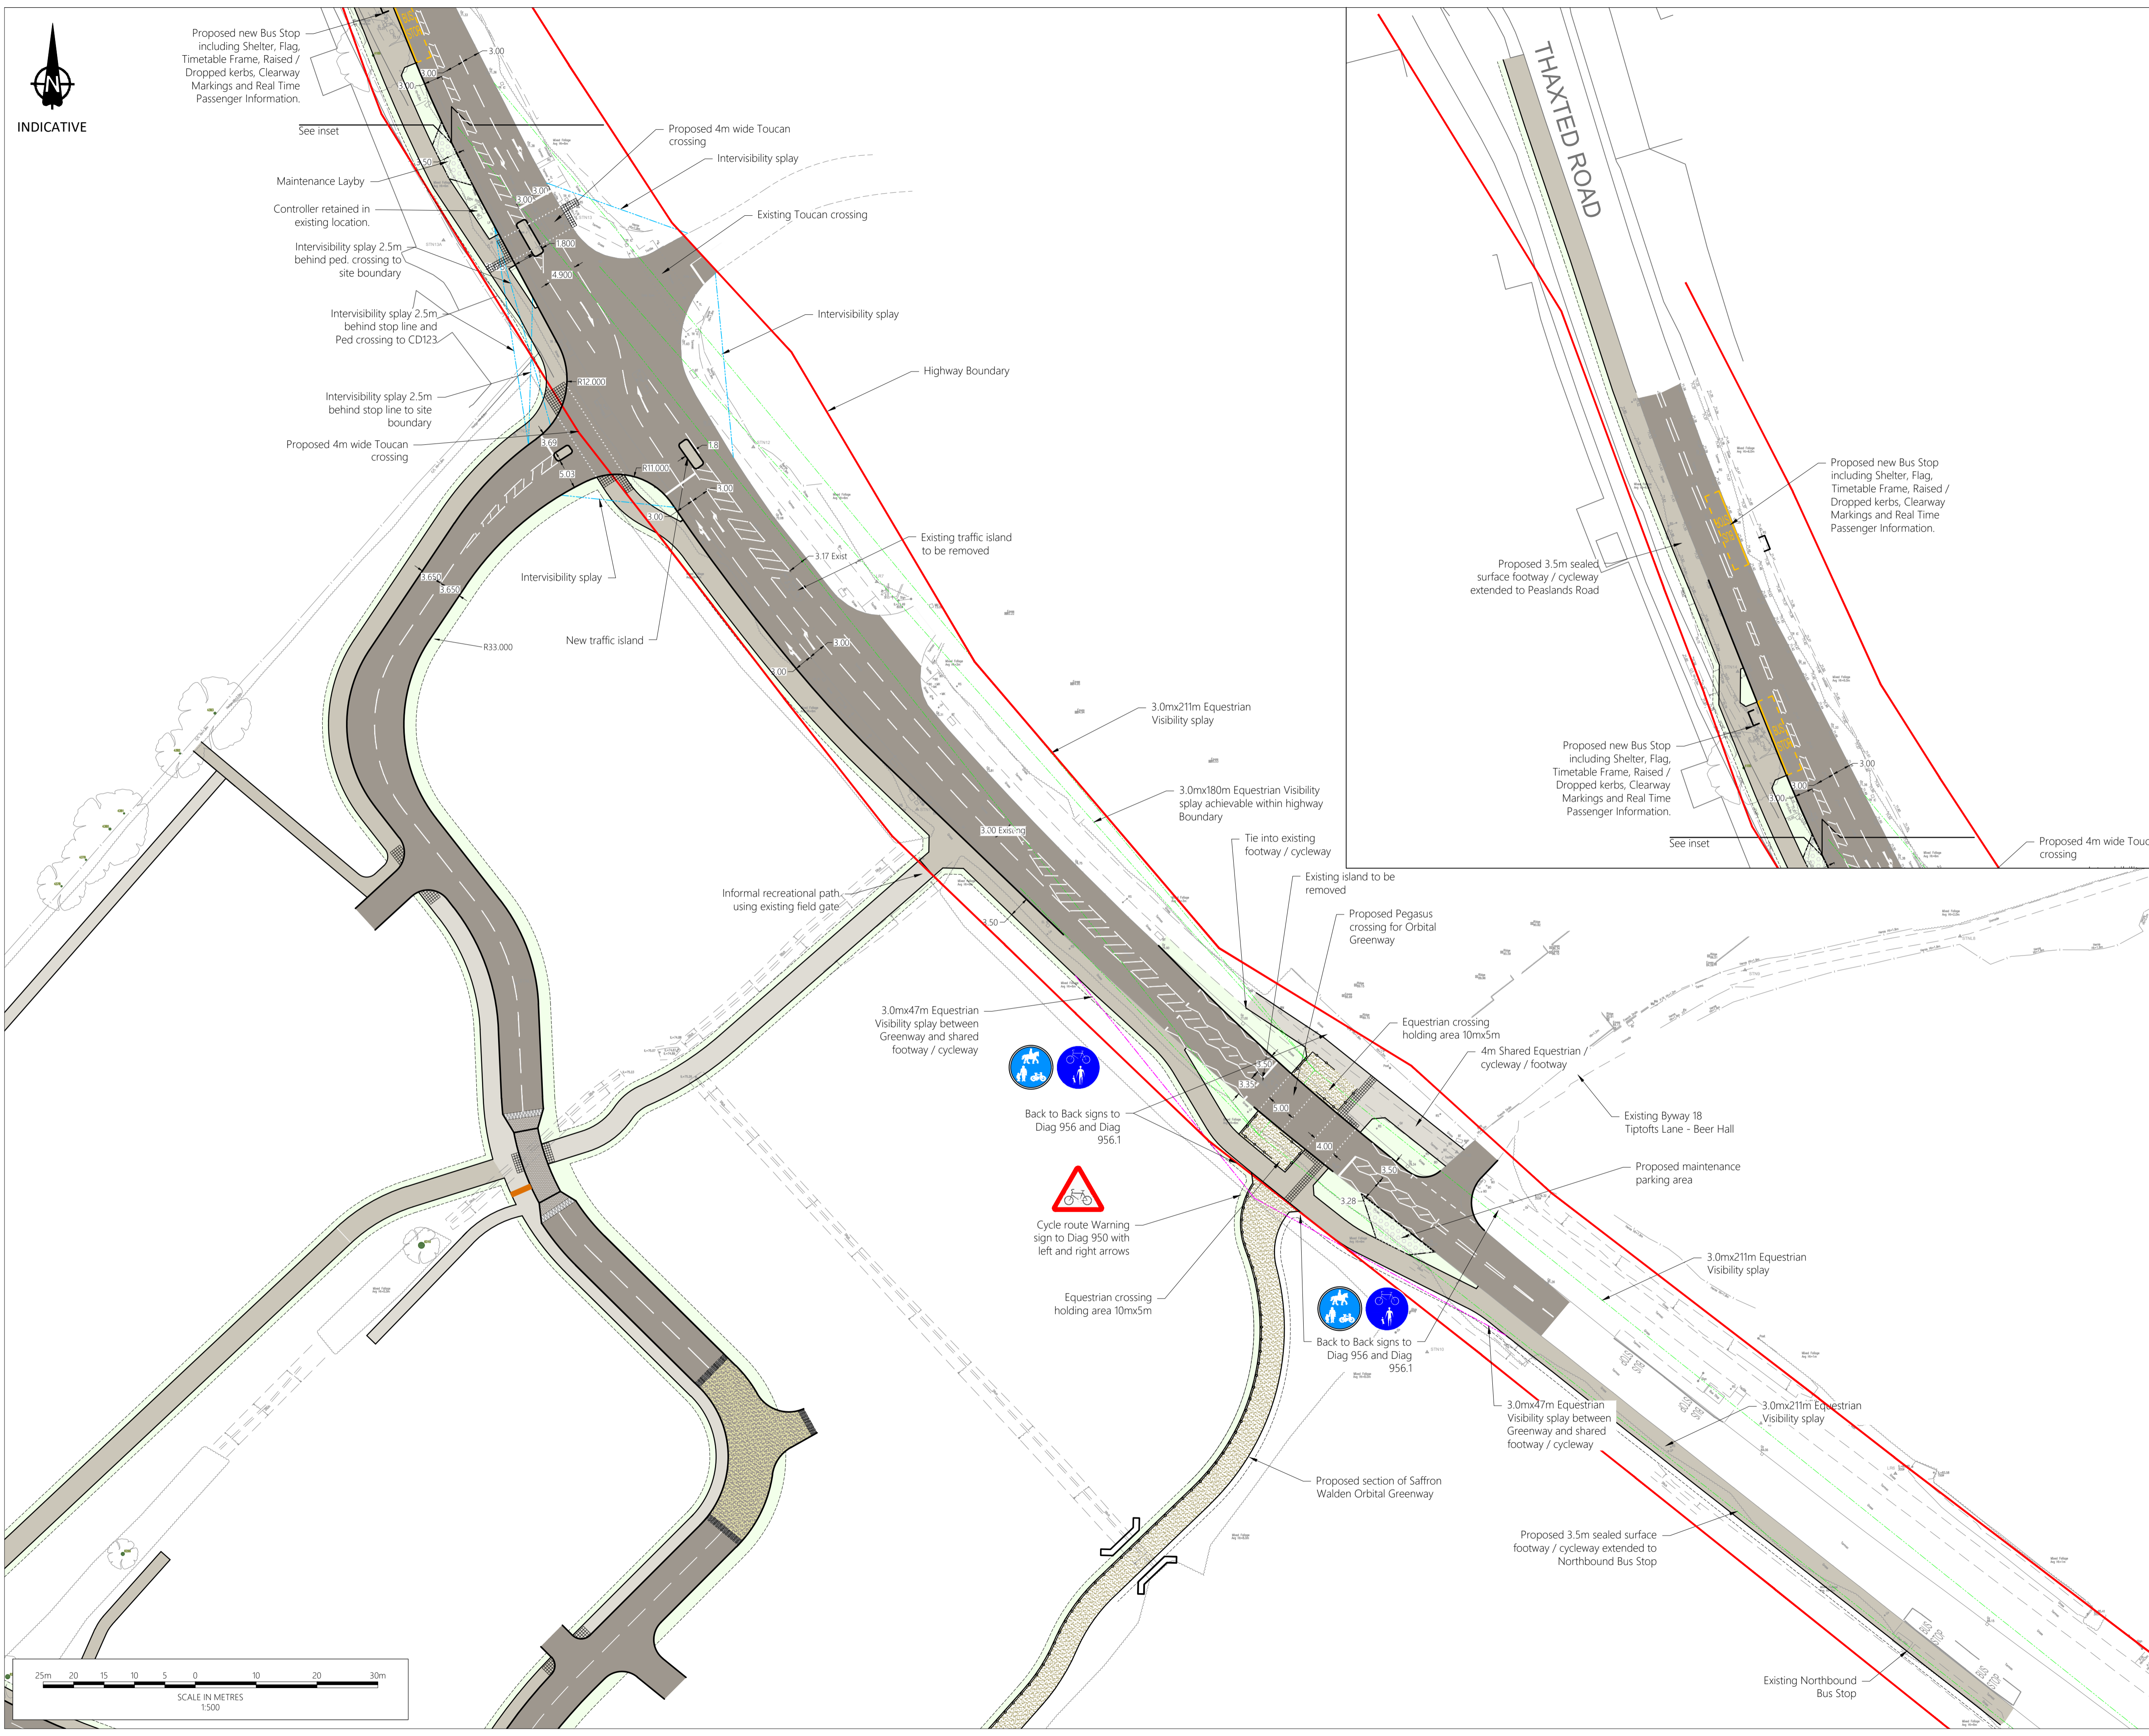
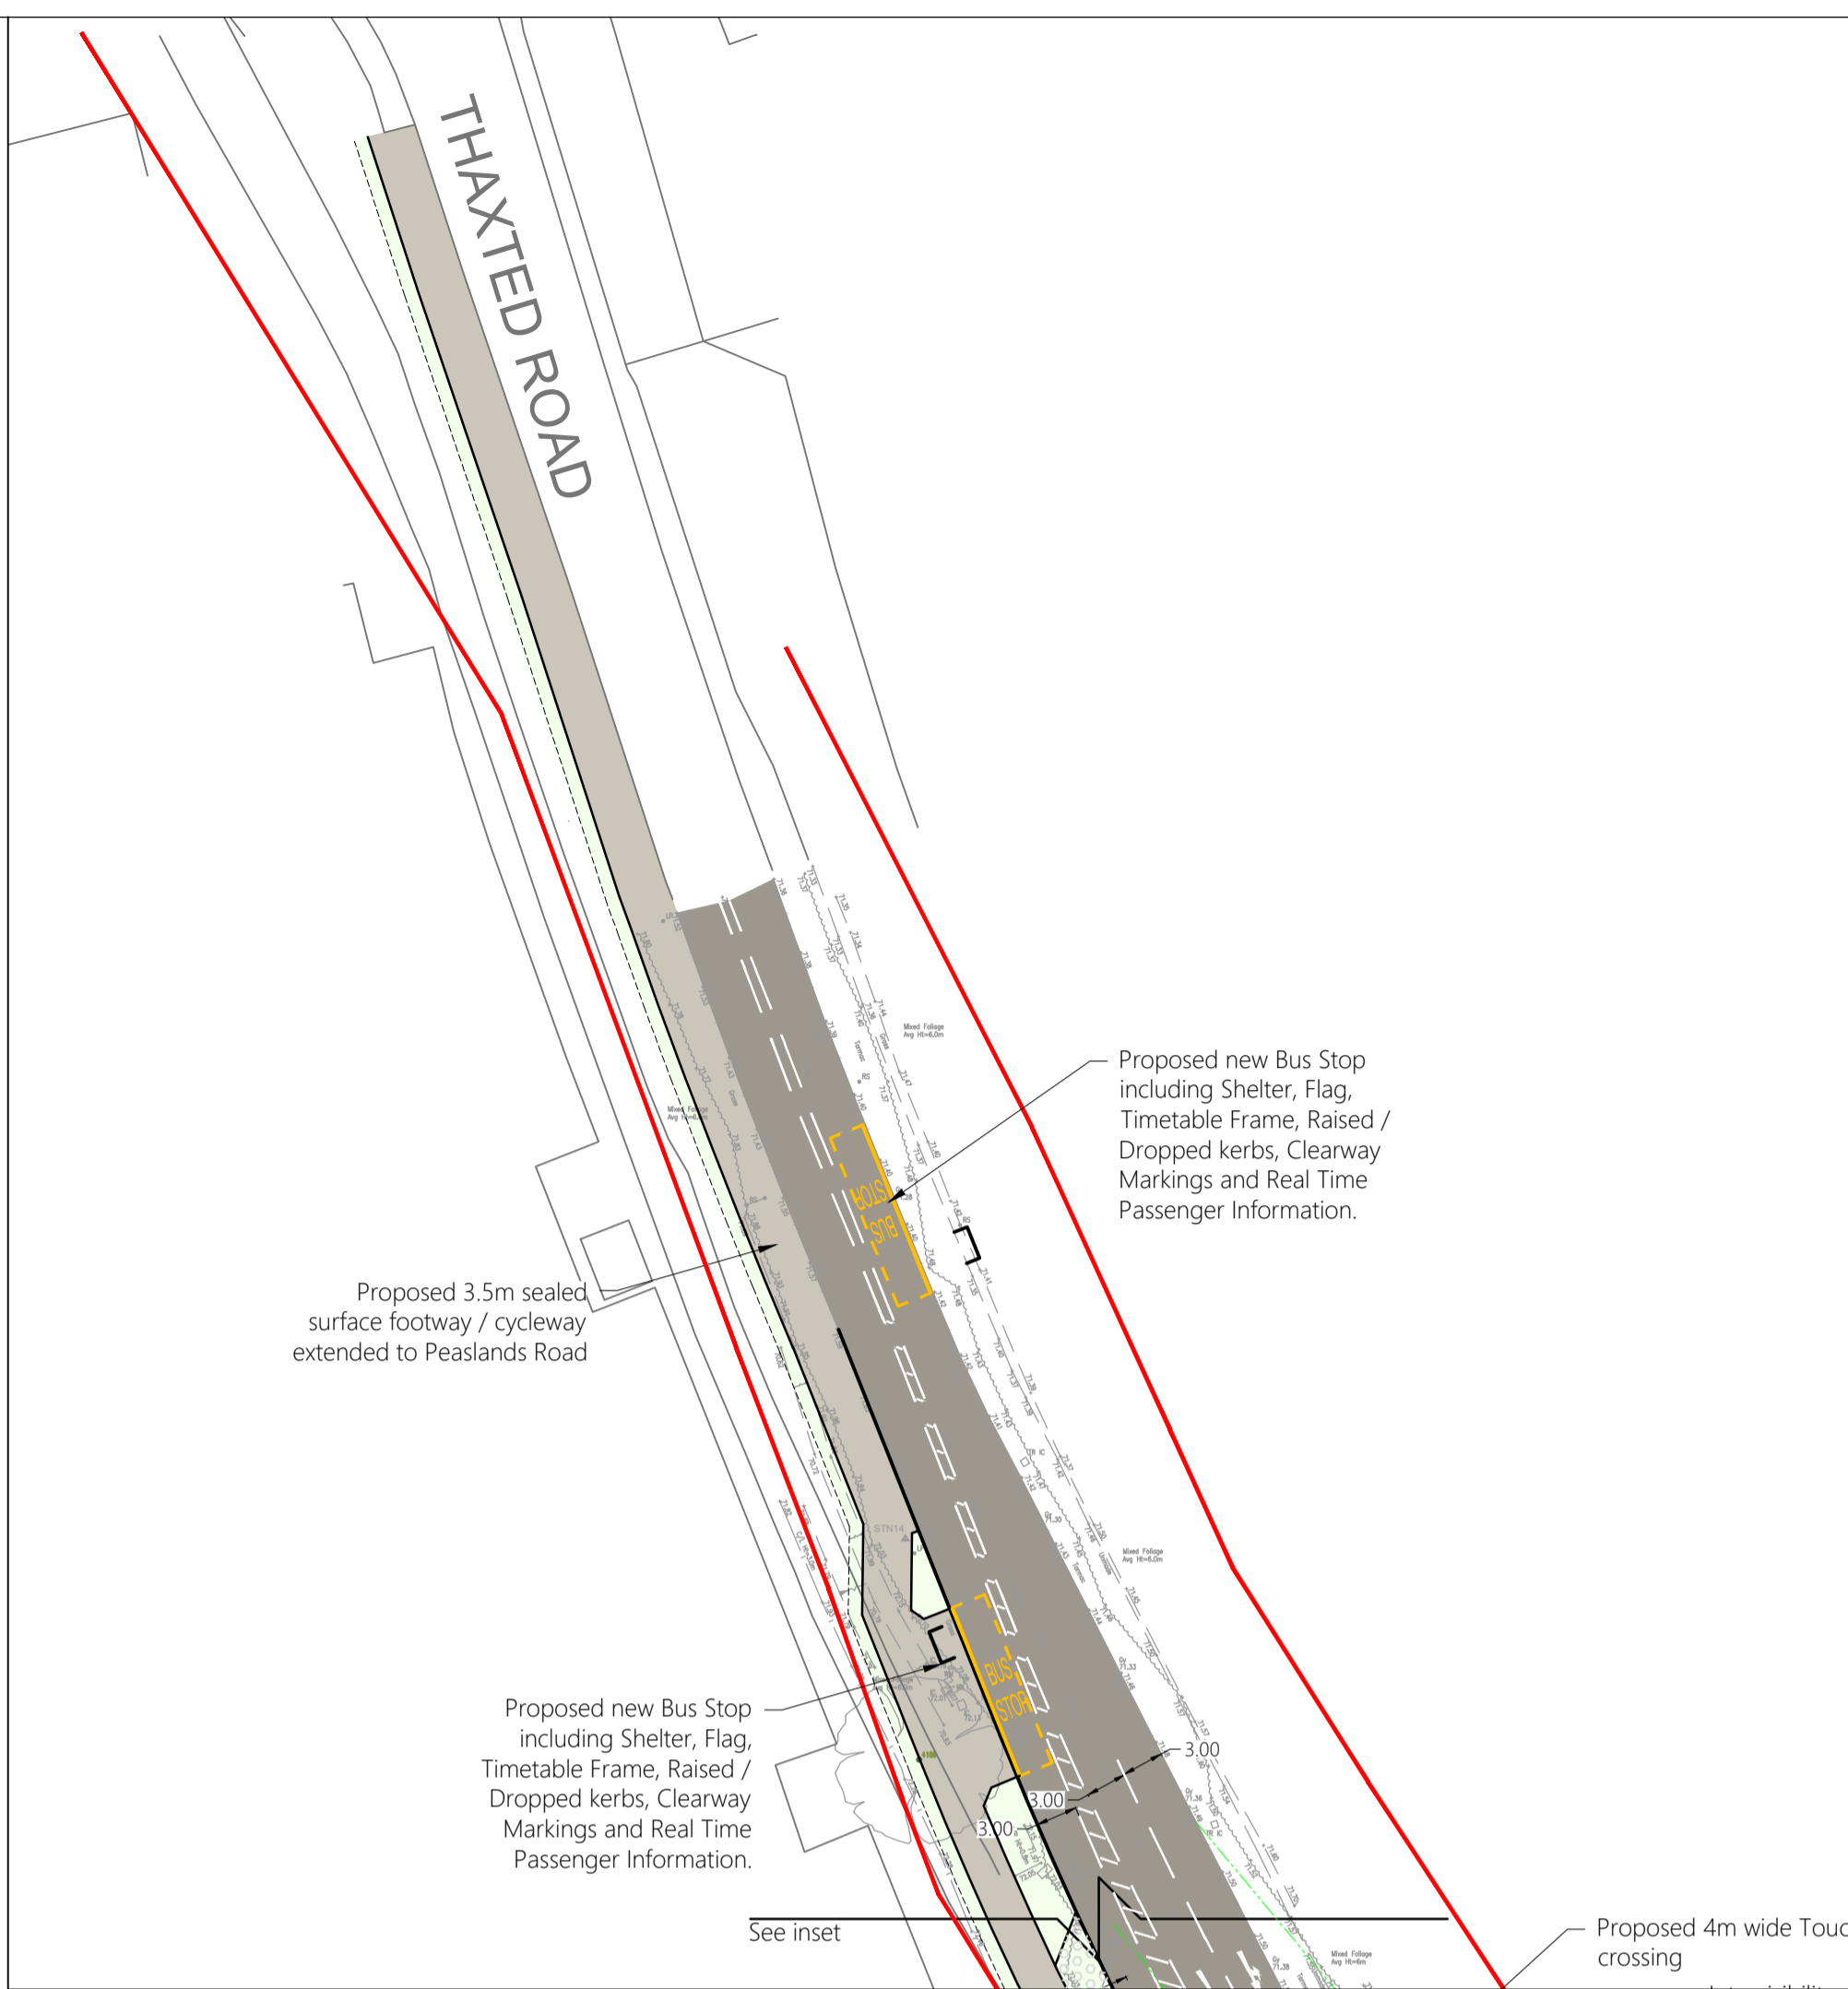
Proposed new Bus Stop including Shelter, Flag, Timetable Frame, Raised / Dropped kerbs, Clearway Markings and Real Time Passenger Information.
