Construction Noise and Vibration Monthly Report – February 2023

London Borough of Camden

Non-Technical Summary

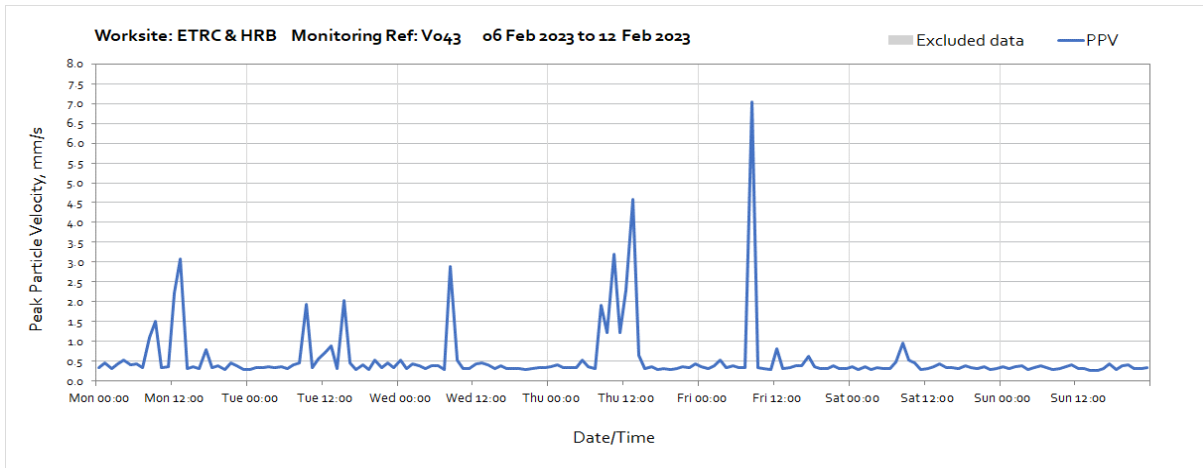
Note: High levels of vibration caused by works close to the monitor. Lower vibration levels anticipated at nearest receptor.
