## **Construction Noise and Vibration Monthly Report – February 2023**

**Lichfield District Council**

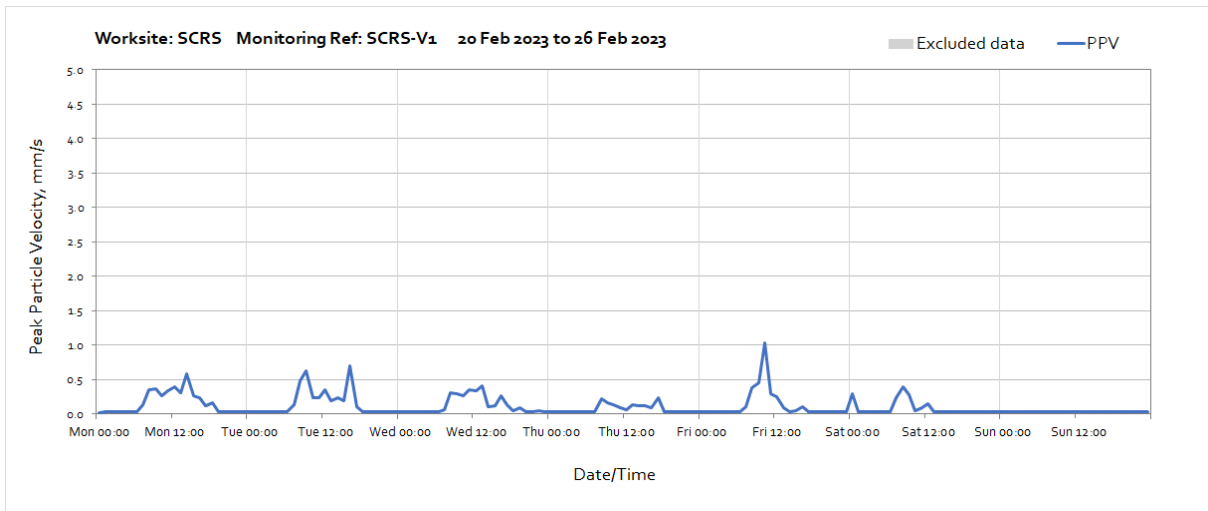
## Worksite: SCRS – Monitoring Ref: SCRS-V1

Note: High vibration levels measured at 10:00 on Friday 24<sup>th</sup> February was due to piling works in the vicinity of the monitor.
