April 2023

Construction Noise and Vibration Monthly Report – February 2023

Stratford-on-Avon District Council

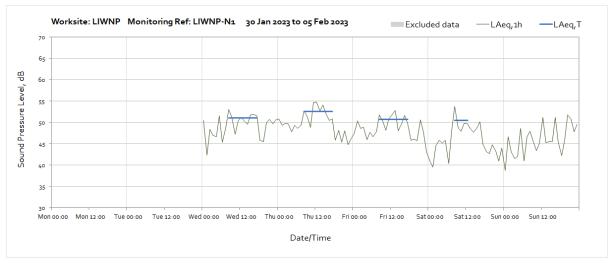
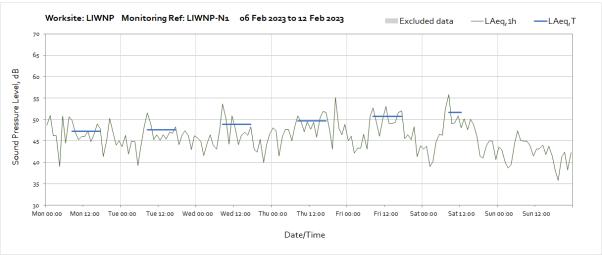
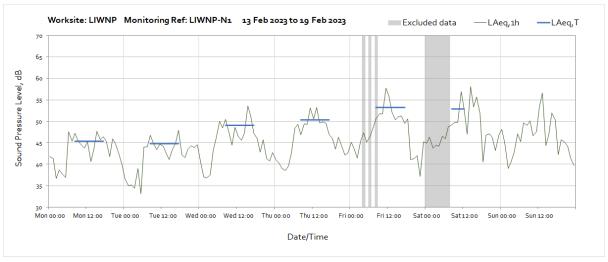
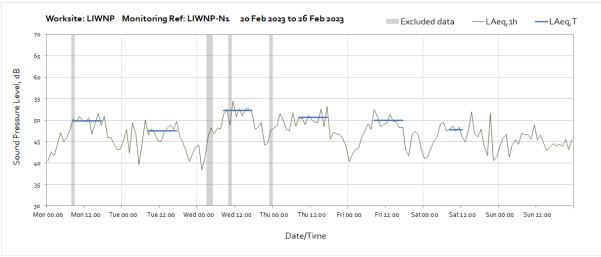
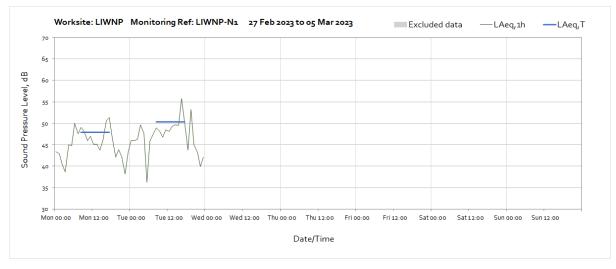
Worksite: LIWNP Monitoring Ref: LIWNP-N1

The following graphs show the hourly measured ambient noise level $L_{Aeq,1h}$ and, where relevant, the averaged noise level $L_{Aeq,T}$ values, where the time period T is as specified in Table 1 of HS2 Information Paper E23. Periods with adversely weather affected noise levels are greyed out and have been excluded from the calculation of the $L_{Aeq,T}$ values in Table 3 of the main report.

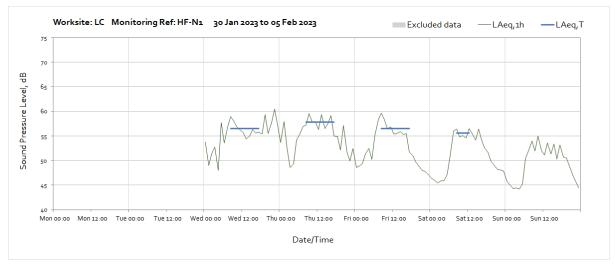
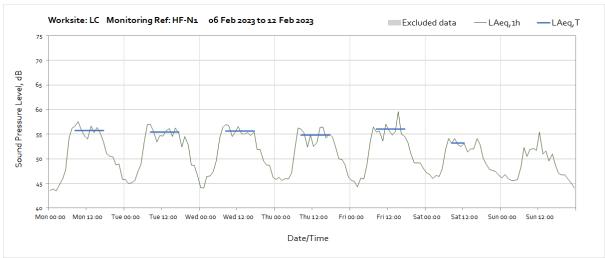
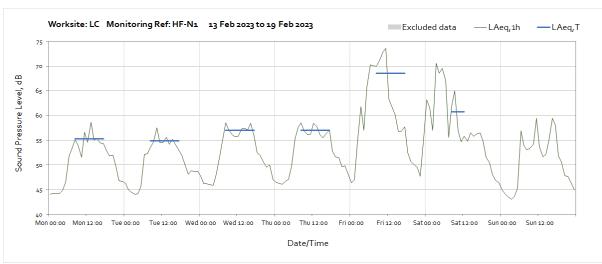
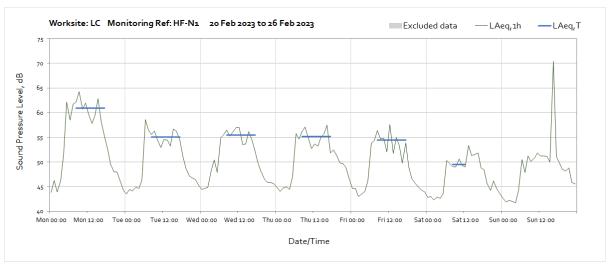
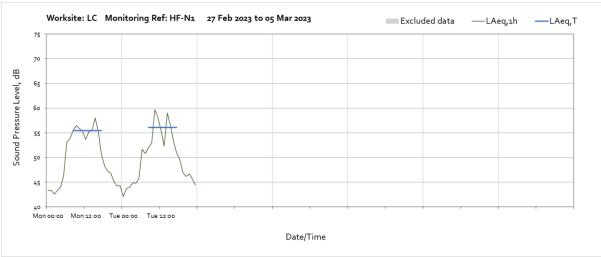
Worksite: LC Monitoring Ref: HF-N1

| Worksite Reference | Measuremen t Reference | Site Address | Day (Weekday, Saturday, Sunday, Night) | Time period | Number of exceedances of LOAEL | Number of exceedances of SOAEL |
|---|---|---|--|---|---|---|
| LC | HF-N1 | Harp Farm, Banbury Road, Southam | Saturday | 14:00-22:00 | 4 | No exceedance |

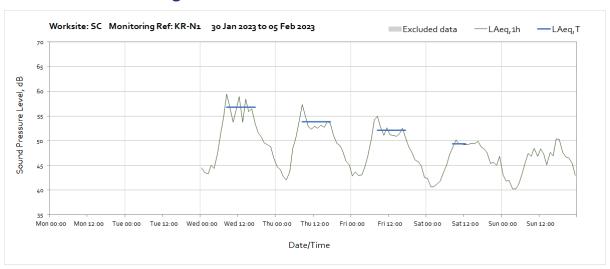
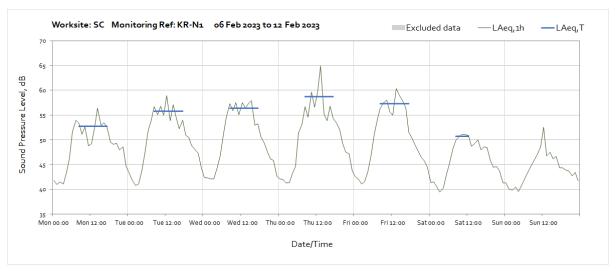
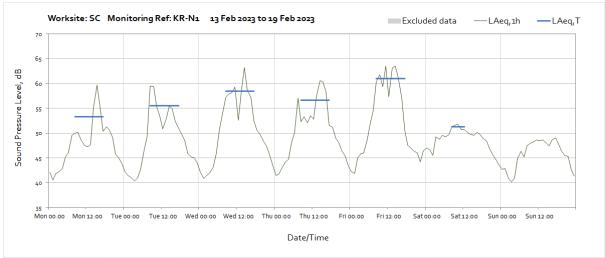
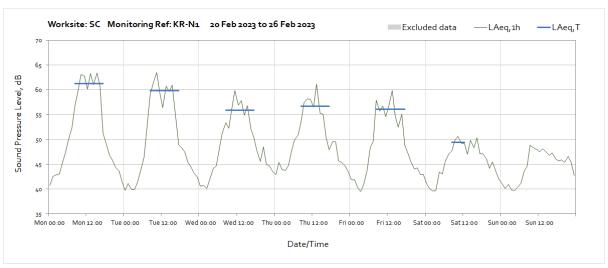
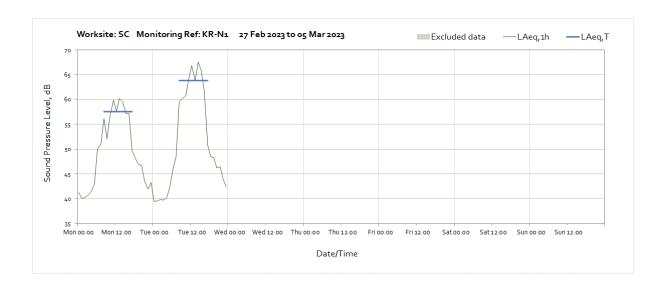
Worksite: SC Monitoring Ref: KR-N1

| Worksite Reference | Measuremen t Reference | Site Address | Day (Weekday, Saturday, Sunday, Night) | Time period | Number of exceedances of LOAEL | Number of exceedances of SOAEL |
|---|---|---|--|---|---|---|
| SC | KR-N1 | Kineton Road, Southam | Weekday | 08:00-18:00 | 1 | No exceedance |

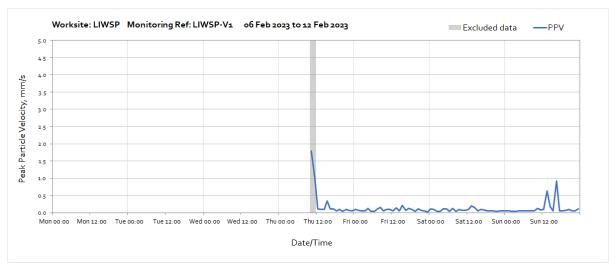
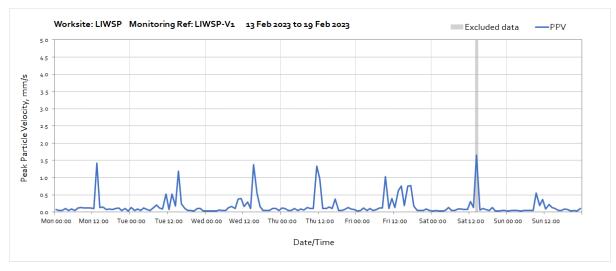
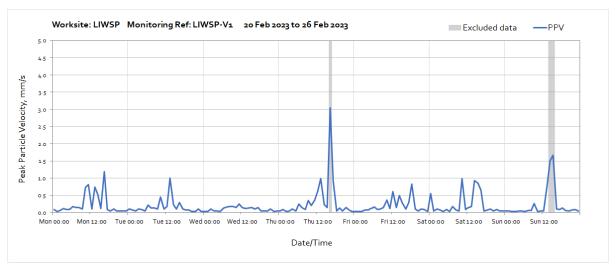
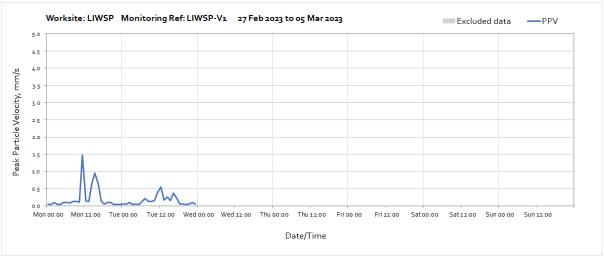
Worksite: LIWSP Monitoring Ref: LIWSP-V1

| Worksite Reference | Measurement Reference | Monitor Address | Highest PPV measured in any axis, mm/s |
|---|---|--|--|
| LIWSP - Long Itchington Wood South Portal | LIWSP-V1 | Woodside House, Bascote Heath, Southam | 1.12 (Z-axis) |

The following graphs show the hourly measured peak particle velocity PPV recorded during the monitoring period. The graphs show the highest PPV of the three orthogonal axes x, y and z. Where high values of PPV were caused by local interference with the vibration monitor, which are not representative of HS2 construction works, these values have been greyed out in the following charts and have been excluded to calculate values in Table 4 of the main report.

Note: Missing data at the beginning of the month was due to loss of solar power caused by poor sunshine in the month of February. An extra battery was added to the system at 10:00 on Thursday 9th February with view of minimising further loss of data.
